ENVIRONMENTAL ASSESSMENT

Appendix E: Cultural Resources Survey

I-405, SR 522 Vicinity to SR 527 Express Toll Lanes Improvement Project (MP 21.79 to 27.06)

Cultural Resources Survey for the Interstate 405, SR 522 Vicinity to SR 527 Express Toll Lanes Improvement Project in King and Snohomish Counties, Washington

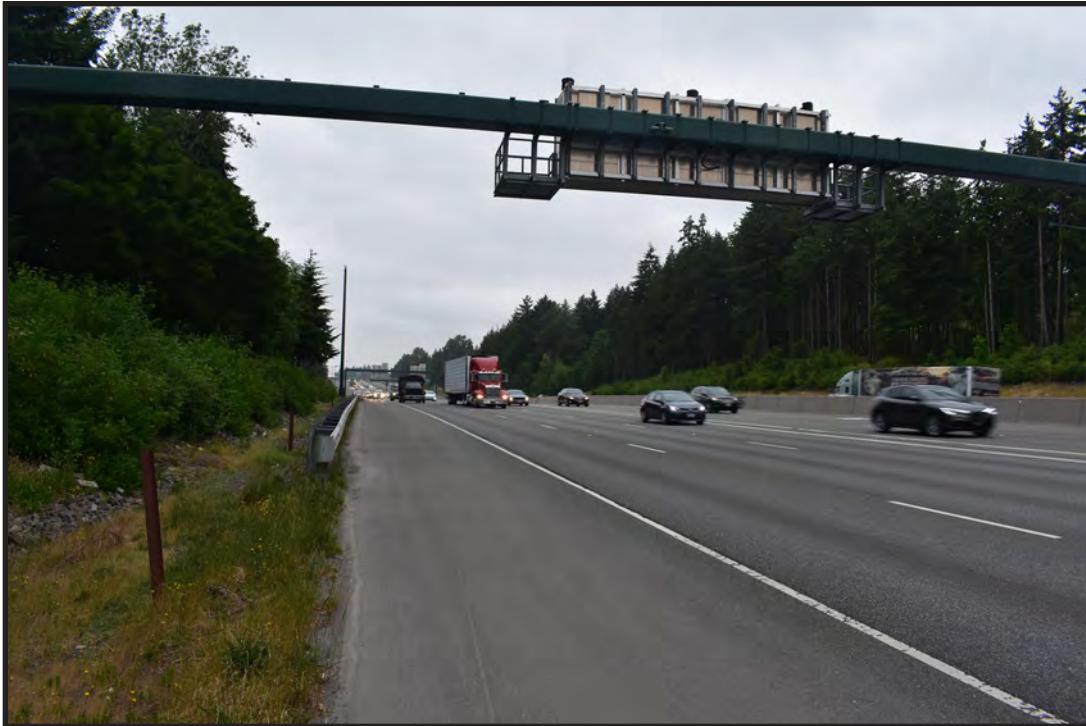
Exhibit 6-3. Overview of Zone 15 in the southern project study area, view is to the north.

Zone 15 is the southernmost zone in the study area and encompasses the existing I-405 northbound and southbound lanes (see Exhibit 1-2). Surface conditions within the LoC consist of the level, paved surface of I-405 (Exhibits 6-3 and 6-4). Intact, shallow (less than 20 cm below the ground surface) Holocene sediments have been documented to the east of the I-405 northbound lane and outside of the Project's LoC (Bundy 2009). Sediments are mapped as Arents-Alderwood material, which forms in Pleistocene glacial till on plains (Soil Survey Staff 2019). Bundy (2009) classified Zone 15 as Restricted because of the presence of shallow Holocene sediments but concluded the probability was low for the area to contain archaeological resources. The portion of Zone 15 within the LoC is considered "unrestricted" due to the proposed construction involving minimal ground disturbance related to restriping and resurfacing, which is limited to the extant northbound lanes of I-405. Survey was not conducted in the LoC of Zone 15 due to the lack of unpaved surfaces.

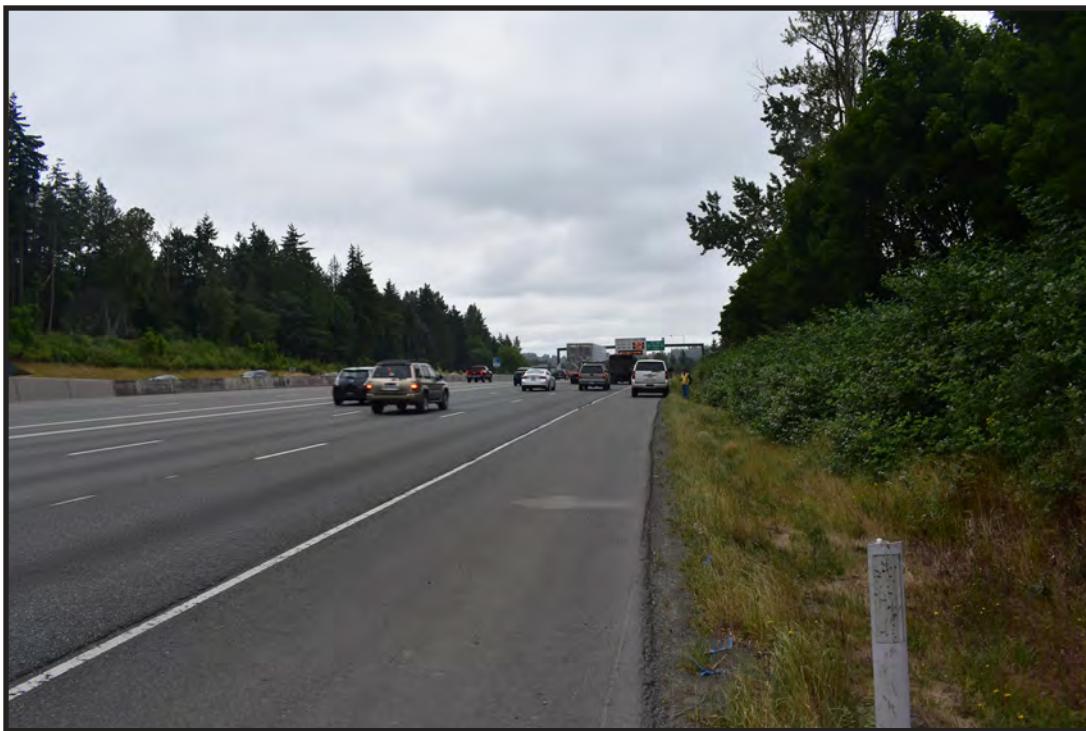
Exhibit 6-4. Overview of Zone 15 in the southern project study area, view is to the south.

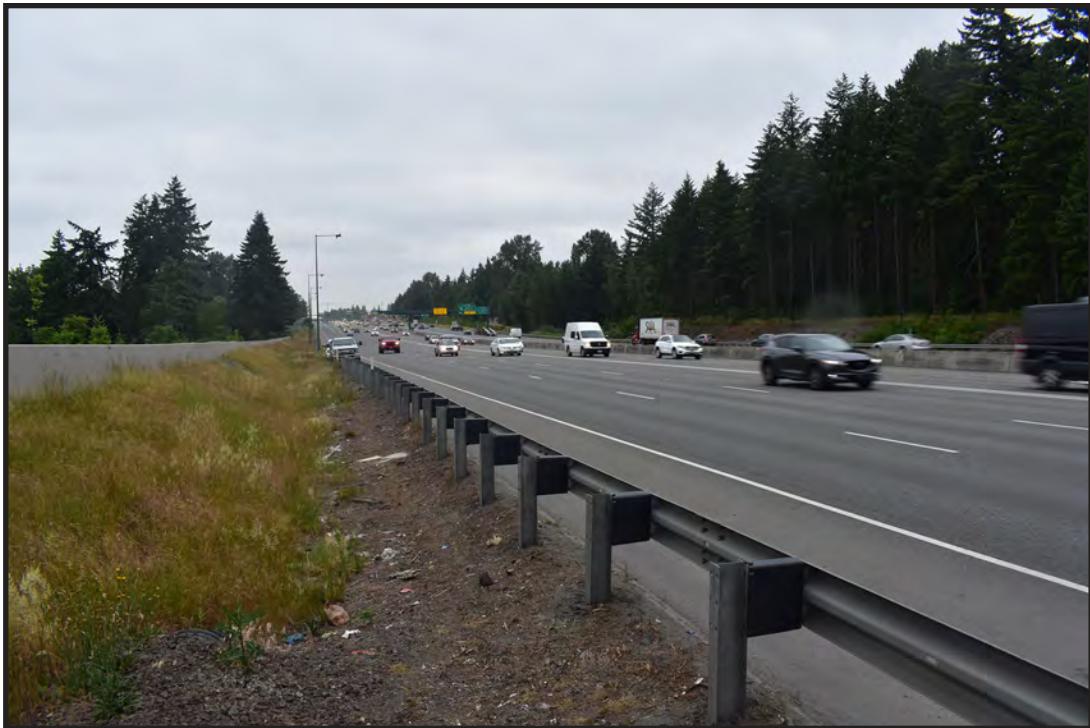
Exhibit 6-5. Overview of Zone 16 in the southern project study area, view is to the north.

Zone 16 is in the southern portion of the study area and encompasses the existing I-405 northbound and southbound lanes including the area along Juanita Creek (see Exhibit 1-2). Zone 16 within the LoC consists of a level, paved surface on an elevated fill prism in an area drained by the upper reaches of Juanita Creek (Bundy 2009). The fill prism is situated atop glacial alluvial landforms that abut major creeks in the area, which include eskers and kames. Sediments are mapped as part of the Rasagnar-Indianola association, which forms in Pleistocene glacial outwash on eskers, kames, and terraces (Soil Survey Staff 2019). Survey was not conducted in the LoC of Zone 16 due to the lack of unpaved surfaces. Proposed construction is limited to the repaving of extant northbound lanes of I-405, at the location of the high fill prism above Juanita Creek (Exhibits 6-5 and 6-6). The depth of fill is unknown, and native sediments may be present under the fill layer. As no Project-related disturbances to native sediments are proposed within Zone 16, no shovel testing was conducted.

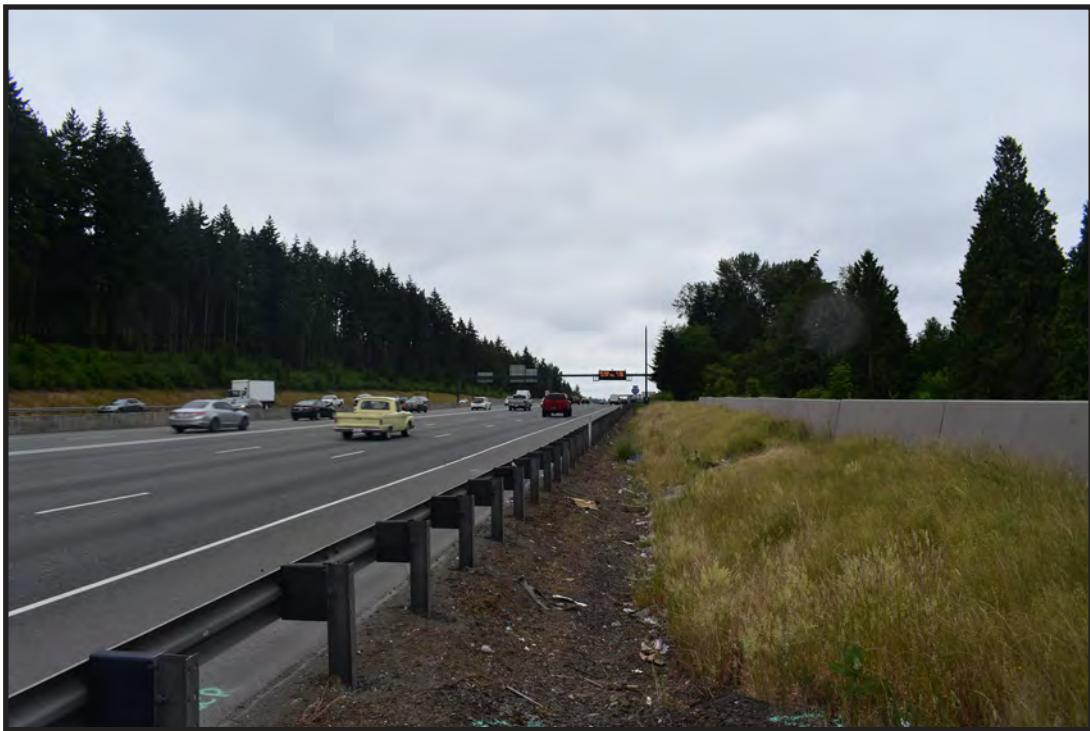
Exhibit 6-6. Overview of Zone 16 in the southern project study area, view is to the south.

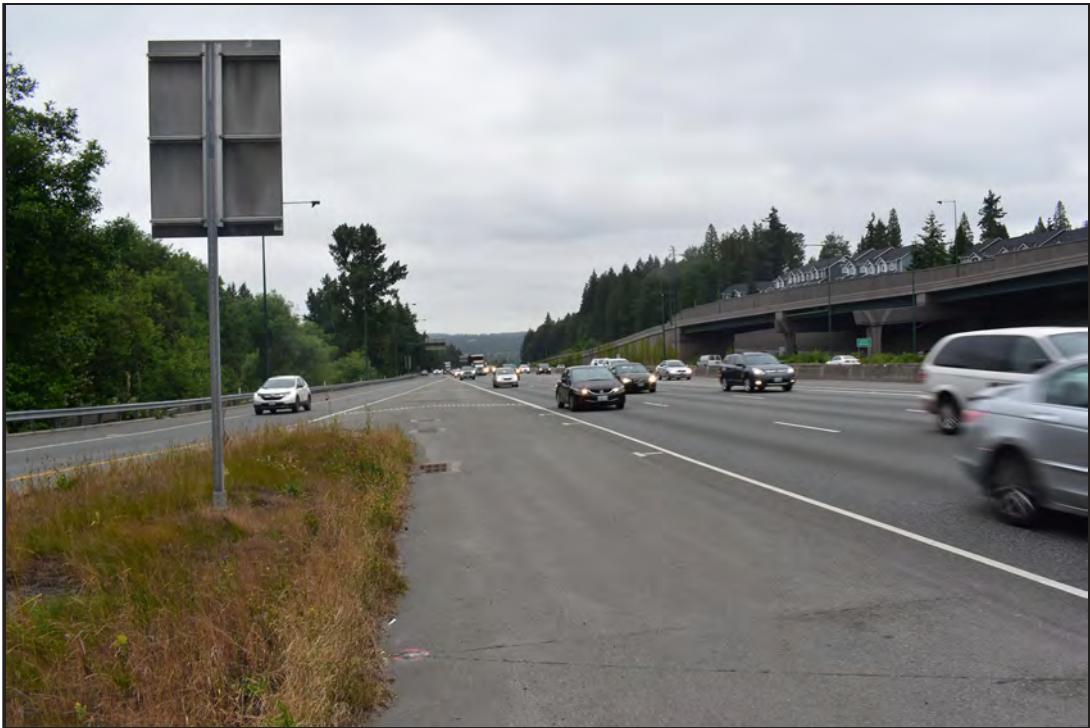
Exhibit 6-7. Overview of Zone 17 in the southern project study area, view is to the south.

Proposed construction is limited to the extant northbound and southbound lanes of I-405, with the installation of stabilized fill and retaining wall pilings adjacent to the southbound lanes of I-405 near the north end of the zone (Exhibits 6-7 through 6-8). No STs were excavated, as no Project-related disturbances to native sediments are proposed within Zone 17.

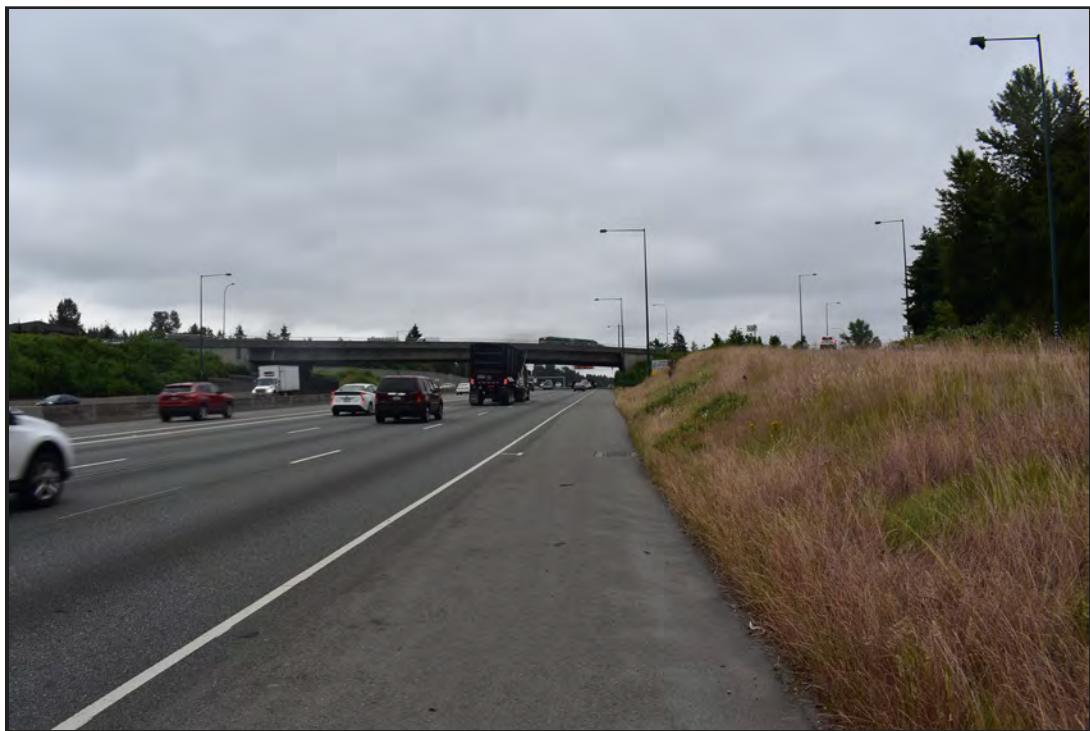
Exhibit 6-8. Overview of Zone 17 in the southern project study area, view is to the north.

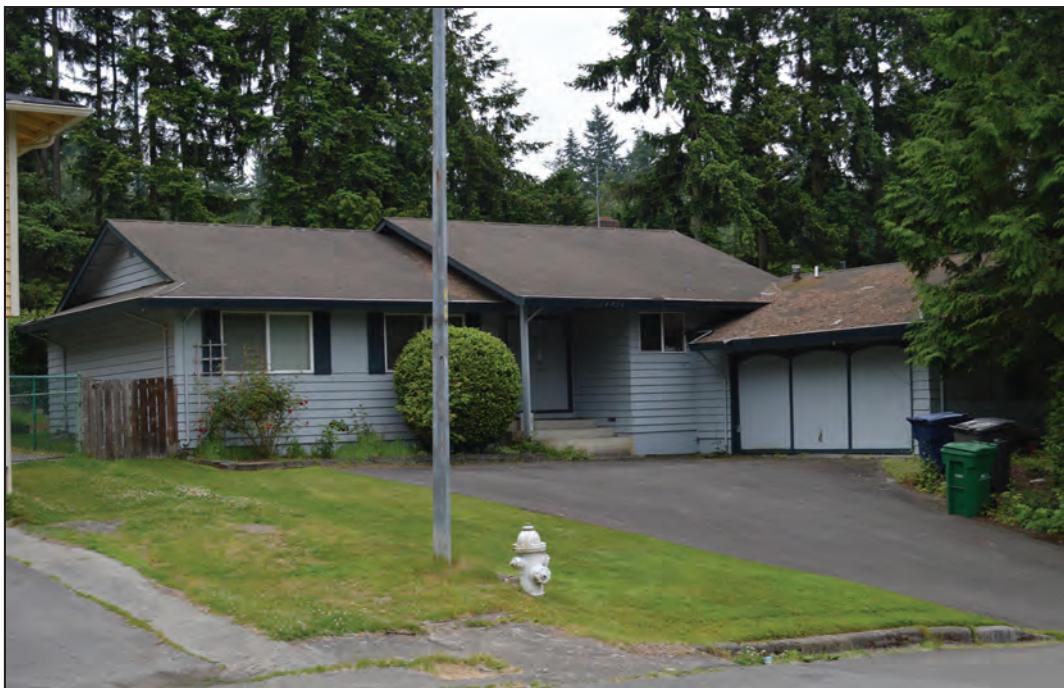
Exhibit 6-9. Property 382500 is within the Windsor Vista subdivision-associated study area. While not NRHP individually eligible, the 1967 single-family residence is an contributing element to a subdivision-based historic district. Property 382500 closely resembles home Model 301, used in late-1960s advertising for the new Windsor Vista development.

Twelve historic built environment resources were observed within the study area adjacent to Zone 17 (see Exhibit 1-2). Nine properties associated with the Windsor Vista subdivision are extant on the west side of the I-405, while three properties associated with the Queensgate subdivision are along the east side. The historic resources are composed of single-family residences built in 1967 and 1968 that are typical of subdivision development of the era. None of these resources is considered individually eligible for listing in the NRHP. Two NRHP historic districts are likely present, each composed of the residential subdivisions adjacent to each side of I-405 in Zone 17. Six of the 12 historic built environment resources form contributing elements to the historic districts, while the remaining six are non-contributing elements. See Exhibit 6-2 and Section 6.19.16 for detail regarding the built environment resources' NRHP status. Exhibits 6-9 and 6-10 show representative examples of these historic resources (see Attachment B for full descriptions)

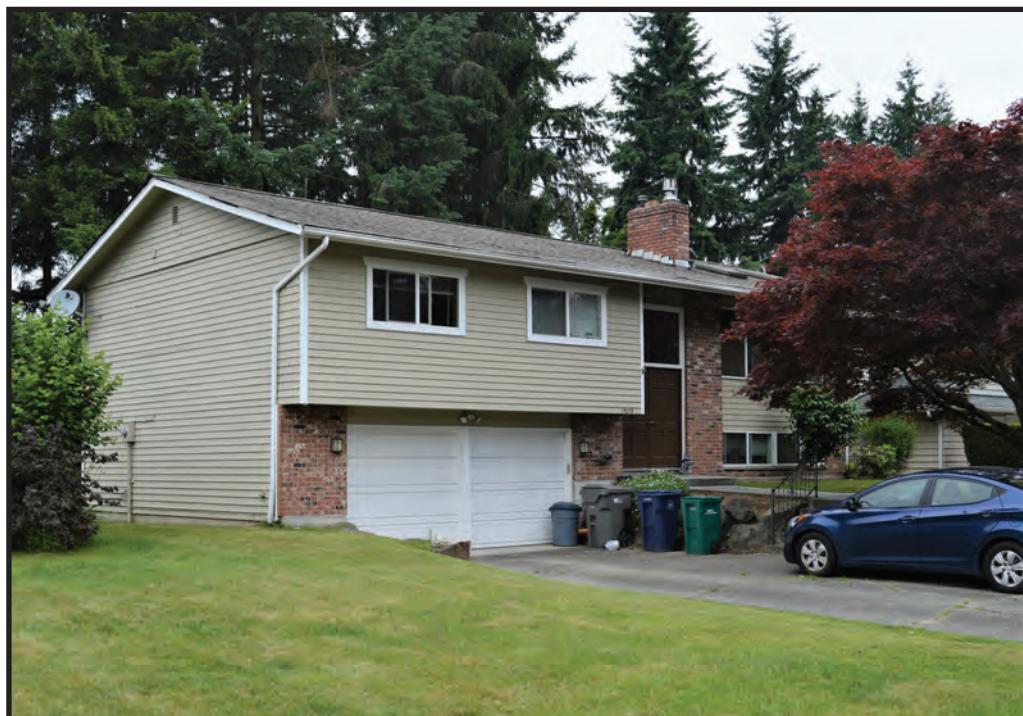
Exhibit 6-10. The 1968 dwelling, property 282698, is within the Queensgate subdivision-associated study area. The residence is not individually eligible for the NRHP, but is a contributing resource to a potential subdivision-based historic district.

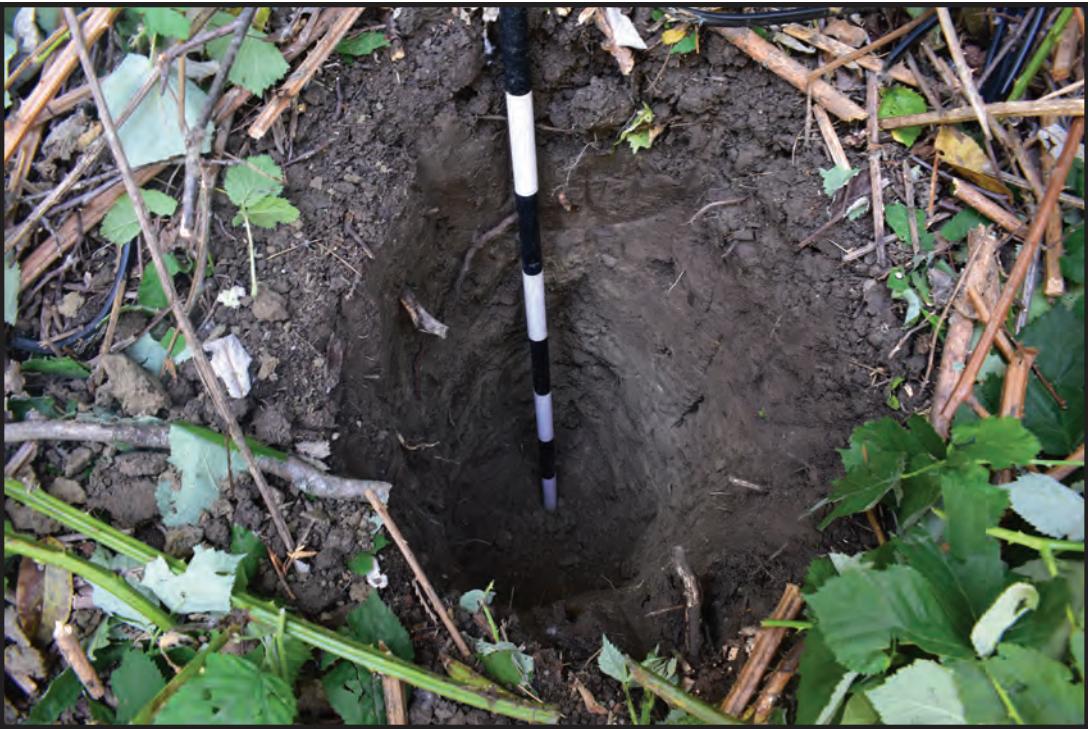
Exhibit 6-13. The ST 12 east wall profile. The ST was excavated to 75 cm below surface, exposing thin Holocene sediments overlying an intact soil profile that forms in Pleistocene glacial outwash. The ST contained no cultural materials. The scale consists of 10-cm long segments.

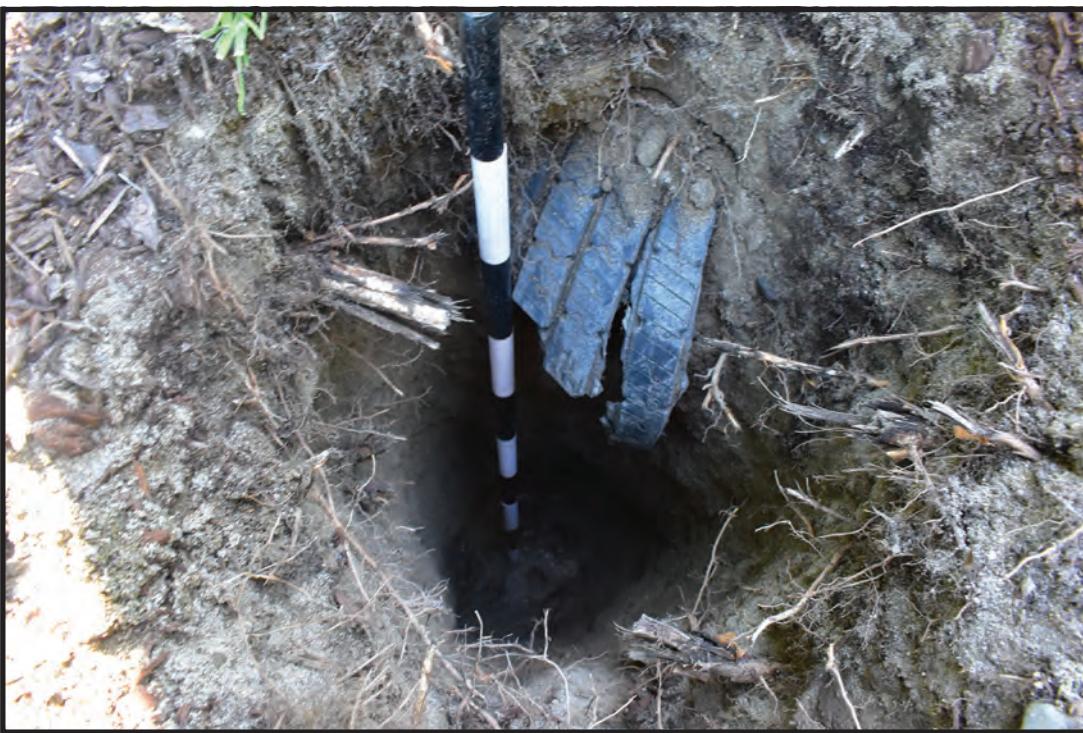
Exhibit 6-15. The ST 13 south wall profile. The ST was excavated down to 110 cm below surface, exposing road fill slope sediments, a tire, and modern debris. The ST contained no historic or precontact cultural materials. The scale is made of 10-cm long segments.

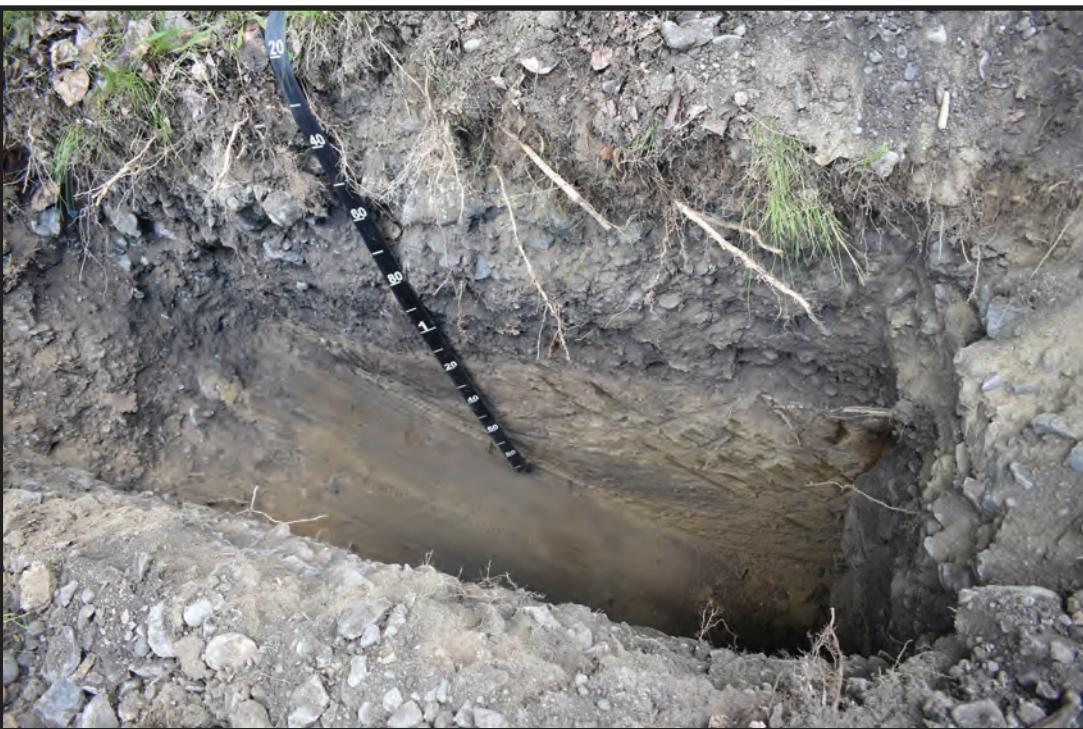
Exhibit 6-16. Pit 1 west wall profile. Trench 1 was excavated down to 260 cm below surface, exposing road fill slope sediments overlying intact Holocene floodplain deposits. The trench contained no historic or precontact cultural materials. The scale is marked with 10-cm long increments.

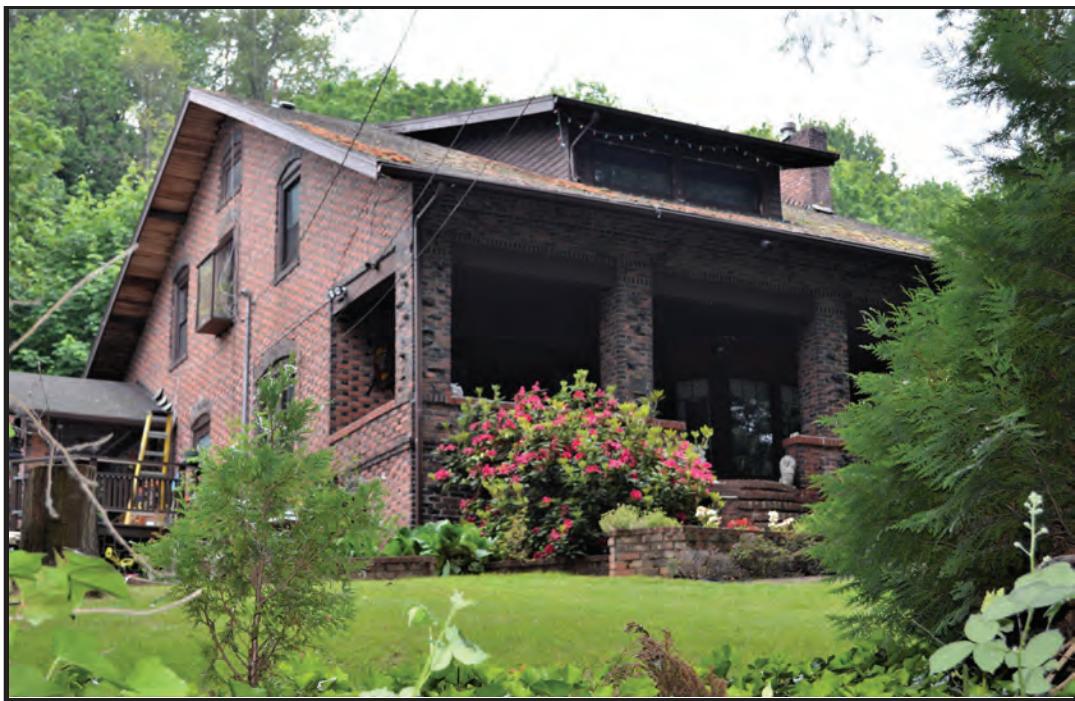
Exhibit 6-17. Constructed in 1906, property 40731 is an excellent local example of Craftsman/Bungalow style architecture, view is to the south. The brick dwelling maintains good integrity, and was determined eligible by DAHP for listing in the NRHP in 2005. The project will not impact the historic property.

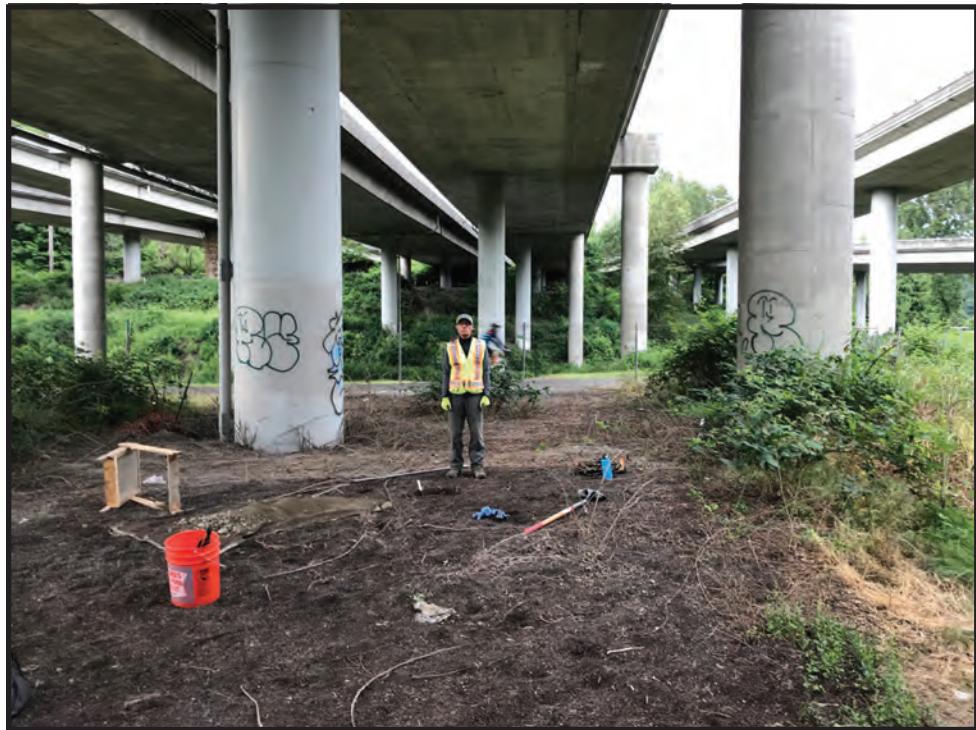
Exhibit 6-19. Overview of the I-405/SR-522 interchange area near the southern boundary of Zone 19, view is to the south. This modified landscape contains numerous overpass supports and significant sediment disturbances. Crewmember is standing at ST 27 with the Sammamish River and bike trail in the background.

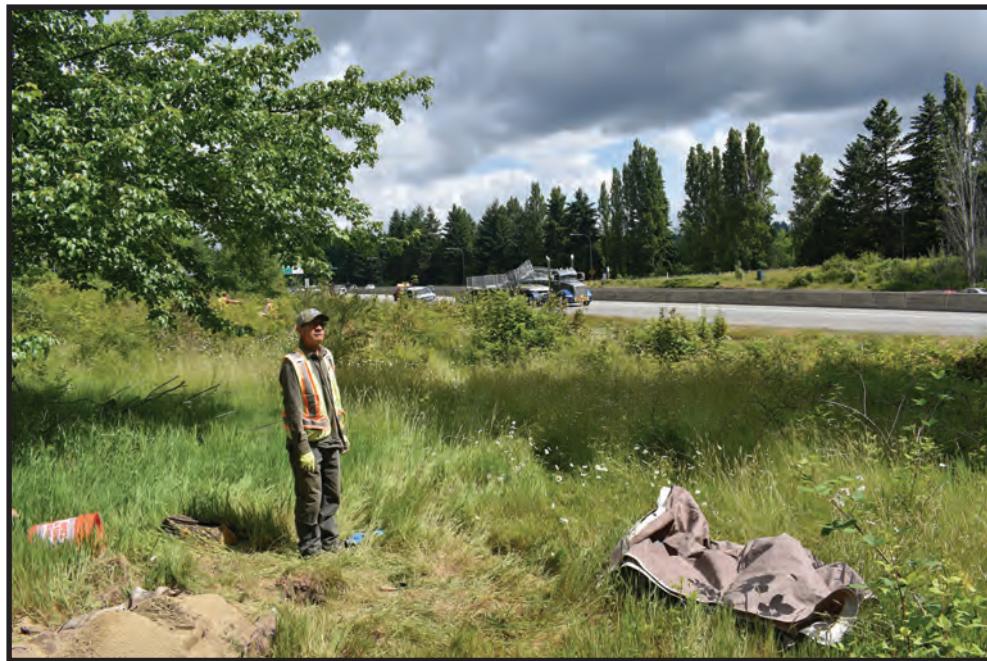
Exhibit 6-20. Overview of a grassy area west of the I-405 southbound lanes just north of NE 195th Street, view is to the northeast. This area in Zone 19 contains compacted fill overlying intact soil profiles that form in Pleistocene glacial outwash. Crewmember is standing at ST 66 with I-405 in the background.

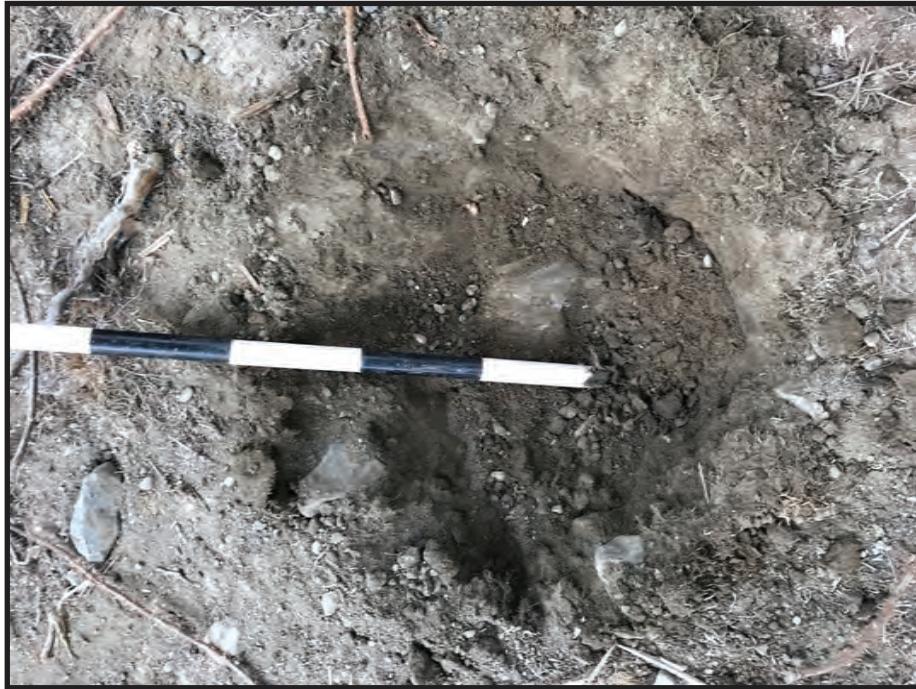
***Exhibit 6-22.** The ST 26 east wall profile. The ST was excavated down to 18 cm below surface, exposing compacted fill sediments that contained imported angular cobbles. The ST contained no historic or precontact cultural materials. The scale is made of 10-cm long increments.*

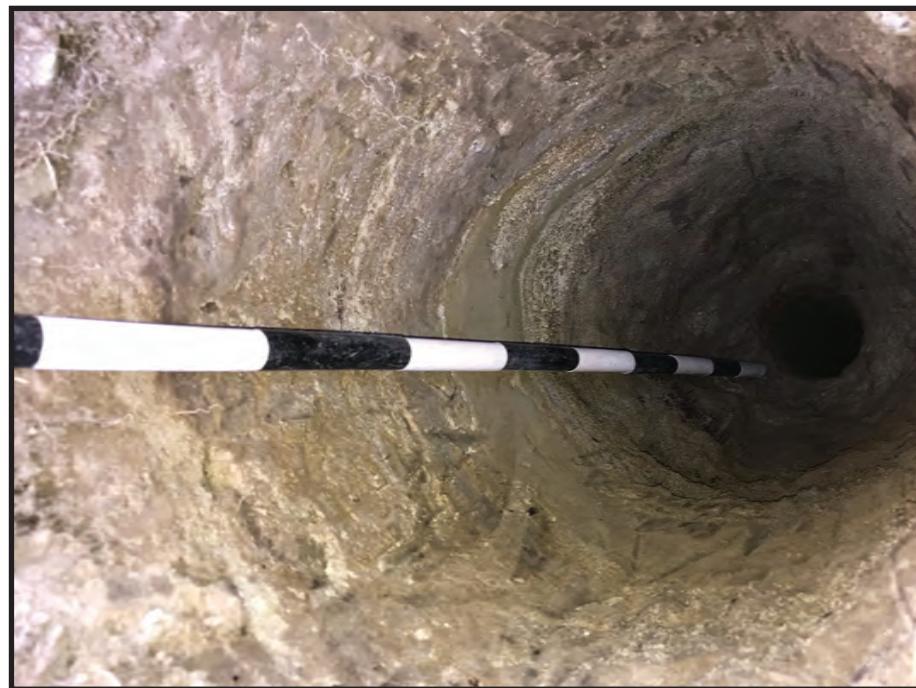
***Exhibit 6-21.** The ST 18 north wall profile. The ST was excavated down to 290 cm below surface, exposing thin fill sediments overlying intact and stratified Holocene floodplain deposits. The ST contained no historic or precontact cultural materials. The scale is divided by 10-cm long increments.*

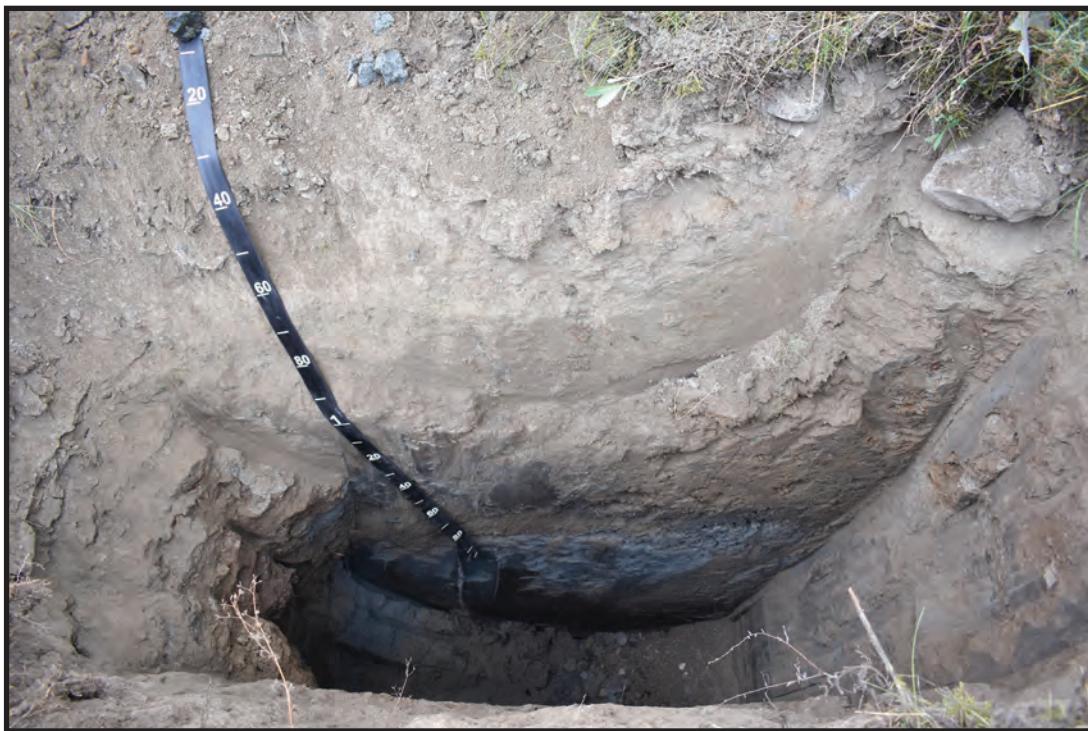
Exhibit 6-24. Pit 4 west wall. The pit was excavated to 236 cm below surface, exposing fill sediments overlying intact Holocene floodplain deposits. The pit contained no historic or precontact cultural materials. The scale is marked with 10-cm long increments.

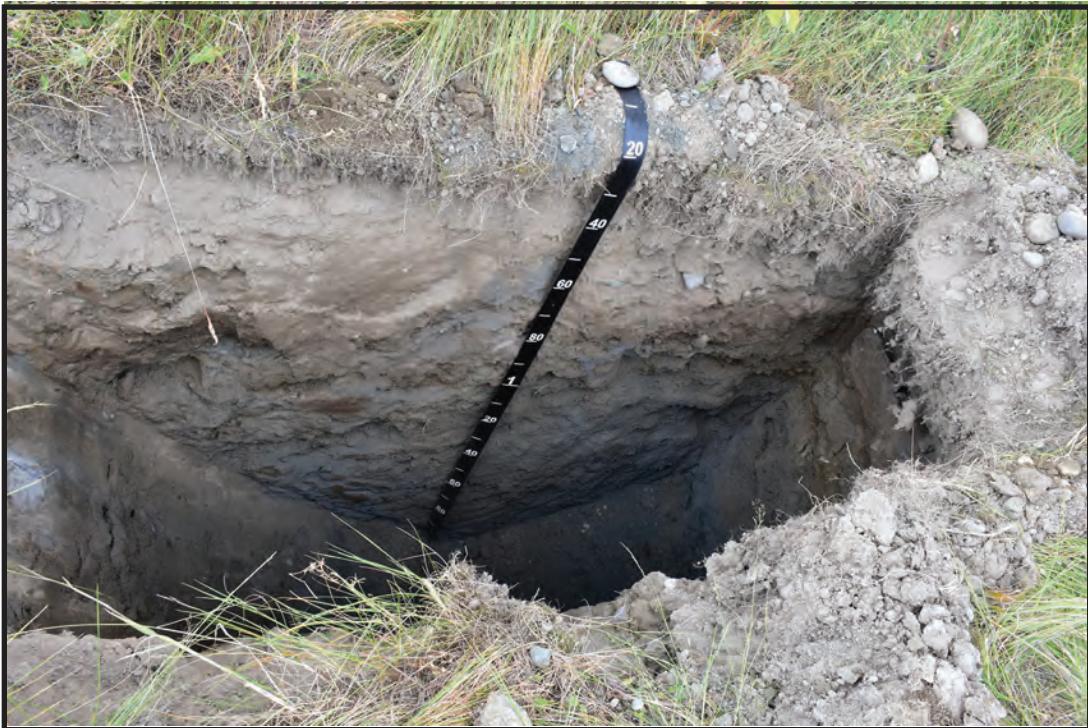
Exhibit 6-25. Pit 13 east wall profile. Pit 13 was excavated down to 213 cm below surface, exposing fill sediments that contained an unnatural mixture of imported cobbles and native sediments observed nearby. The trench contained no historic or precontact cultural materials. The scale is marked with 10-cm long increments.

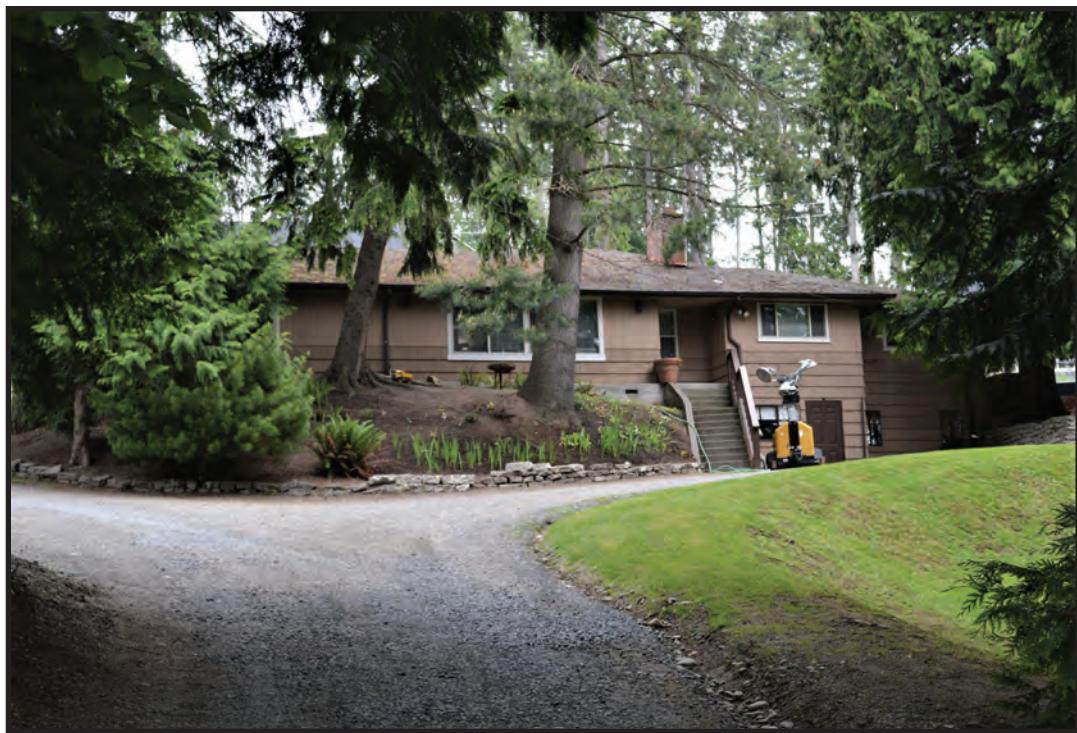
Exhibit 6-26. Constructed in 1955, property 719423 is a single-family residence adjacent to the west side of Zone 19, view is to the west. The resource is not recommended as eligible for listing in the NRHP.

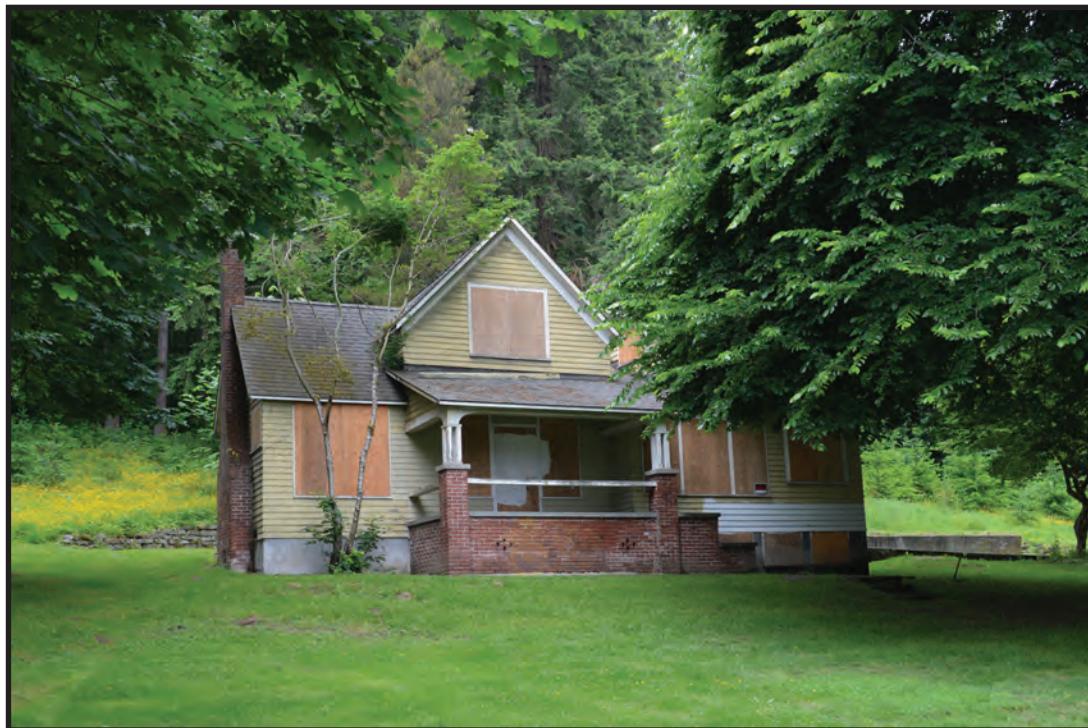
Exhibit 6-27. Property 644373 was determined not eligible for listing in the NRHP in 2017, view is to the west. Today, the resource is within the boundary of the City of Bothell's North Creek Forest Park. Other historic-era residences once adjacent to the subject resource are no longer extant.

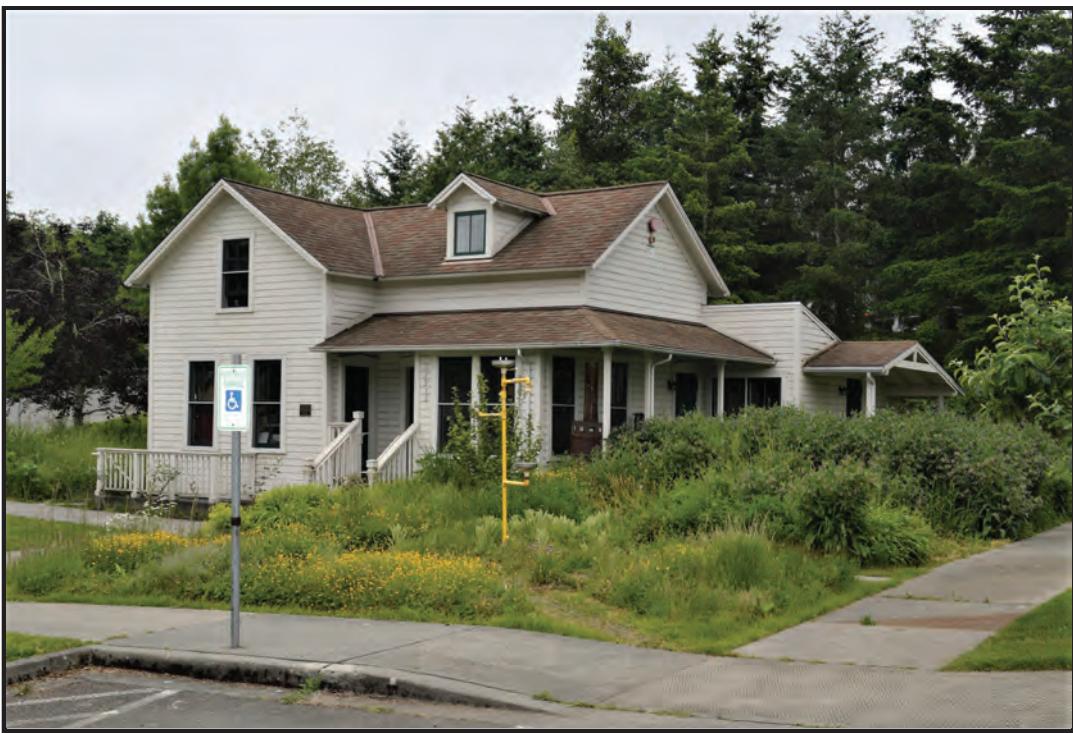
Exhibit 6-28. Overview of the Chase House, listed in the NRHP. The resource occupies its historic location, today within the southeast area of the University of Washington's Bothell campus. Project activities will not impact the historic property, already within a compromised historic setting.

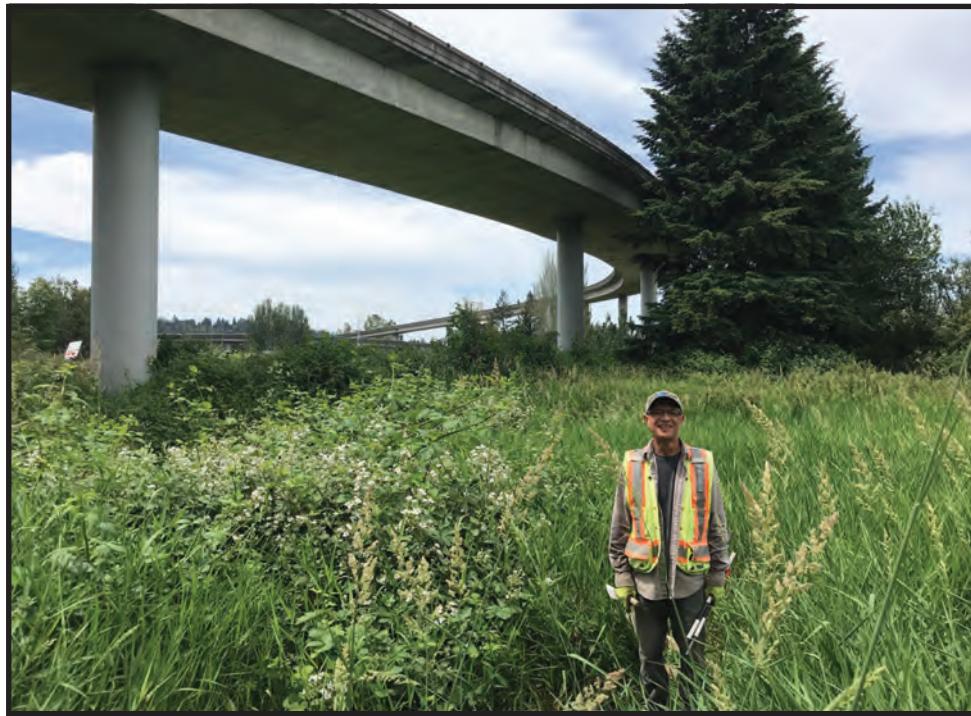
Exhibit 6-31. Overview of a grassy area northeast of the I-405/SR-522 interchange westbound lanes just west of Par Creek, view is to the west. This area in Zone 20 contains thick fill deposits south of Par Creek near SR-522, and intact Holocene deposits north of Par Creek.

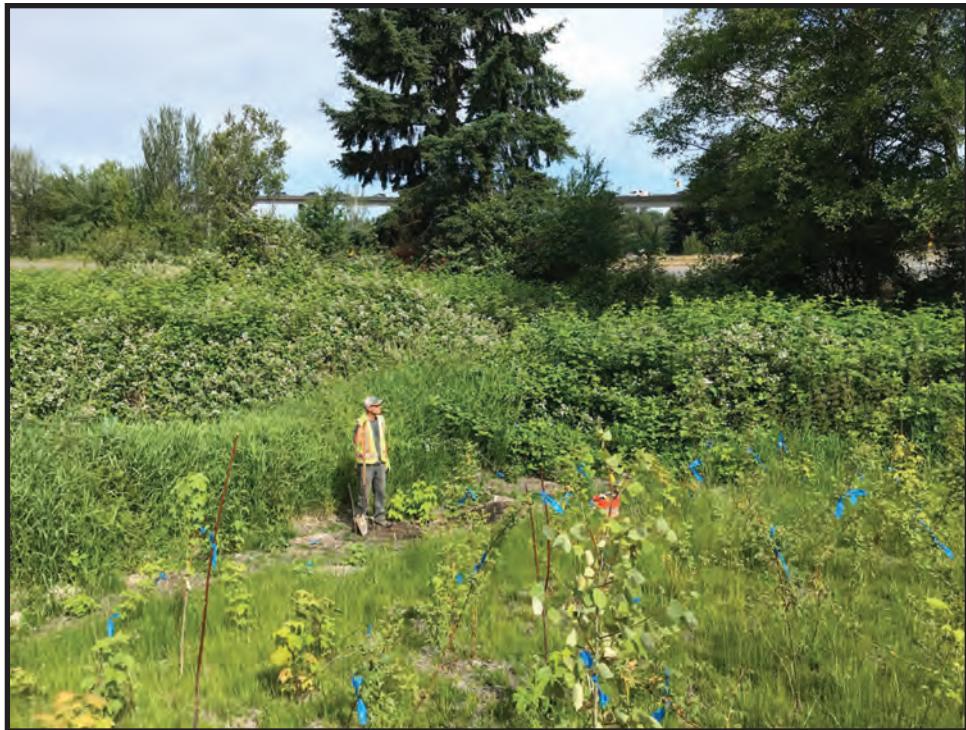
Exhibit 6-32. Overview of the shovel tested area along Par Creek just south of the SR-522 eastbound lanes, view is to the northwest. This area in Zone 20 contains intact and stratified Holocene floodplain deposits. Crewmember is standing at ST 78 with the SR-522 (west) to I-405 (south) on-ramp in the distant background.

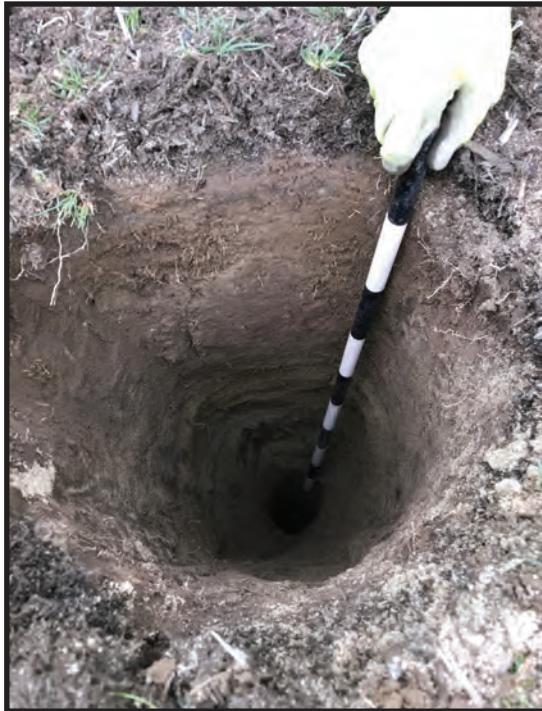
Exhibit 6-33. The north wall of ST 78 which was excavated down to 240 cm below surface, exposing intact and stratified Holocene floodplain deposits. The ST contained no historic or precontact cultural materials. The scale is made of 10-cm long segments.

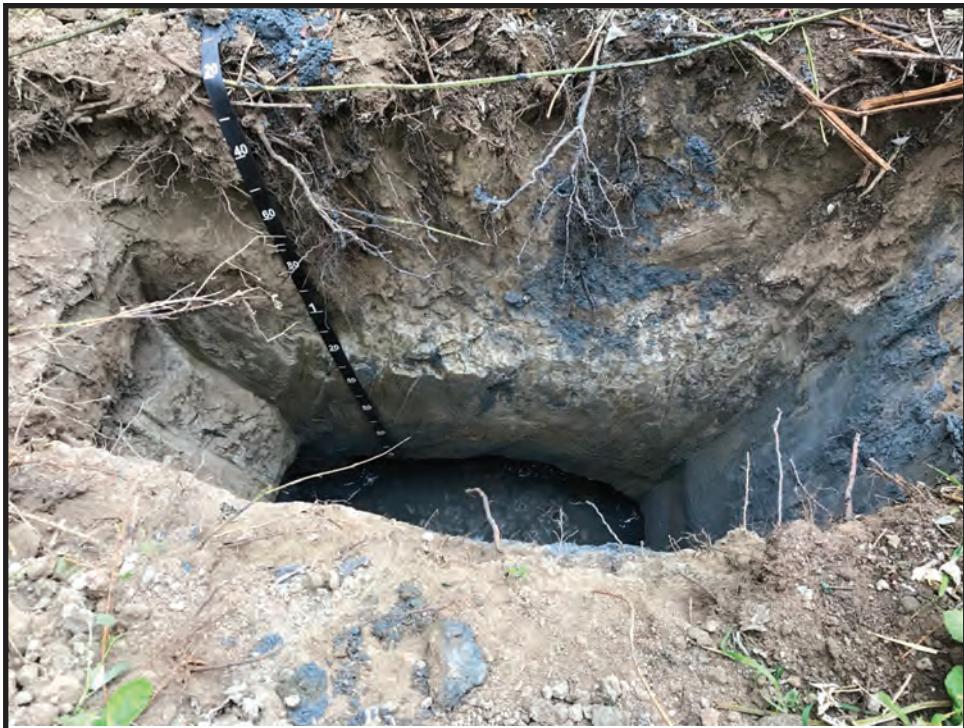
Exhibit 6-34. Pit 16 east wall profile. The pit was excavated to 290 cm below surface, exposing intact Holocene floodplain sediments and a shallow water table that caused walls to slough. The pit contained no historic or precontact cultural materials. The scale is marked with 10-cm long increments.

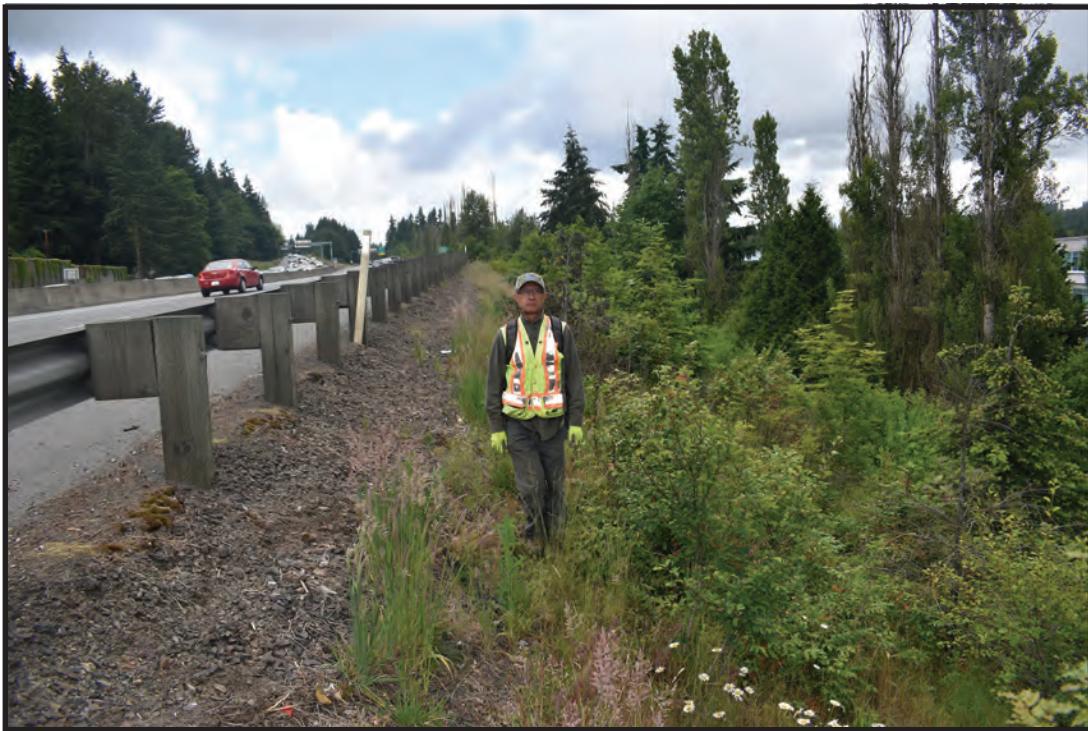
Exhibit 6-37. Overview of the fill slope immediately east of the I-405 northbound lanes in Zone 22, view is to the north. This area in Zone 22 contains a steep, 45-degree fill slope that could not be safely excavated. Crewmember is standing at the eastern boundary of the Limits of Construction.

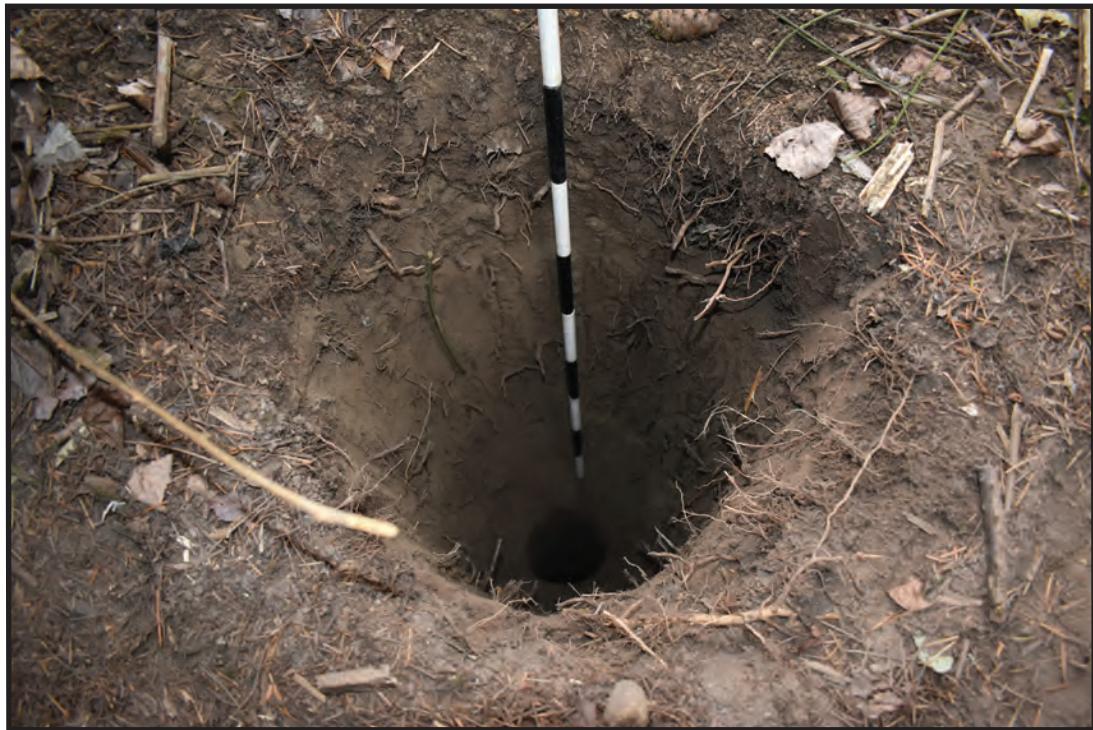
Exhibit 6-38. The ST 88 west wall profile. The ST was excavated to 190 cm below surface, exposing disturbed native sediments (pictured) overlying intact Holocene and Pleistocene sediments (not visible). The ST contained no historic or precontact cultural materials. The scale is made of 10-cm long segments.
