ENVIRONMENTAL ASSESSMENT

Appendix E: Cultural Resources Survey

I-405, SR 522 Vicinity to SR 527 Express Toll Lanes Improvement Project (MP 21.79 to 27.06)

Cultural Resources Survey for the Interstate 405, SR 522 Vicinity to SR 527 Express Toll Lanes Improvement Project in King and Snohomish Counties, Washington

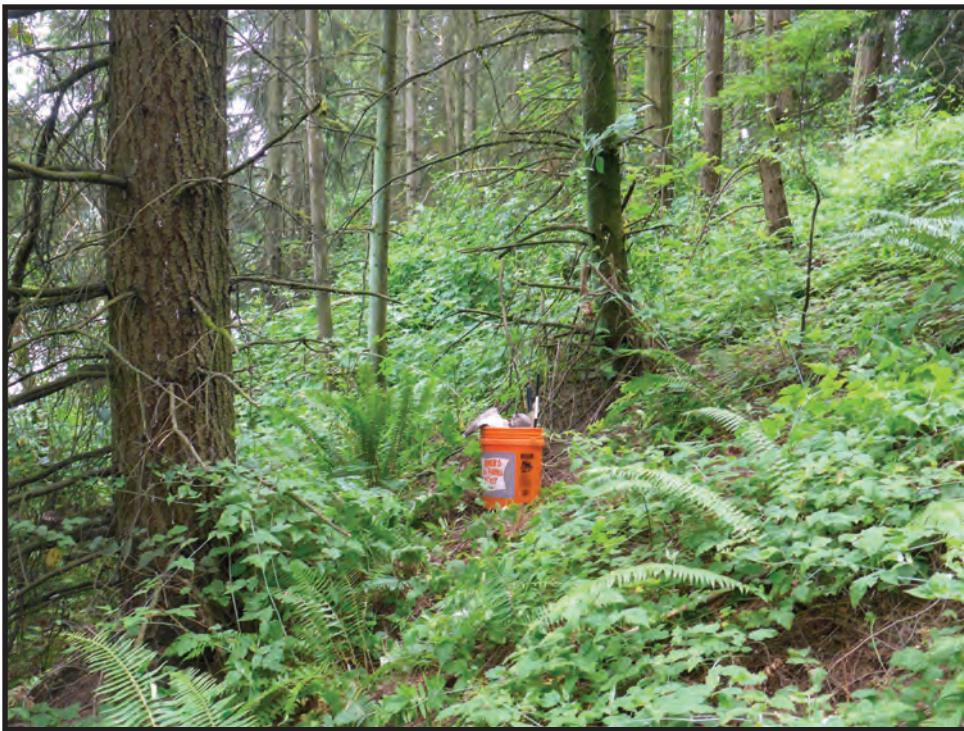
Exhibit 6-42. Overview of steep terrain representative of forested areas in between I-405 northbound and southbound lanes in Zone 23, view is to the south. The orange bucket is near ST 111 at a location that contains steep, 45-degree natural slopes that could not be safely excavated.

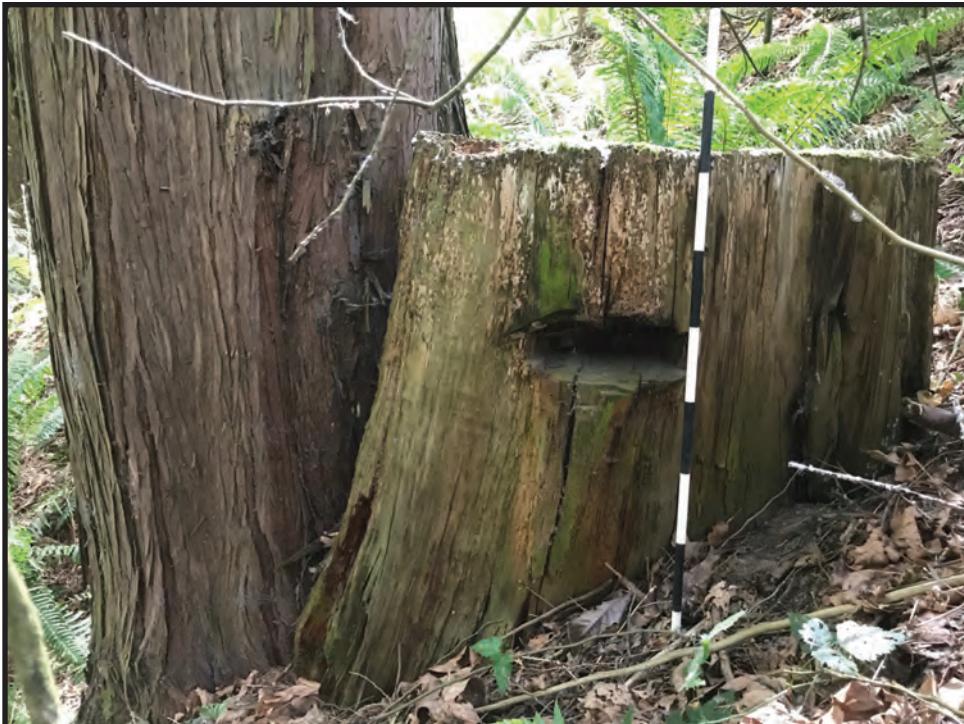
Exhibit 6-43. A springboard notch hatcheted out of the trunk of a cedar located between I-405 northbound and southbound lanes in Zone 23, view is to the south.

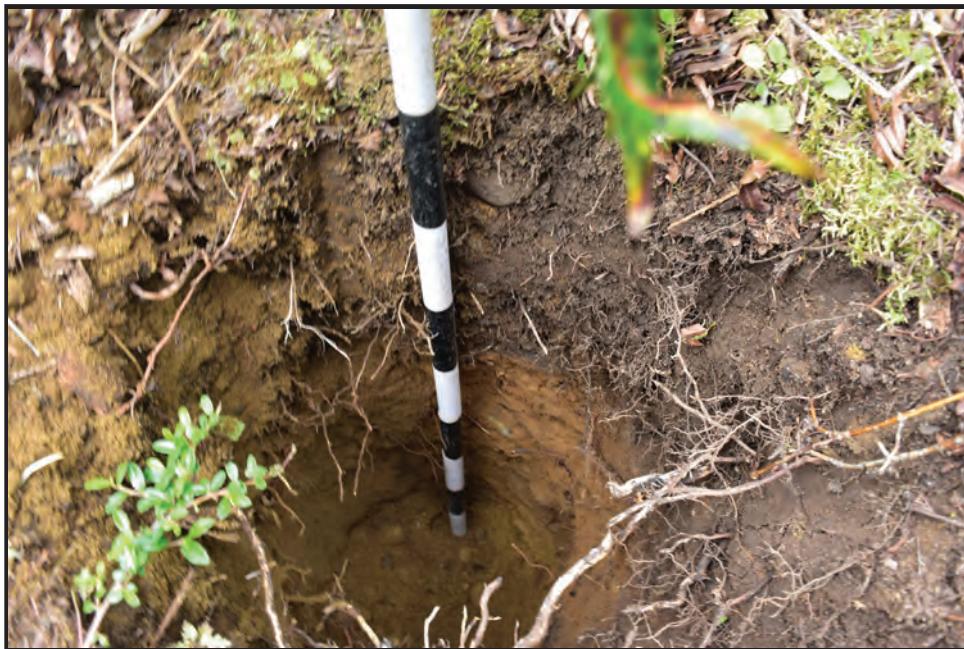
Exhibit 6-44. The ST 149 west wall profile. The ST was excavated to 80 cm below surface, exposing an intact soil profile formed in Pleistocene glacial till. Notice the brown organic horizon overlying the comparatively reddish horizon, a hallmark of well-developed Pleistocene soils. The ST contained no historic or precontact cultural materials. The scale is made of 10-cm long segments.

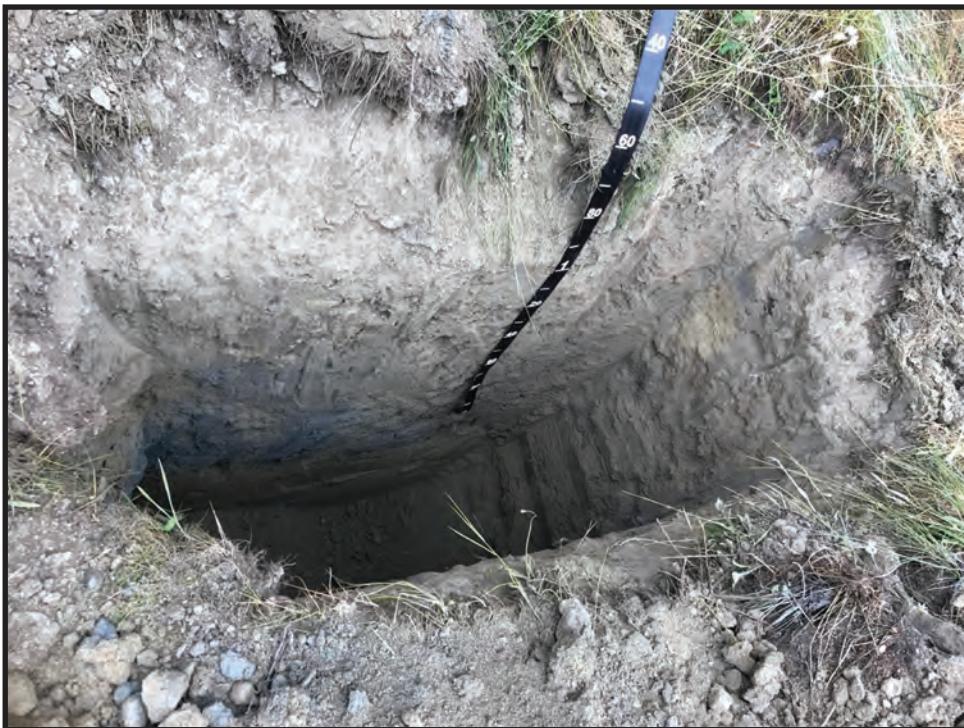
Exhibit 6-46. Pit 17 east wall profile. The pit was excavated to 290 cm below surface, exposing disturbed native sediments overlying intact Pleistocene glacial sediments. The pit contained no historic or precontact cultural materials. The scale is marked with 10-cm long increments.

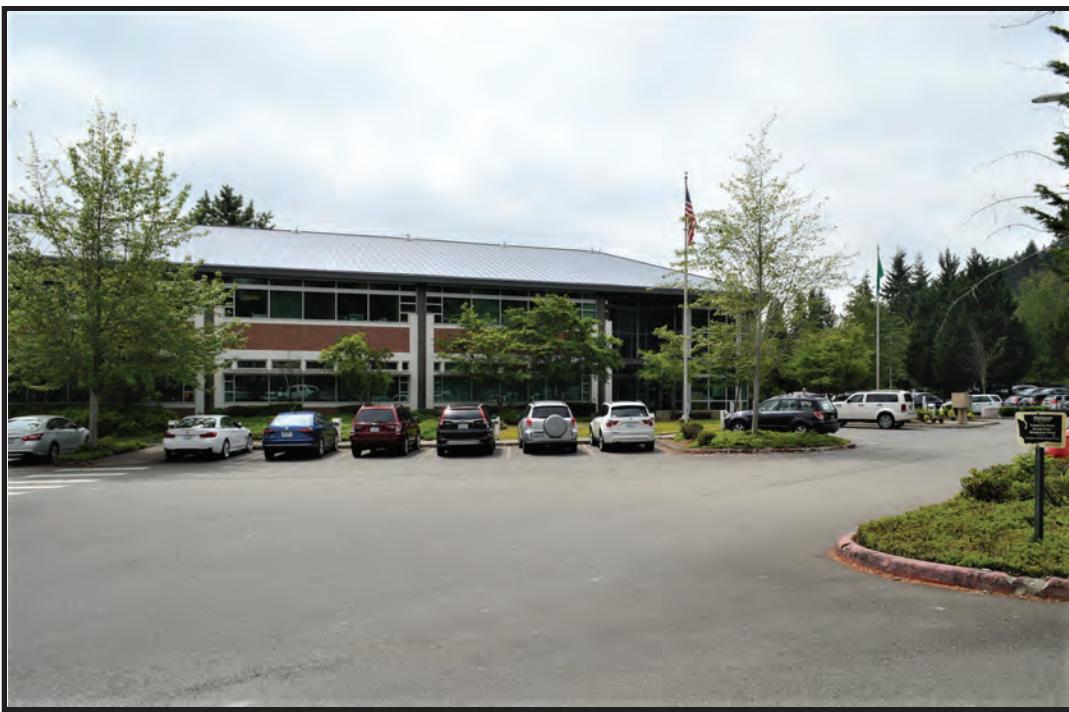
Exhibit 6-47. This area of the project APE was once occupied by resources associated with the Monte Villa Farm, view is to the south. The present North Shore School District building and parking lot, built in 1996, are within the project APE and several of the resources associated with the farm complex are no longer extant. The modern development typifies the character of the current built environment along much of the I-405 corridor study area. A handful of remaining farm-associated resources are extant nearby, within the highly-modified setting, but are not within the project APE.

Exhibit 6-47 shows a portion of the study area, adjacent to Zone 23 on the east side of the I-405 corridor. The area was once the location of the historic-era Monte Villa Farm; the new development visible in the photograph demonstrates the highly-modified and modernized setting along I-405 in the study area.

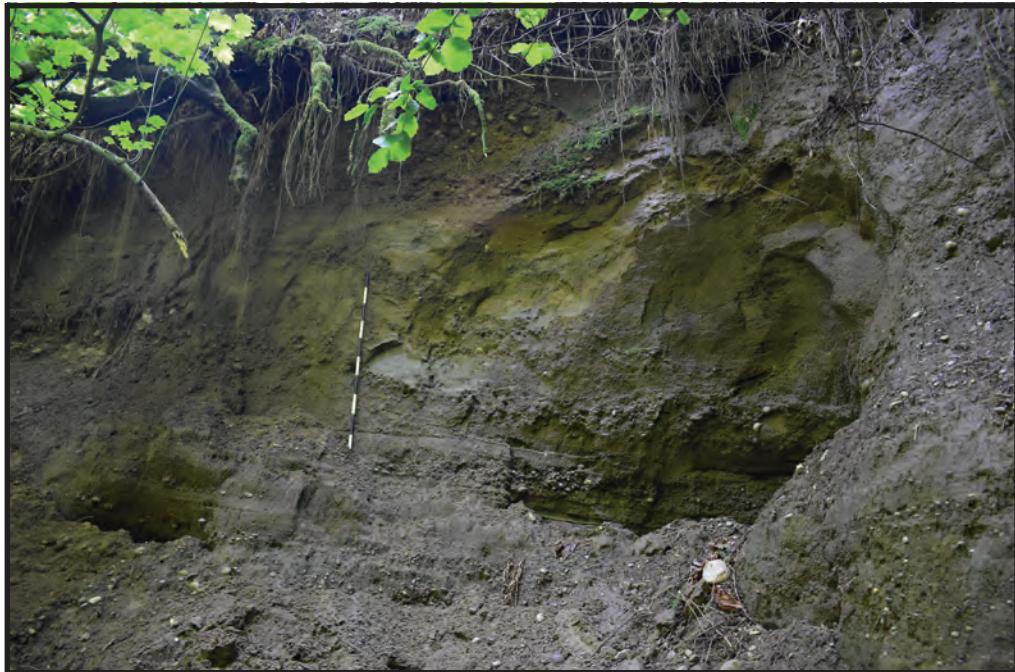
Exhibit 6-48. Overview of a deeply incised creek located east of ST 131, within the North Creek Forest in Zone 24 (central), view is to the east. The incised creek exposes a section of glacial outwash deposits observed throughout the northern Limits of Construction. The scale is made of 10-cm long segments.

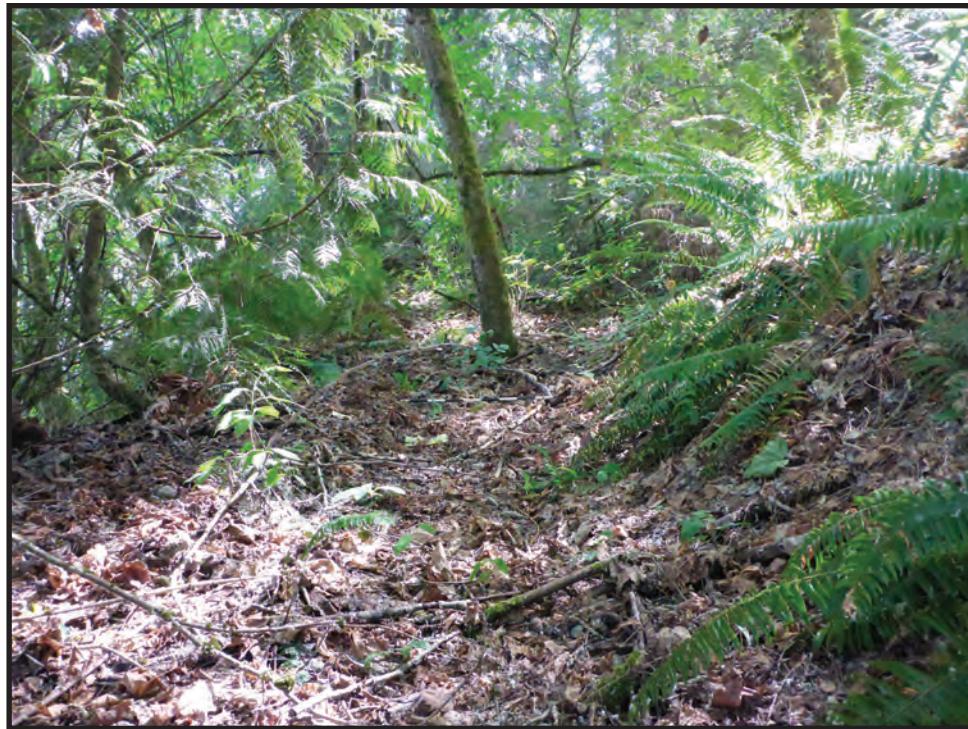
Exhibit 6-49. Overview of site 45SN0716, two adjacent historic logging road segments recorded near ST 124, within the North Creek Forest in Zone 24 (south). The segments are in a forest setting with steep and uneven terrain, typical of Zone 24 (south). The scale is barely visible in the center and consists of 10-cm long segments. The site is not recommended as eligible for listing in the NRHP.

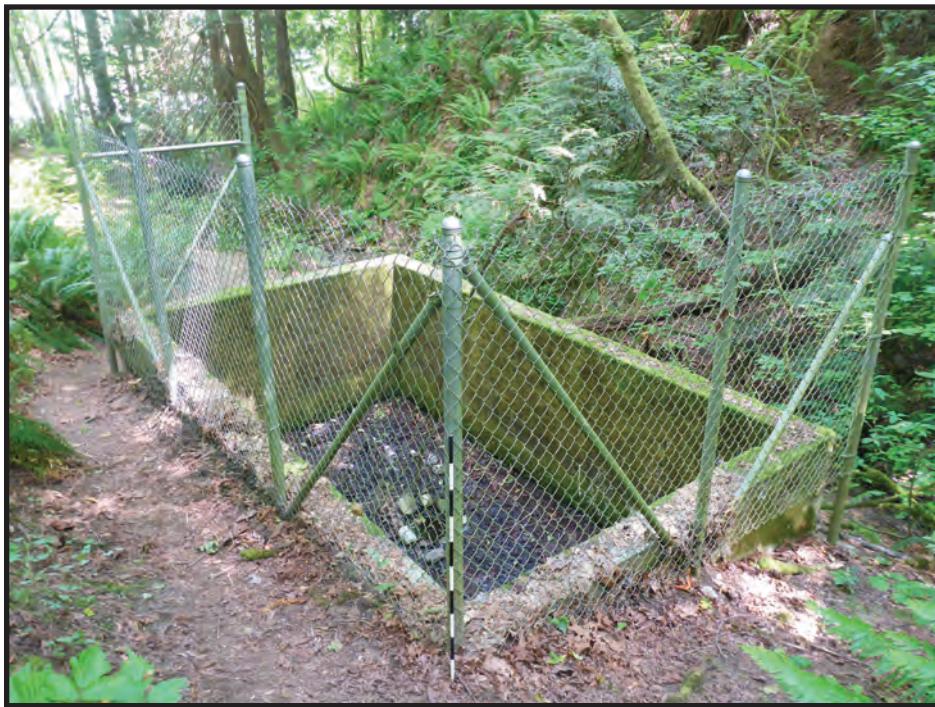
Exhibit 6-50. Overview of the modern cistern observed near ST 126, within the North Creek Forest in Zone 24 (south), view is to the southeast. The concrete cistern drains uphill slopes that contain hiking trails. The cistern is modern and is likely associated with the Boy Scouts of America-era of parcel ownership, which began in the late-1970s and ended with the sale of the parcel to the City of Bothell in 2011. The scale is marked in 10-cm increments.

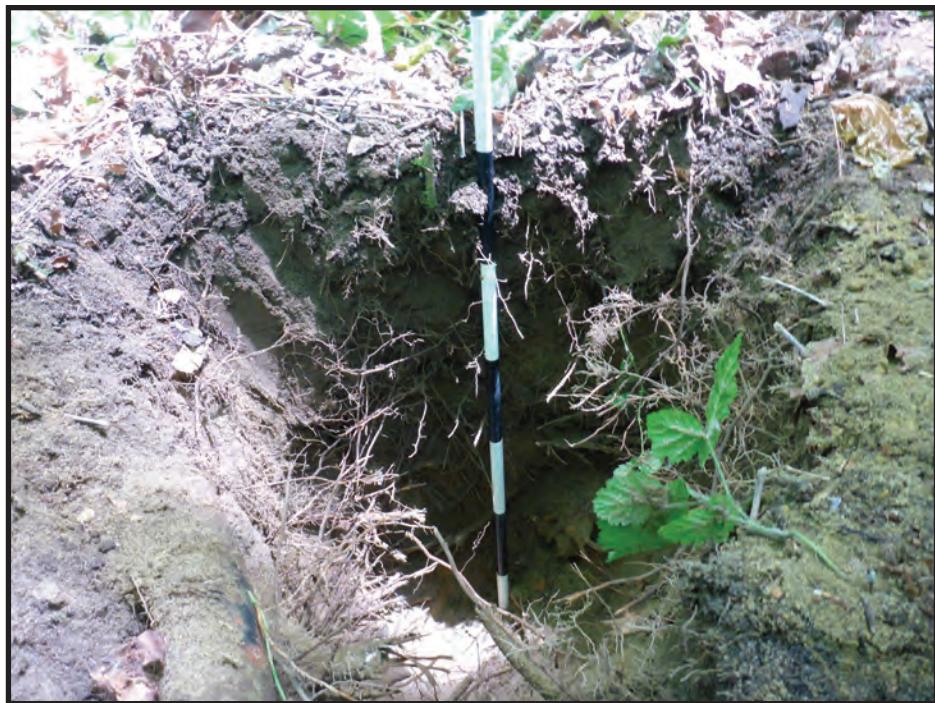
Exhibit 6-51. South wall of ST 126 which was excavated to 61 cm below surface, exposing an intact soil profile that forms in Pleistocene glacial sediments. The ST contained no historic or precontact cultural materials. The scale is made of 10-cm long segments.

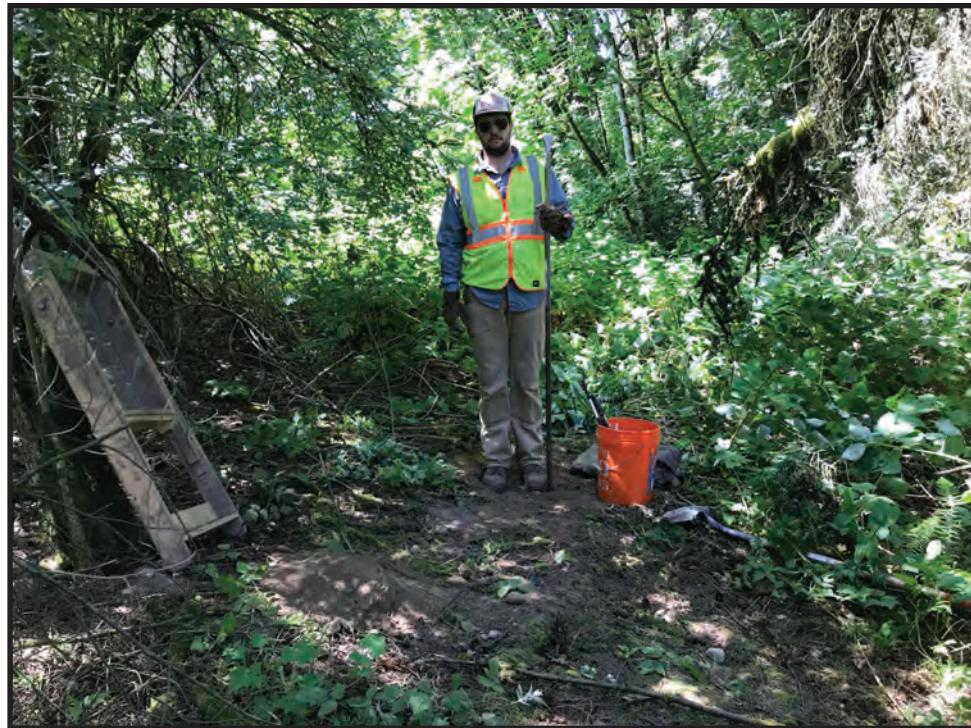
Exhibit 6-53. Overview of the forested creek setting near ST 137 in Zone 25, view is to the north.

Twelve STs (STs 133-144) were excavated along the creek and exposed mostly intact profiles consistent with Pleistocene glacial outwash sediments mapped nearby (Exhibits 6-53 and 6-54). The STs are summarized in Exhibit 6-55. The ST stratigraphy is described in Attachment A. No cultural materials were observed during ST excavation.

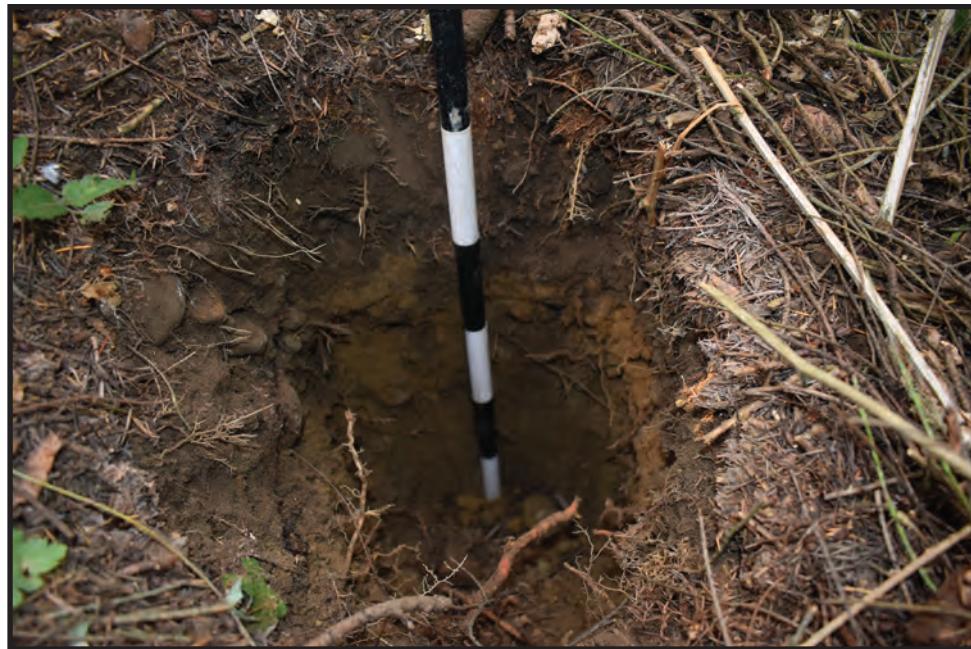
Exhibit 6-54. The south wall of ST 140, which was excavated to 55 cm below surface, exposing a soil profile that forms in Pleistocene glacial sediments. The ST contained no historic or precontact cultural materials. The scale is made of 10-cm long segments.

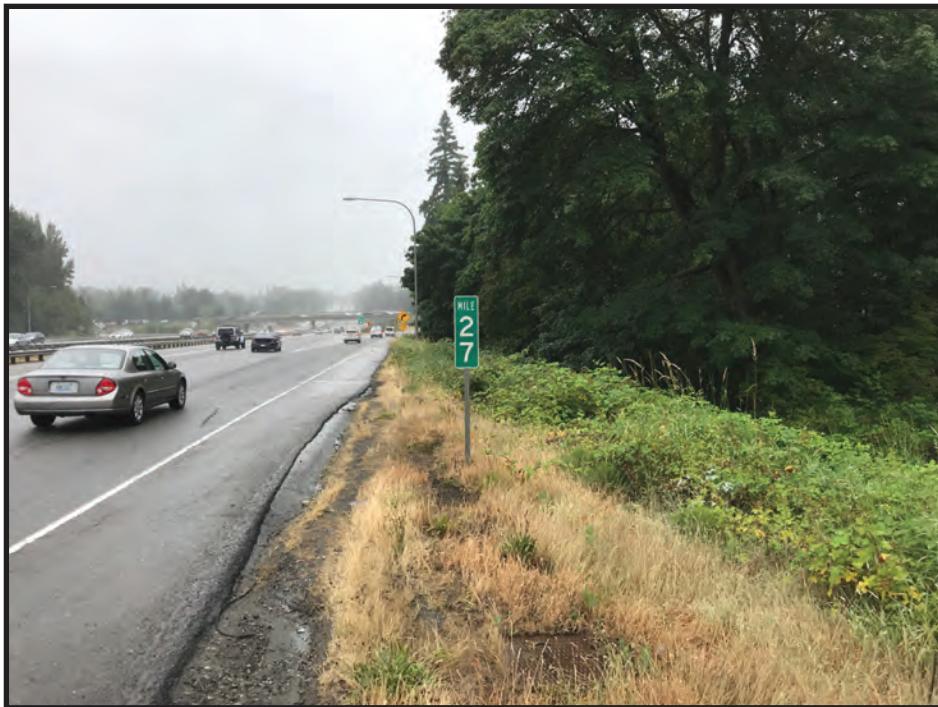
Exhibit 6-58. Overview of the fill slope immediately west of the I-405 southbound lanes at milepost 27, near the northern boundary of Zone 26, view is to the south. The fill slope is near Pit 20, which decreases in thickness with distance from 9th Ave and eventually transitions into intact native soil near the off-ramp.

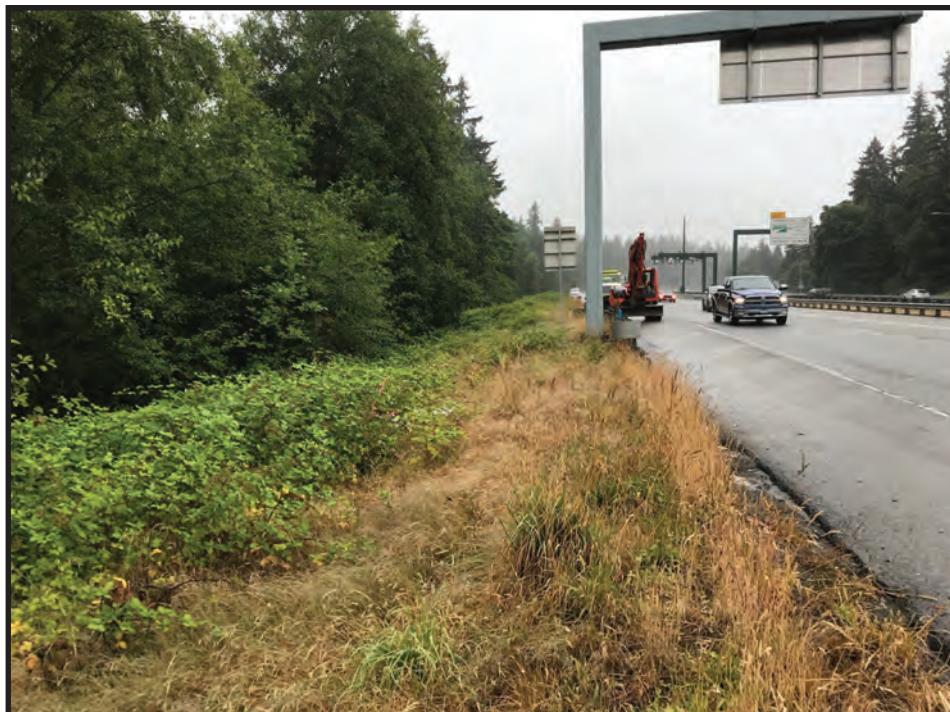
Exhibit 6-59. Overview of the fill slope immediately west of the I-405 southbound lanes at milepost 27, near the northern boundary of Zone 26, view is to the north. The fill slope pictured is near Pit 20, which increases in thickness north to 9th Ave.

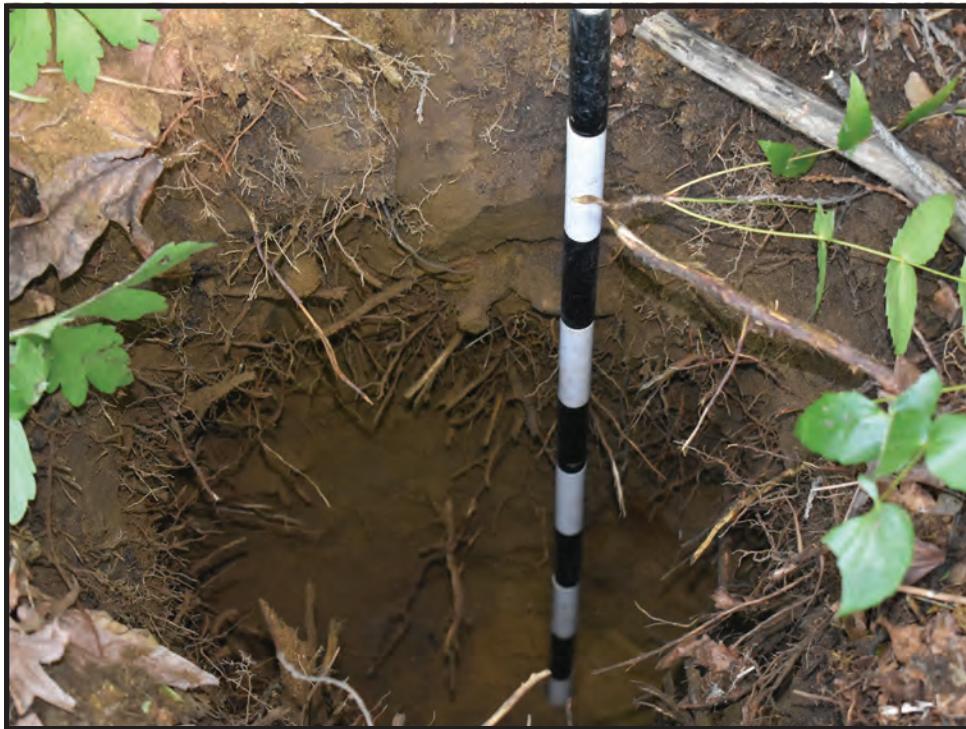
Exhibit 6-60. The west wall of ST 159 which was excavated to 100 cm below surface, exposing an intact soil profile that forms in Pleistocene glacial outwash. The ST contained no historic or precontact cultural materials. The scale consists of 10-cm long segments.

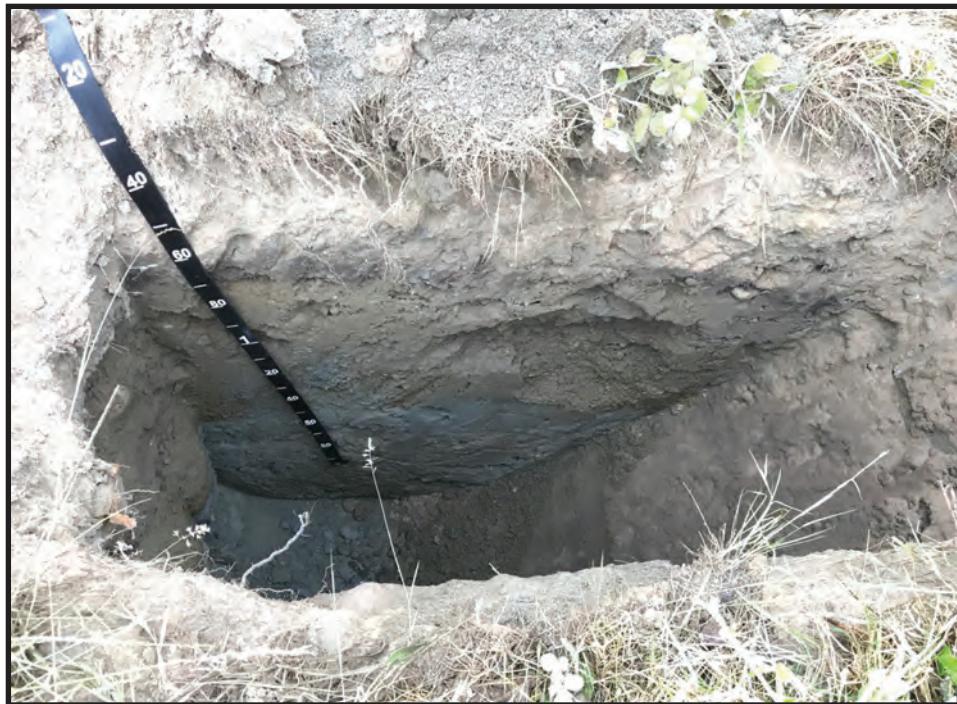
Exhibit 6-62. Pit 20 south wall profile. The pit was excavated to 240 cm below surface, exposing a profile consisting entirely of fill. Pockets of the fill have a bluish-gray color, indicating an origin from low-lying, wetland areas where soils would be saturated. The scale consists of 10-cm long increments.

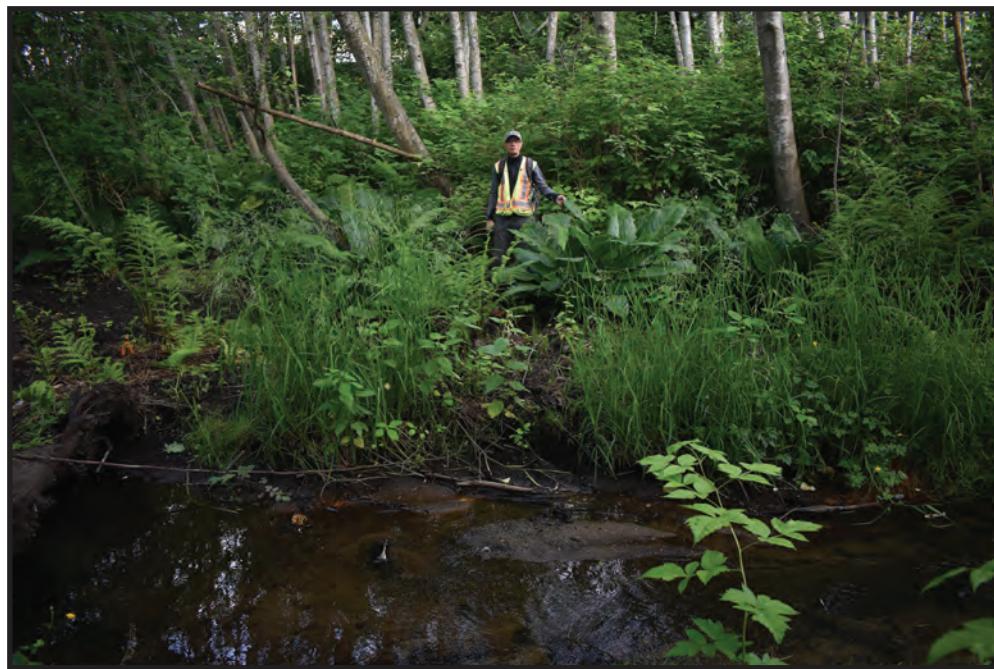
Exhibit 6-64. Overview of the marshy field conditions surrounding ST 187 along Northfork Perry Creek in Zone 27 (south), view is to the north. Low-lying areas near the creek (foreground) contain wetland species that include skunk cabbage and horsetail. Soils were correspondingly moist, consisting of muck overlying Pleistocene glacial outwash.

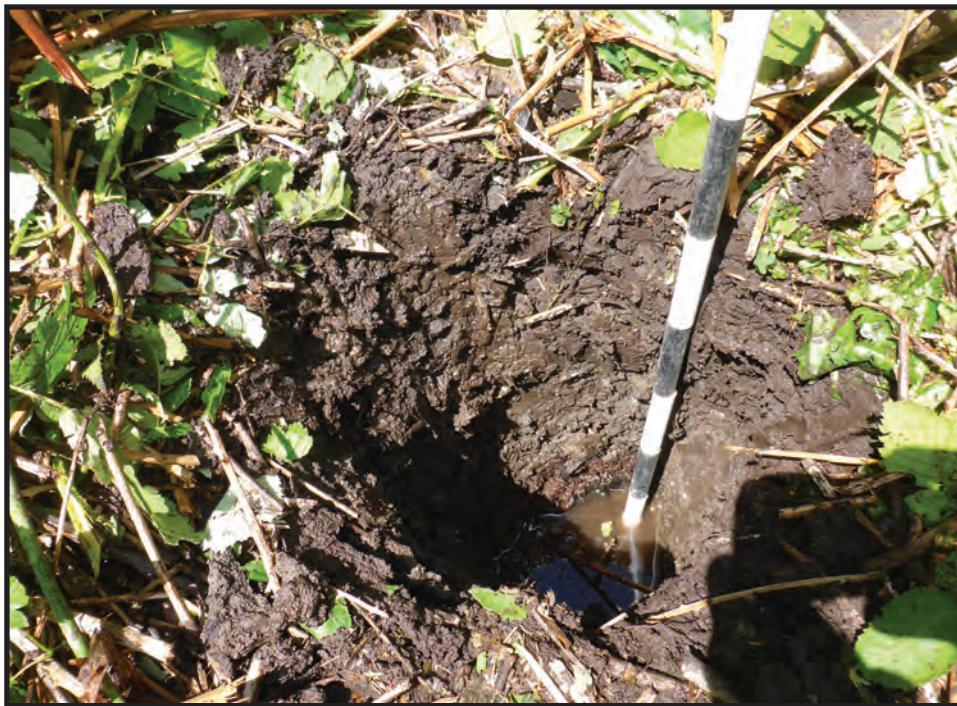
Exhibit 6-65. The north wall of ST 201, along Queensborough Creek in Zone 27 (north). The ST was excavated to 45 cms below surface, exposing an intact soil profile that forms in Pleistocene glacial outwash. The ST contained no historic or precontact cultural materials. The scale is made of 10-cm long segments.

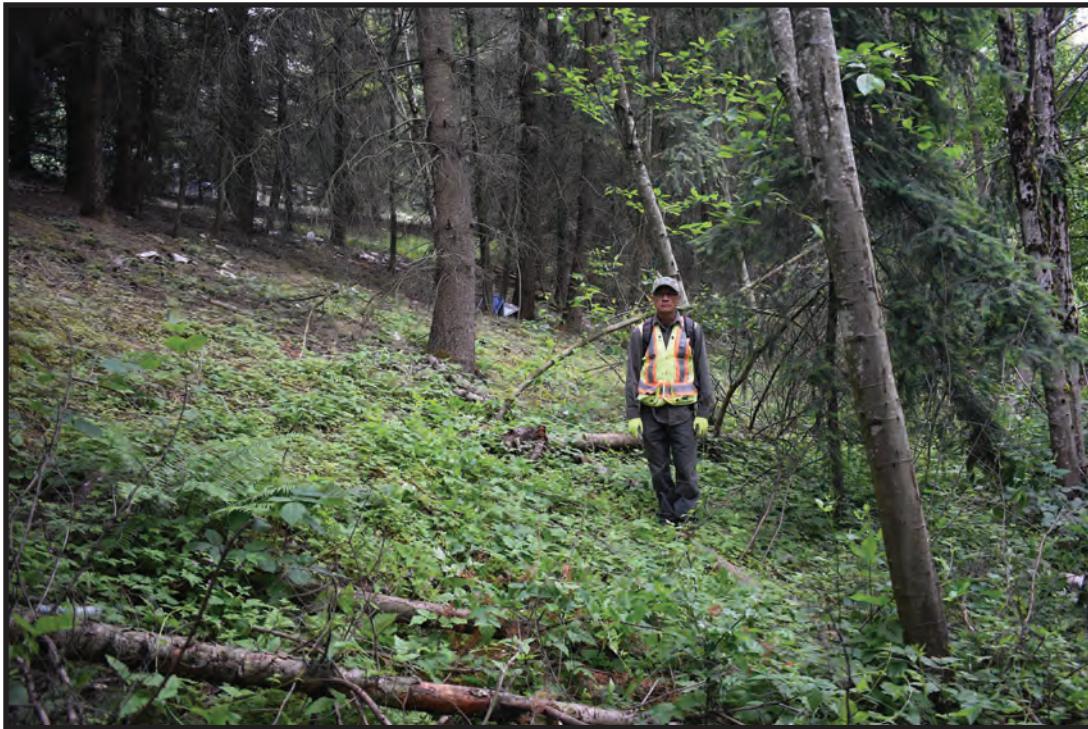
Exhibit 6-69. Overview of field conditions near ST 261 in Zone 28 (north), view is to the south. Crewmember is standing on a road fill slope that supports the I-405 (south) to SR 527 (south) off-ramp.

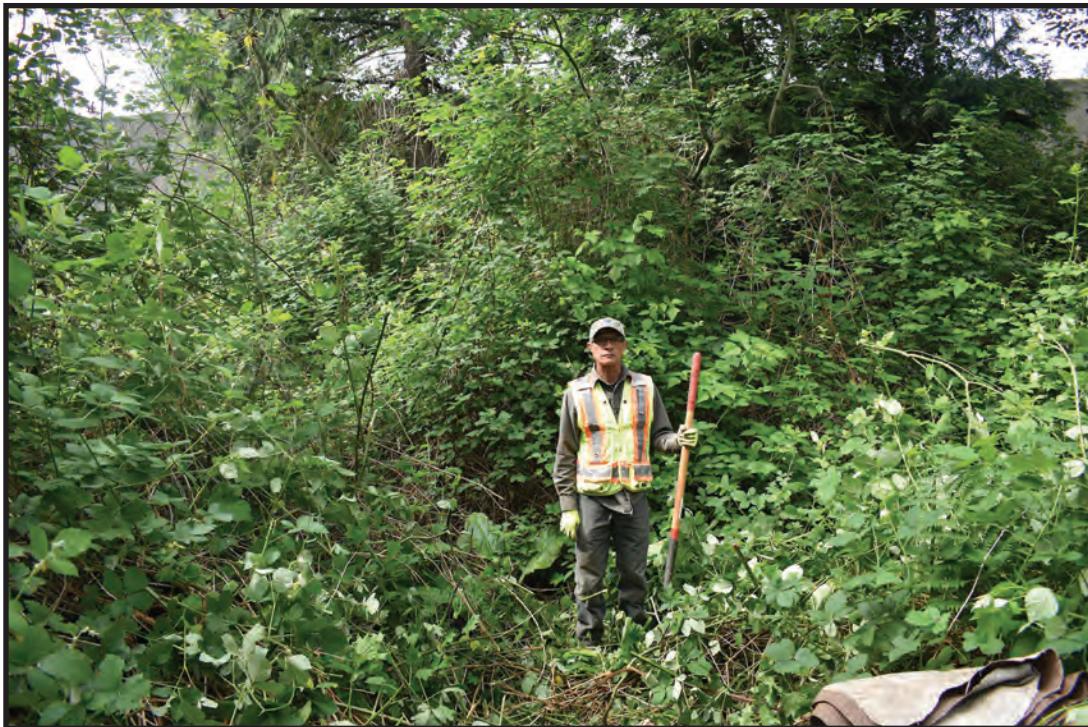
Exhibit 6-70. Overview of the lush field conditions near ST 244 along North Fork Perry Creek in Zone 28 (south), view is to the south. Low-lying areas near the creek contain wetland species that include skunk cabbage, which is pictured to the lower left of the crewmember. Soils were correspondingly moist, consisting of muck overlying Pleistocene glacial outwash.

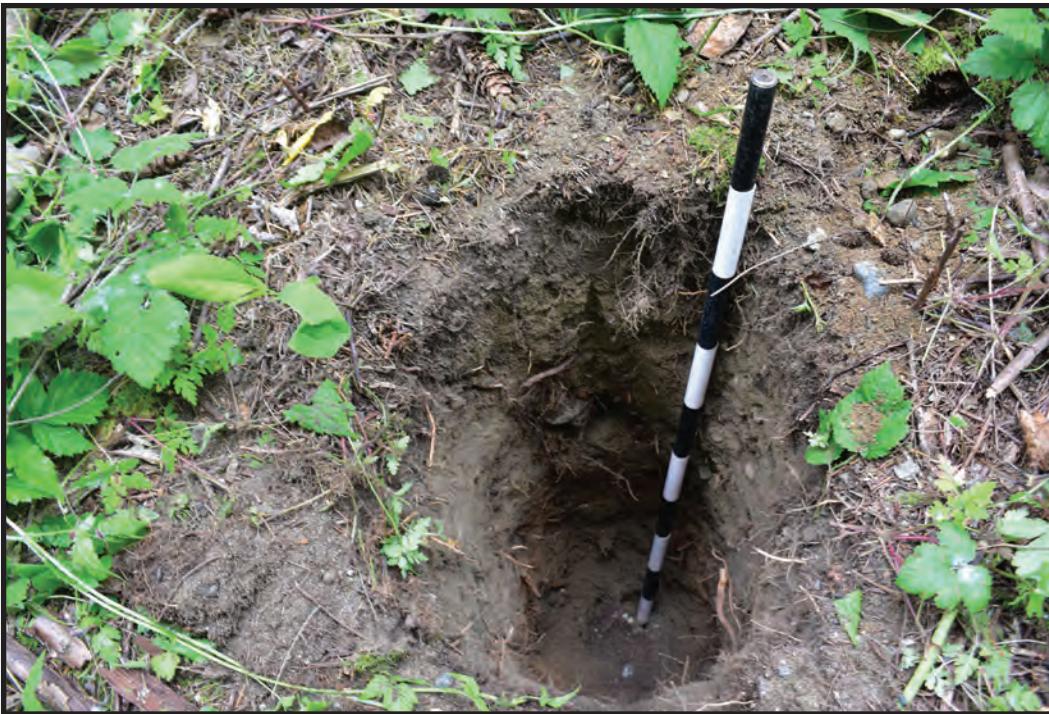
Exhibit 6-71. The south wall of ST 261 located along a road fill slope in Zone 28 (north) and was excavated to 90 cm below surface, exposing a profile consisting entirely of fill road fill. The ST contained no historic or precontact cultural materials. The scale consists of 10-cm long segments.

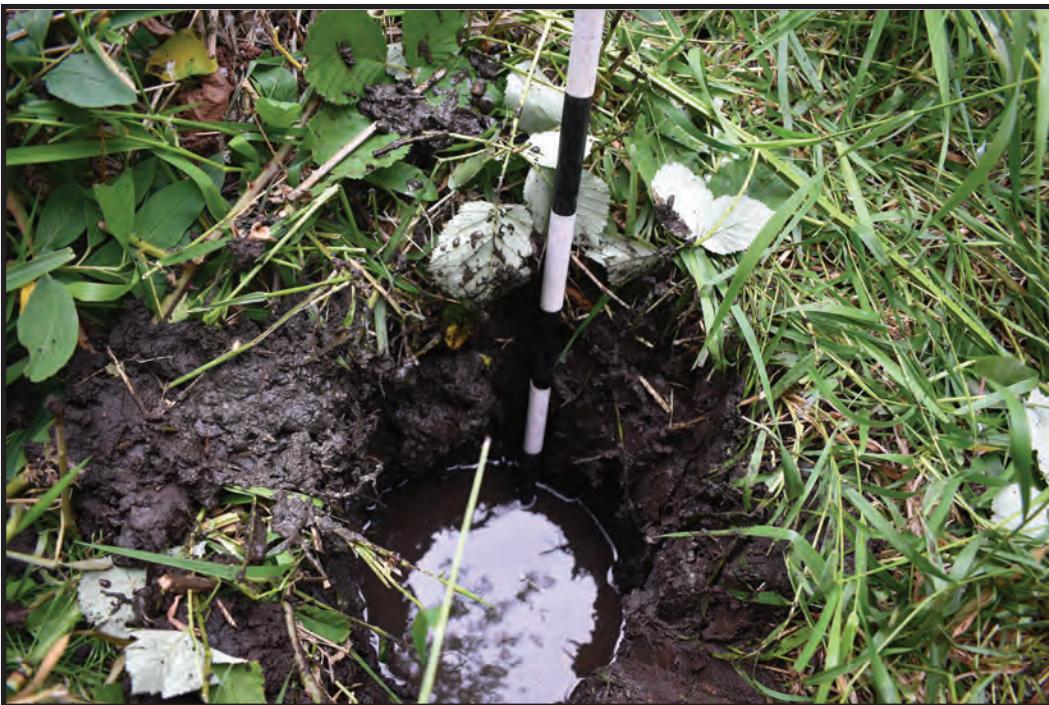
Exhibit 6-72. The west wall of ST 244 located along North Fork Perry Creek in Zone 28 (south) and was excavated to 90 cm below surface, exposing a profile consisting of muck overlying Pleistocene glacial outwash. The ST contained no historic or precontact cultural materials. The scale consists of 10-cm long segments.

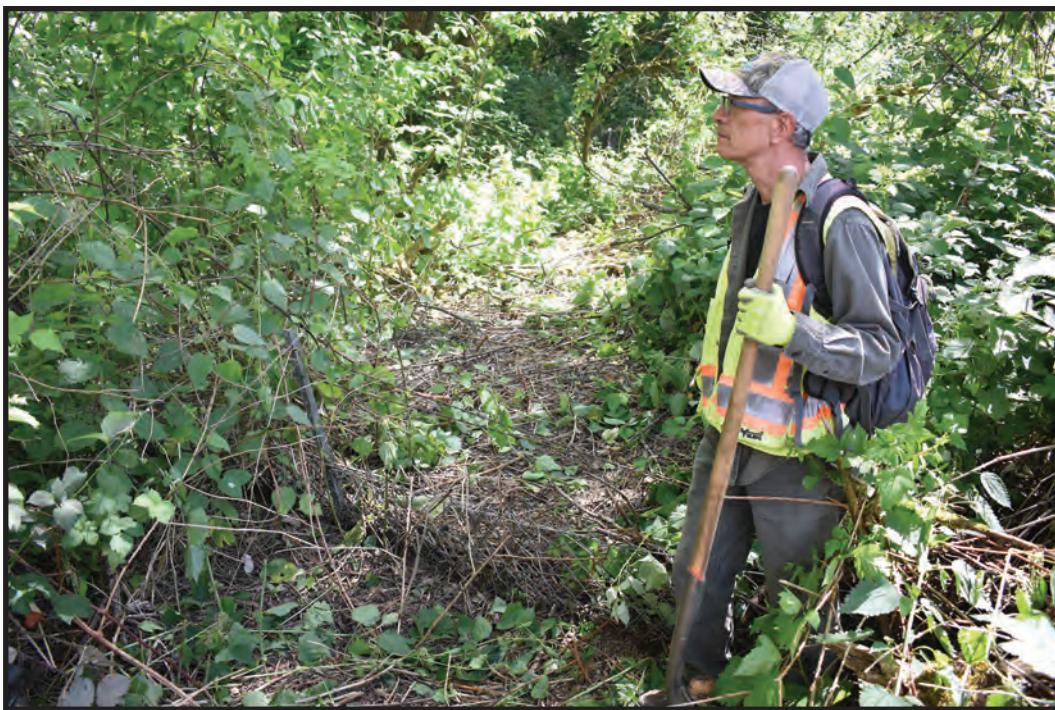
Exhibit 6-74. Overview of field conditions near ST 264 in Zone 29, view is to the south. Western and southern areas in Zone 29 have been disturbed by road building and land clearing. Crewmember is standing adjacent to a fence (center) mostly buried by several feet of sediment.

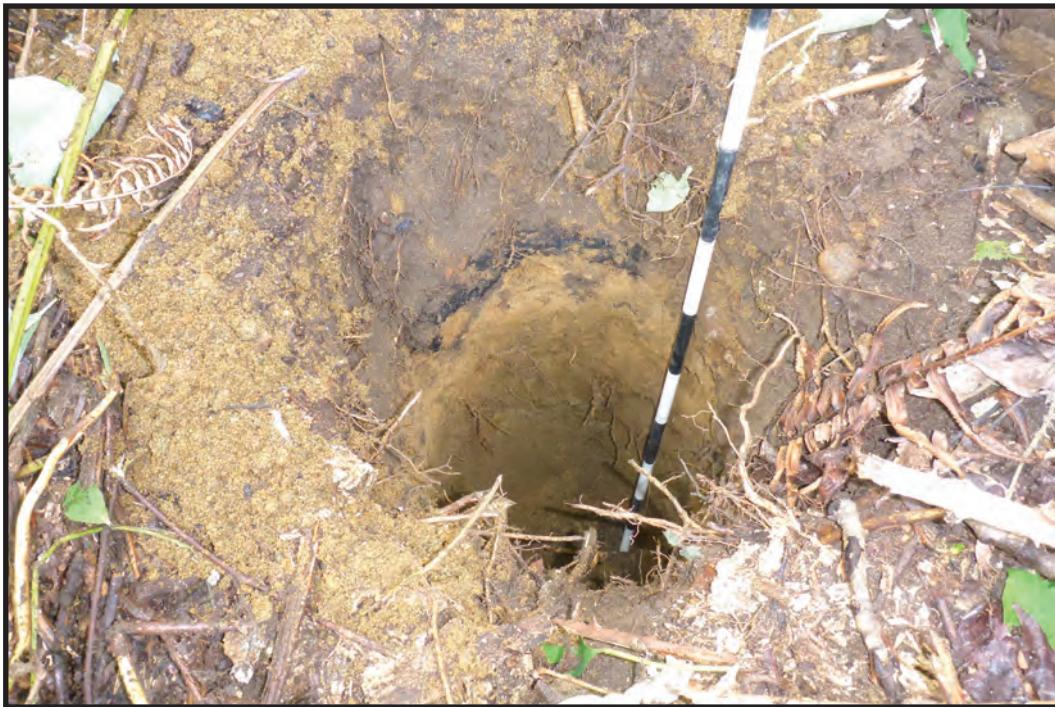
Exhibit 6-75. The north wall profile of ST 274 which was excavated down to 85 cm below surface, exposing a disturbed organic layer overlying an intact soil profile that forms in Pleistocene glacial outwash. The ST contained no historic or precontact cultural materials. The scale consists of 10-cm long segments.

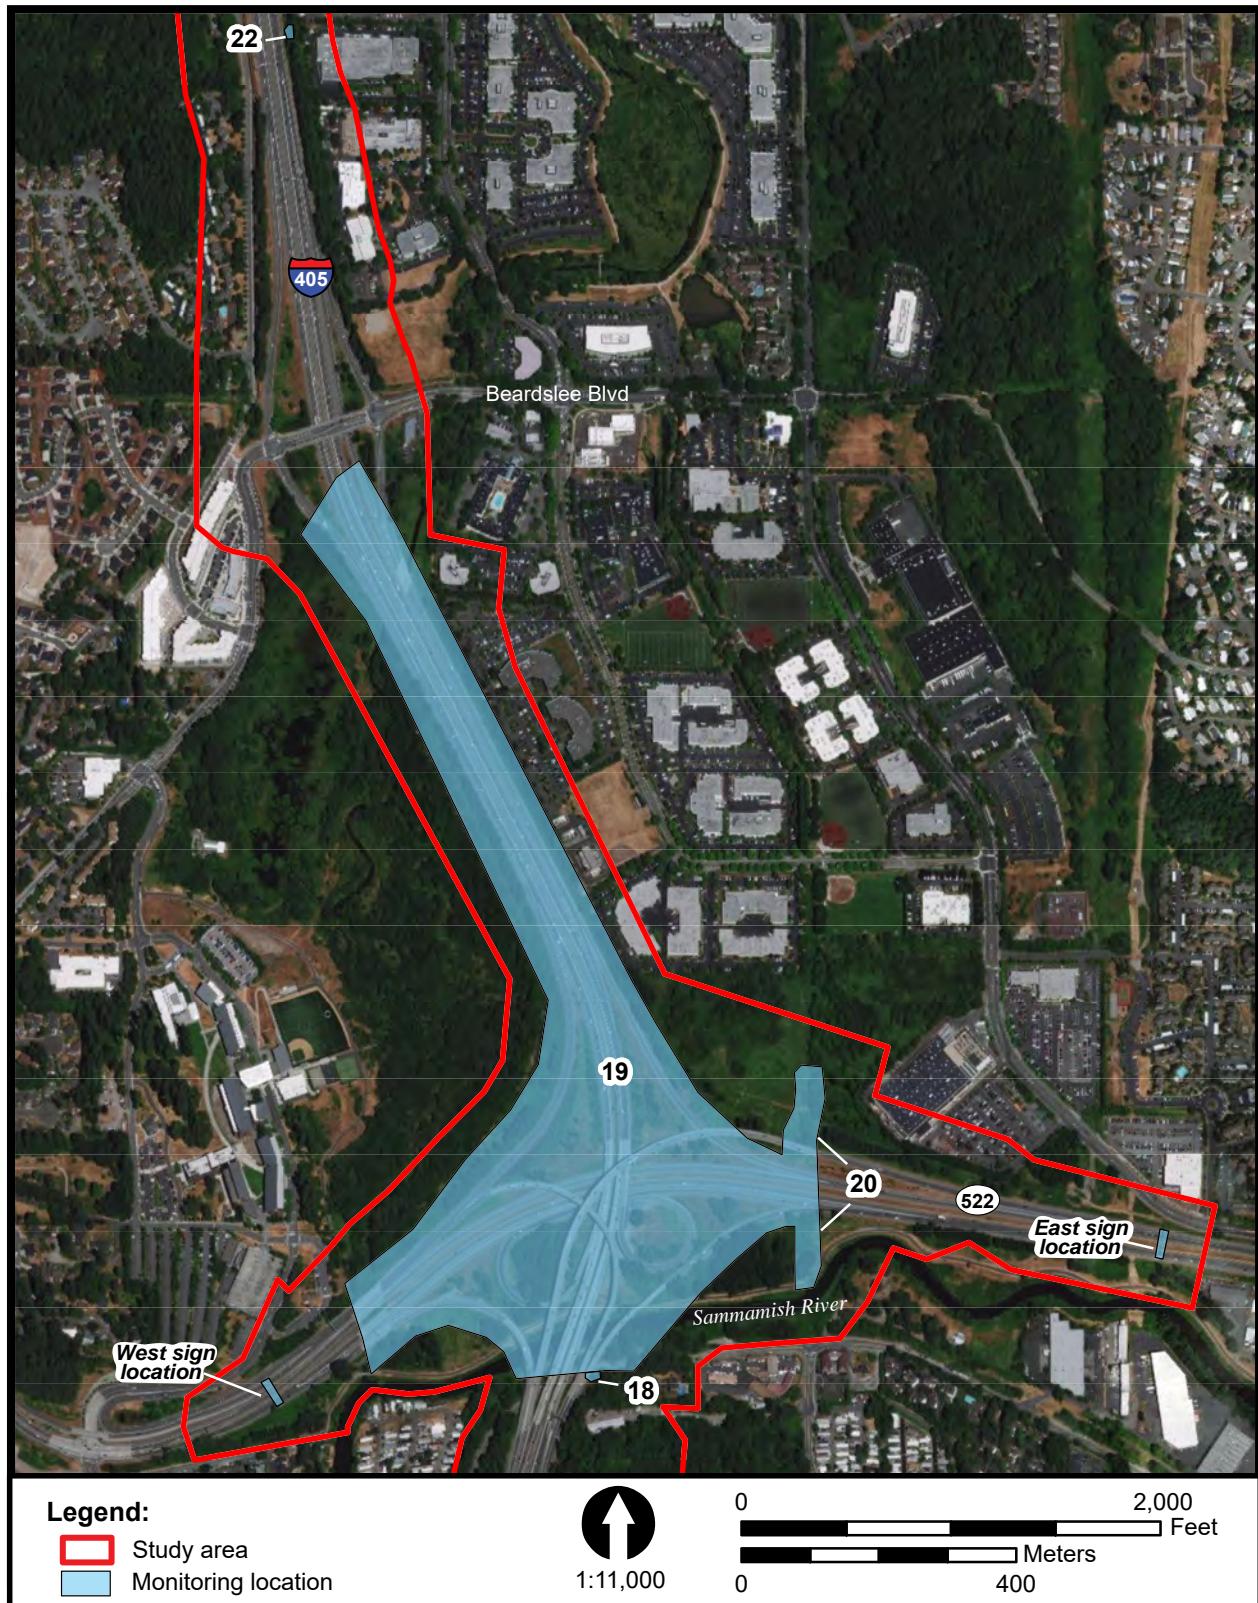
Exhibit 6-78. Aerial photograph showing the recommended monitoring locations in zones 18, 19, 20, and 22.

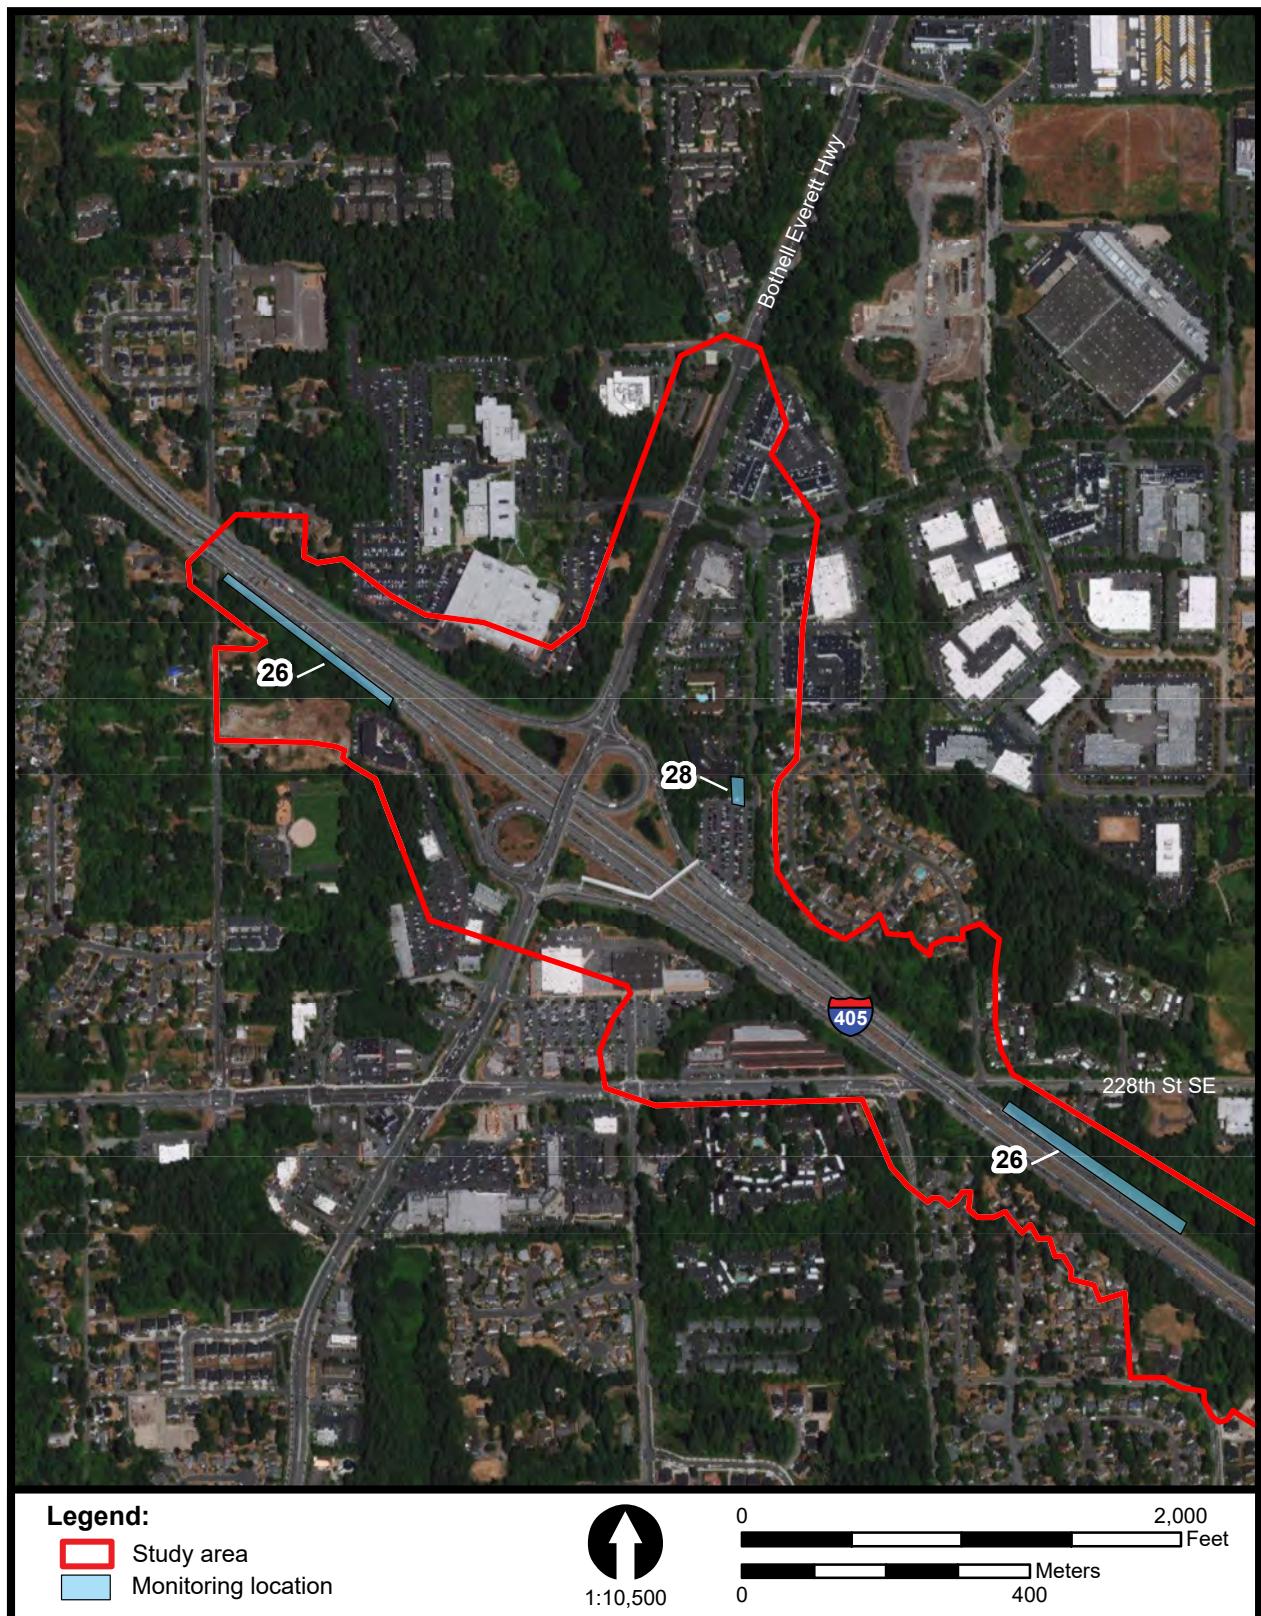
Exhibit 6-79. Aerial photograph showing the recommended monitoring locations in zones 26 and 28.
