ENVIRONMENTAL ASSESSMENT

Appendix E: Cultural Resources Survey

I-405, SR 522 Vicinity to SR 527 Express Toll Lanes Improvement Project (MP 21.79 to 27.06)

Cultural Resources Survey for the Interstate 405, SR 522 Vicinity to SR 527 Express Toll Lanes Improvement Project in King and Snohomish Counties, Washington

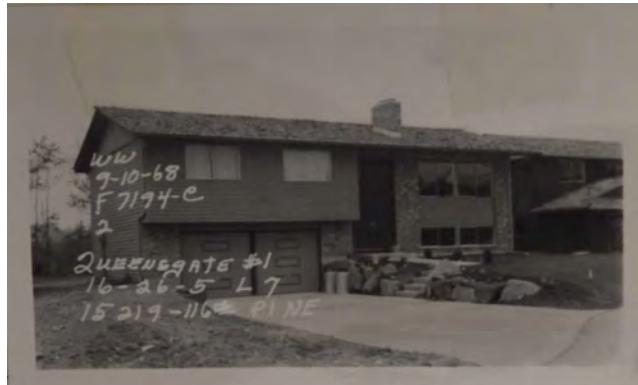
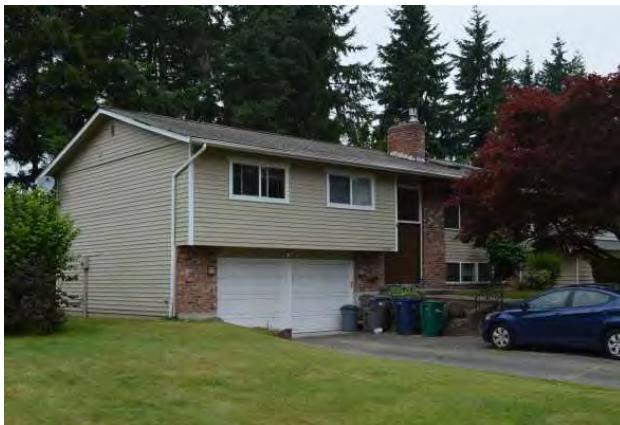
15219 116TH PL NE

The subject residence is not eligible under Criterion C. The dwelling is typical of local and regional mid-to-late 1960s and early 1970s split-level single family dwellings, and does not represent significant and distinctive architectural characteristics, demonstrate the work of an accomplished architect, or feature noteworthy methods of construction. No architect or builder is listed on the historic King County Assessor data cards or current Assessor forms for the subject residence. The dwelling has also undergone alterations to original materials, including the removal and replacement of original aluminum-sash windows.

Property 282698 is recommended as a contributing resource to the district. While observed district resources have all experienced alterations including modernized fenestration, roofing material and garage doors, the subject property has maintained its original cladding and form, as well the prominent entryway fenestration arrangement. As such, the property continues to represent its historic period as a contributing district resource.

Completed in 1968, the subject building is a one-story (split-level), rectangular, single-family residence on a 0.16-acre suburban parcel. The side-gabled and wood-frame dwelling is built on a poured concrete foundation and features composition shingle roofing. An interior common-bond brick chimney with three terra cotta and metal caps extends from the roof's east slope. Cladding consists of cedar clapboard siding and brick veneer along the primary (east) elevation. No fenestration is present along the south and north (side) elevation. Along the primary (west) elevation, the main entrance is accessed by a concrete path and steps which connects to the driveway. The paneled front double door features a large vinyl-clad single-pane window above it. Two slight projections are present to the north and south of the main entrance. Fenestration on the north projection consists of two side-by-side divided-light vinyl-sash sliders, with a narrow vinyl-sash slider at basement-level, along the full basement. The south projection features two vinyl-sash sliders, above the two-bay garage. Per Assessor data and present conditions, the original cladding is intact but the original aluminum-sash windows have been replaced. The original roofing materials consisted of medium wood shakes.

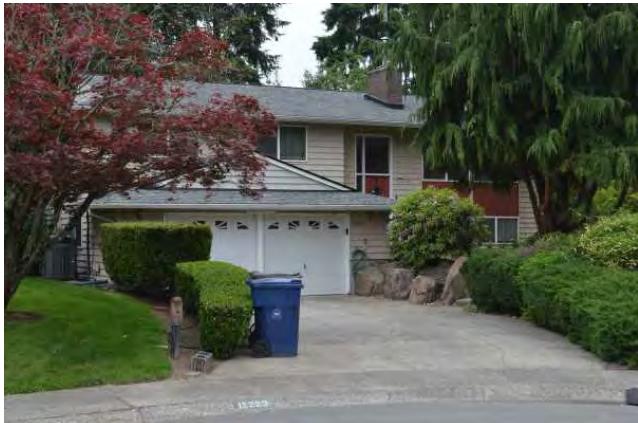
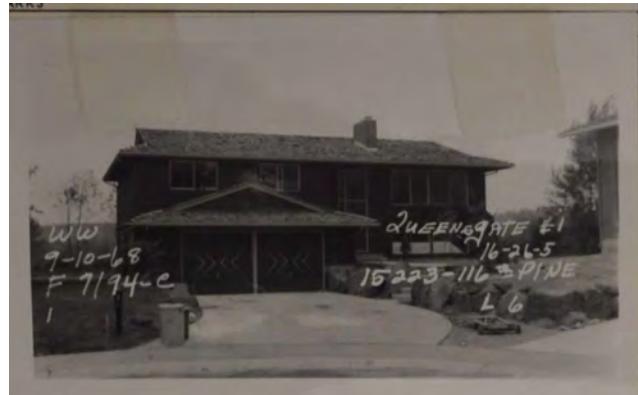
15223 116th PL NE

The subject residence is not eligible under Criterion C. The dwelling is typical of local and regional mid-to-late 1960s and early 1970s split-level single family dwellings, and does not represent significant and distinctive architectural characteristics, demonstrate the work of an accomplished architect, or feature noteworthy methods of construction. No architect or builder is listed on the historic King County Assessor data cards or current Assessor forms for the subject residence. The dwelling has also undergone alterations to original materials, including the removal and replacement of the original aluminum-sash windows.

Property 639202 is recommended as a contributing resource to the district. While observed district resources have all experienced alterations including modernized fenestration, roofing material and garage doors, the subject property has maintained its original cladding and form, as well the prominent entryway fenestration arrangement. As such, the property continues to represent its historic period as a contributing district resource.

Completed in 1968, the subject building is a one-story (split-level), L-shaped, single-family residence on a 0.21-acre suburban parcel. The side-gabled and wood-frame dwelling is built on a poured concrete foundation and features composition shingle roofing. An interior common-bond brick chimney with two terra cotta and metal caps extends from the roof's east slope. Cladding consists of cedar clapboard siding. The primary (east) elevation is dominated by a dutch-gabled, two-bay garage projection. A stepped concrete path leads from the driveway to the main entrance, a paneled front door. A textured glass sidelight is adjacent to the door on its south side, and additional textured glass panels are above the door. Four vinyl-sash sliders are along the elevation, north of the main entrance. The primary elevation features a slight projection which connects to the garage is south of the entryway. There, fenestration consists of two evenly-spaced vinyl-sash sliders. Per Assessor data and present conditions, the original cladding is intact but the original aluminum-sash windows have been replaced. The original roofing materials consisted of medium wood shakes and the garage doors are not original.

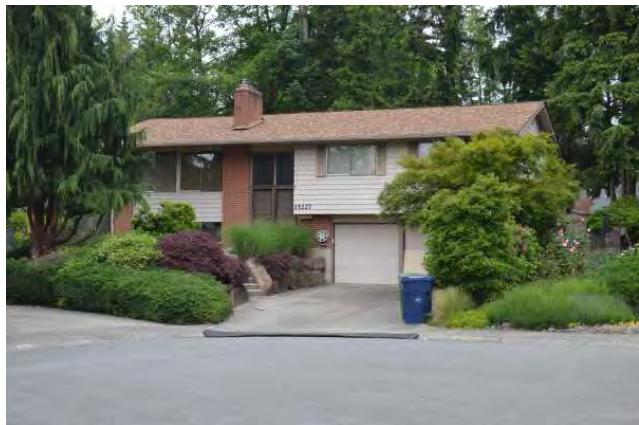
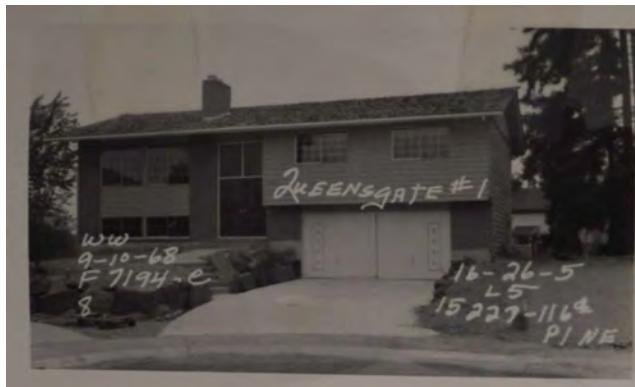
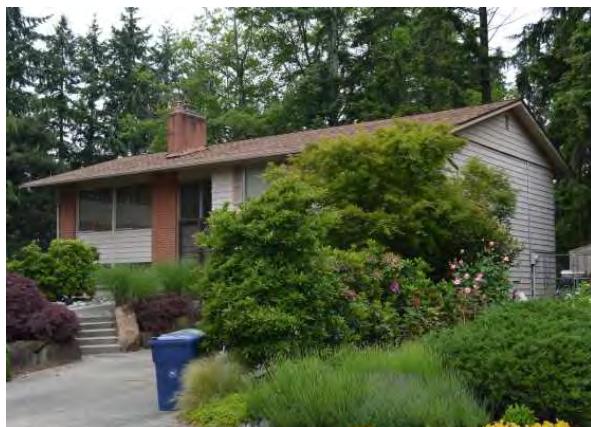
15227 116th Pl NE

The subject residence is not eligible under Criterion C. The dwelling is typical of local and regional mid-to-late 1960s and early 1970s split-level single family dwellings, and does not represent significant and distinctive architectural characteristics, demonstrate the work of an accomplished architect, or feature noteworthy methods of construction. No architect or builder is listed on the historic King County Assessor data cards or current Assessor forms for the subject residence. The dwelling has also undergone alterations to original materials, including the removal and replacement of original divided-light windows.

Property 719422 is recommended as a contributing resource to the district. While observed district resources have all experienced alterations including modernized fenestration, roofing material and garage doors, the subject property has maintained its original cladding and form, as well the prominent entryway fenestration arrangement. As such, the property continues to represent its historic period as a contributing district resource.

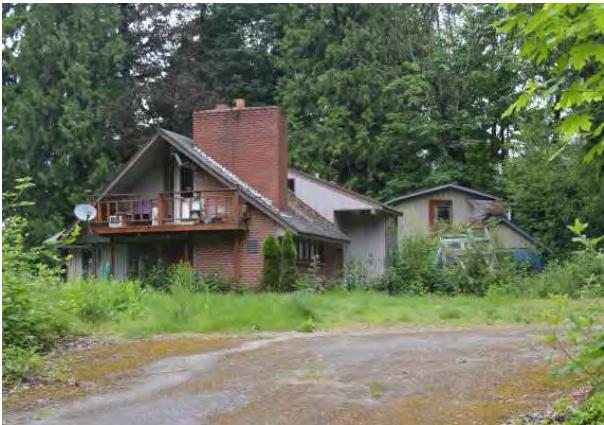
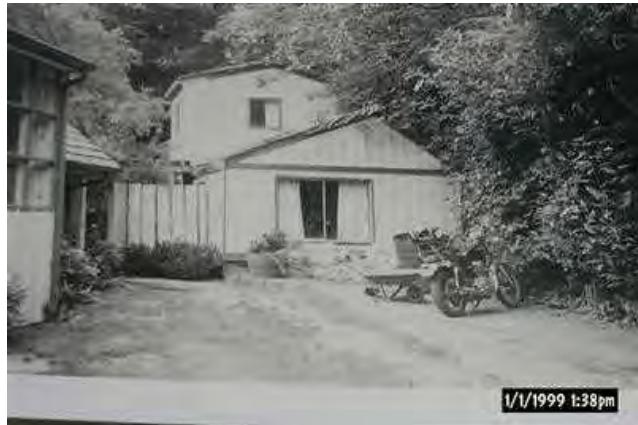
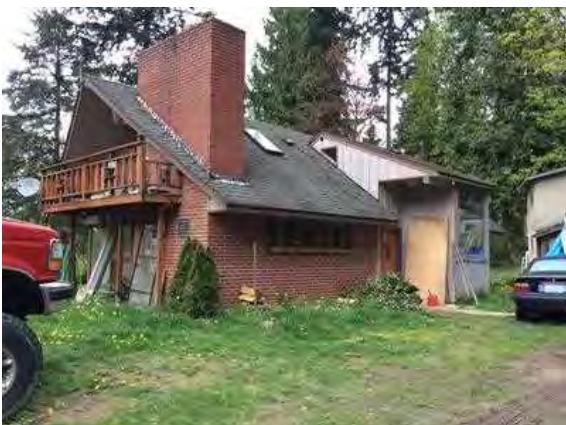
11403 E RIVERSIDE DR

Category	Item
Foundation	Concrete - Poured
Form Type	Single Dwelling - Side Gable
Roof Type	Gable - Side
Roof Material	Asphalt/Composition - Shingle
Cladding	Brick - Common Bond
Structural System	Wood - Platform Frame
Plan	Rectangle
Cladding	Wood - Board & Batten

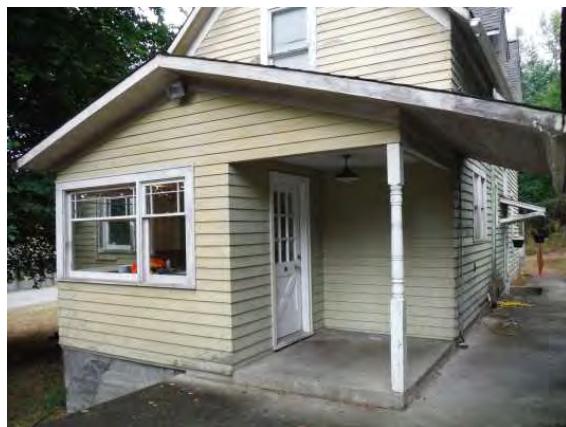
Stoop detail facing southwest

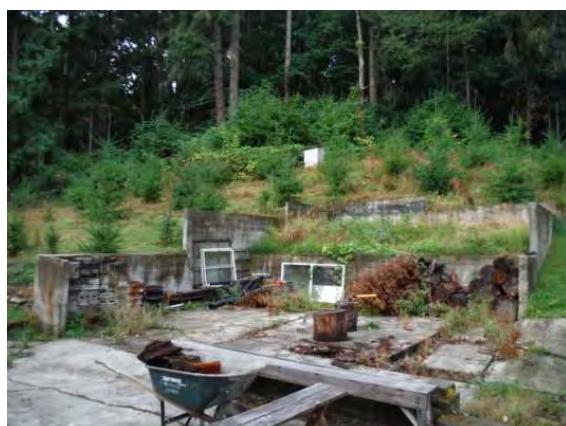
Demolished garage, facing southwest

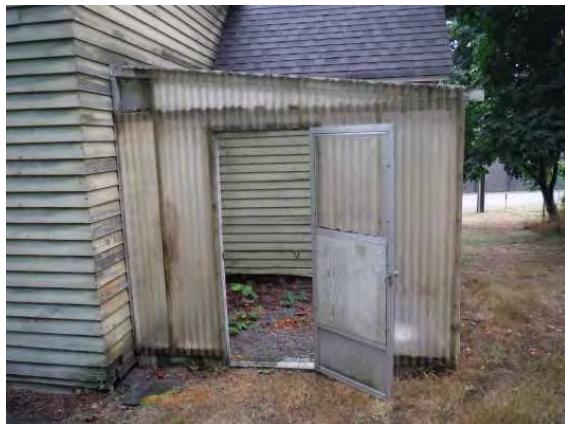
Shed addition, facing west

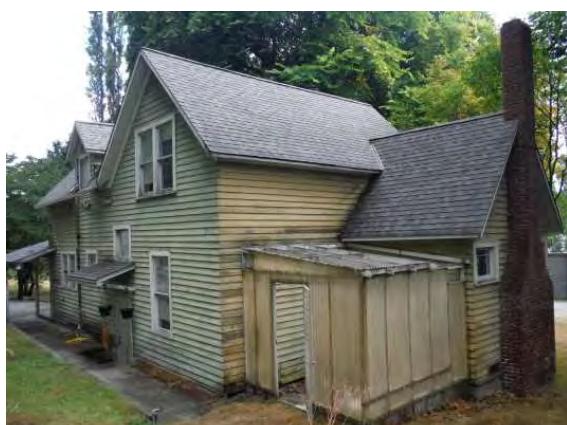
House, facing northeast

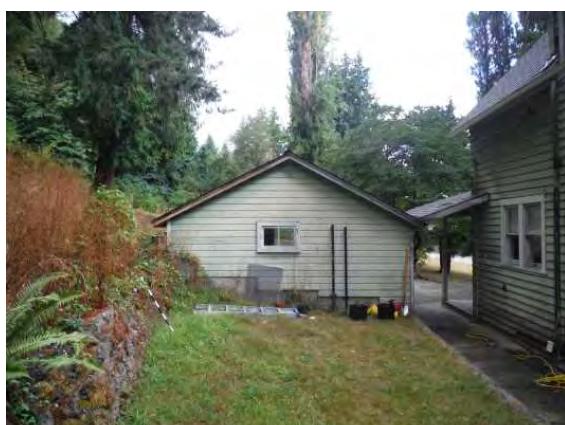
Garage, facing north

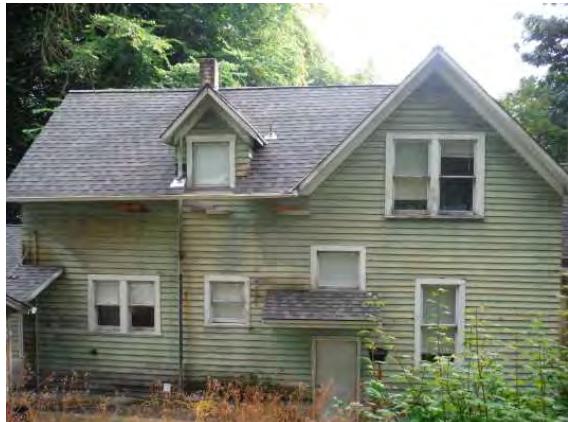
House, facing east

Physical description: The Philip Fries House is located in Bothell and consists of a farmhouse, a garage, a smoker, and the foundation of a former garage no longer standing. The house is 1.5 stories and has a cross-gabled roof. The roof is clad with wood shingles. Two dormers have been added, a gable-roof dormer on the west side of the roof and a shed-roof dormer on the east side of the roof. There is one double-hung window in the north-facing gable end and paired double-hung windows in the east- and west-facing gable ends. The first floor has 6-1 light windows on the east and north facades, and double-hung windows on the west facade. The walls are clad in clapboard siding. Due to the slope, the basement is partially exposed on the east side of the house. The basement walls are concrete and there are six-light windows on the east side. There is a partially below-grade door on the west façade that likely provides access to the basement. It is covered by a small shed roof with a single-pane, fixed window above and accessed by concrete stairs. A brick porch with a shed roof extension is located on the east façade. The porch was likely built c. 1930 and has Craftsman influences including the brick base and brick piers with curved wood elements under the porch roof. A front door with sidelights is located centrally within the porch. An external brick chimney is located on the south side façade.

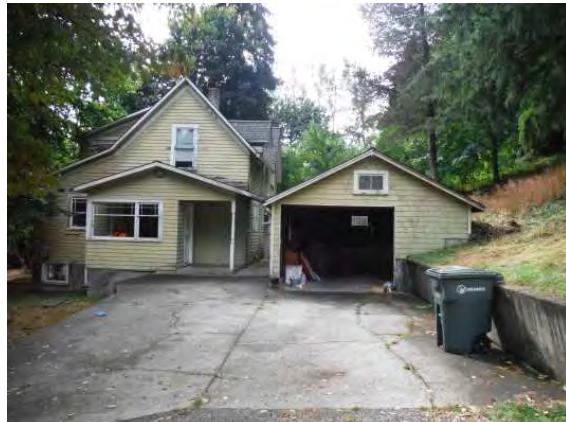
House and garage, facing south
