DUWAMISH RIVER PEOPLES PARK AND HABITAT AREA T-117 HABITAT RESTORATION PROJECT – SITES 23 & 25

TEST PILE COMBINED MONITORING REPORT

PORT OF SEATTLE

GRETTE ASSOCIATES^{LLC}
2102 NORTH 30TH, SUITE A
TACOMA, WASHINGTON 98403
(253) 573-9300

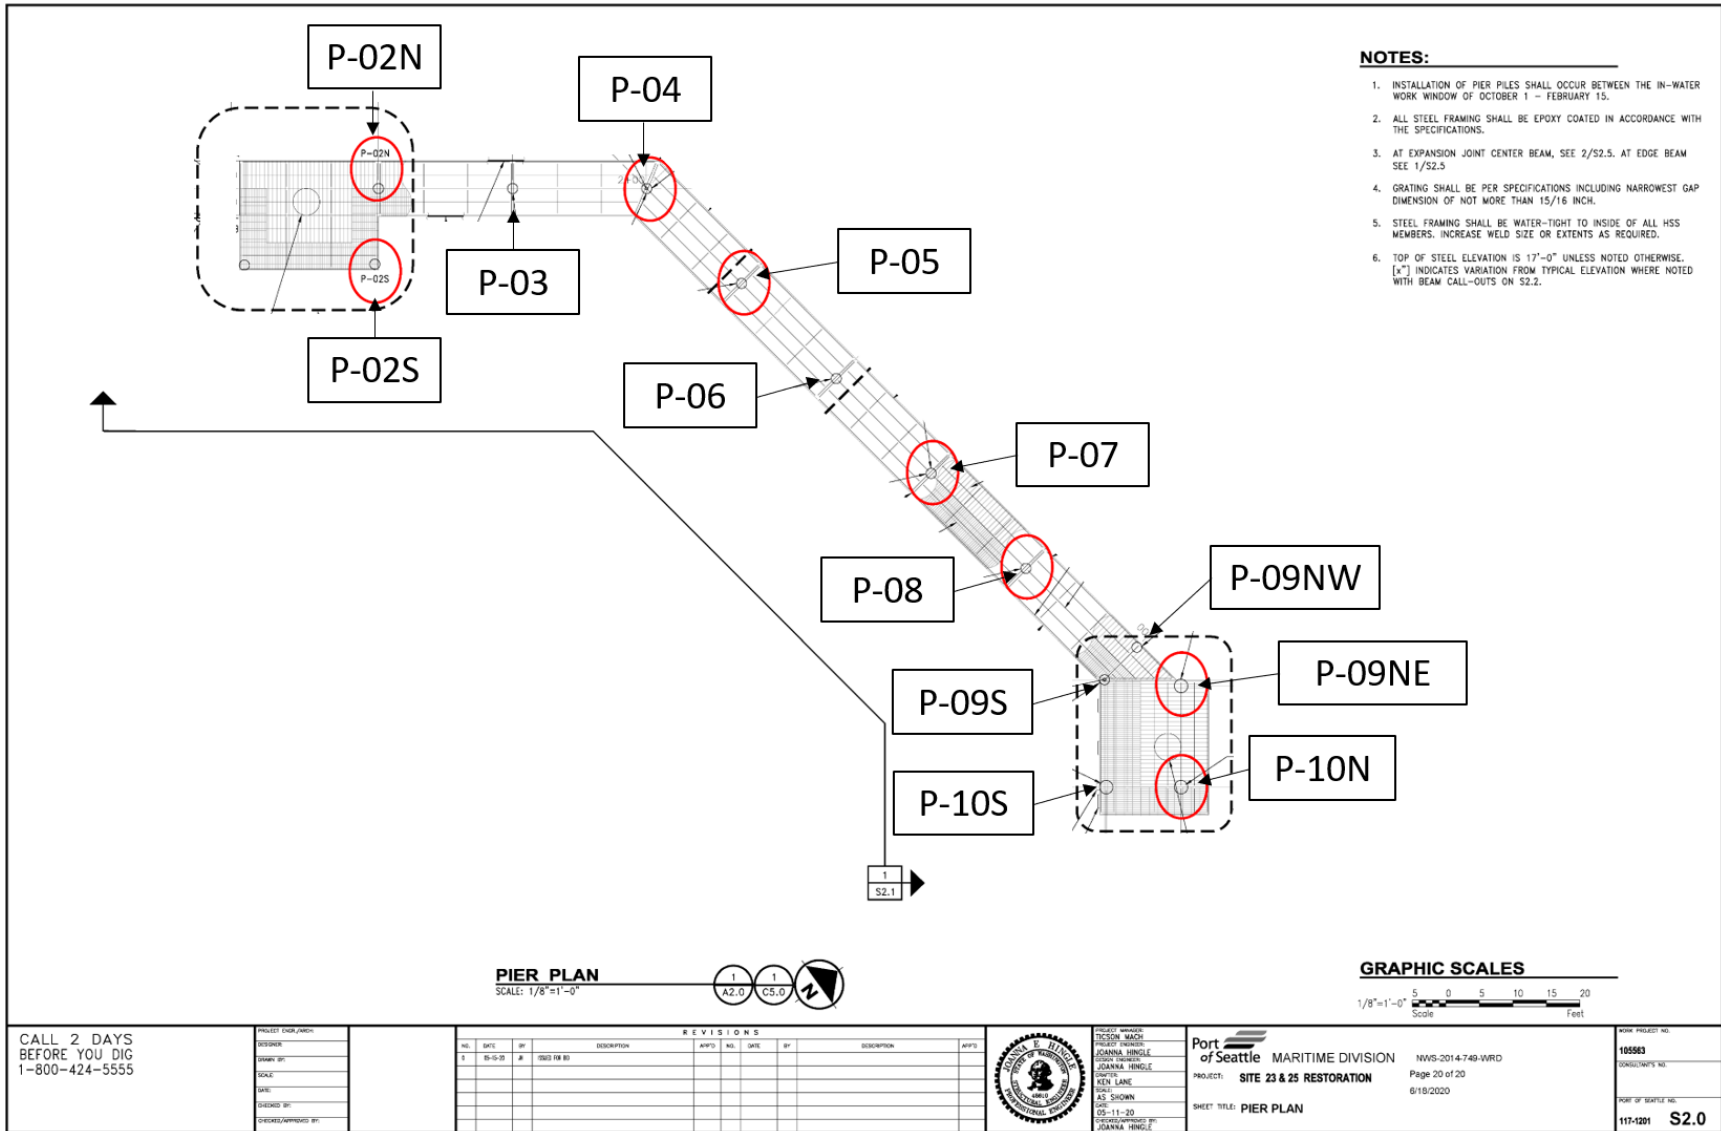
Figure 3. Pile number locations. Note that north is to the top right (rotated 90° clockwise from Figure 2).

Due to operational issues with the double-walled pile, only three double-walled pile were installed: one upland and two in-water. Hydroacoustic data were collected for the one upland and one of the two in-water pile. The remaining thirteen (13) pile installed were standard pipe pile. Hydroacoustic data were collected for three of these: one upland and two in-water. Pile unique identification numbers are shown in Figure 3.

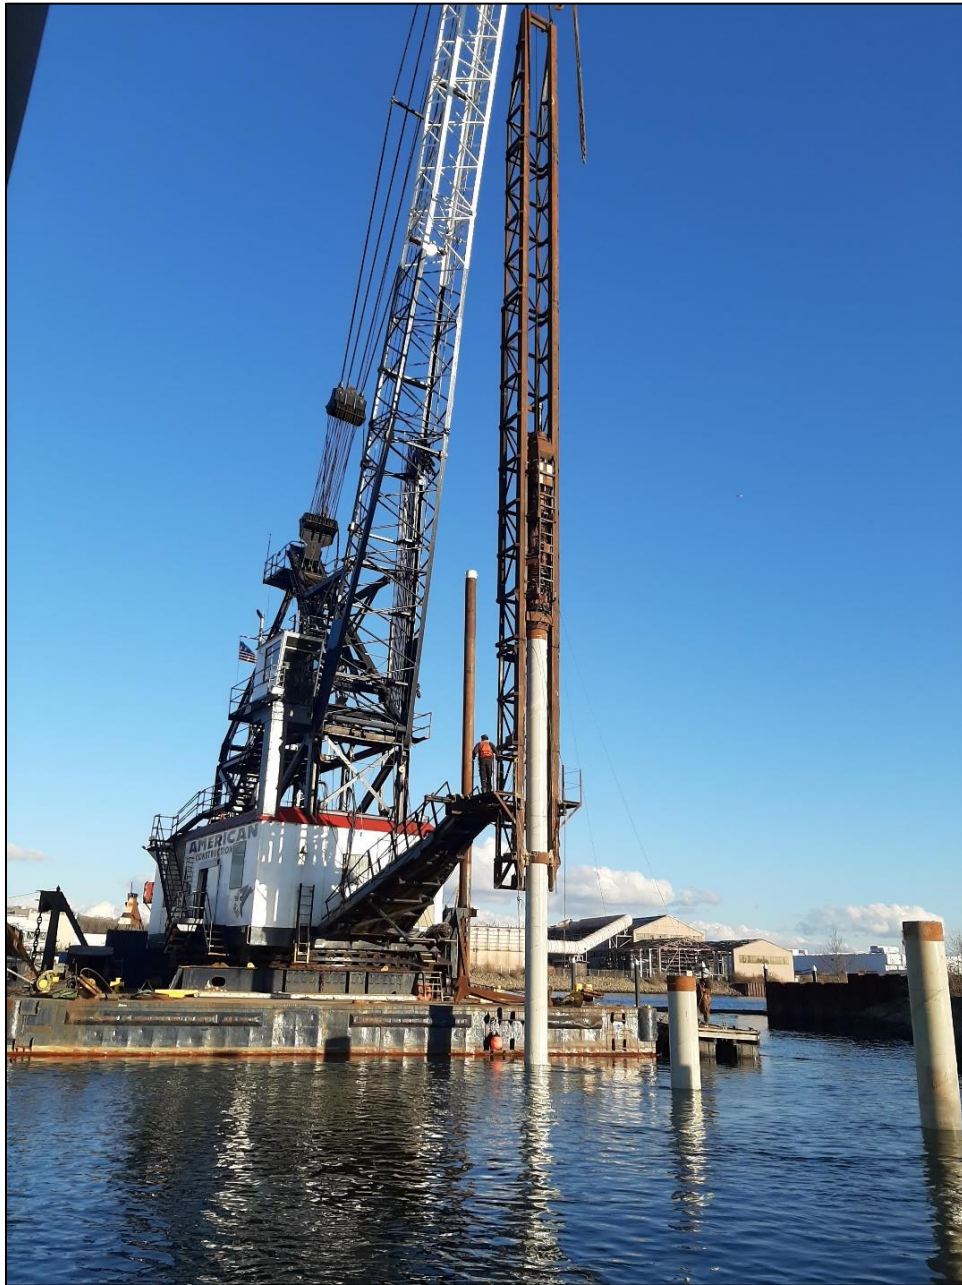
Photograph 1. Impact hammer configuration.

All pile included in this hydroacoustic monitoring study were impact driven, allowing for cross-comparison of data. Upland standard and Reinhall pile were impact driven with no additional attenuation devices. In-water standard pile were driven with a bubble curtain on except for three approximately thirty-second periods during which the bubble curtain was shut off to record unattenuated noise levels. These periods occurred toward the first third, the middle third, and the final third of the drive. Reinhall pile were driven with no additional attenuation devices beyond the double-walled design.

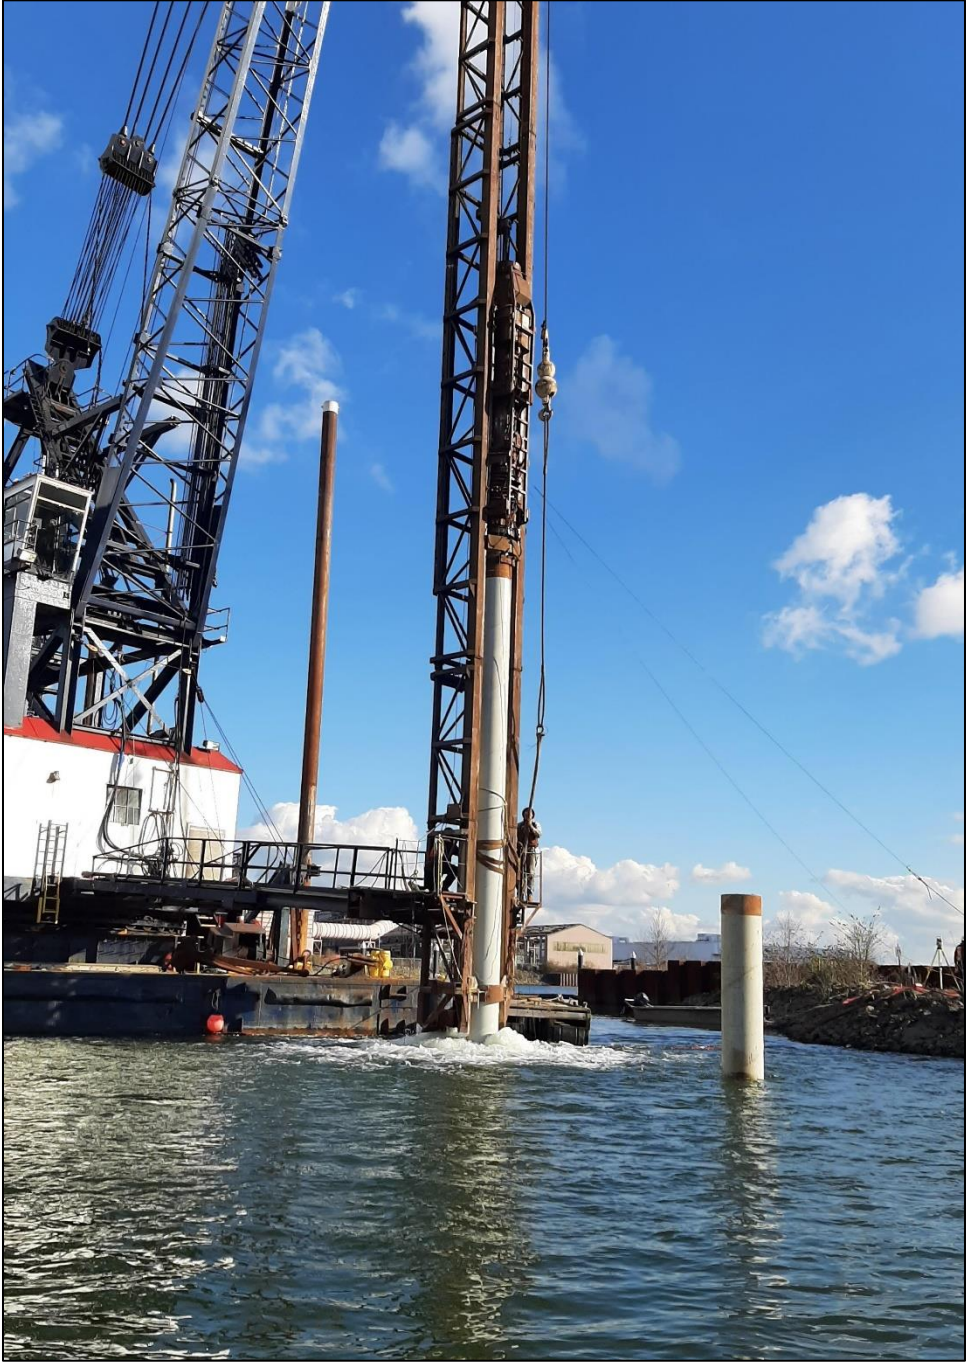
Photograph 3. Bubble curtain running during impact driving of pile P-05.

The bubble curtain was comprised of aerated rings made out of 2.5-inch, schedule 80 marine-grade aluminum pipe (Photograph 2). The rings had 1/16-inch diameter air holes spaced approximately ¾-inch apart, and placed in four (4) adjacent rows along the top-side of the pipe for uniform air bubble flux when in operation. Each ring was comprised of two halves joined at the ends with paired hinge plates secured with removable ¾-inch bolt/hardware. The hinged connection allowed the rings to individually “open up” for easier placement (or removal) around a pile. The system provided bubble flux of approximately 32.91 cubic feet per minute per linear foot of pipe in a single layer (Photograph 3).

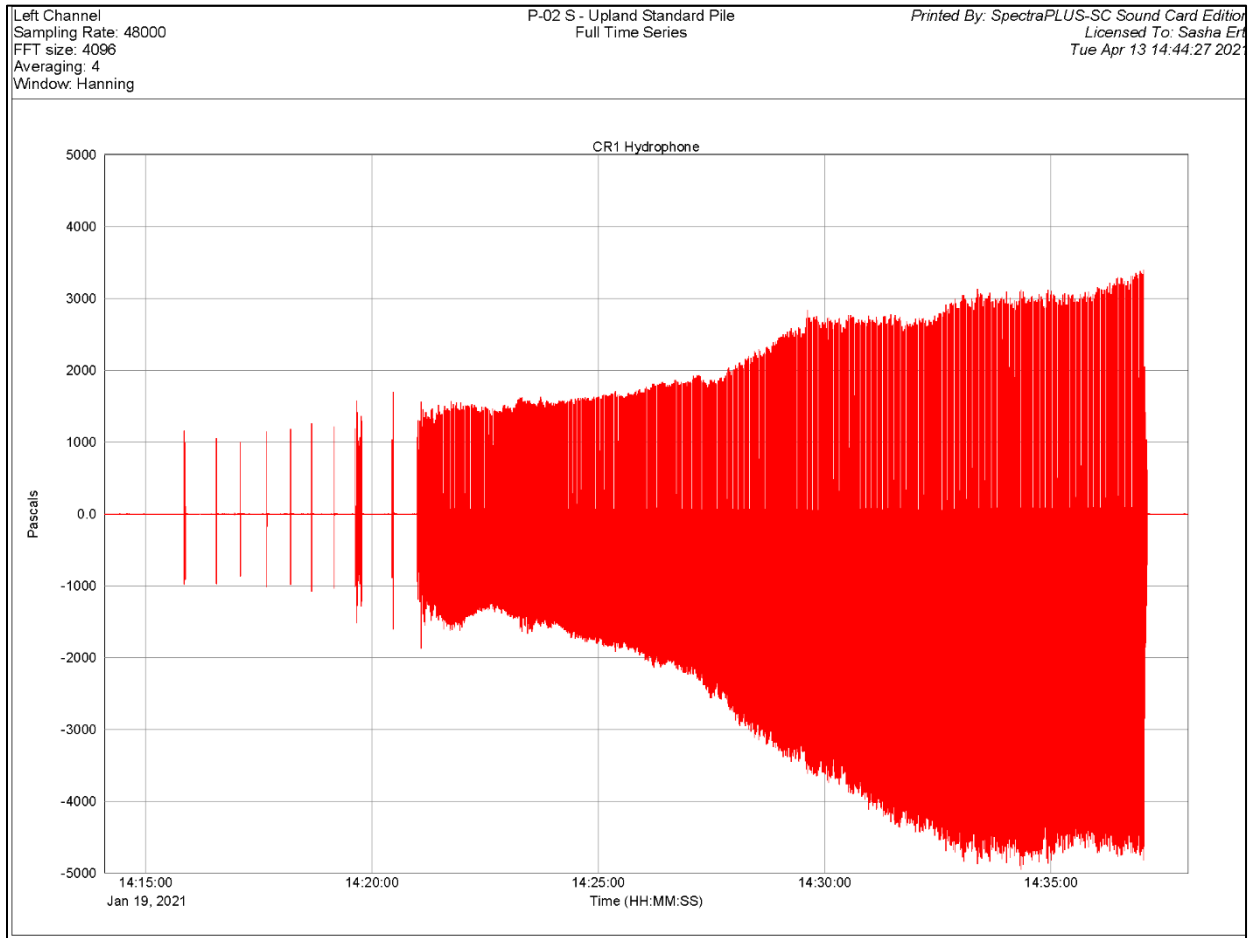
Figure 3-1. Time series for upland standard pile P-02 S.

Although this was an upland pile and the Practical Spreading Loss Model may not apply, in an effort to standardize results for comparison purposes, the max peak SPL was run through the model. The max peak SPL for this pile at 10 meters was 200 dB_{peak}.

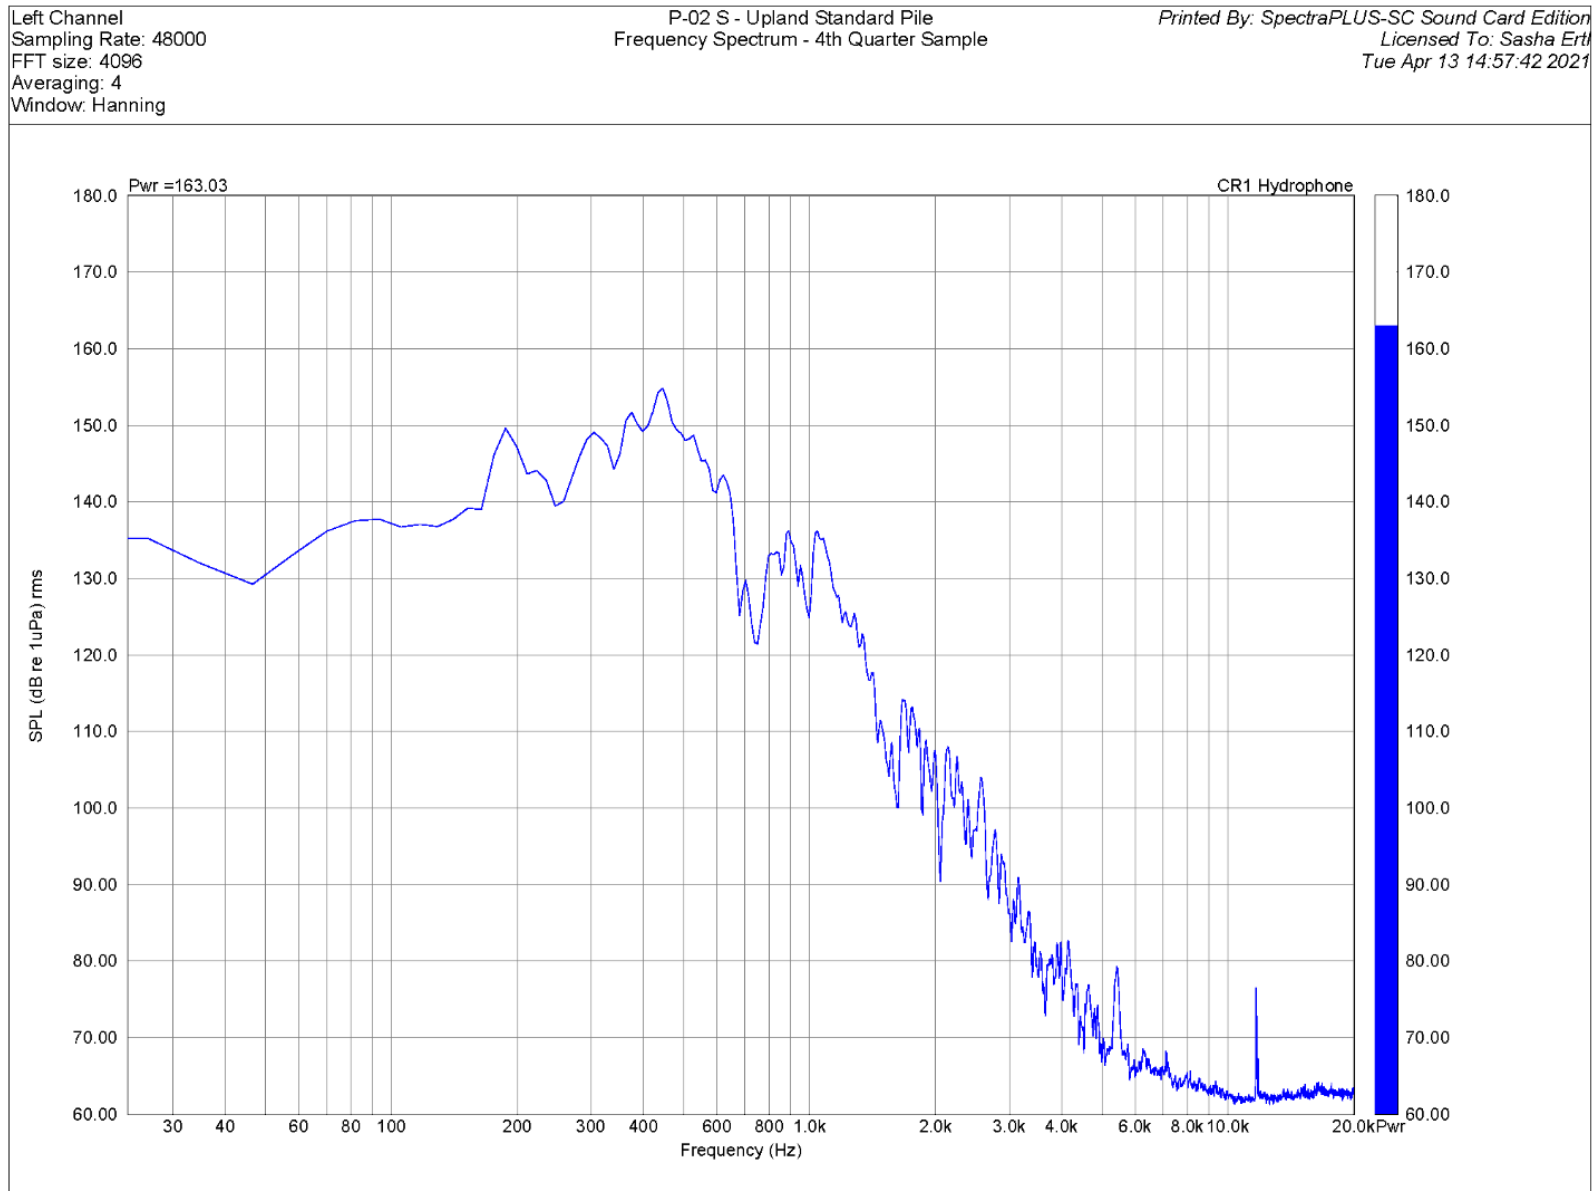
Figure 7-1. Frequency spectrum for subsample from first quarter of P-02 S drive.

Figure 7-2. Frequency spectrum for subsample from second quarter of P-02 S drive.

Figure 7-3. Frequency spectrum for subsample from third quarter of P-02 S drive.

Figure 7-4. Frequency spectrum for subsample from fourth quarter of P-02 S drive.

Hydroacoustic data were analyzed for subsets of five strikes in the first, second, third, and fourth quarters of this drive. Results are presented in Table 3-4. Frequency spectra for subsets of eight strikes in each quarter of the drive are presented in Appendix A in Section 7.1.1.

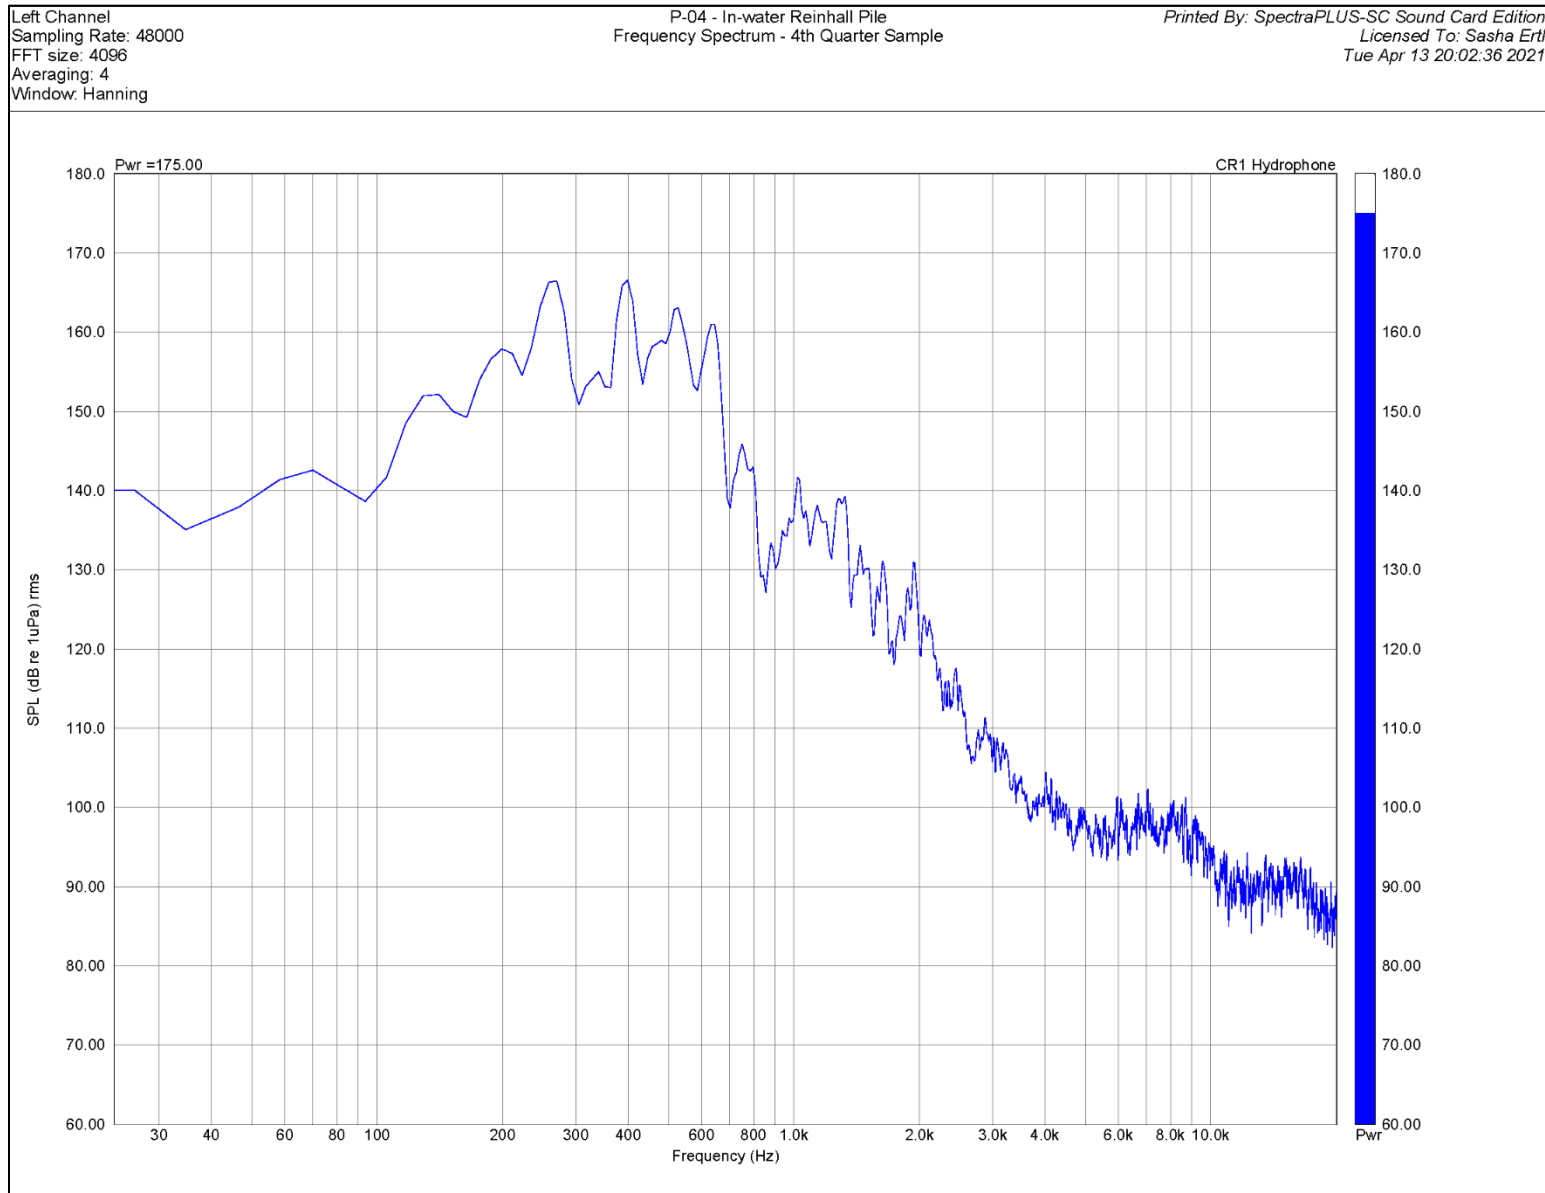
Figure 7-9. Frequency spectrum for subsample from first quarter of P-04 drive.

Figure 7-10. Frequency spectrum for subsample from second quarter of P-04 drive.

Figure 7-11. Frequency spectrum for subsample from third quarter of P-04 drive.

Figure 7-12. Frequency spectrum for subsample from fourth quarter of P-04 drive.

Hydroacoustic data were analyzed for subsets of five strikes in the first, second, third, and fourth quarters of this drive. Results are presented in Table 3-6Table 3-5. Frequency spectra for subsets of eight strikes in each quarter of the drive are presented in Appendix A in Section 7.1.3.

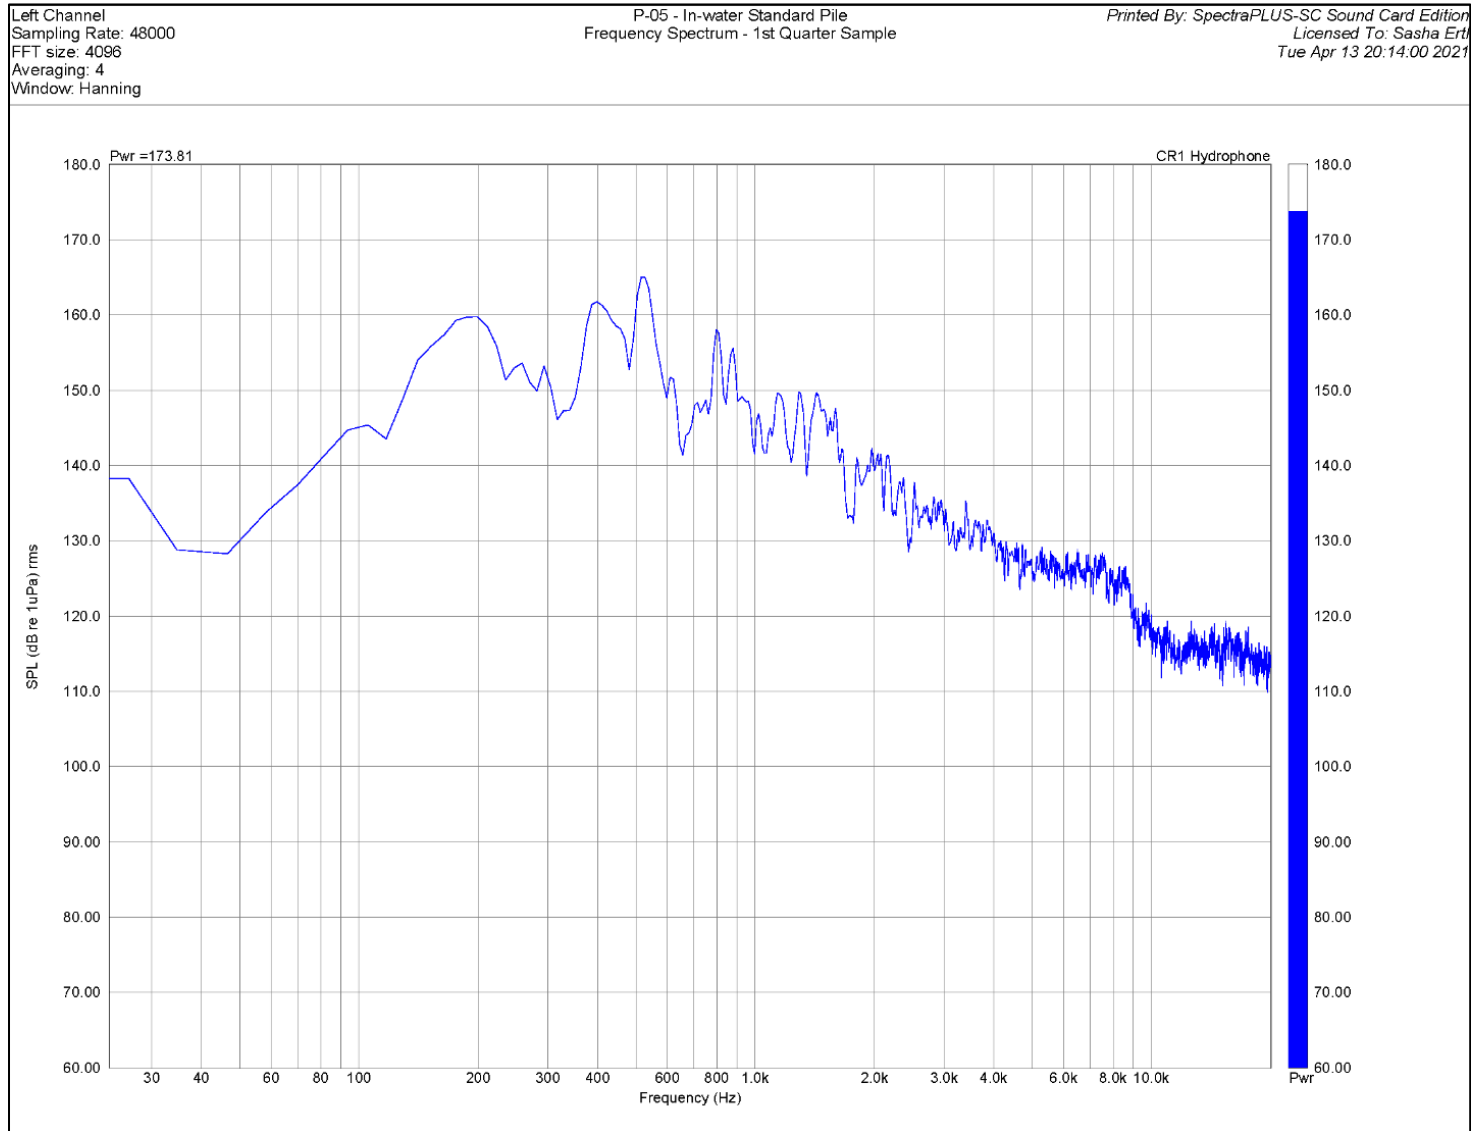
Figure 7-13. Frequency spectrum for subsample from first quarter of P-05 drive with the bubble curtain on.

Figure 7-14. Frequency spectrum for subsample from first 30-second segment of P-05 drive with the bubble curtain off.

Figure 7-15. Frequency spectrum for subsample from second quarter of P-05 drive with the bubble curtain on.

Figure 7-16. Frequency spectrum for subsample from second 30-second segment of P-05 drive with the bubble curtain off.

Figure 7-17. Frequency spectrum for subsample from third quarter of P-05 drive with the bubble curtain on.

Figure 7-18. Frequency spectrum for subsample from third 30-second segment of P-05 drive with the bubble curtain off.

Figure 7-19. Frequency spectrum for subsample from fourth quarter of P-05 drive with the bubble curtain on.

Hydroacoustic data were analyzed for subsets of five strikes in the first, second, third, and fourth quarters of this drive and from each of the three segments during which the bubble curtain was inactive. Results are presented in Table 3-7Table 3-5. Frequency spectra for subsets of eight strikes during the same seven segments are presented in Appendix A in Section 7.1.4.

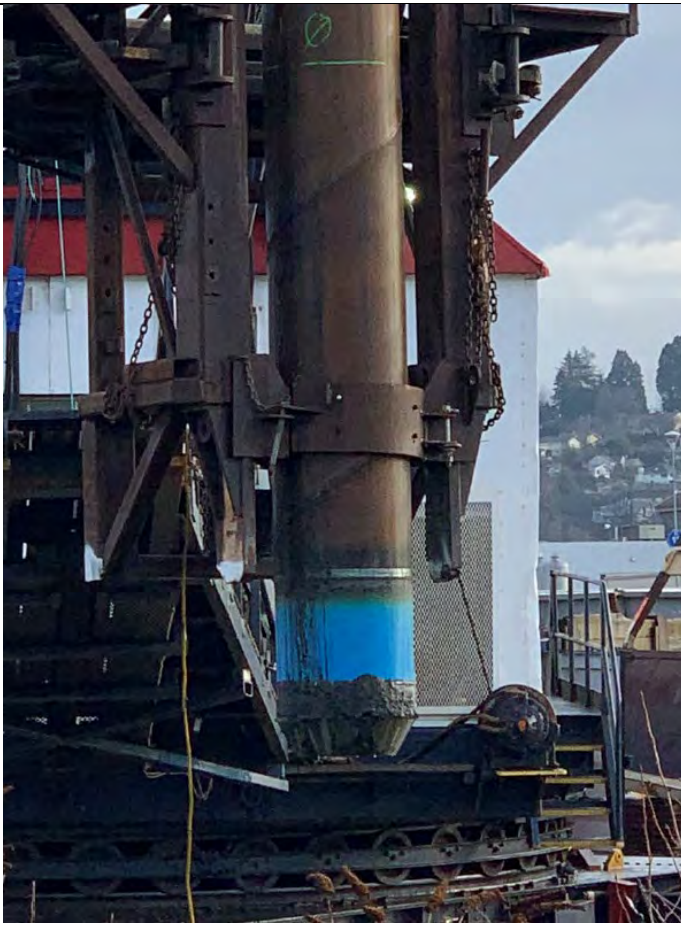
Plate 1 – Impacting Reinhall pile P-02N using Delmag D62-22 impact hammer on 2/8/2021. Note about the bottom of the structural pile attached to a 3-foot-long tip assembly with inner rings. The inner rings of the structural pile were impacted by the (inside) mandrel during pile driving.

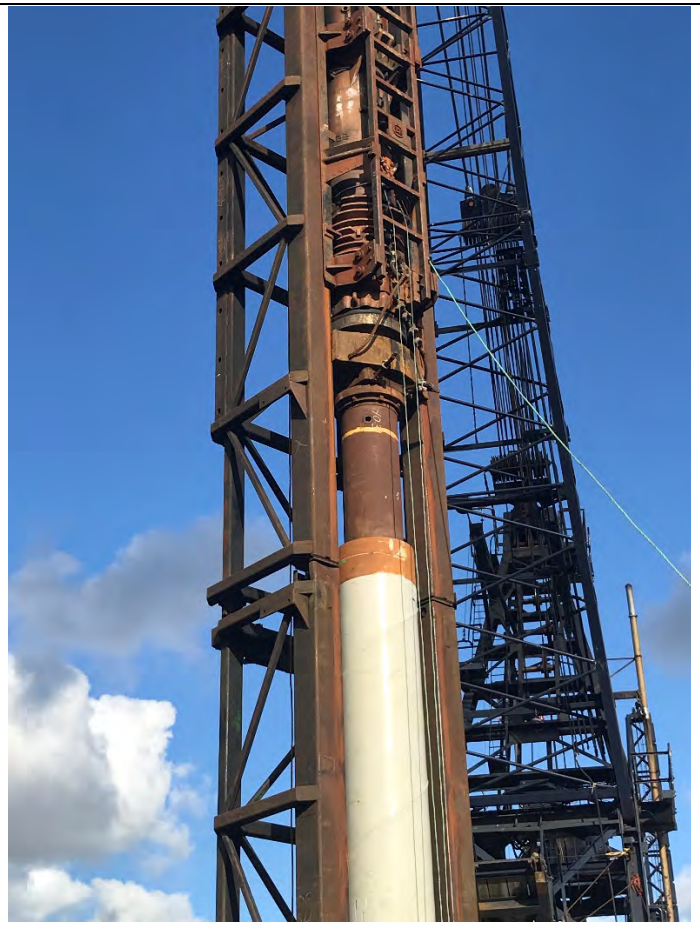
Plate 2 – Impacting Reinhall pile P-02N using Delmag D62-22 impact hammer on 2/8/2021. Note 18" O.D. mandrel inside the structural pile was directly impacted by the diesel hammer.

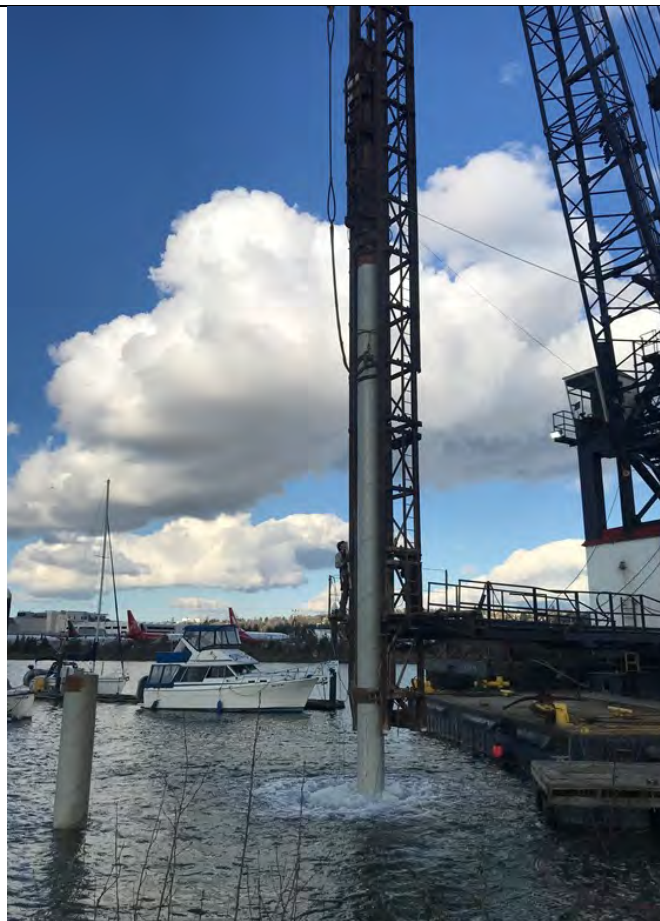
Plate 4 – Impacting pile P-05 on 2/9/21 using bubble curtain method. Looking northeast.

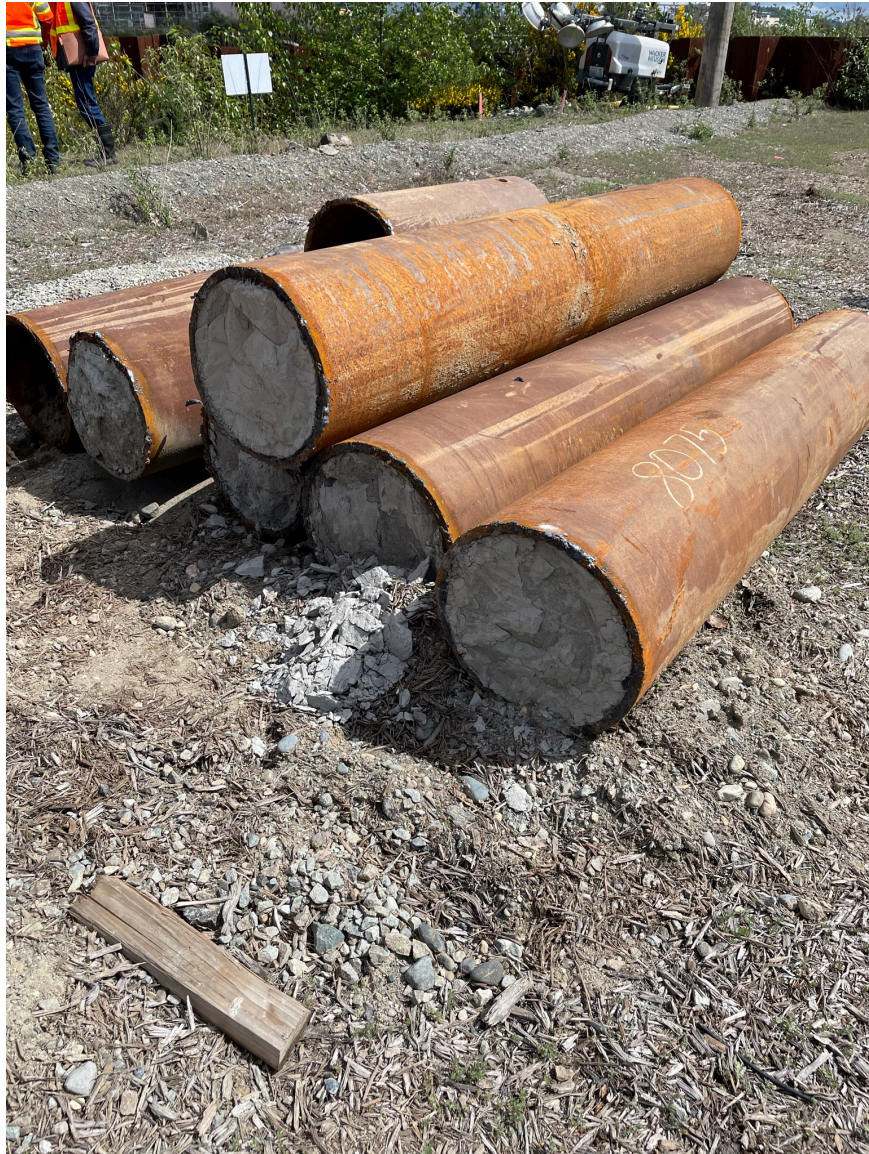
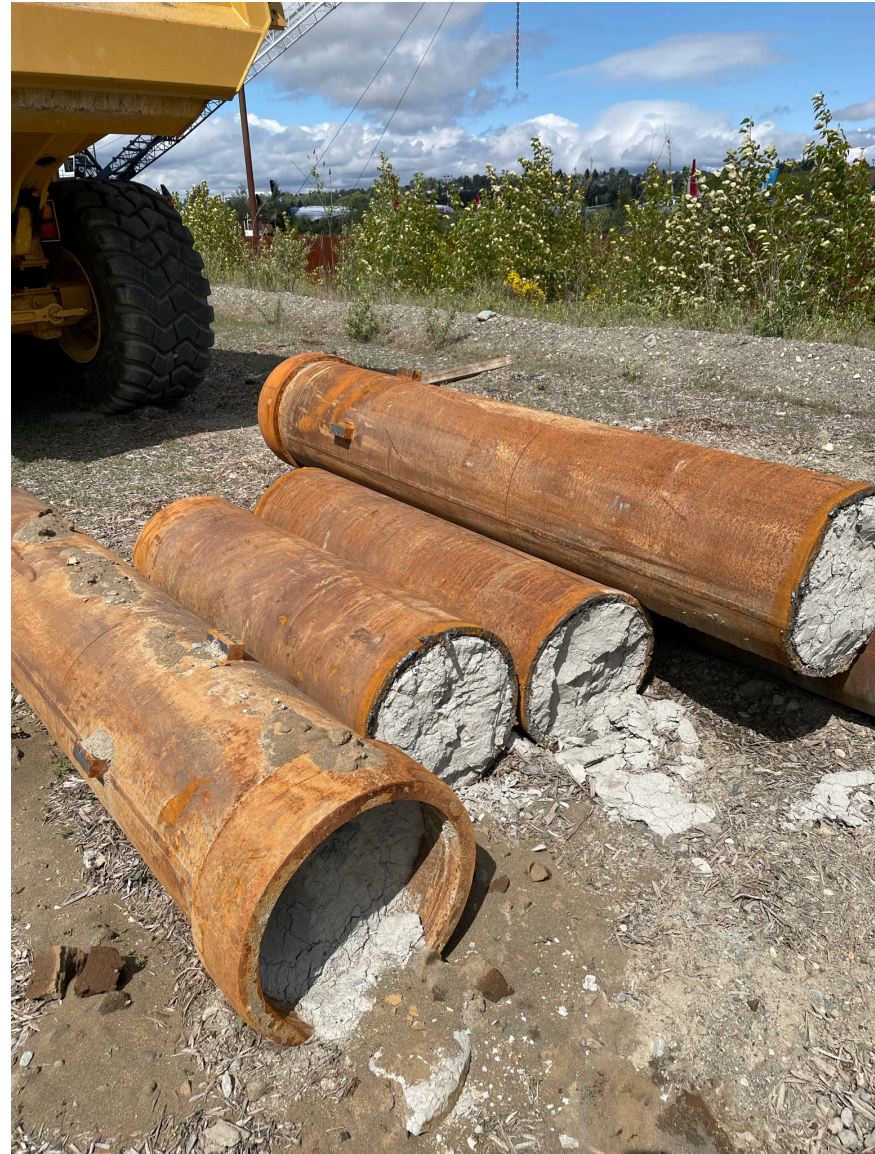
7.3 Appendix C – Photos of Mandrels After Driving

On February 9, PanGEO observed American attempt to drive Reinhall pile P-04 using the mandrel that was previously used to drive P-02N. During driving, the inside of the mandrel became plugged with soils, which significantly increased the driving resistance. As a result, American was unable to drive the pile to the design tip elevation of -44 feet, meeting refusal at tip elevation of about -43 feet (with about 80+ blows/ft at the end of the pile driving). American contacted the owner and structural engineer on the same day to discuss the issue. Based on conversations with American, we understand that the structural engineer has approved the at-built pile tip elevation -43 feet for pile P-04. From a geotechnical standpoint, based on the observed number of blow counts per minute and the corresponding hammer stroke (~10 feet) and the number of blow counts (80+ blows/ft) we observed at the end of the impact pile driving, it is our opinion that the installed pile P-04 with the at-built pile tip elevation -43 feet is adequate to support the design ultimate load of 90 kips per pile.
