VASHON TRESTLE AND TERMINAL REPLACEMENT

Underwater Sound Level Report: Vashon Timber Trestle and Terminal Replacement

Prepared by:
Peter Soderberg
Washington State Department of Transportation
Office of Air Quality and Noise
15700 Dayton Avenue North, P.O. Box 330310
Seattle, WA 98133-9710

February, 2016

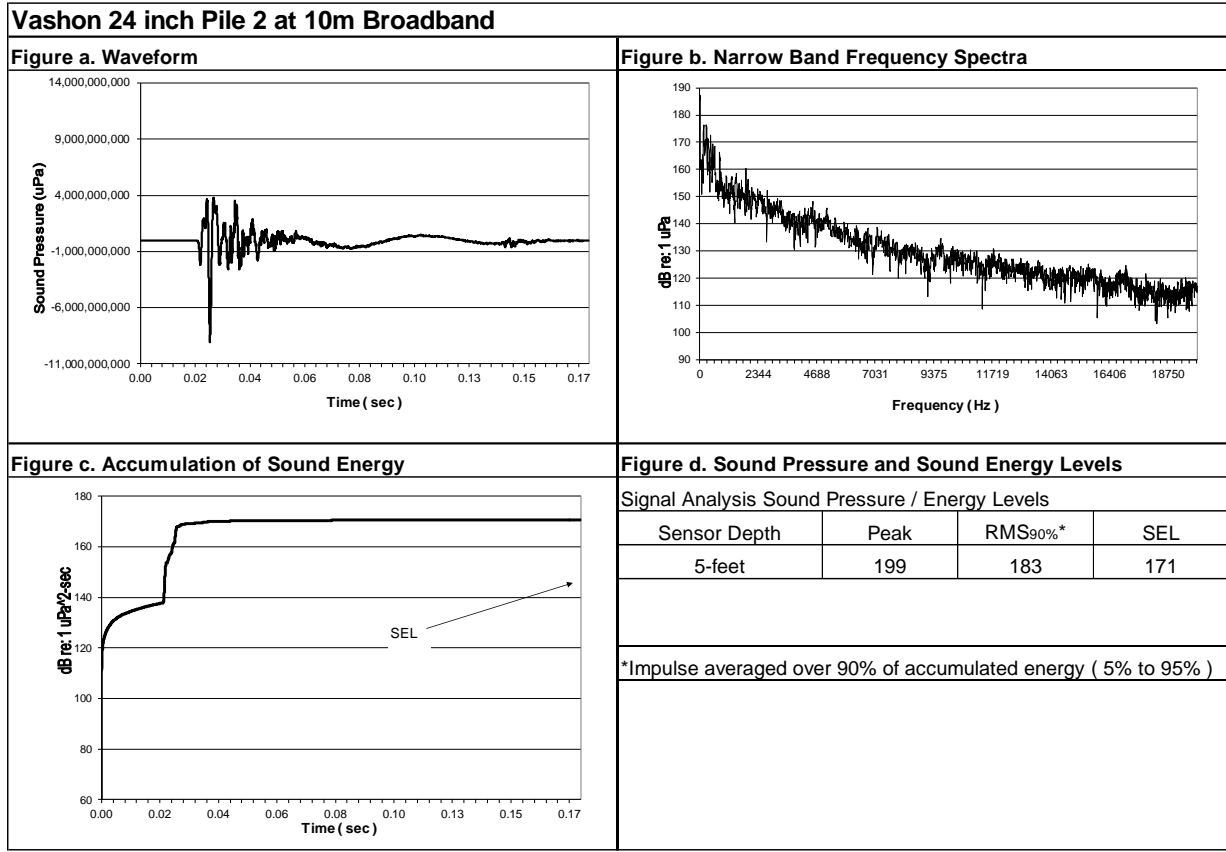
Figure 8: Waveform analysis of attenuated Pile 2, 10M

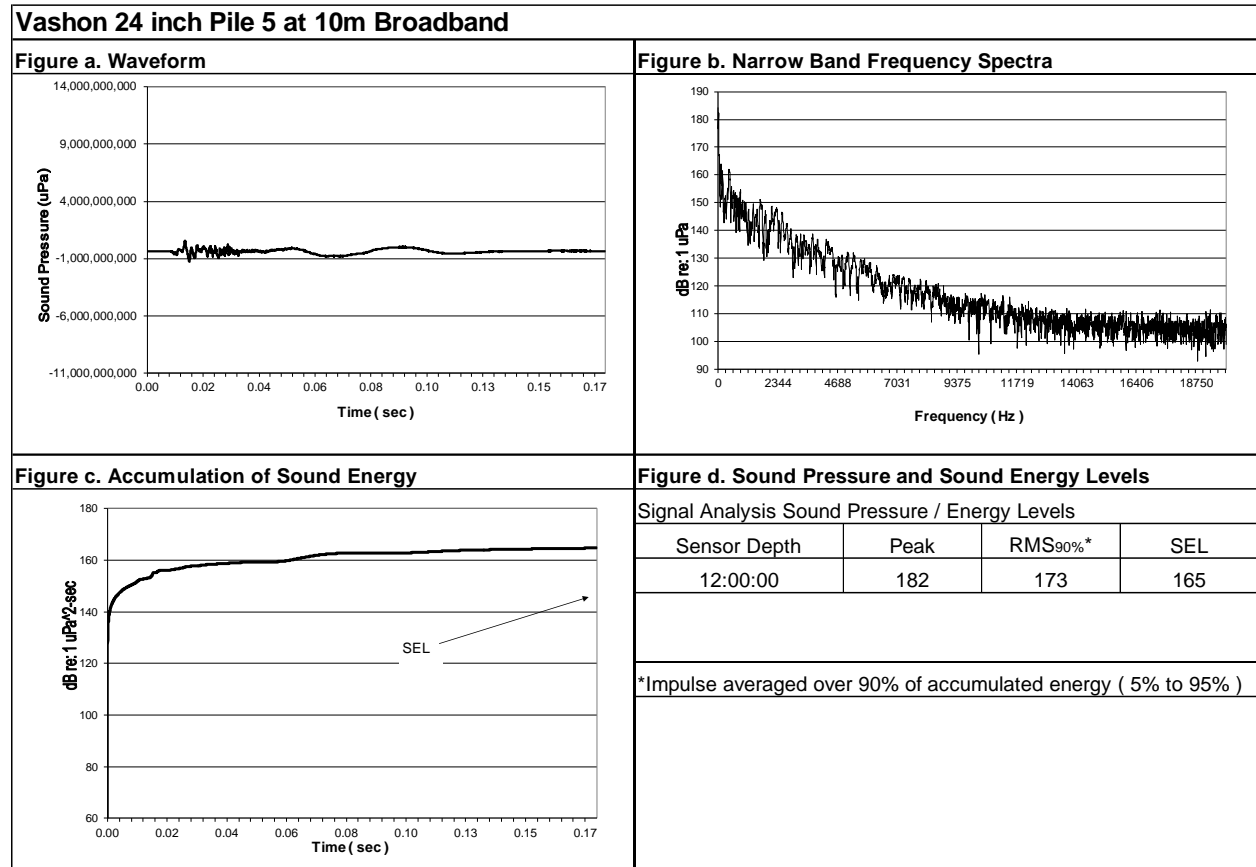
Figure 11: Waveform analysis of attenuated Pile 5, 10M

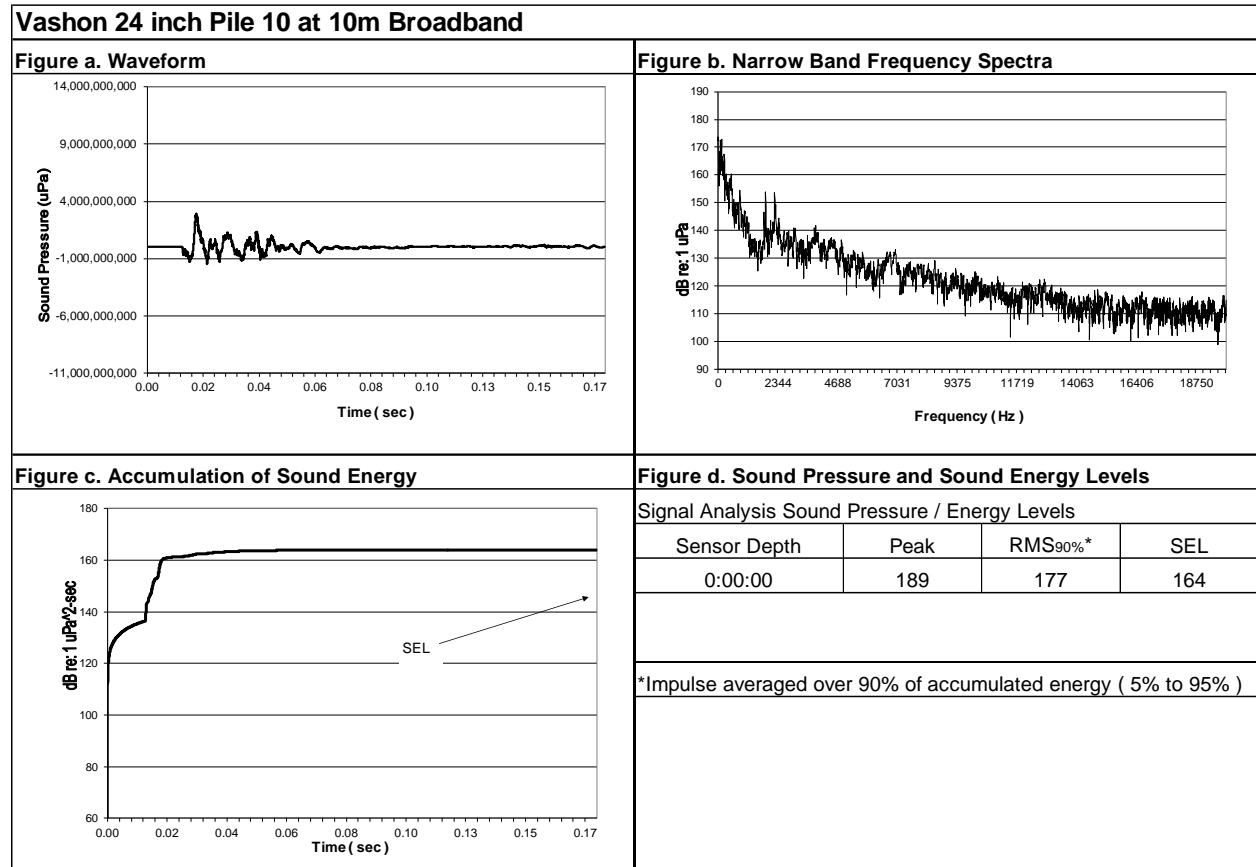
Figure 16: Waveform analysis of attenuated Pile 10, 10M

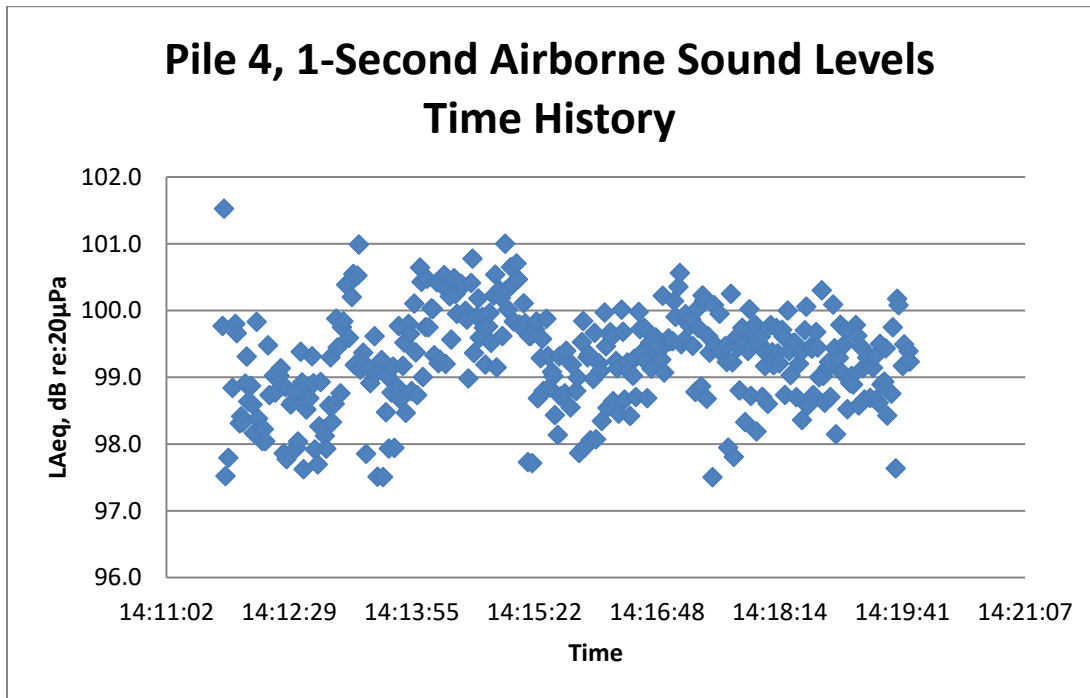
Figure 17: Pile 4 One Second Airborne Time History

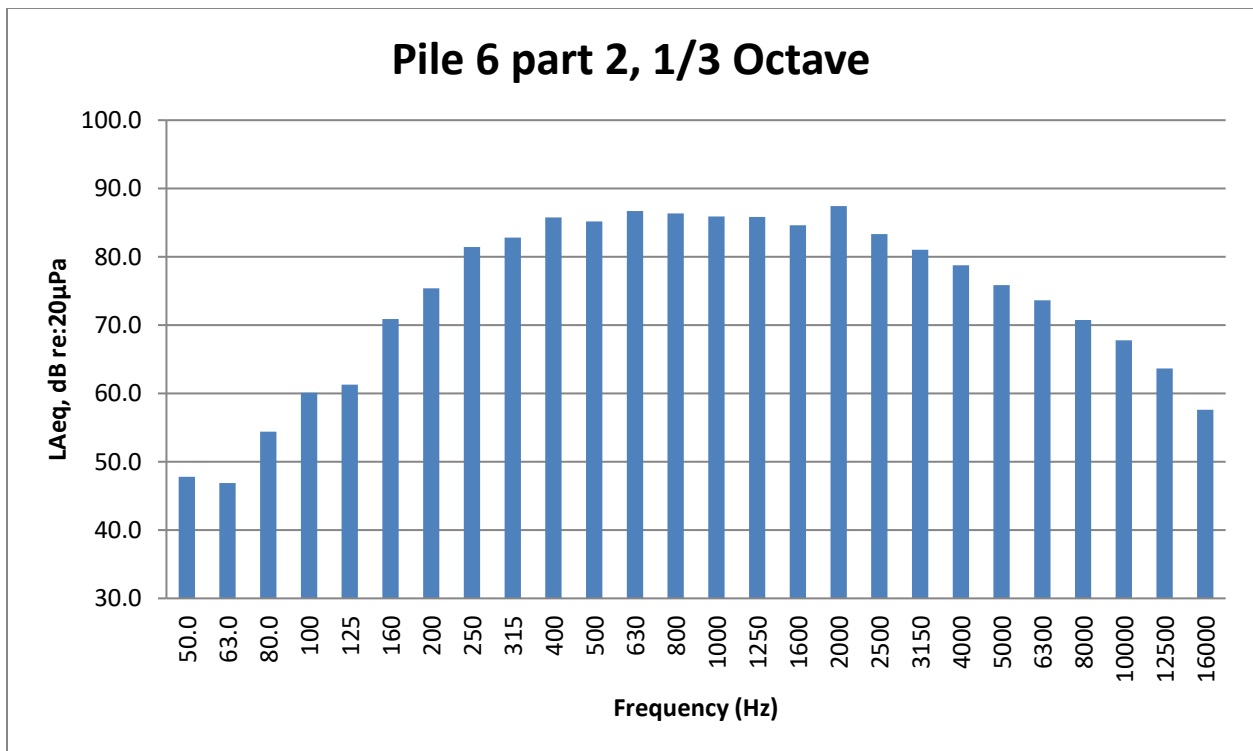
Figure 24: Pile 6 part 2 Airborne 1/3rd Octave
