ANACORTES AIRPORT
2005 PAVEMENT MANAGEMENT REPORT

February 2006

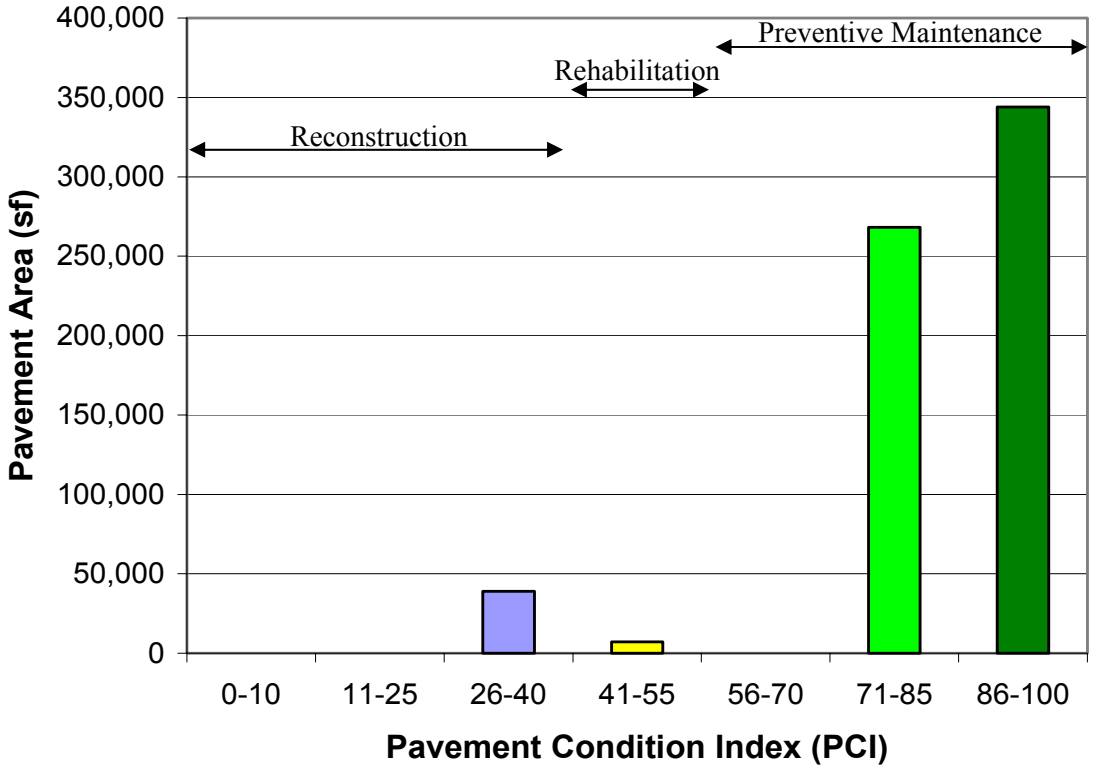
Figure 6. Anacortes Airport overall condition.

The pavements at Anacortes Airport were inspected on April 22, 2005. The 2005 area-weighted condition of Anacortes Airport is 86, with conditions ranging from 39 to 100 (on a scale of 0 [failed] to 100 [excellent]).
Figures 6 and 7 summarize the overall condition of the pavements at the Anacortes Airport. Figure 8 displays the condition of the pavements evaluated. Table 1 summarizes the results of the pavement evaluation. Appendix C presents photographs taken during the PCI inspection and Appendix D details the distresses observed during the visual survey.

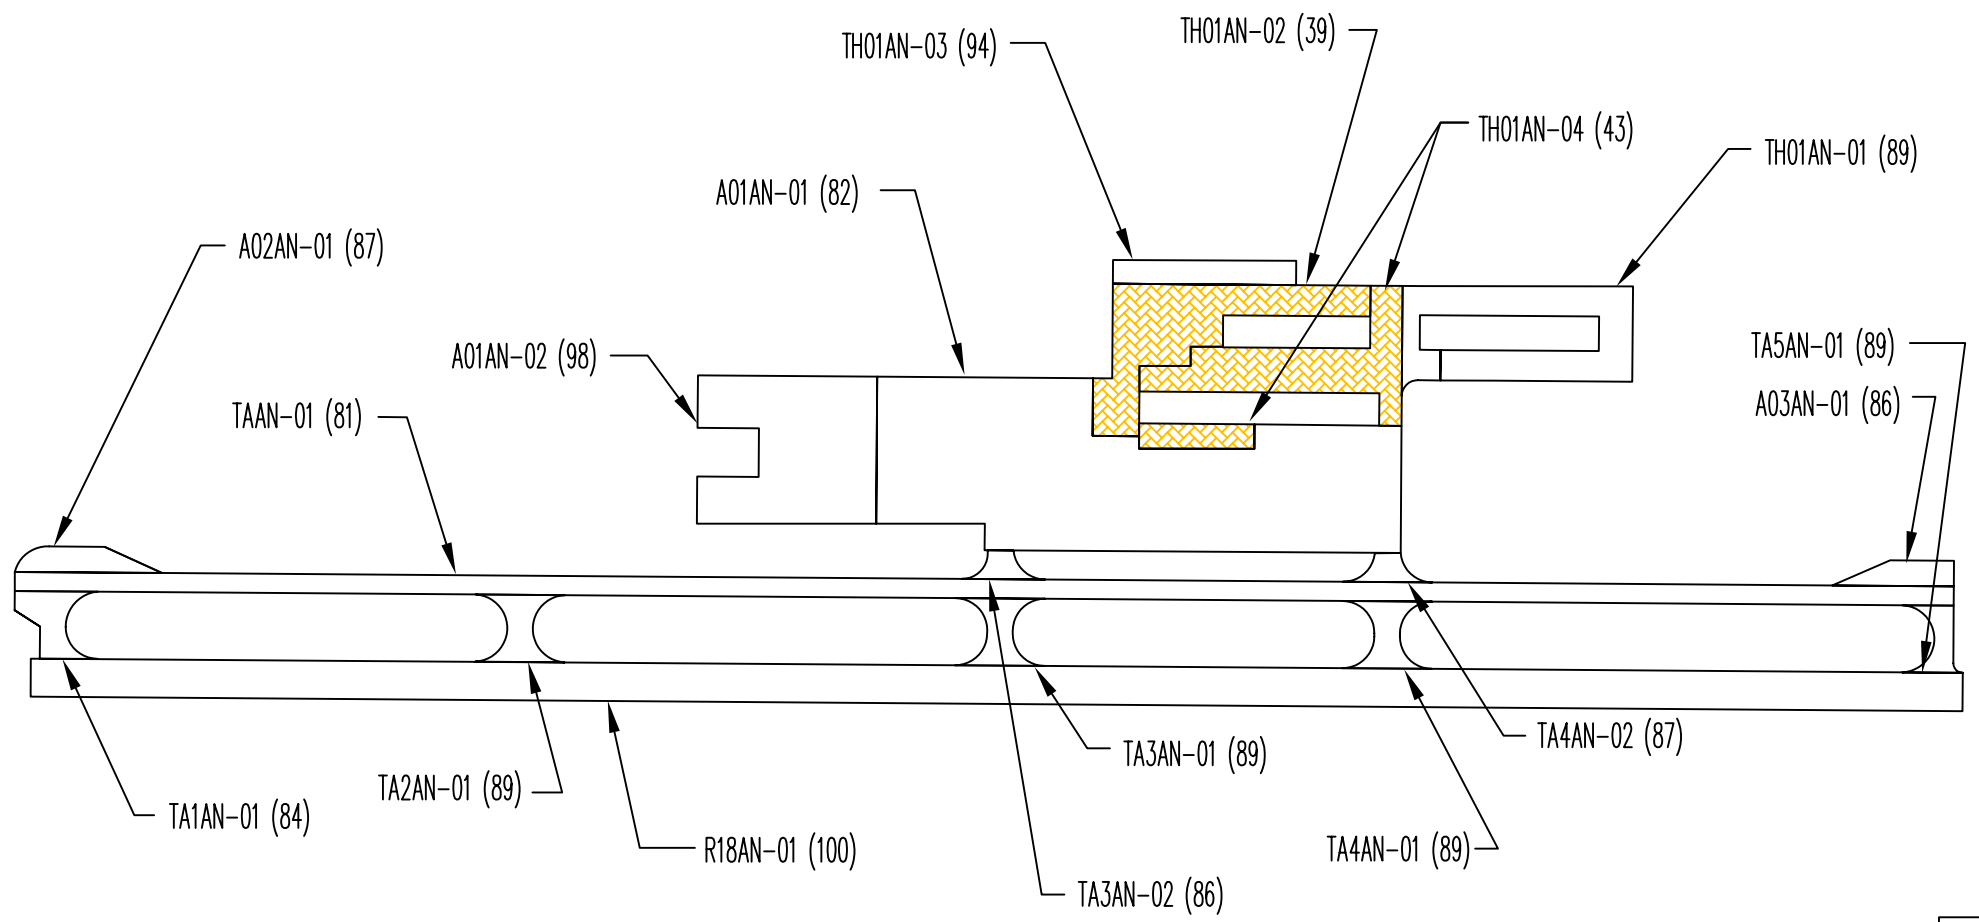
CAPITAL IMPROVEMENT PROGRAM
2006 THROUGH 2012

A summary of the pavement repair program for Anacortes Airport is presented in Table 4 and in Figure 9. Detailed information on the localized maintenance plan for 2006 is contained in Appendix F.
