SAND CANYON AIRPORT
2005 PAVEMENT MANAGEMENT REPORT

February 2006

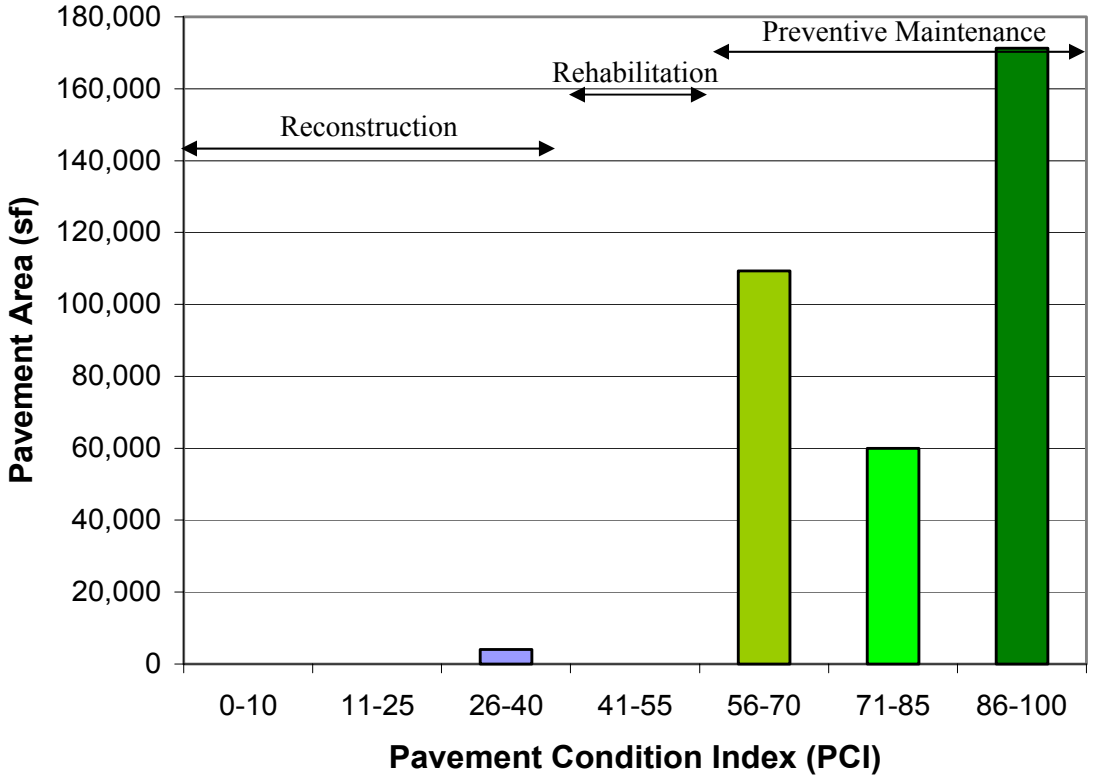
Figure 6. Sand Canyon Airport overall condition.

The pavements at Sand Canyon Airport were inspected on June 16, 2005. The 2005 area-weighted condition of Sand Canyon Airport is 79, with conditions ranging from 33 to 100 (on a scale of 0 [failed] to 100 [excellent]). During the previous inspection in 1999, the area-weighted condition was 85.

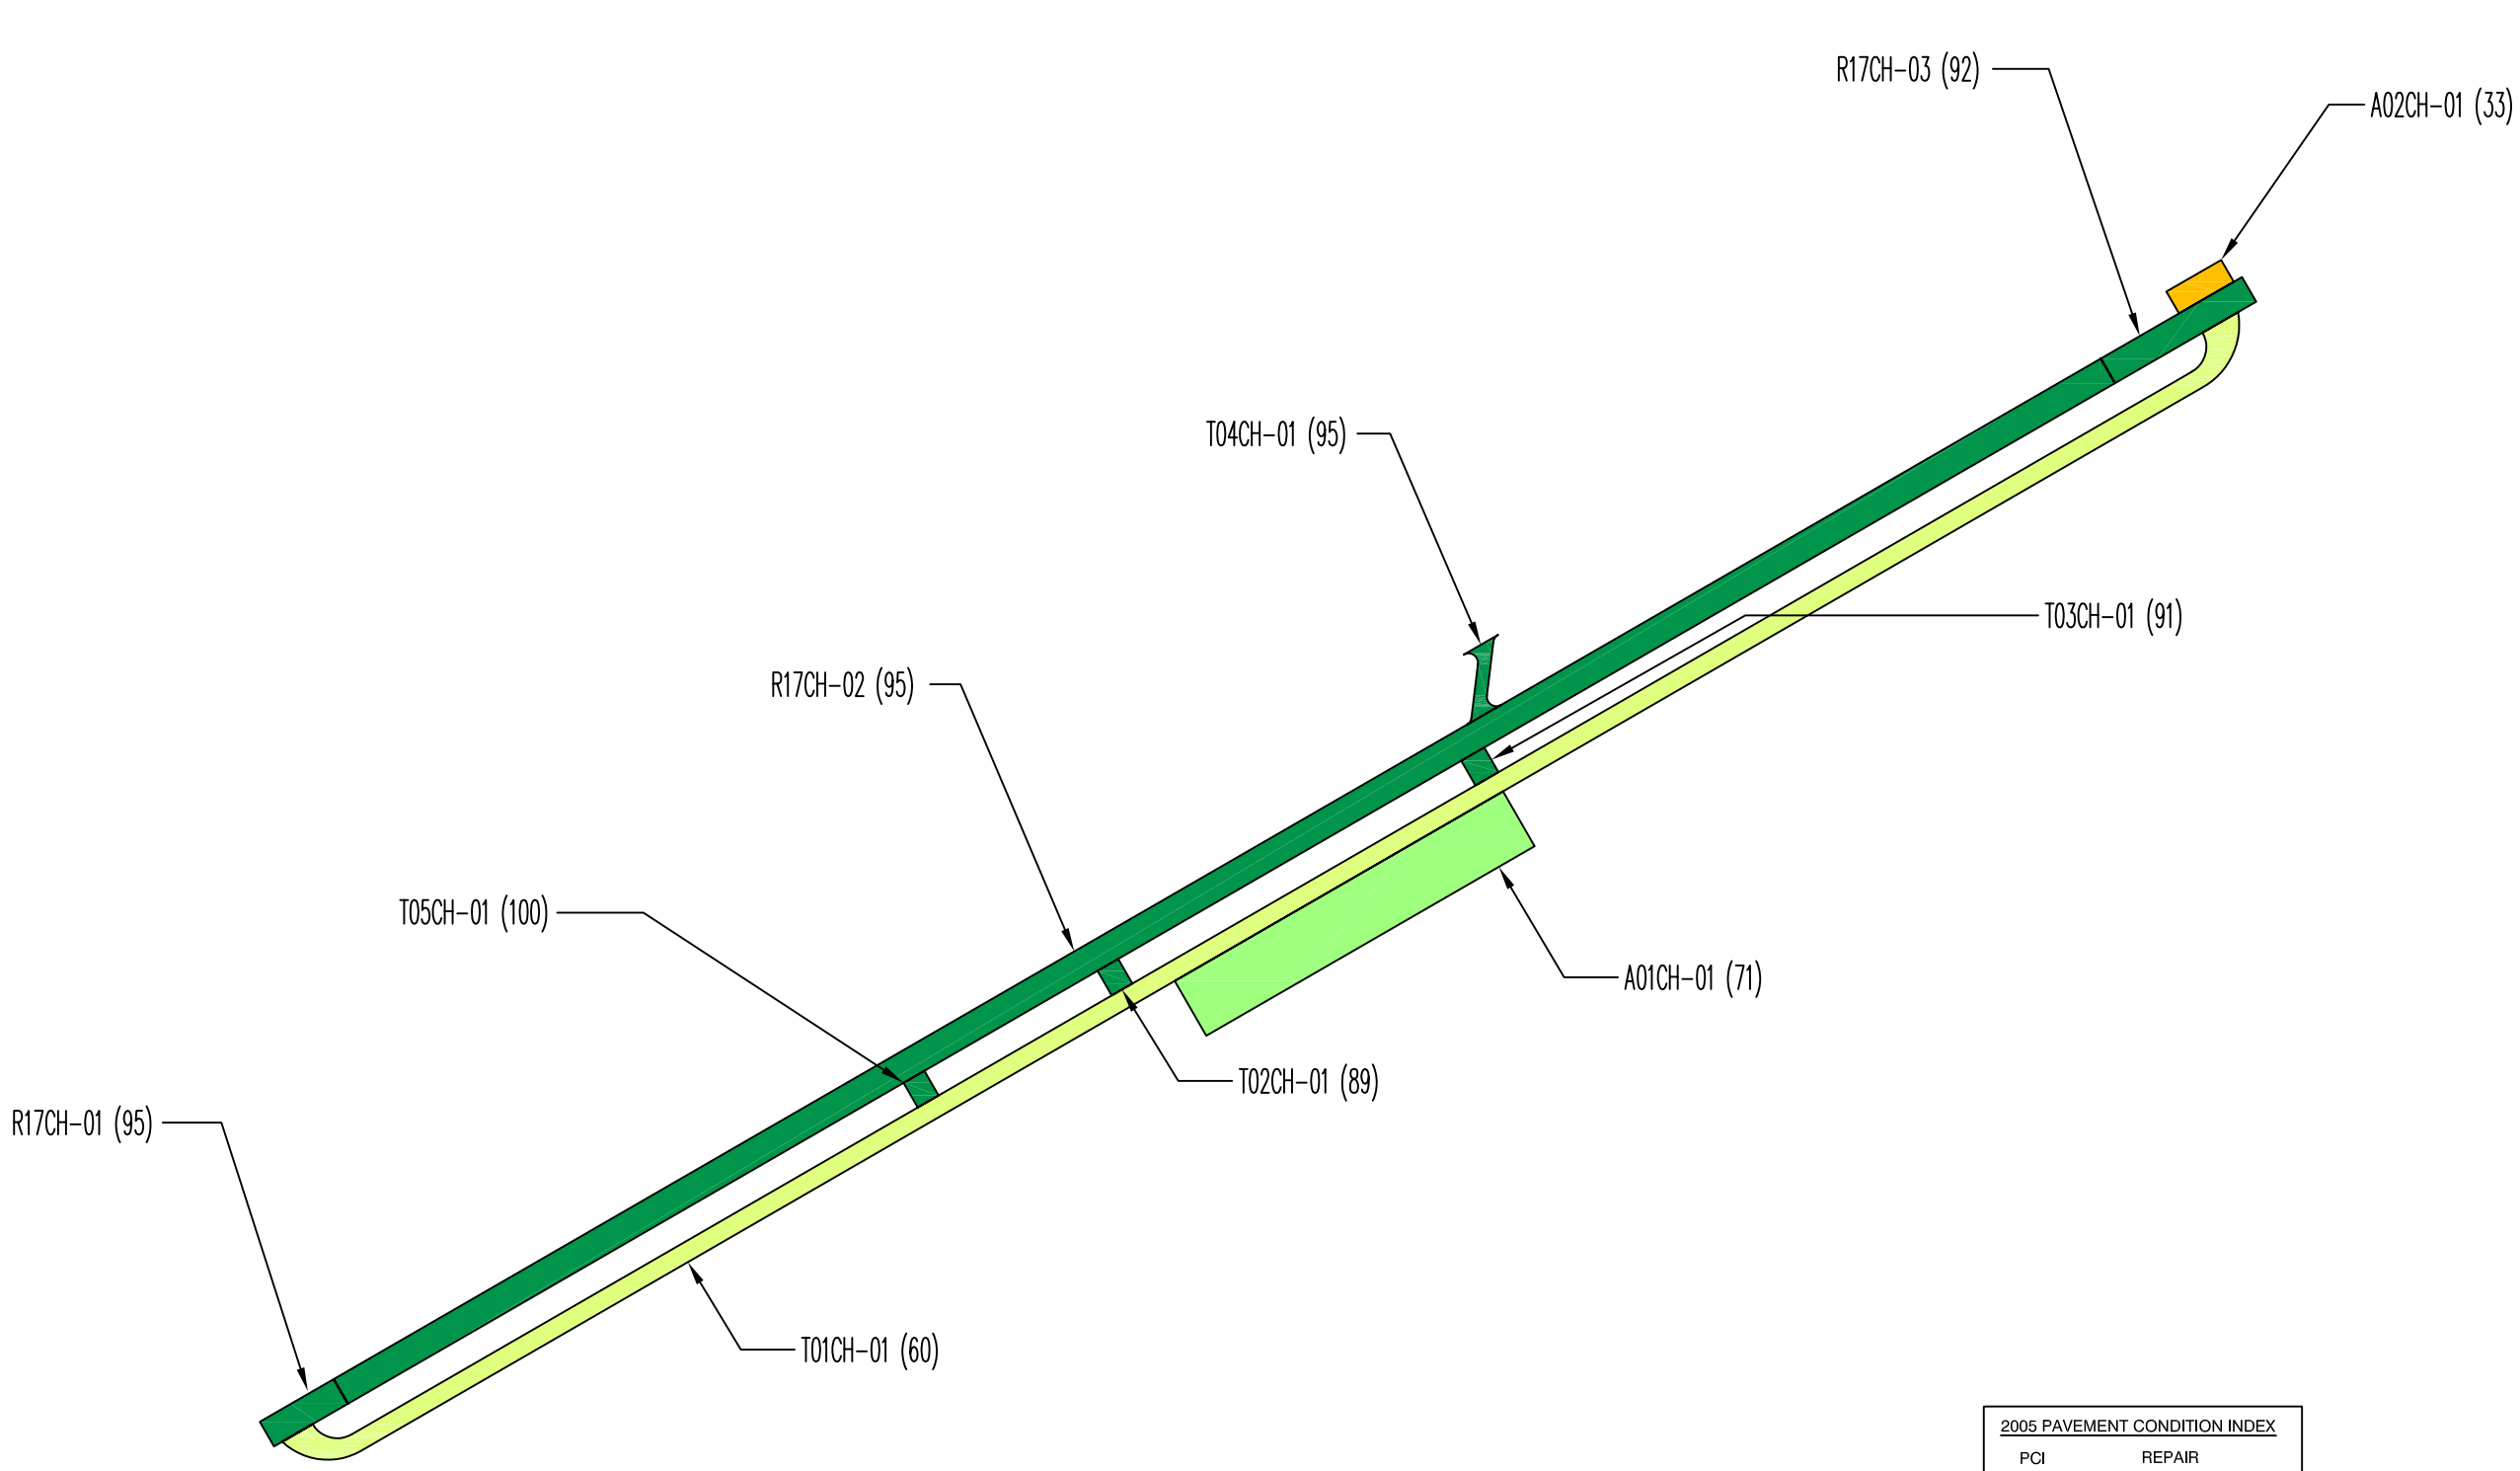
LOCATION: Sand Canyon Airport, Chewelah, Washington			
PAGE TITLE: 2005 Pavement Condition Index Map			
DRAWING SCALE: 1" = 300'	DATE: Februrary 2006	REVISED BY: AM	DRAWN BY: AM
FILENAME: Chewelah.dwg	AIRPORT ID: 1S9	LAYOUT NAME/NUMBER: CHEWELAH (PCI)	PAGE NUMBER: 9

Figures 6 and 7 summarize the overall condition of the pavements at the Sand Canyon Airport. Figure 8 displays the condition of the pavements evaluated. Table 1 summarizes the results of the pavement evaluation. Appendix C presents photographs taken during the PCI inspection and Appendix D details the distresses observed during the visual survey.

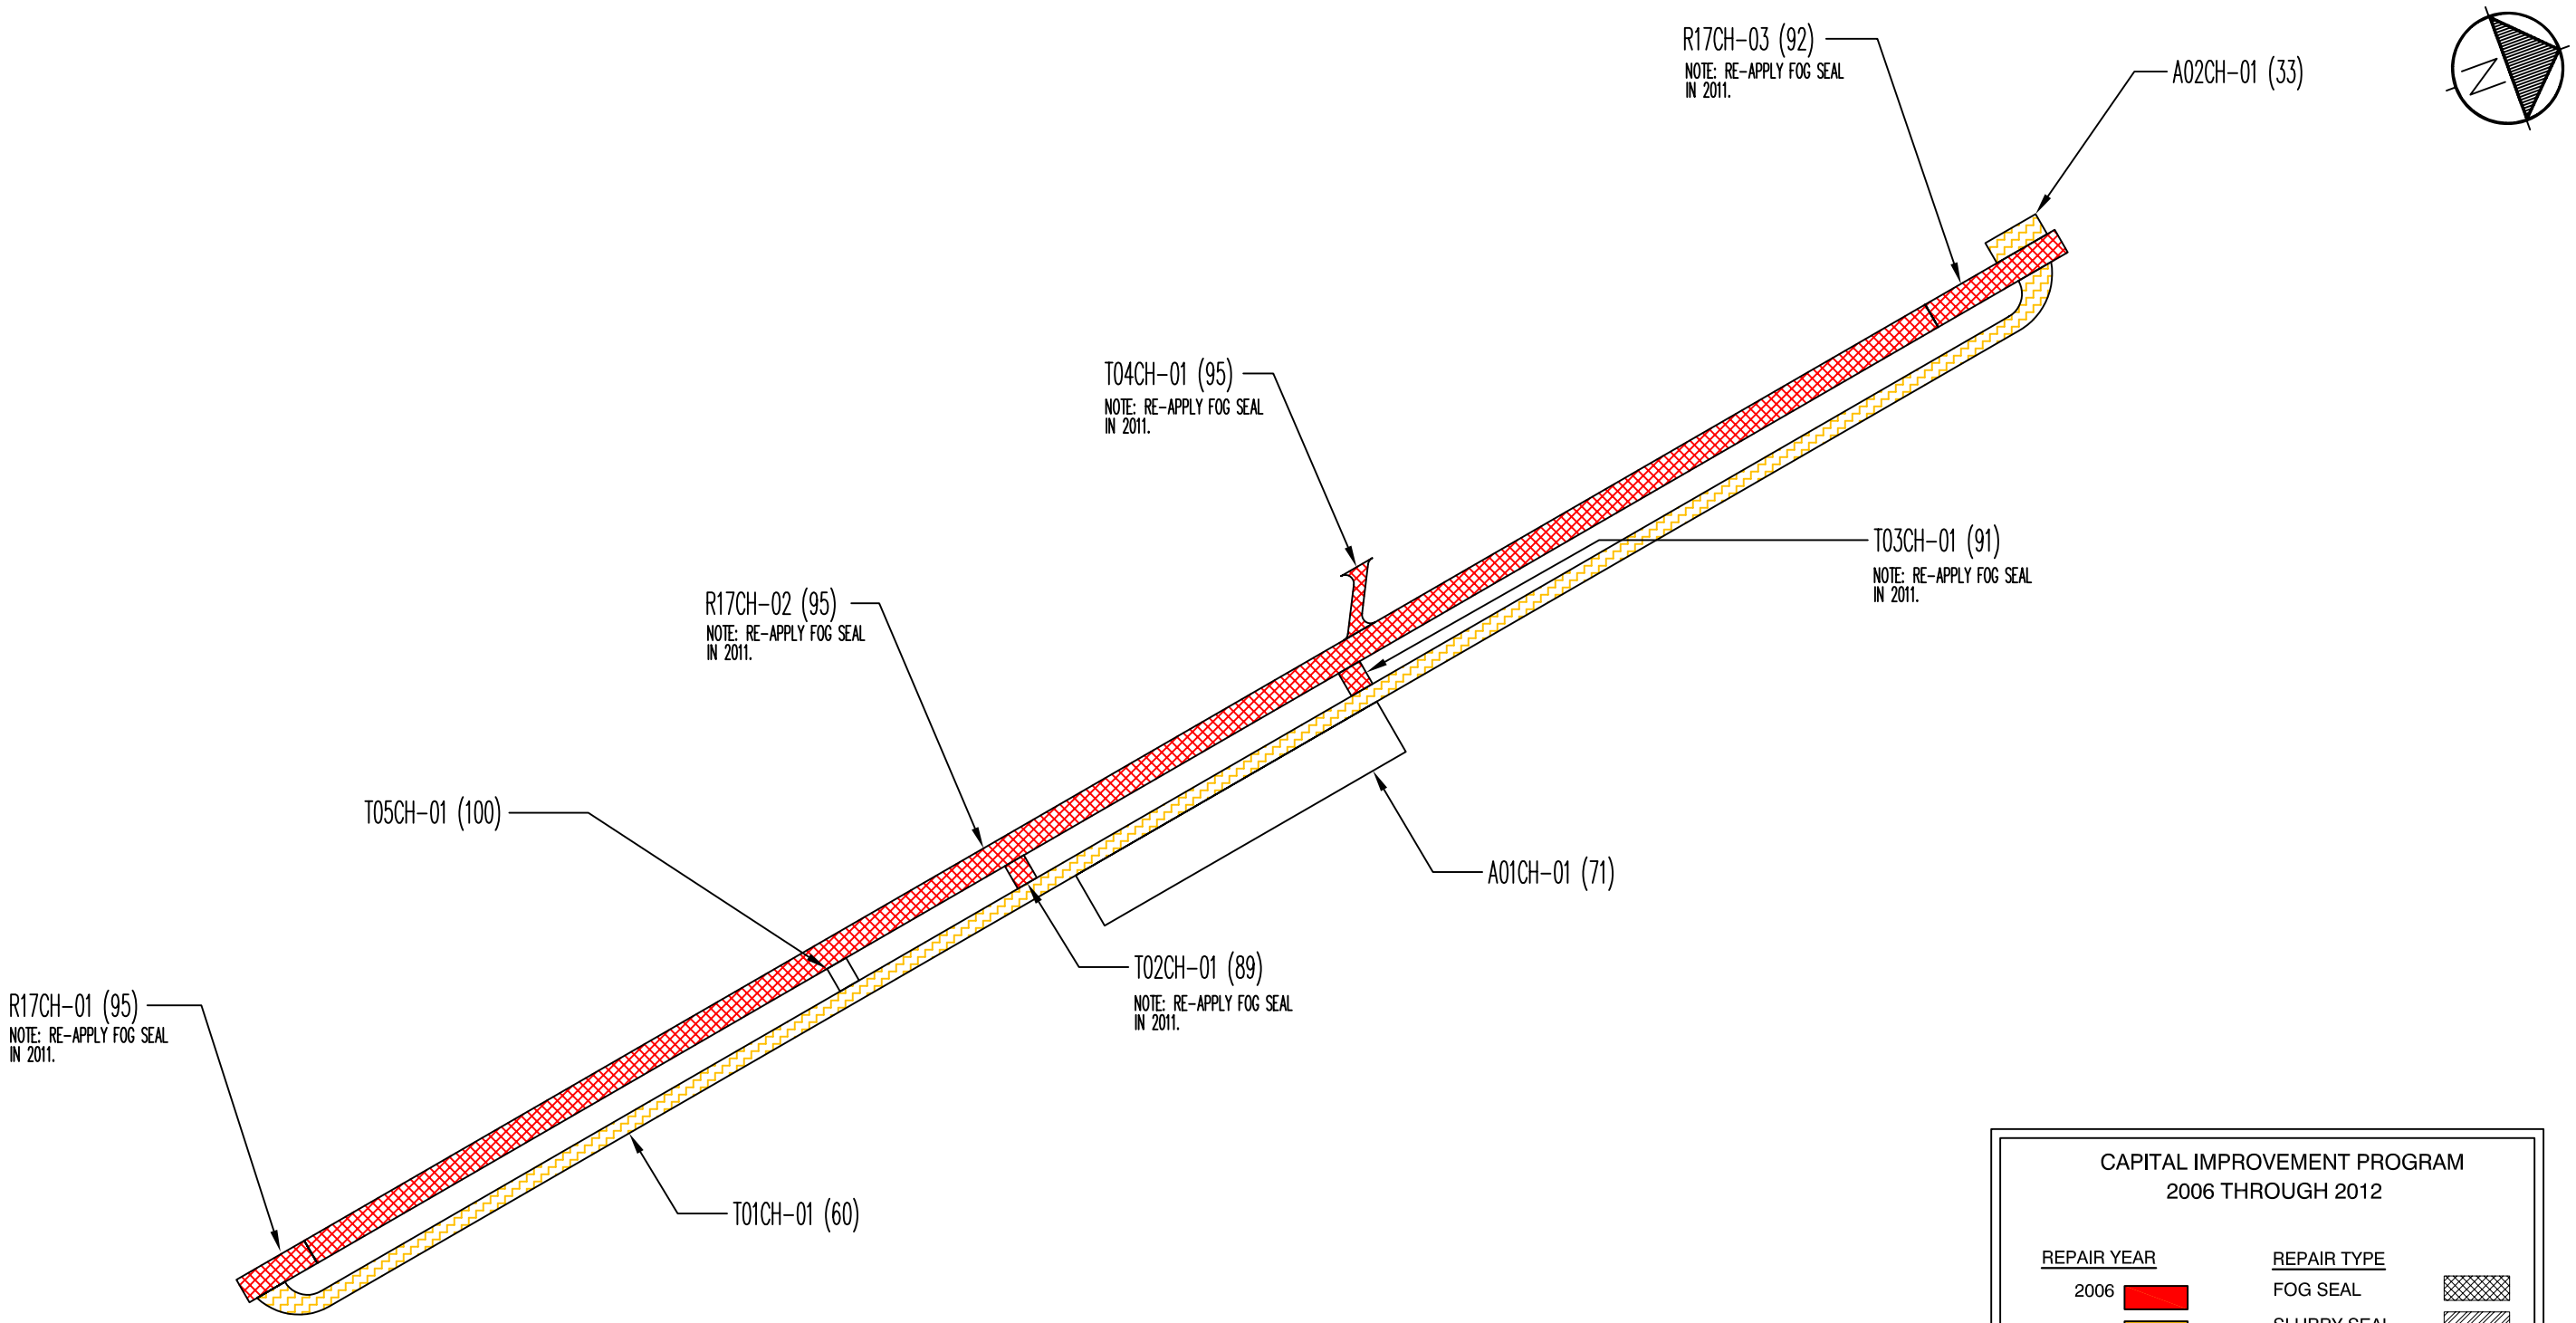
CAPITAL IMPROVEMENT PROGRAM
2006 THROUGH 2012

A summary of the pavement repair program for Sand Canyon Airport is presented in Table 4 and in Figure 9. Detailed information on the localized maintenance plan for 2006 is contained in Appendix F.

REPAIR YEAR	REPAIR TYPE
2006	FOG SEAL
2007	SLURRY SEAL
2008	REHABILITATION
2009	RECONSTRUCTION
2010	
2011	
2012

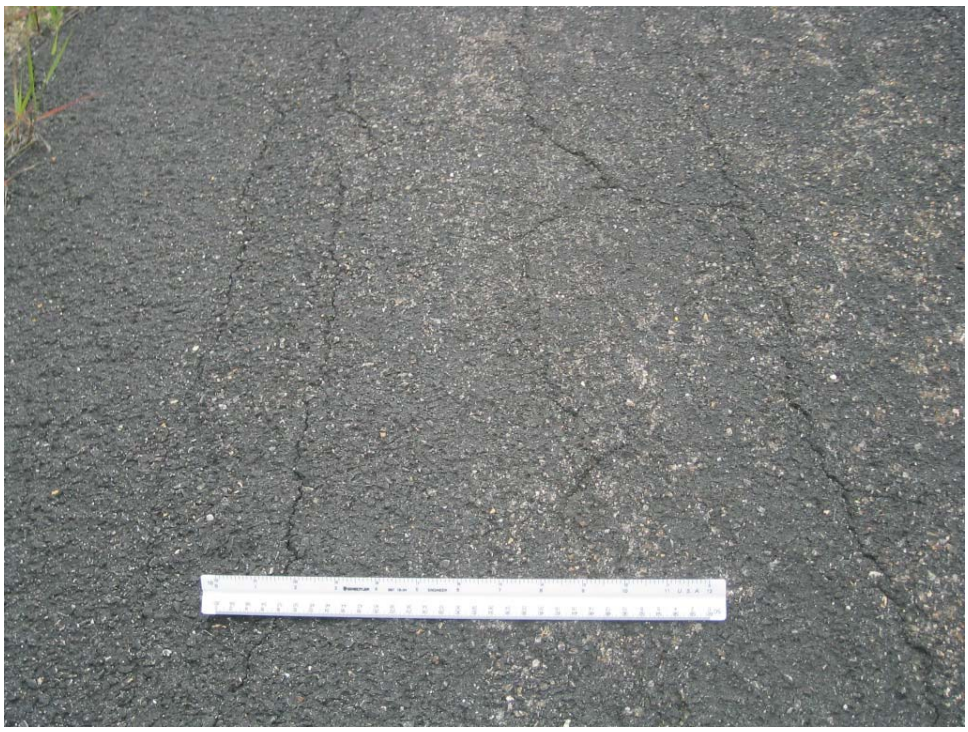
T01CH-01. Alligator cracking (2).
