LOPEZ ISLAND AIRPORT
2005 PAVEMENT MANAGEMENT REPORT

February 2006

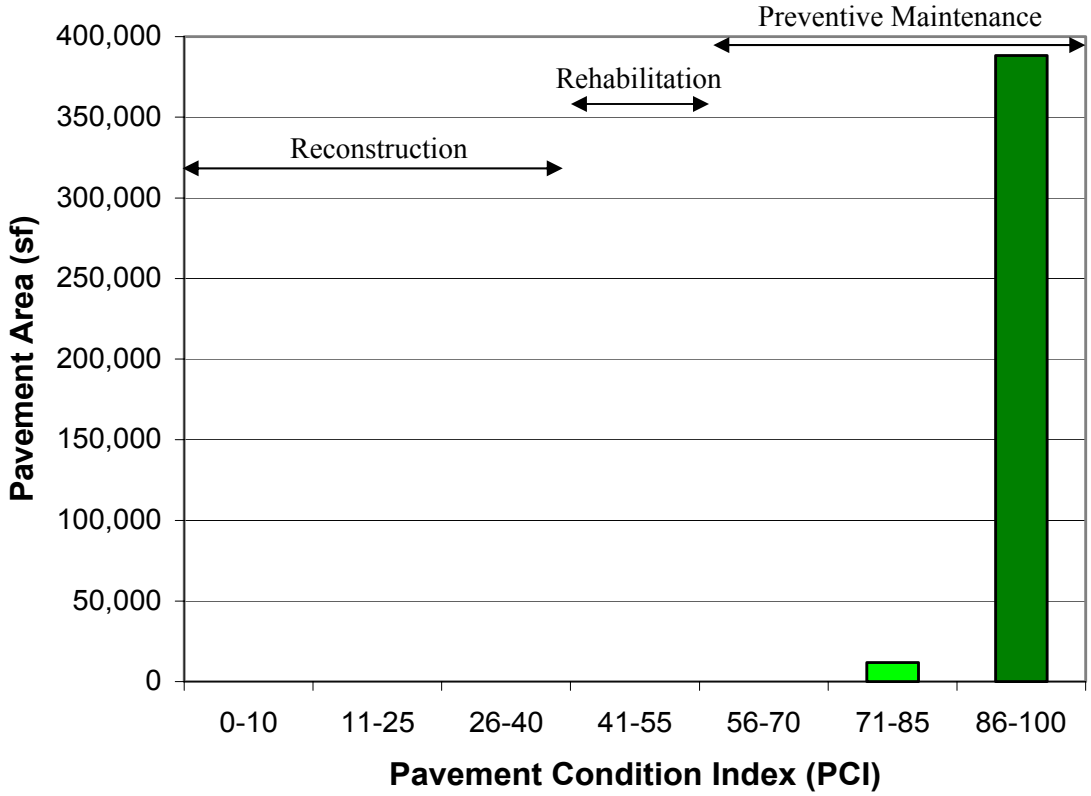
Figure 6. Lopez Island Airport overall condition.

The pavements at Lopez Island Airport were inspected on April 12, 2005. The 2005 area-weighted condition of Lopez Island Airport is 95, with conditions ranging from 72 to 100 (on a scale of 0 [failed] to 100 [excellent]). During the previous inspection in 1999, the area-weighted condition was 98.

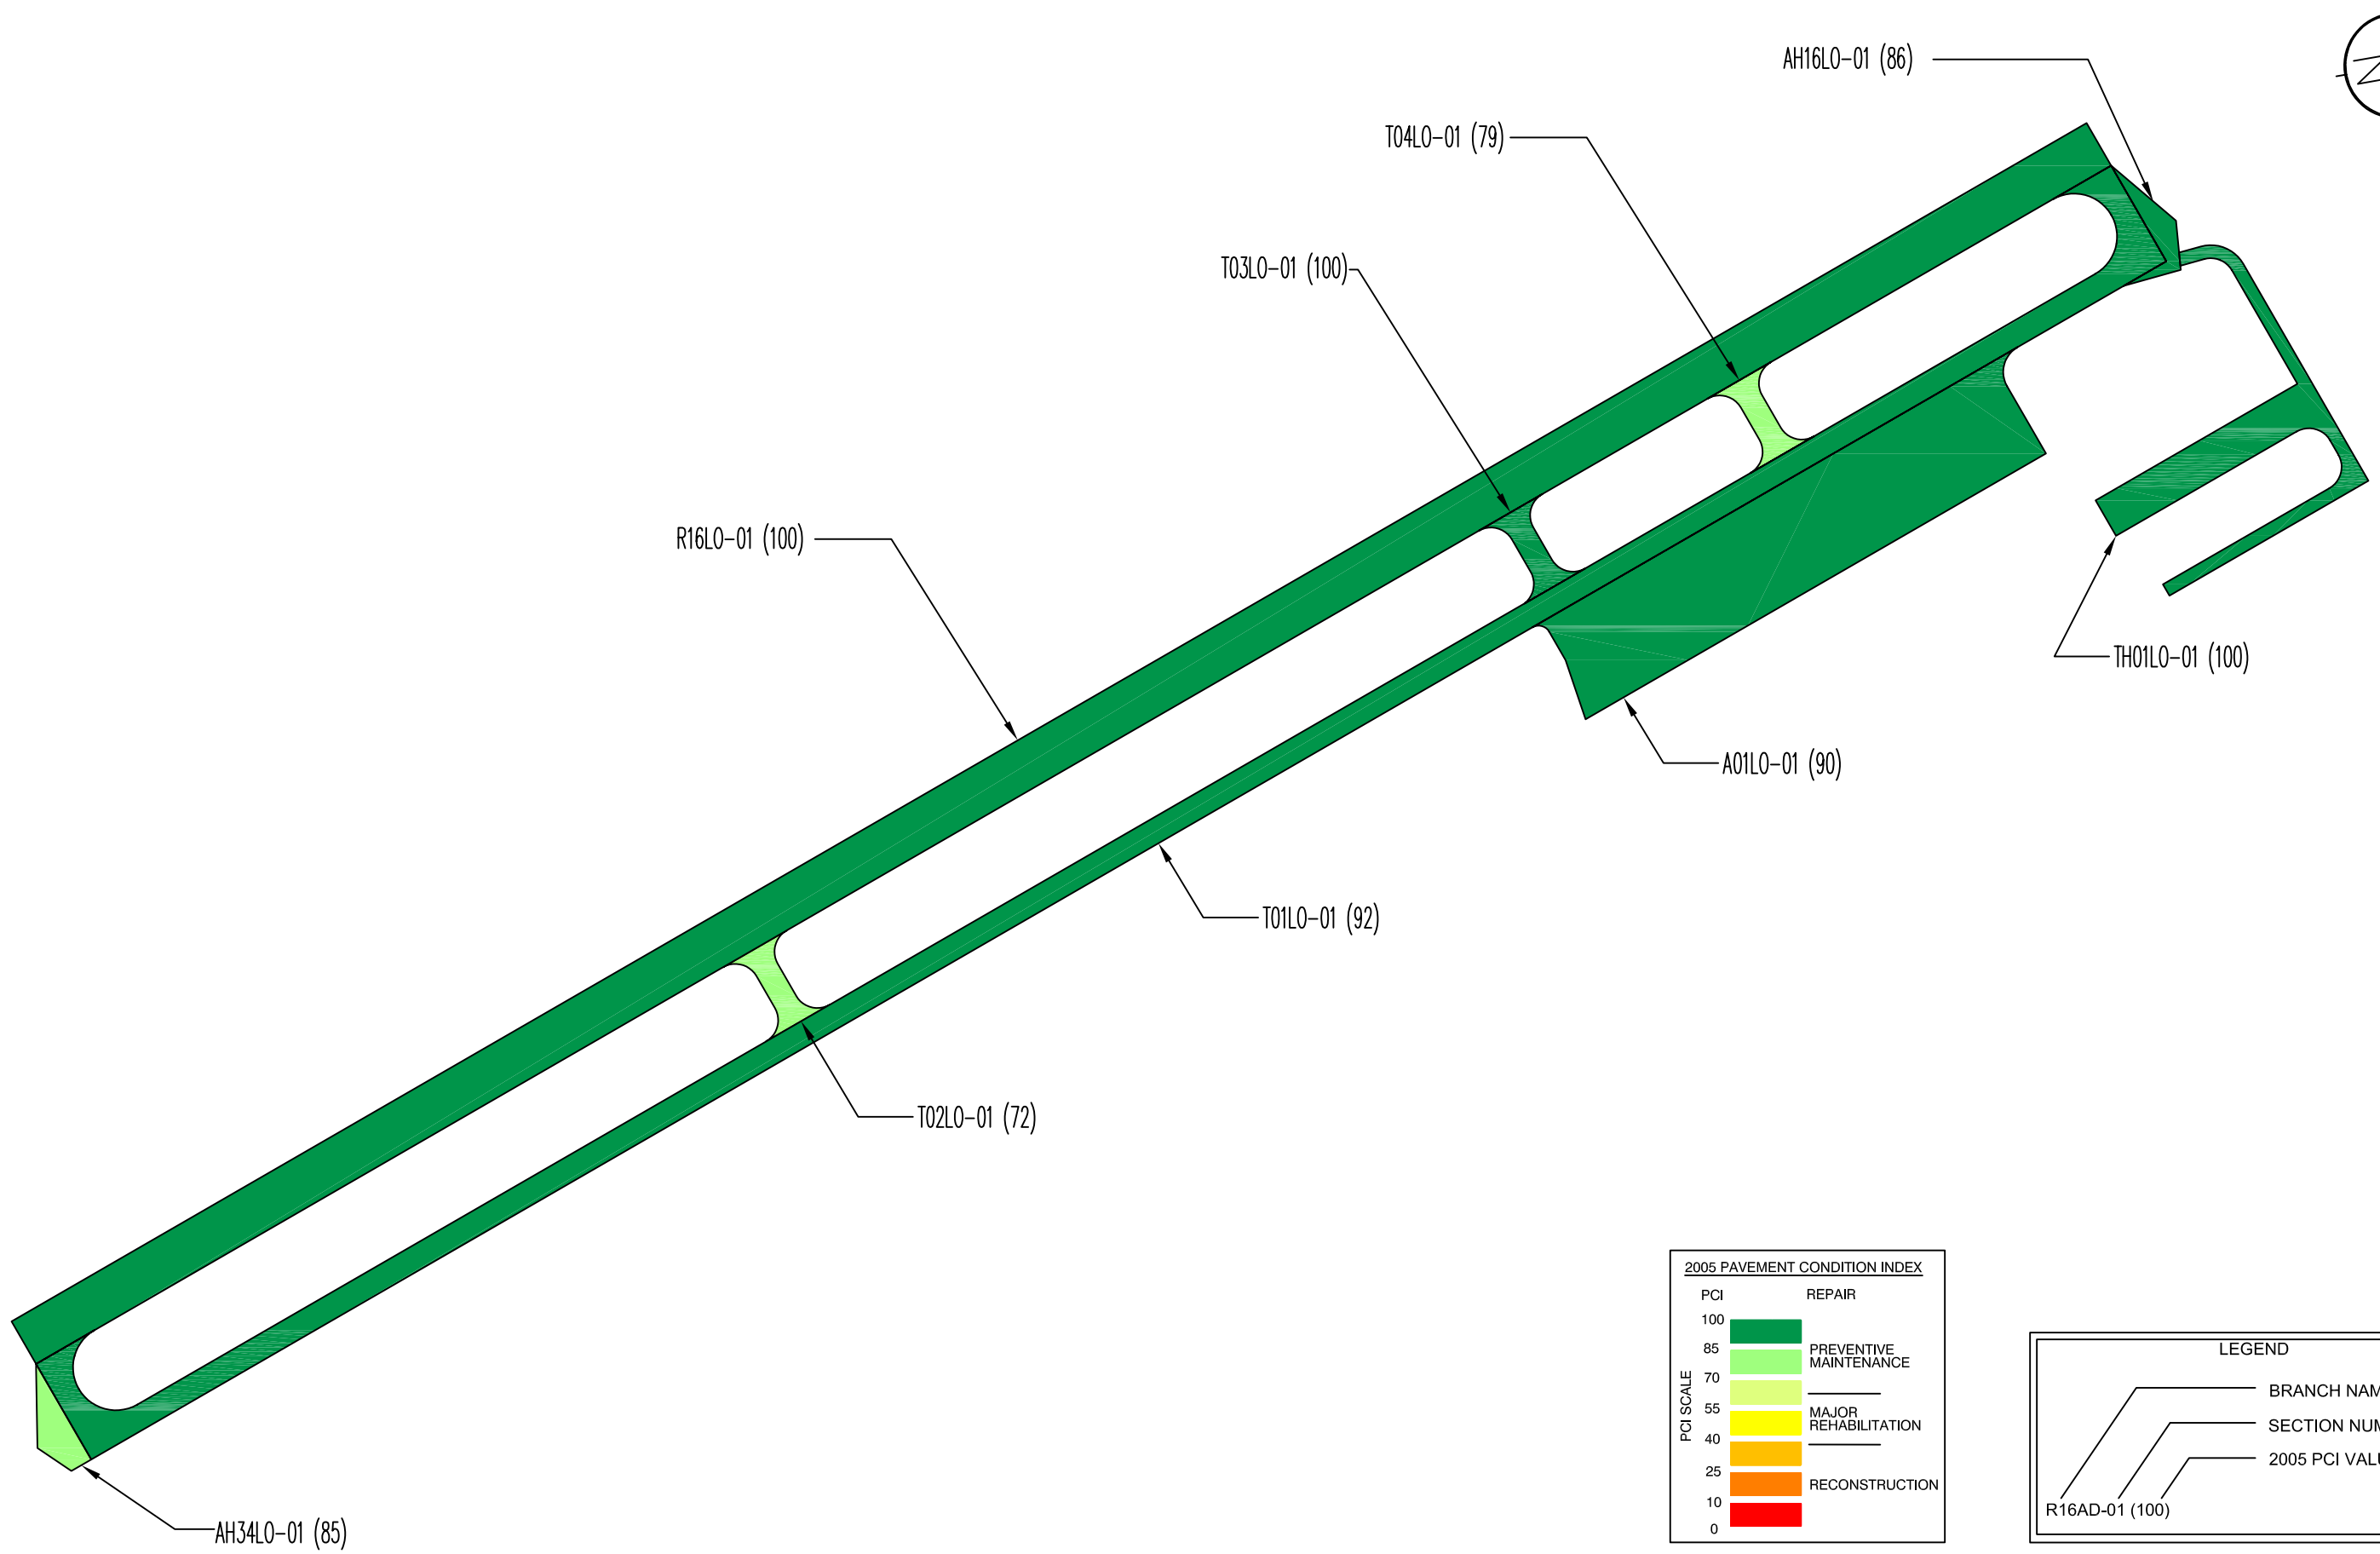
2005 PAVEMENT CONDITION INDEX

Figures 6 and 7 summarize the overall condition of the pavements at the Lopez Island Airport. Figure 8 displays the condition of the pavements evaluated. Table 1 summarizes the results of the pavement evaluation. Appendix C presents photographs taken during the PCI inspection and Appendix D details the distresses observed during the visual survey.
