TONASKET MUNICIPAL AIRPORT
2005 PAVEMENT MANAGEMENT REPORT

February 2006

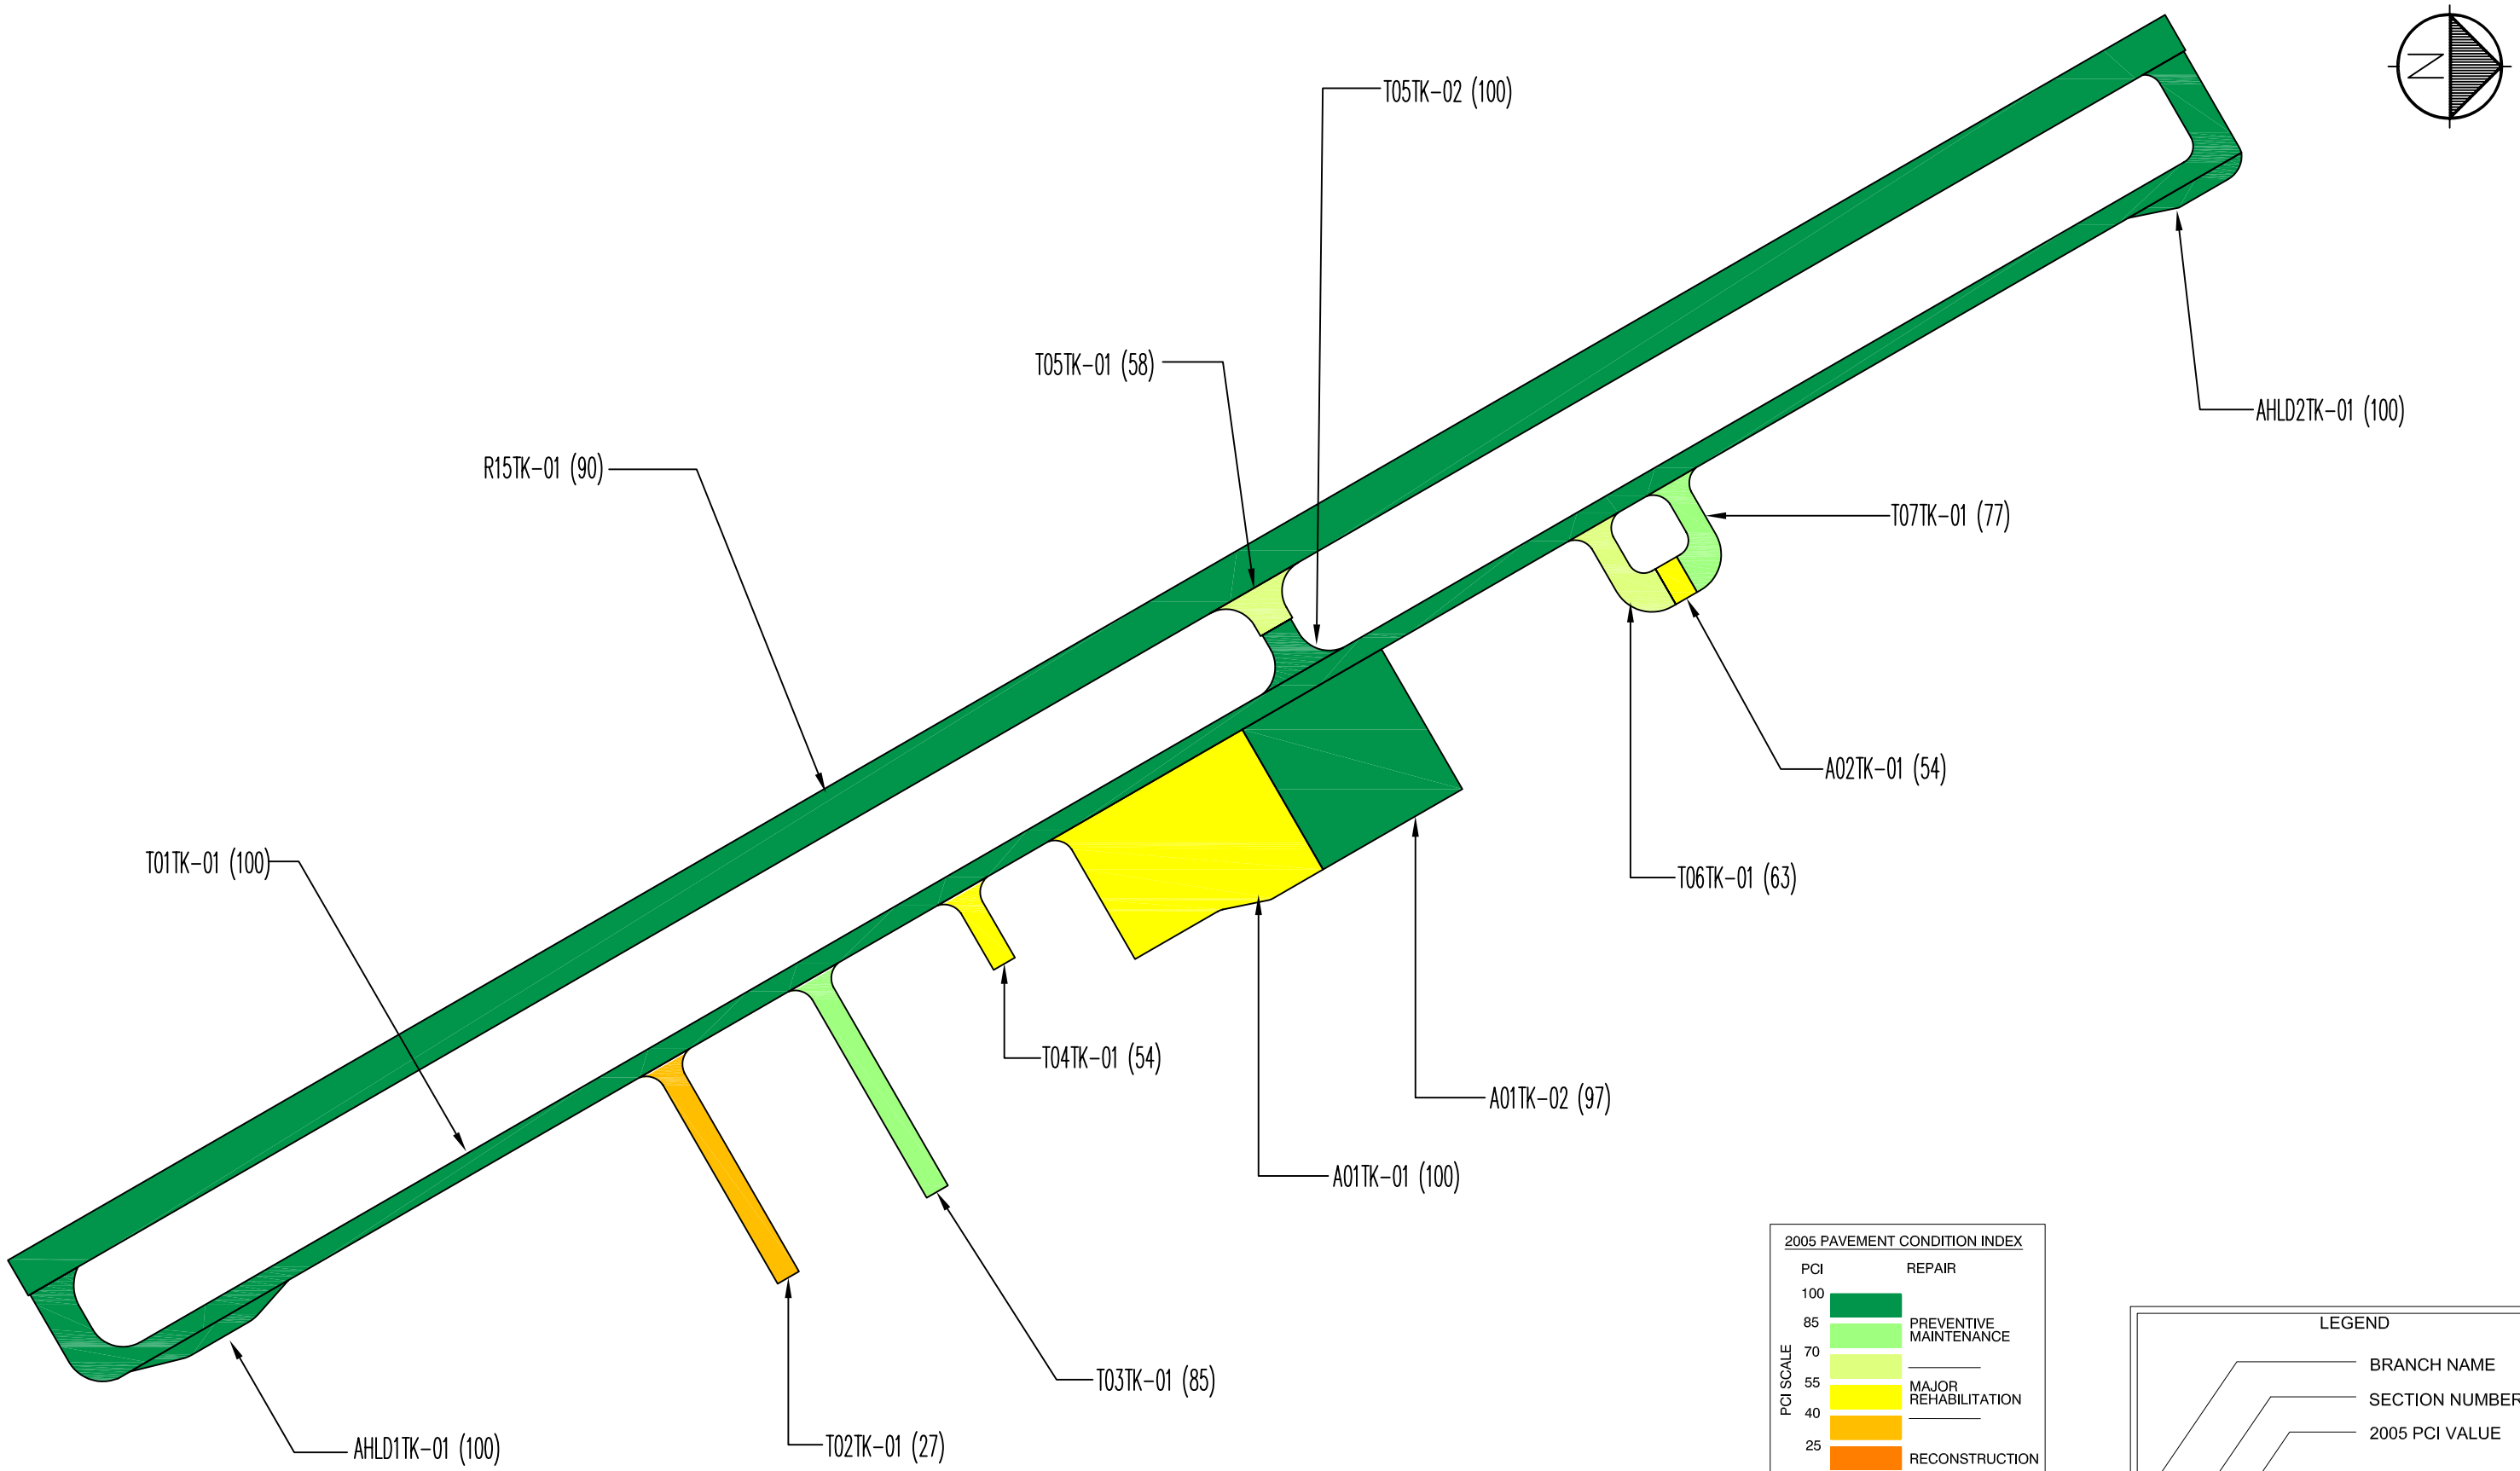
The pavements at Tonasket Municipal Airport were inspected on June 5, 2005. The 2005 area-weighted condition of Tonasket Municipal Airport is 86, with conditions ranging from 34 to 100 (on a scale of 0 [failed] to 100 [excellent]). During the previous inspection in 1999, the area-weighted condition was 91.

Figures 6 and 7 summarize the overall condition of the pavements at the Tonasket Municipal Airport. Figure 8 displays the condition of the pavements evaluated. Table 1 summarizes the results of the pavement evaluation. Appendix C presents photographs taken during the PCI inspection and Appendix D details the distresses observed during the visual survey.

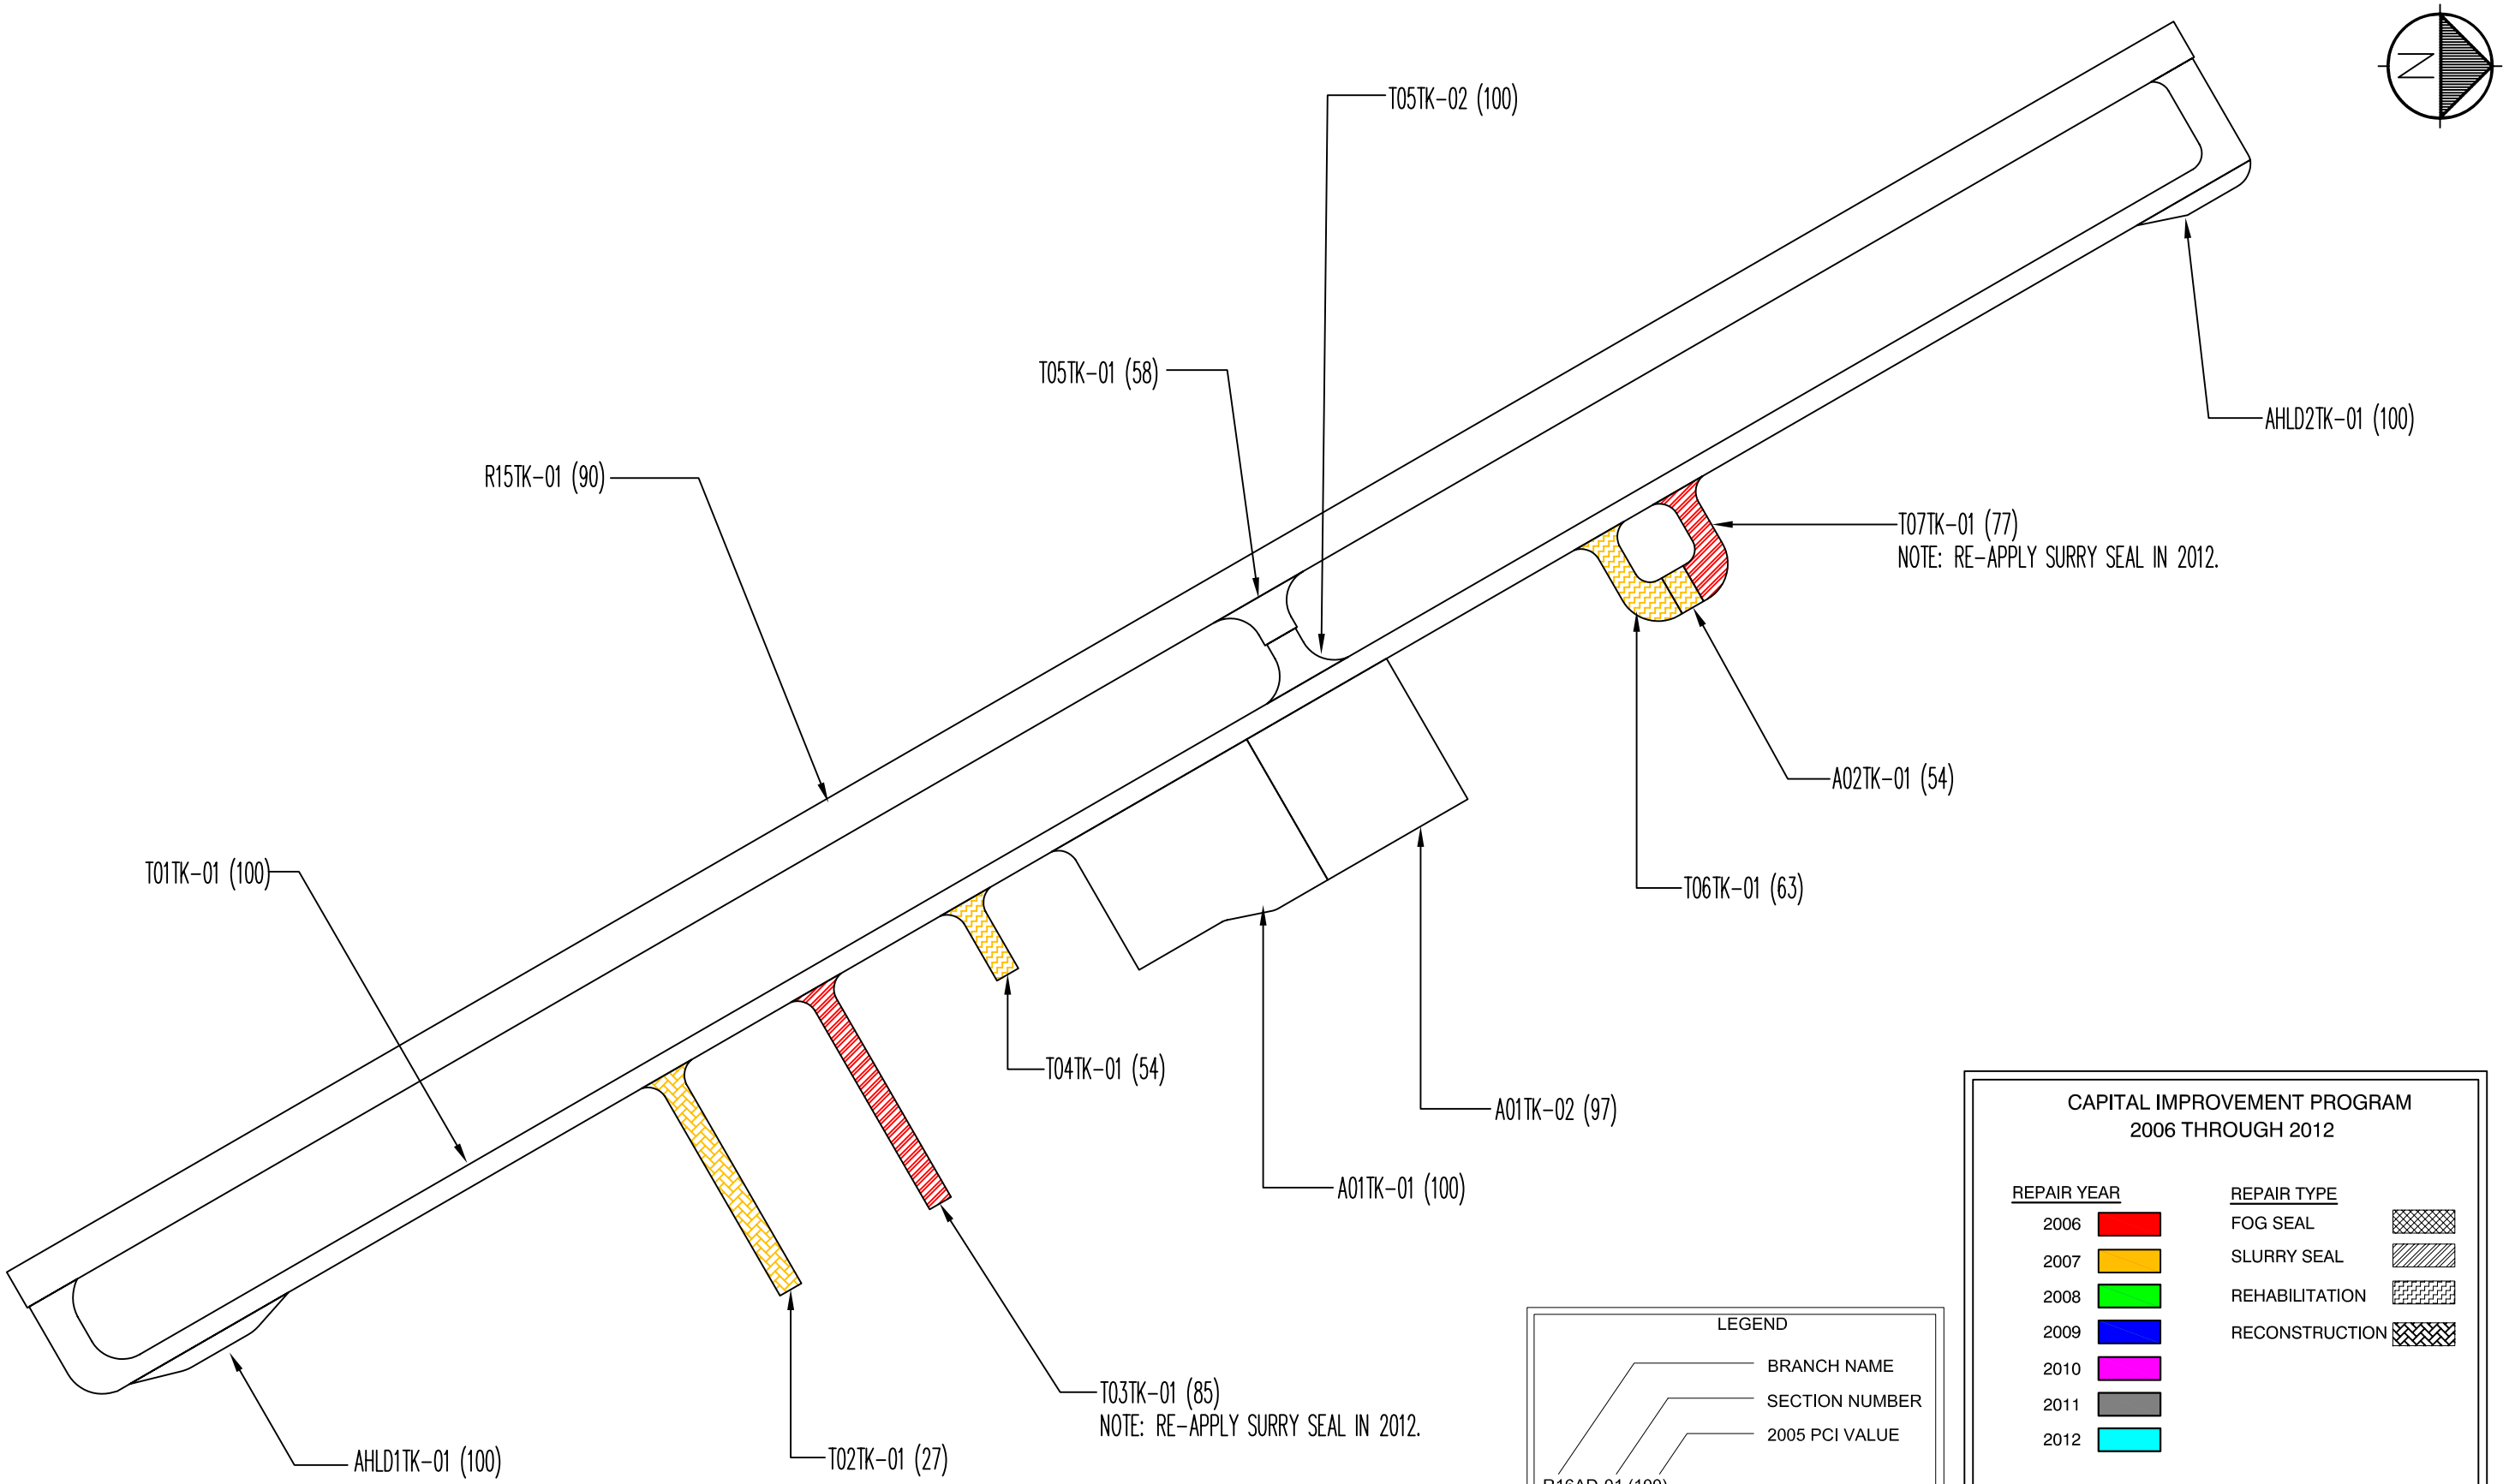
A summary of the pavement repair program for Tonasket Municipal Airport is presented in Table 4 and in Figure 9. Detailed information on the localized maintenance plan for 2006 is contained in Appendix F.

REPAIR YEAR	REPAIR TYPE
2006	FOG SEAL
2007	SLURRY SEAL
2008	REHABILITATION
2009	RECONSTRUCTION
2010	
2011	
2012
