GOLDENDALE AIRPORT
2005 PAVEMENT MANAGEMENT REPORT

February 2006

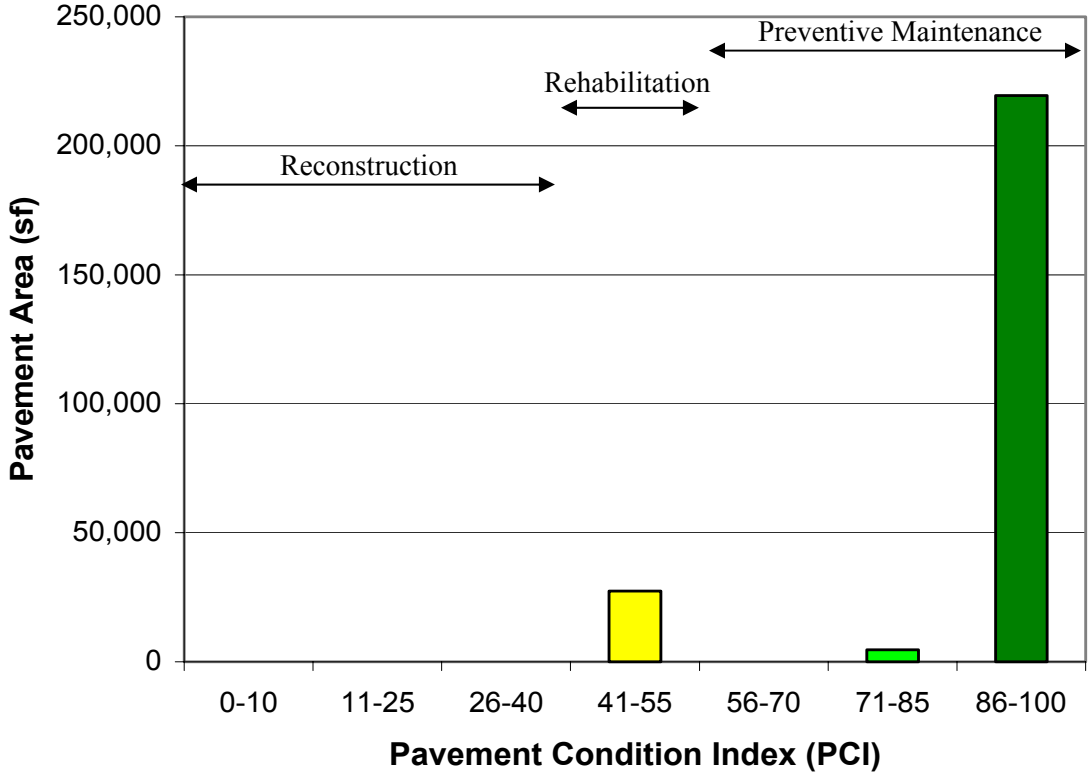
Figure 6. Goldendale Airport overall condition.

The pavements at Goldendale Airport were inspected on May 4, 2005. The 2005 area-weighted condition of Goldendale Airport is 94, with conditions ranging from 48 to 100 (on a scale of 0 [failed] to 100 [excellent]). During the previous inspection in 1999, the area-weighted condition was 80.

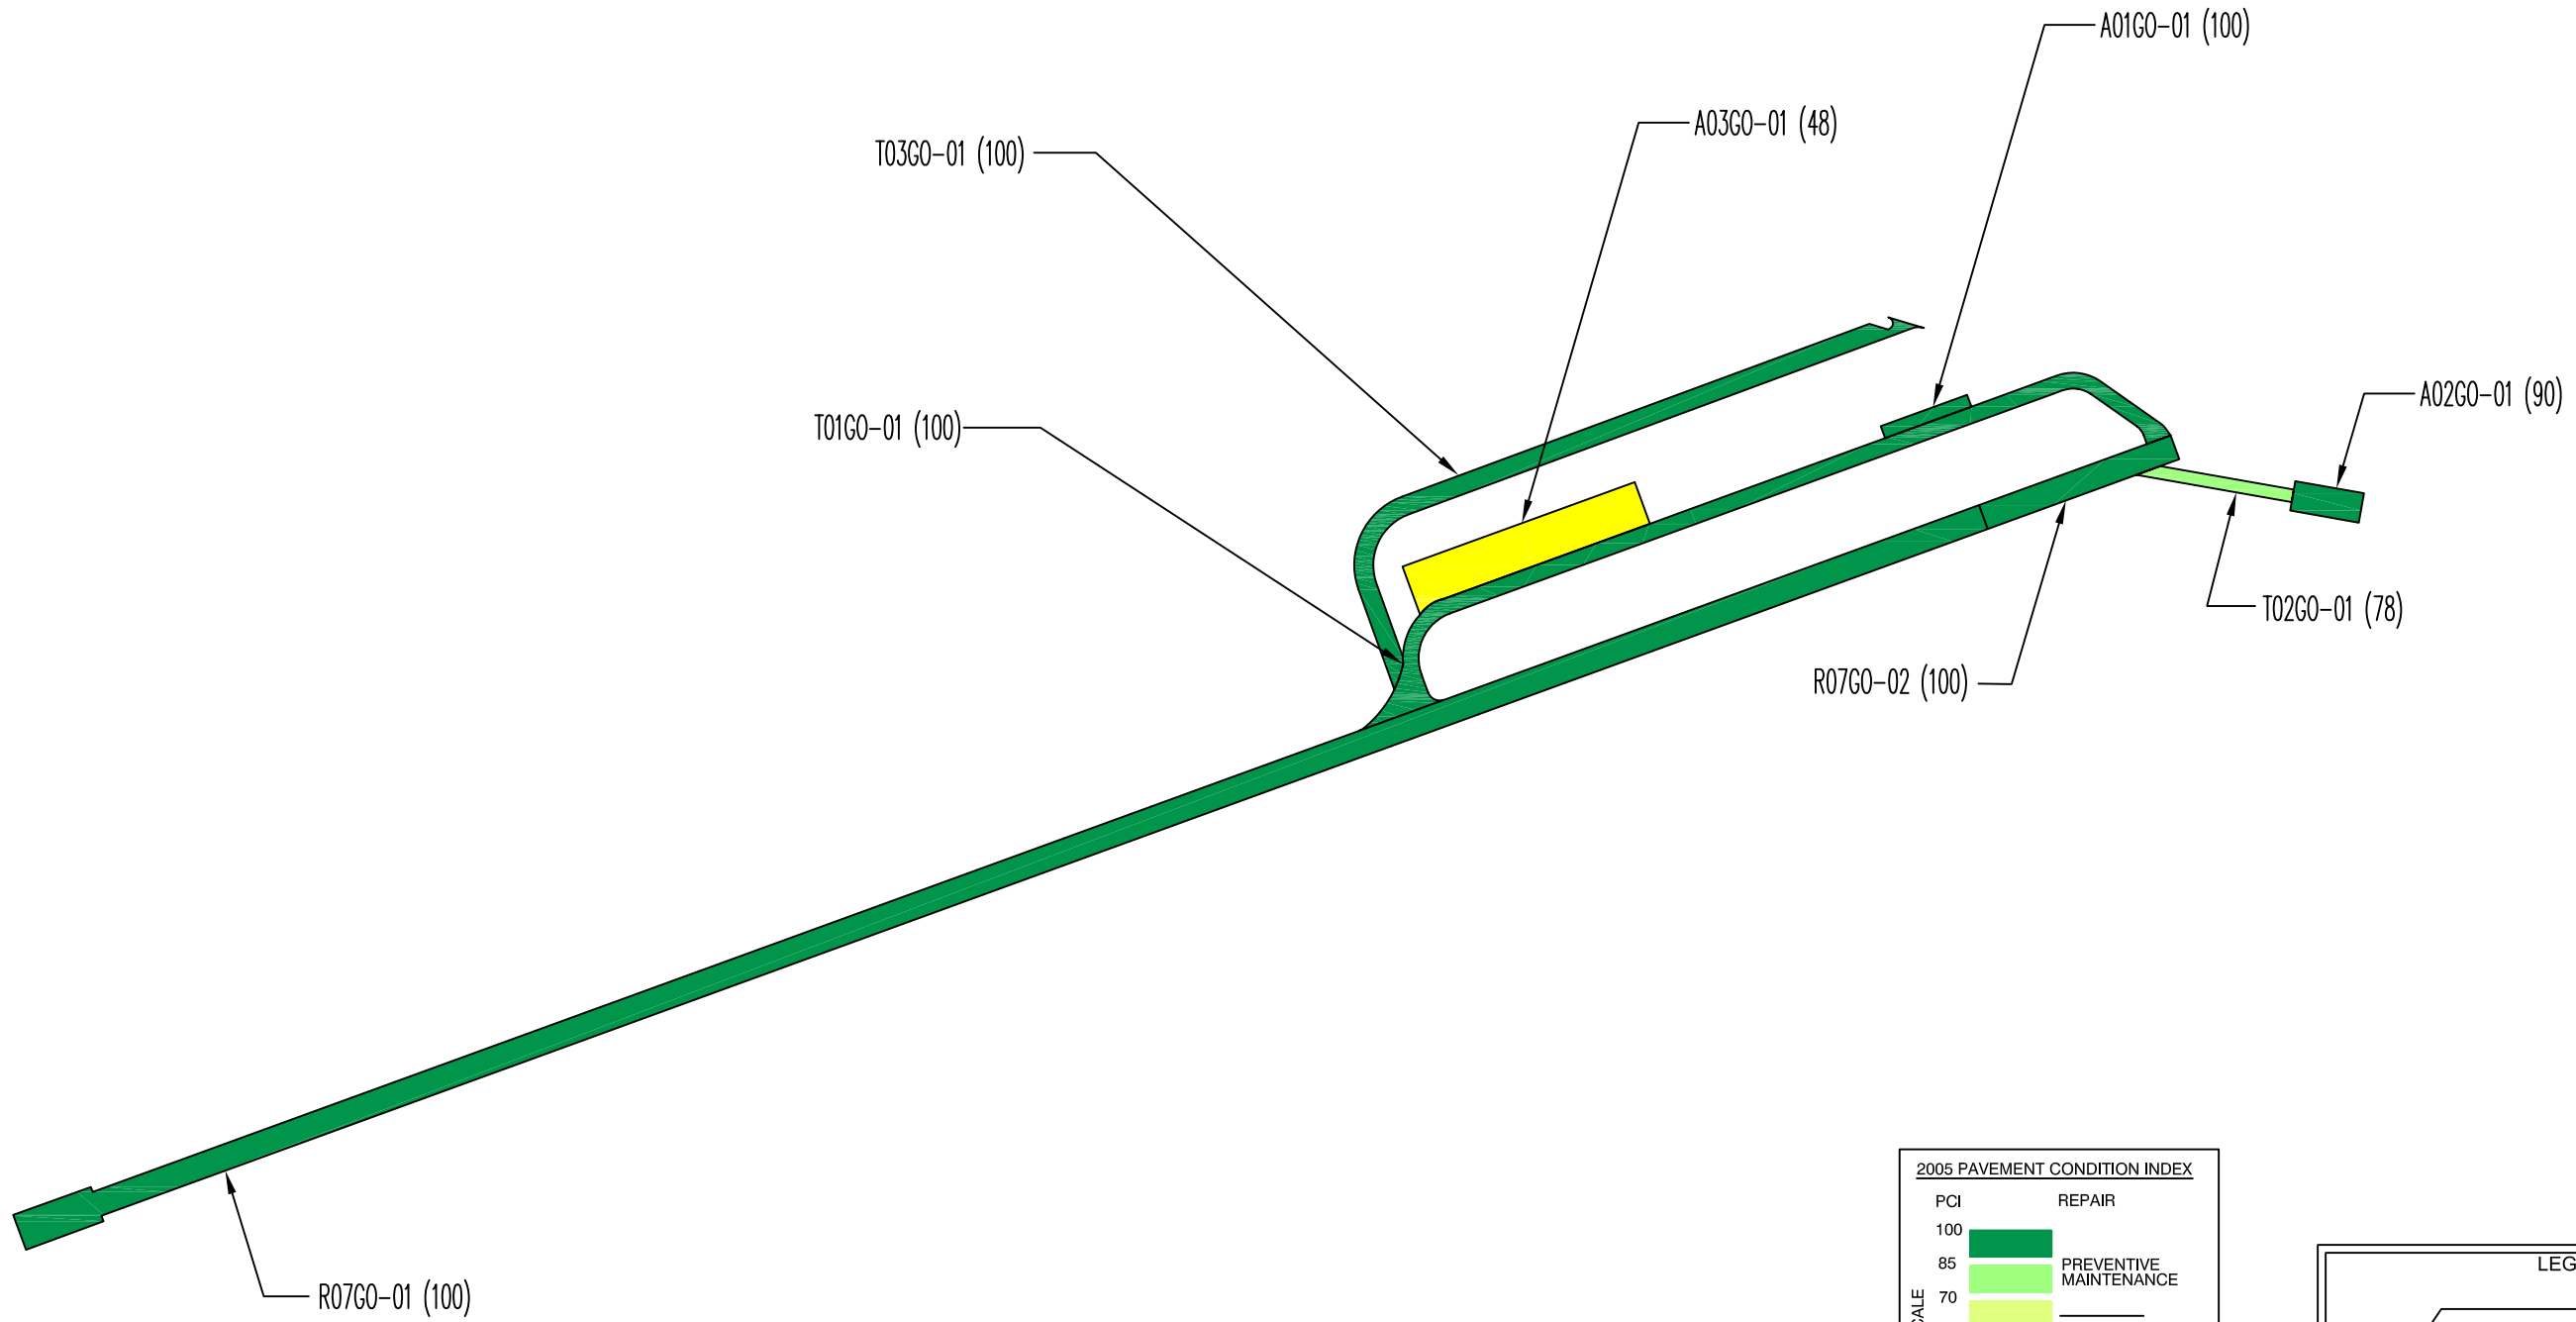
LOCATION: Goldendale-Horinbrook Airport, Goldendale , Washington			
PAGE TITLE: 2005 Pavement Condition Index Map			
DRAWING SCALE: 1" = 300'	DATE: February 2006	REVISED BY: MK	DRAWN BY: MK
FILENAME: Goldendale.dwg	AIRPORT ID: S20	LAYOUT NAME/NUMBER: Goldendale (PCI)	PAGE NUMBER: 9

Figures 6 and 7 summarize the overall condition of the pavements at the Goldendale Airport. Figure 8 displays the condition of the pavements evaluated. Table 1 summarizes the results of the pavement evaluation. Appendix C presents photographs taken during the PCI inspection and Appendix D details the distresses observed during the visual survey.
