OKANOGAN LEGION AIRPORT
2005 PAVEMENT MANAGEMENT REPORT

February 2006

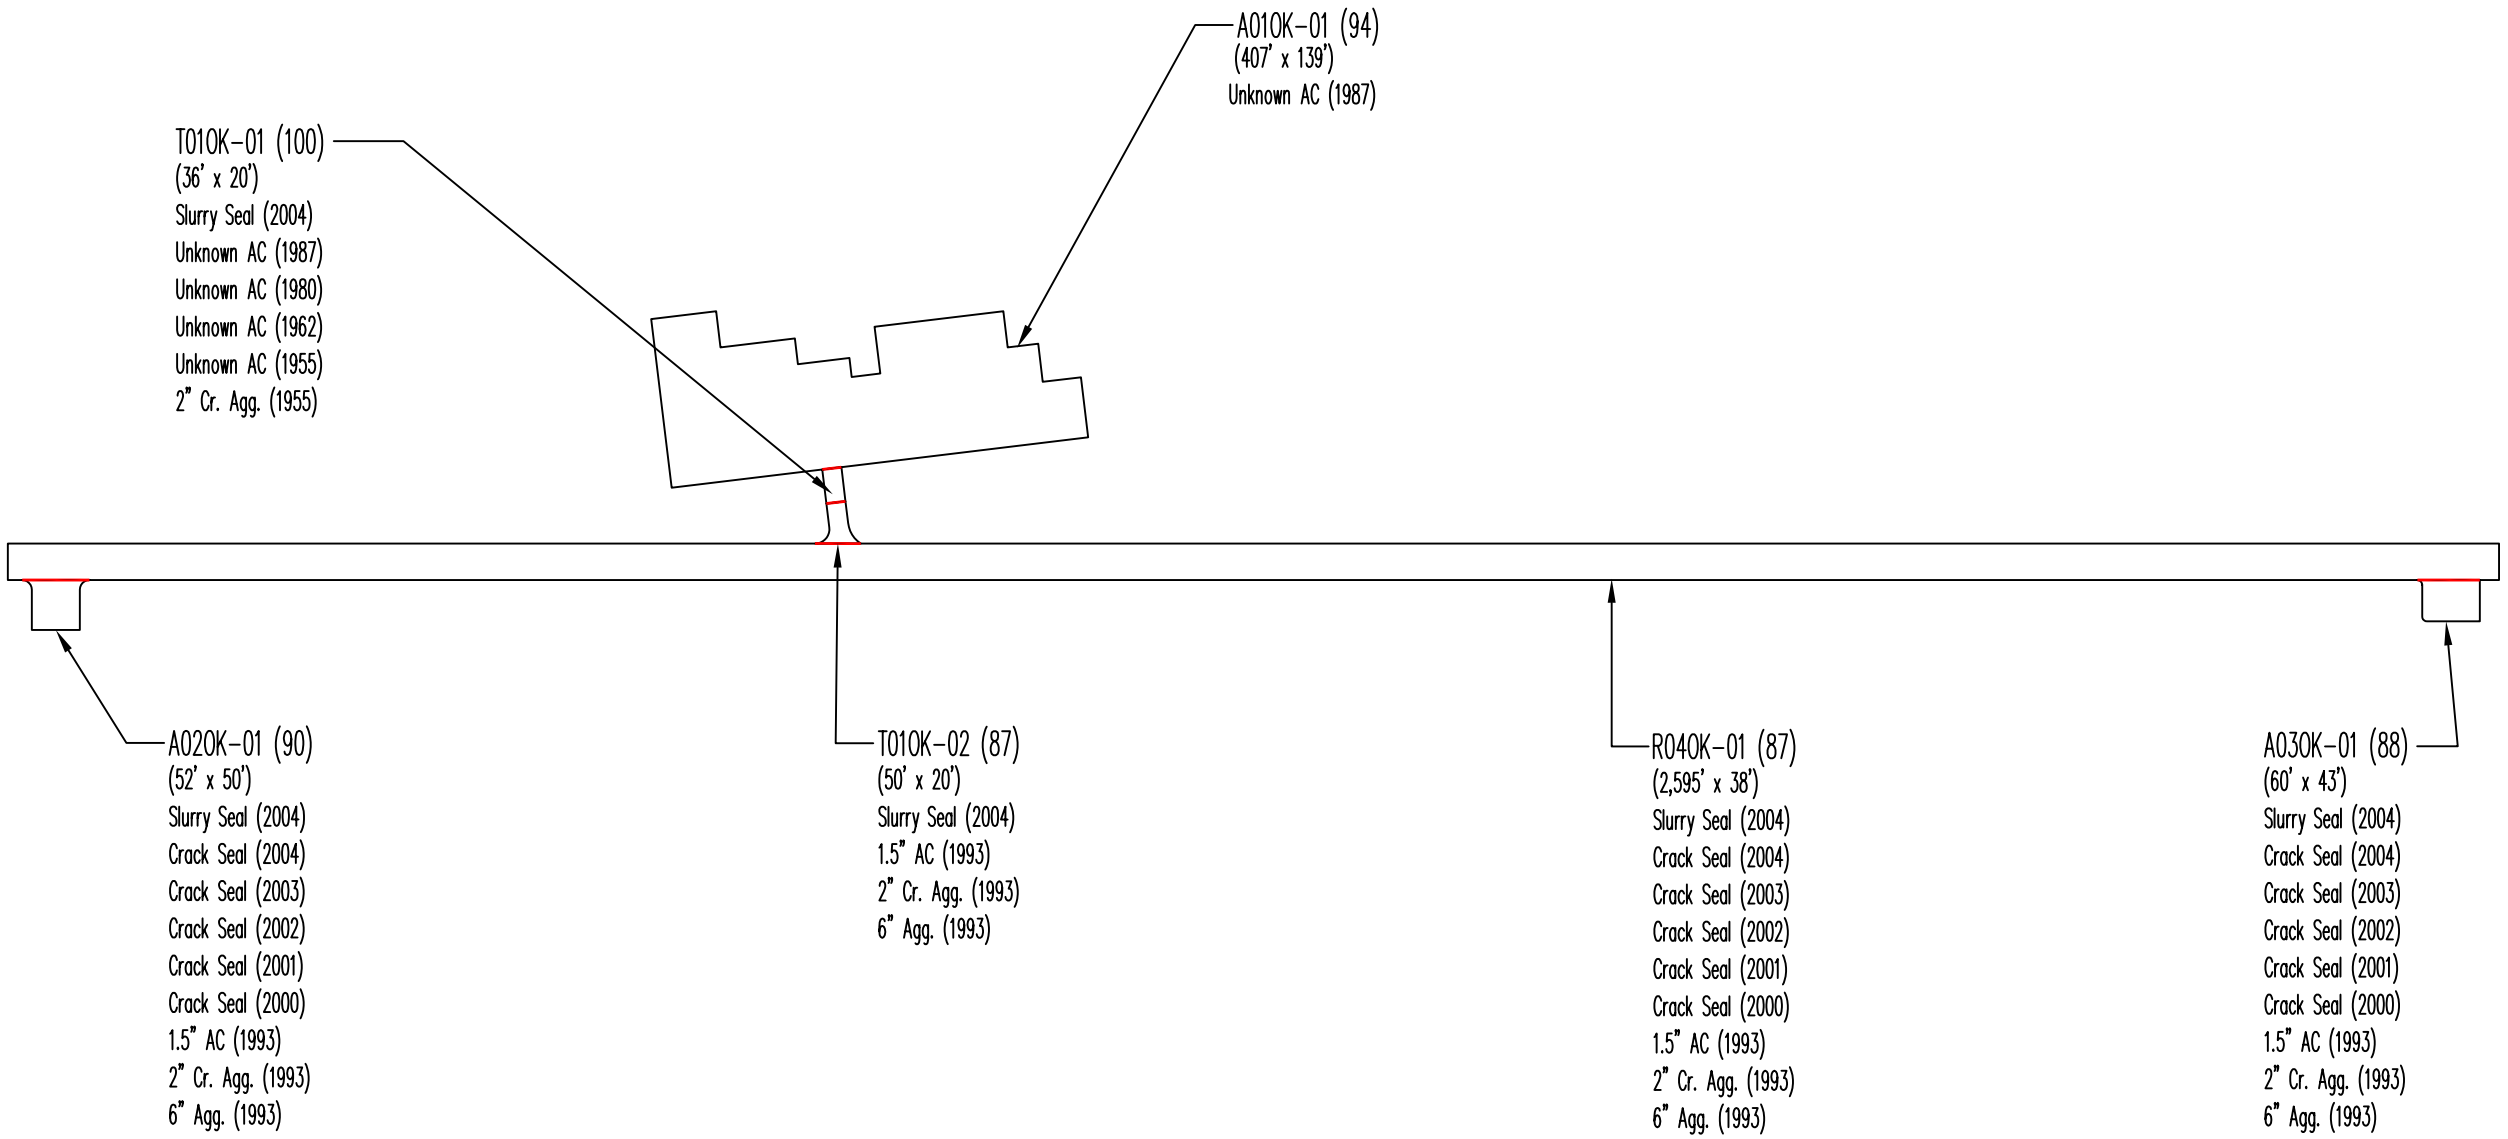
LOCATION: Okanogan Legion Airport, Okanogan, Washington			
PAGE TITLE: 2005 Work History Map			
DRAWING SCALE: 1" = 200'	DATE: February 2006	REVISED BY: TJS	DRAWN BY: JR
FILENAME: Okanogan.dwg	AIRPORT ID: S35	LAYOUT NAME/NUMBER: Okanogan (WH)	PAGE NUMBER: 4

Figure 3 presents the records review results in the form of a work history map. The Micro PAVER database (see the inside back cover of this report) contains detailed inventory information about the pavement system at the airport.

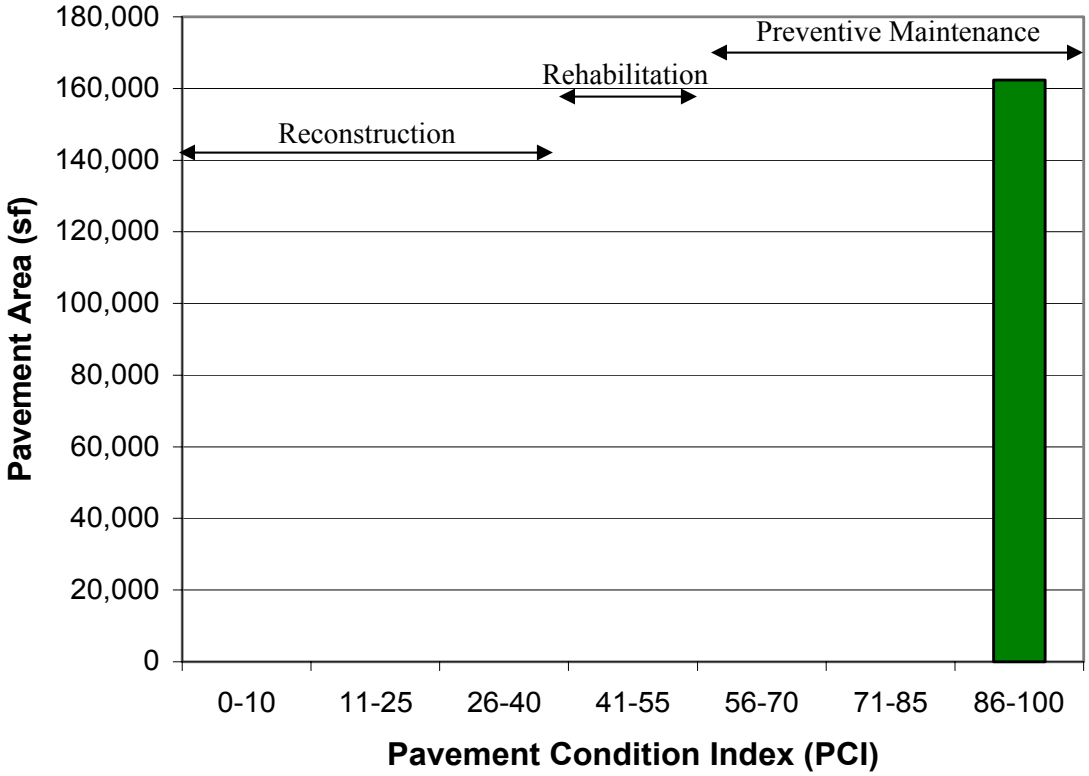
Figure 6. Okanogan Legion Airport overall condition.

The pavements at Okanogan Legion Airport were inspected on June 4, 2005. The 2005 area-weighted condition of Okanogan Legion Airport is 90, with conditions ranging from 87 to 100 (on a scale of 0 [failed] to 100 [excellent]). During the previous inspection in 1999, the area-weighted condition was 67.

Figures 6 and 7 summarize the overall condition of the pavements at the Okanogan Legion Airport. Figure 8 displays the condition of the pavements evaluated. Table 1 summarizes the results of the pavement evaluation. Appendix C presents photographs taken during the PCI inspection and Appendix D details the distresses observed during the visual survey.

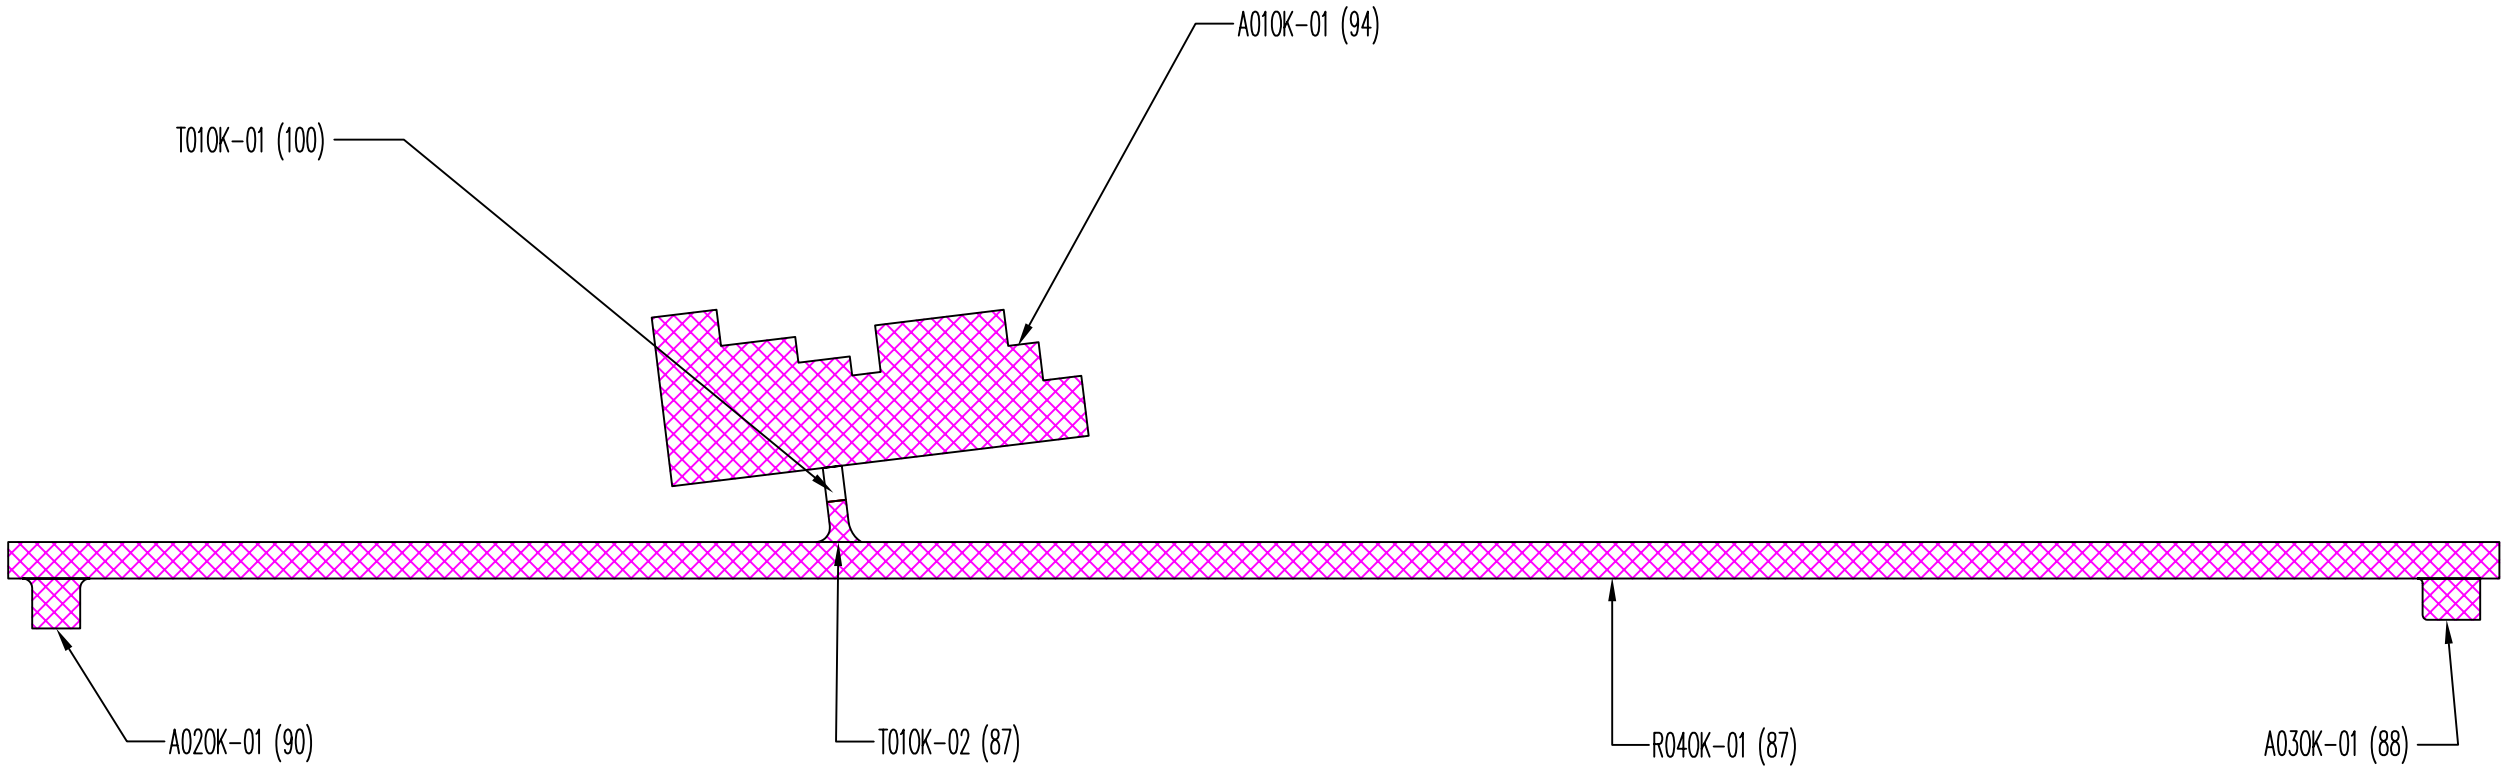
CAPITAL IMPROVEMENT PROGRAM
2006 THROUGH 2012

A summary of the pavement repair program for Okanogan Legion Airport is presented in Table 4 and in Figure 9. Detailed information on the localized maintenance plan for 2006 is contained in Appendix F.

REPAIR YEAR	REPAIR TYPE
2006	FOG SEAL
2007	SLURRY SEAL
2008	REHABILITATION
2009	RECONSTRUCTION
2010	
2011	
2012
