Gold Mines and CIDH Piles

September 21, 2009 Caltrans Division of Engineering Services Sacramento, California

Angels Camp Hwy 49 Bypass

Murphys Grade Rd UC

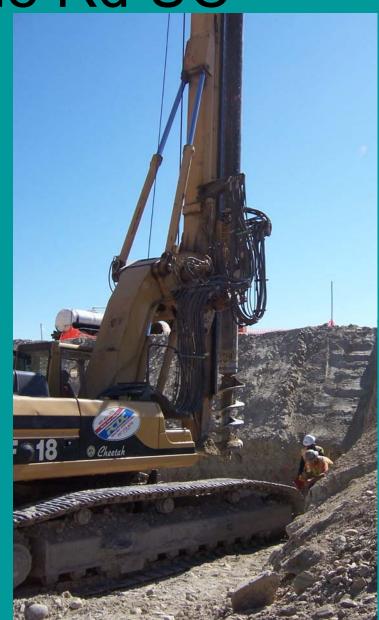
- September 11 began drilling Bent 2 piles
- September 12 Heidi got a phone call

Contractor: Heidi, I think we have a problem.
Yesterday, we drilled 4 piles 40' deep.
Today two of them were 44' deep. Didn't think much of it.
So we put the cage in and started placing concrete. We've put two trucks of concrete in the hole and it hasn't come up the shaft...

AT ALL.

Heidi: "Stop wasting concrete. You're never going to fill that hole! Looks like we found a mineshaft.Pull out the rebar cage.

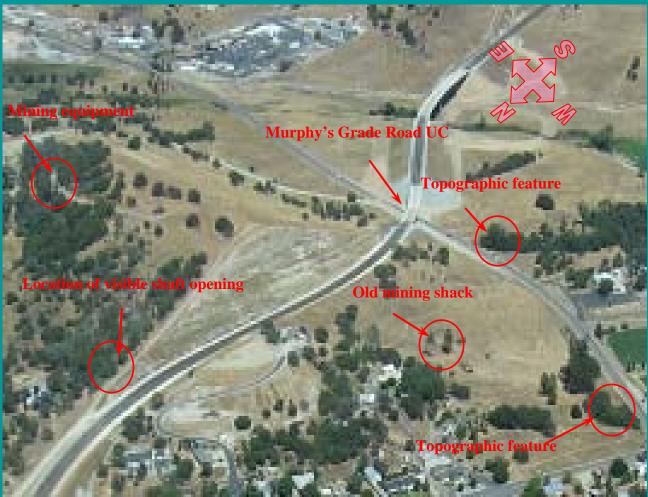
Upon arriving to the project location, several topographic features stood out as being locations of abandoned mines.

Prominent feature stood out to the south of Murphy's Grade Road.

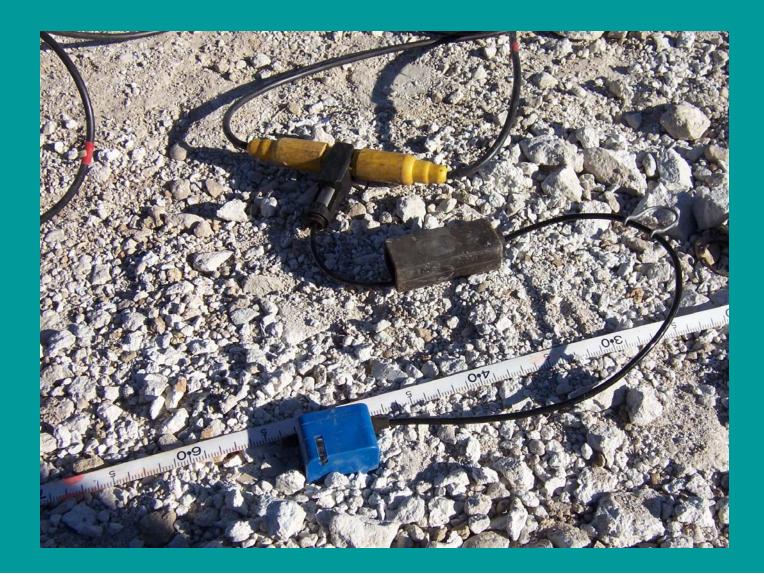
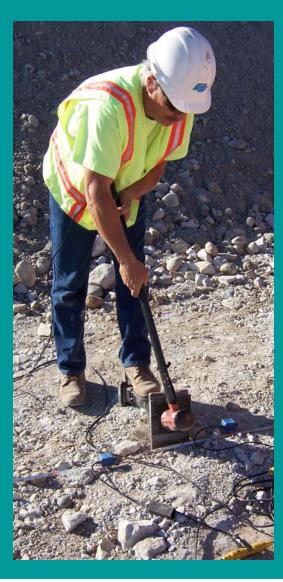
Performed Surface Resistivity.

Results concluded that there was not a large scale void beneath the bent cap.

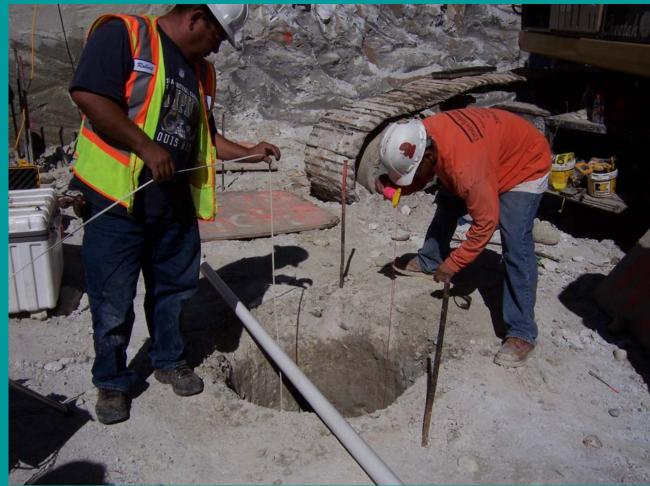
Resourced and consulted with Foundation Testing Branch for downhole video logging.

Piles 3, 5, 6, 11 and 12 were downhole logged as well as the abandoned shaft at Station 18+60.

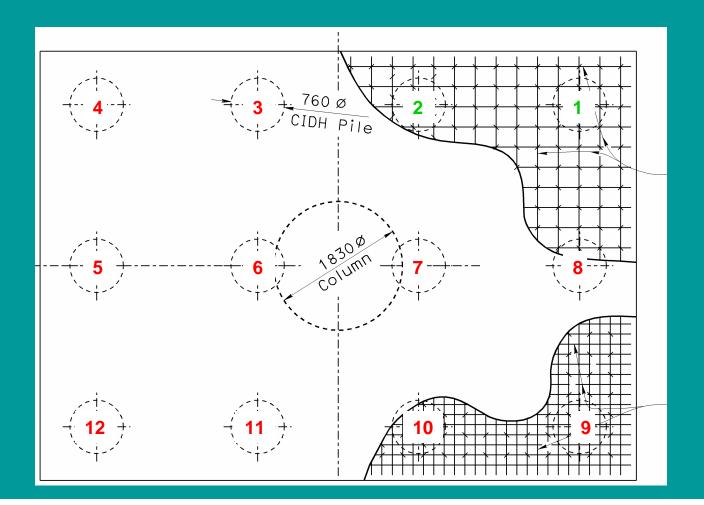
•Additional information about the mine tunnel was needed.

- •How deep is the roof?
- •How tall is the tunnel?

- In what direction does it run?
- •Which piles are affected?

Direction from Bill was:

- Install casing larger than original hole
- •Embed it 2-3' into bottom of tunnel
- •Drill additional 10' below bottom of casing
- •Extend rebar cage the full length

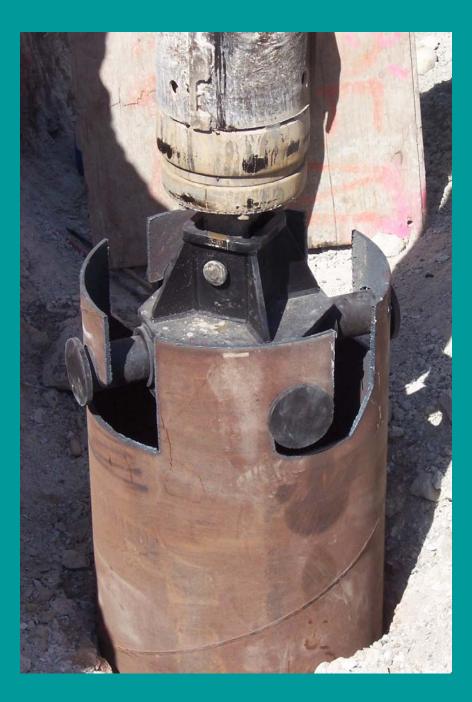
But when the casing is below the water line, they can't see the top of casing to align the auger in the shaft

Contractor used auger to drill additional 10' below bottom of casing

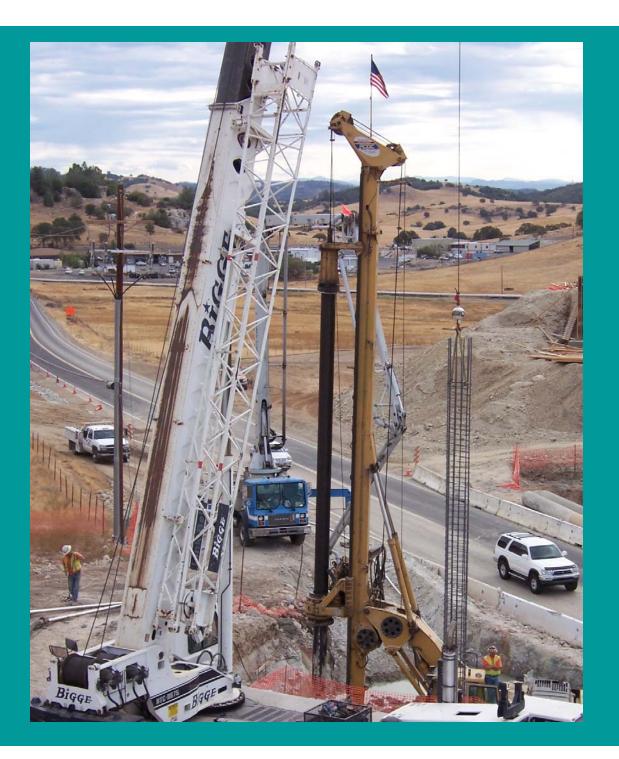
The casing for this pile had a plate welded to the bottom and no additional length was required Concrete was placed in the wet condition Requiring density testing Pile 6 became an extraordinary case. Pile 3 had 2 truckloads of concrete placed in it. That concrete had filled an area all around it Auger bit broke off while drilling pile 6

Pile 6 had an anomaly

Crane was used to place rebar cage

Larger concrete pump was used to place concrete

Adjacent piles gave sufficient strength to the footing. Pile 6 anomaly mitigation was not required. Remaining footings were completed without incidence...
