# Unknown Foundation Testing and Emergency Repairs for the Lake Cushman Bridge

Kathy Van Hecke, US Forest Service  
Dan Stromberg, Collins Engineers

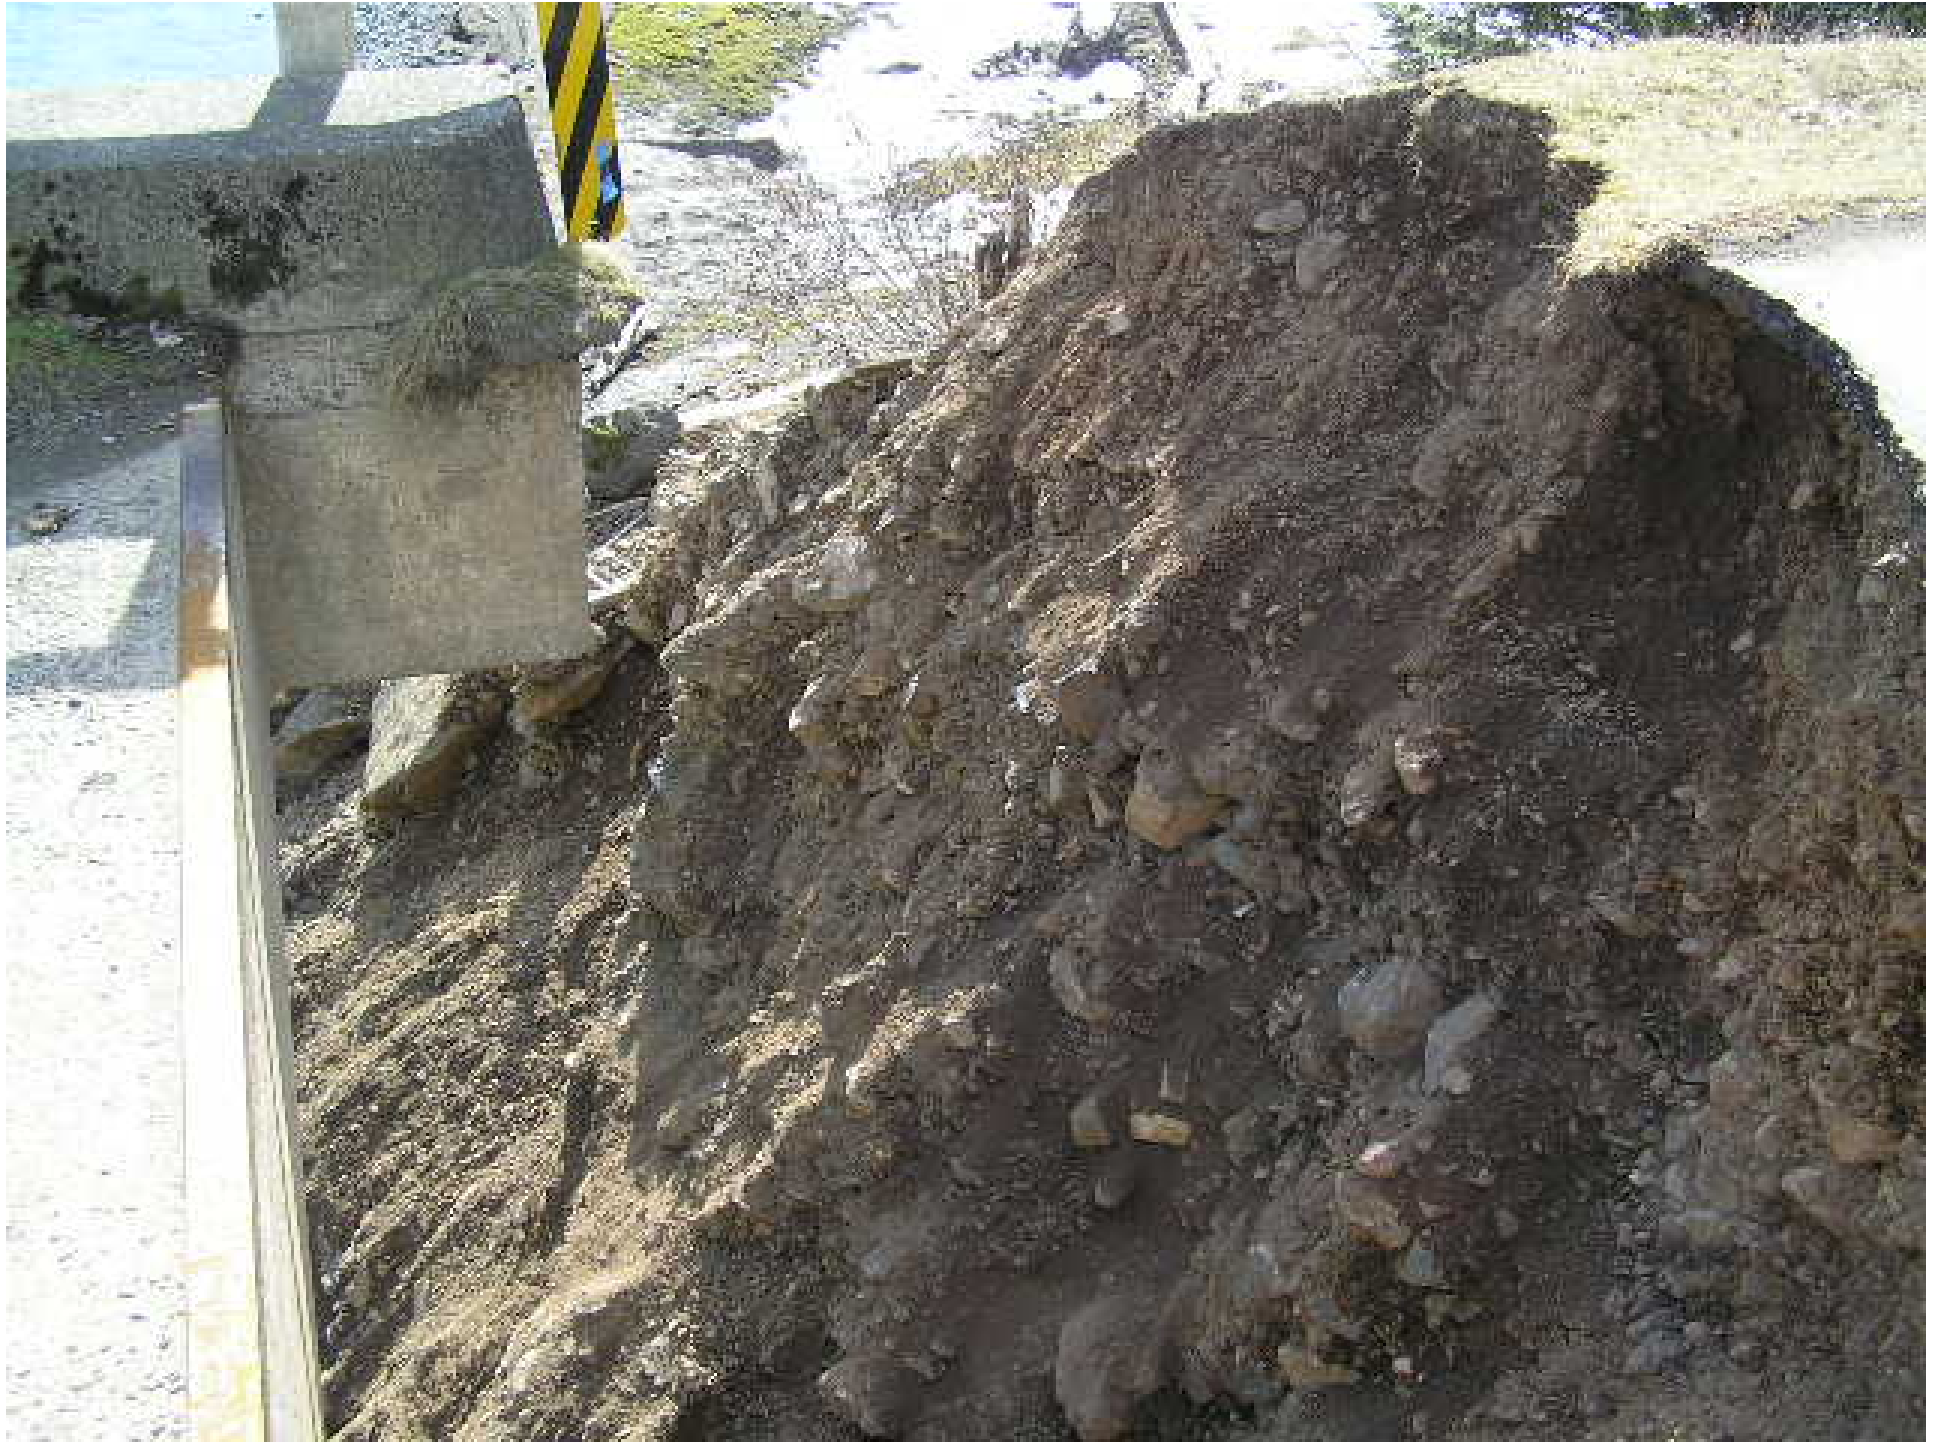
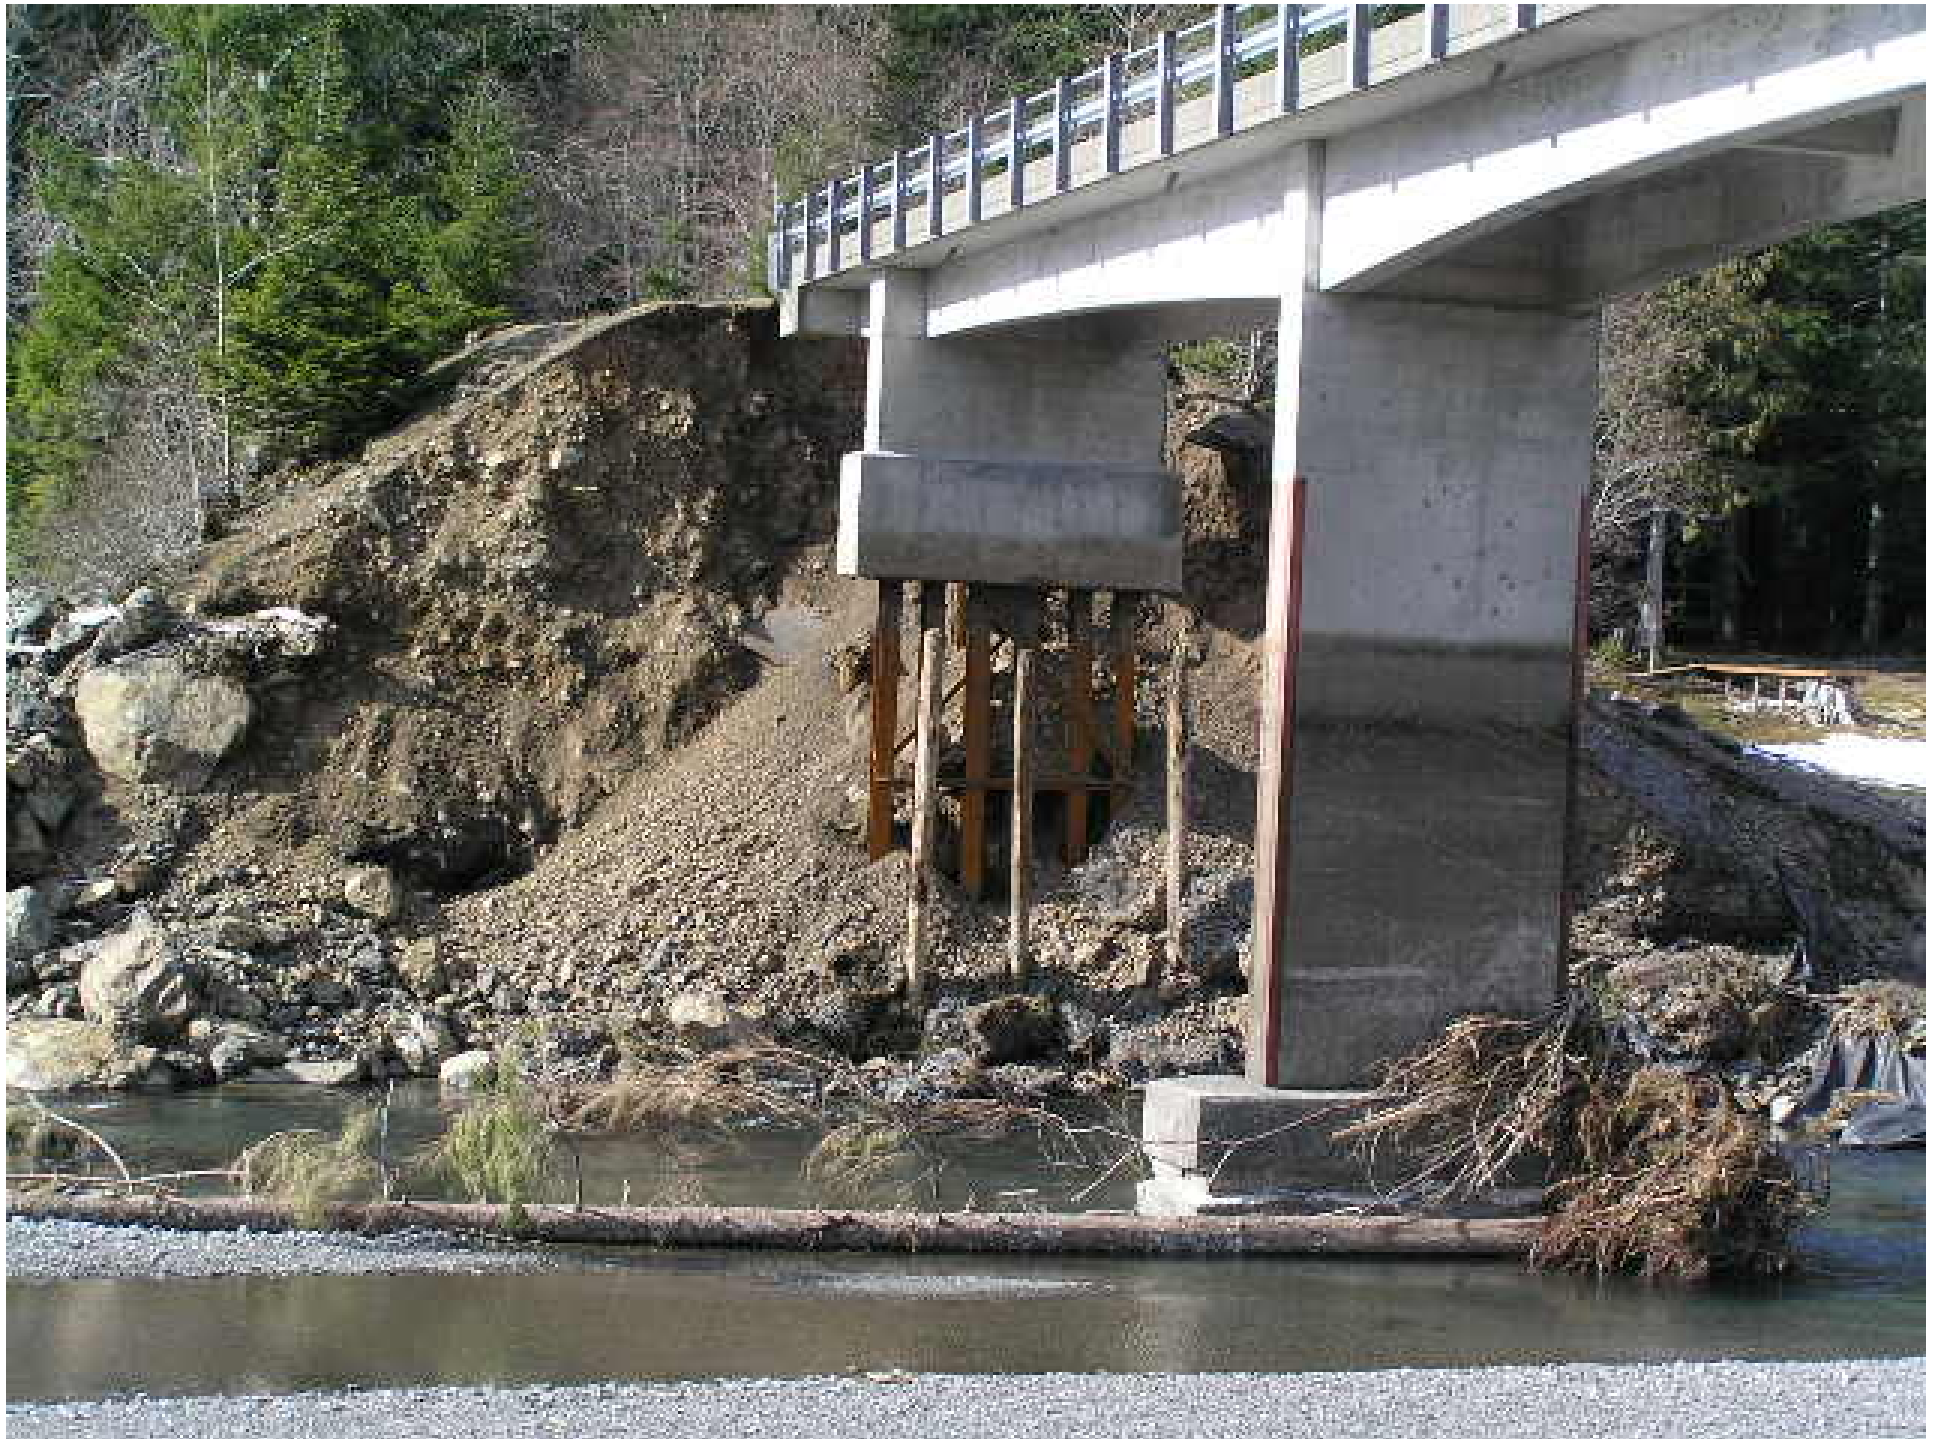
# December 3, 2007

- Stream Gage 1.2 miles upstream from bridge
- Logged discharge at 20,100 cfs which exceeds a 50-year flood
- Largest flow since construction of the bridge (1934 – 27,000; 1949 – 24,200)
- Highest flows occur in Nov/Dec—after reservoir has been lowered

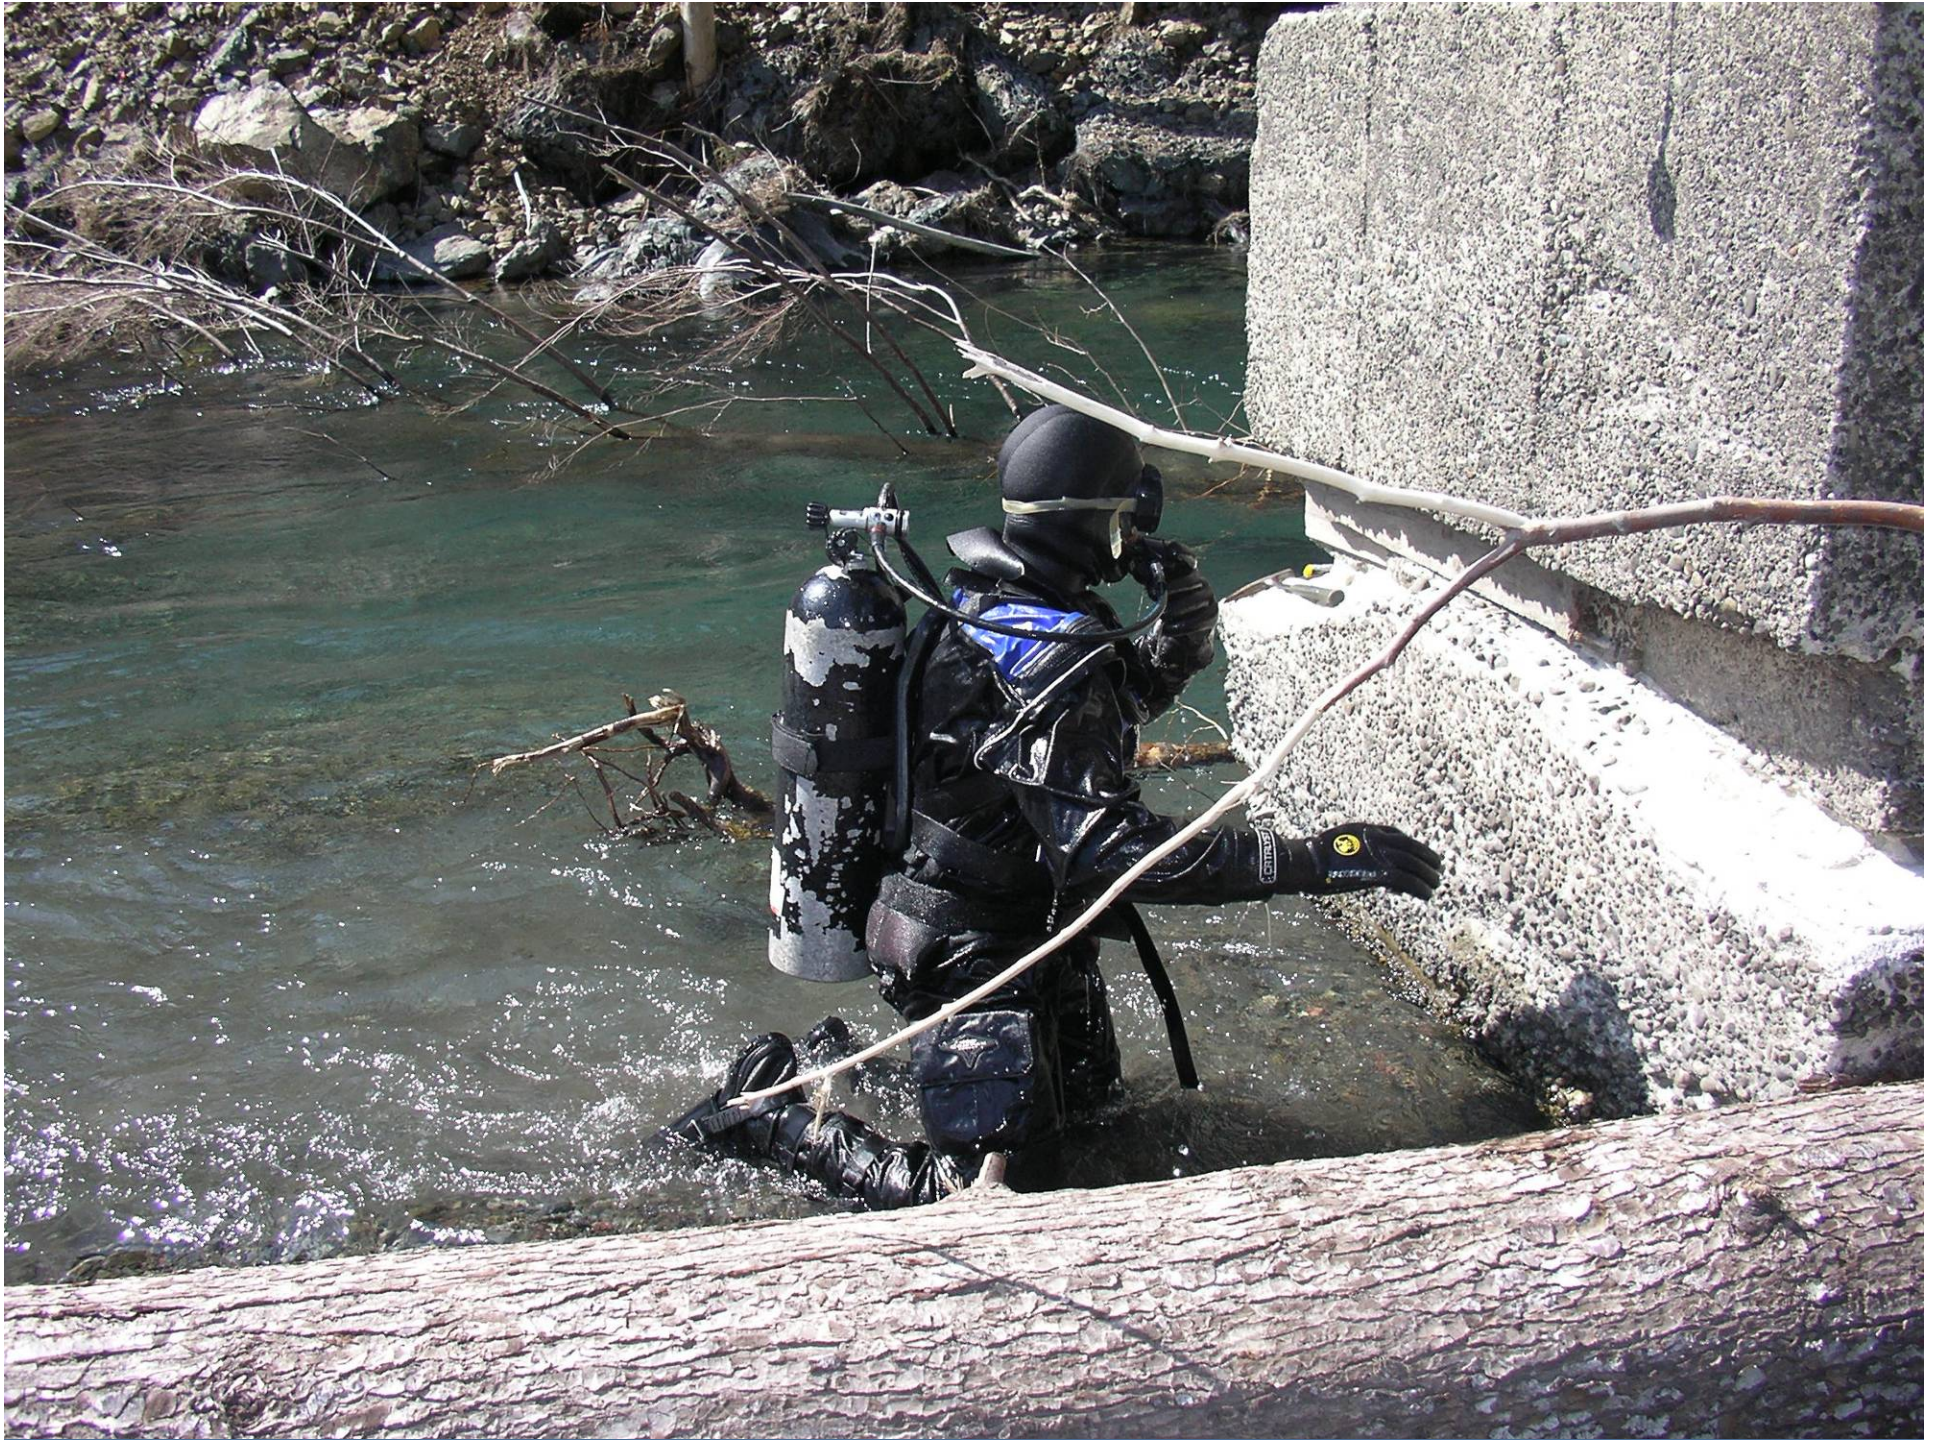
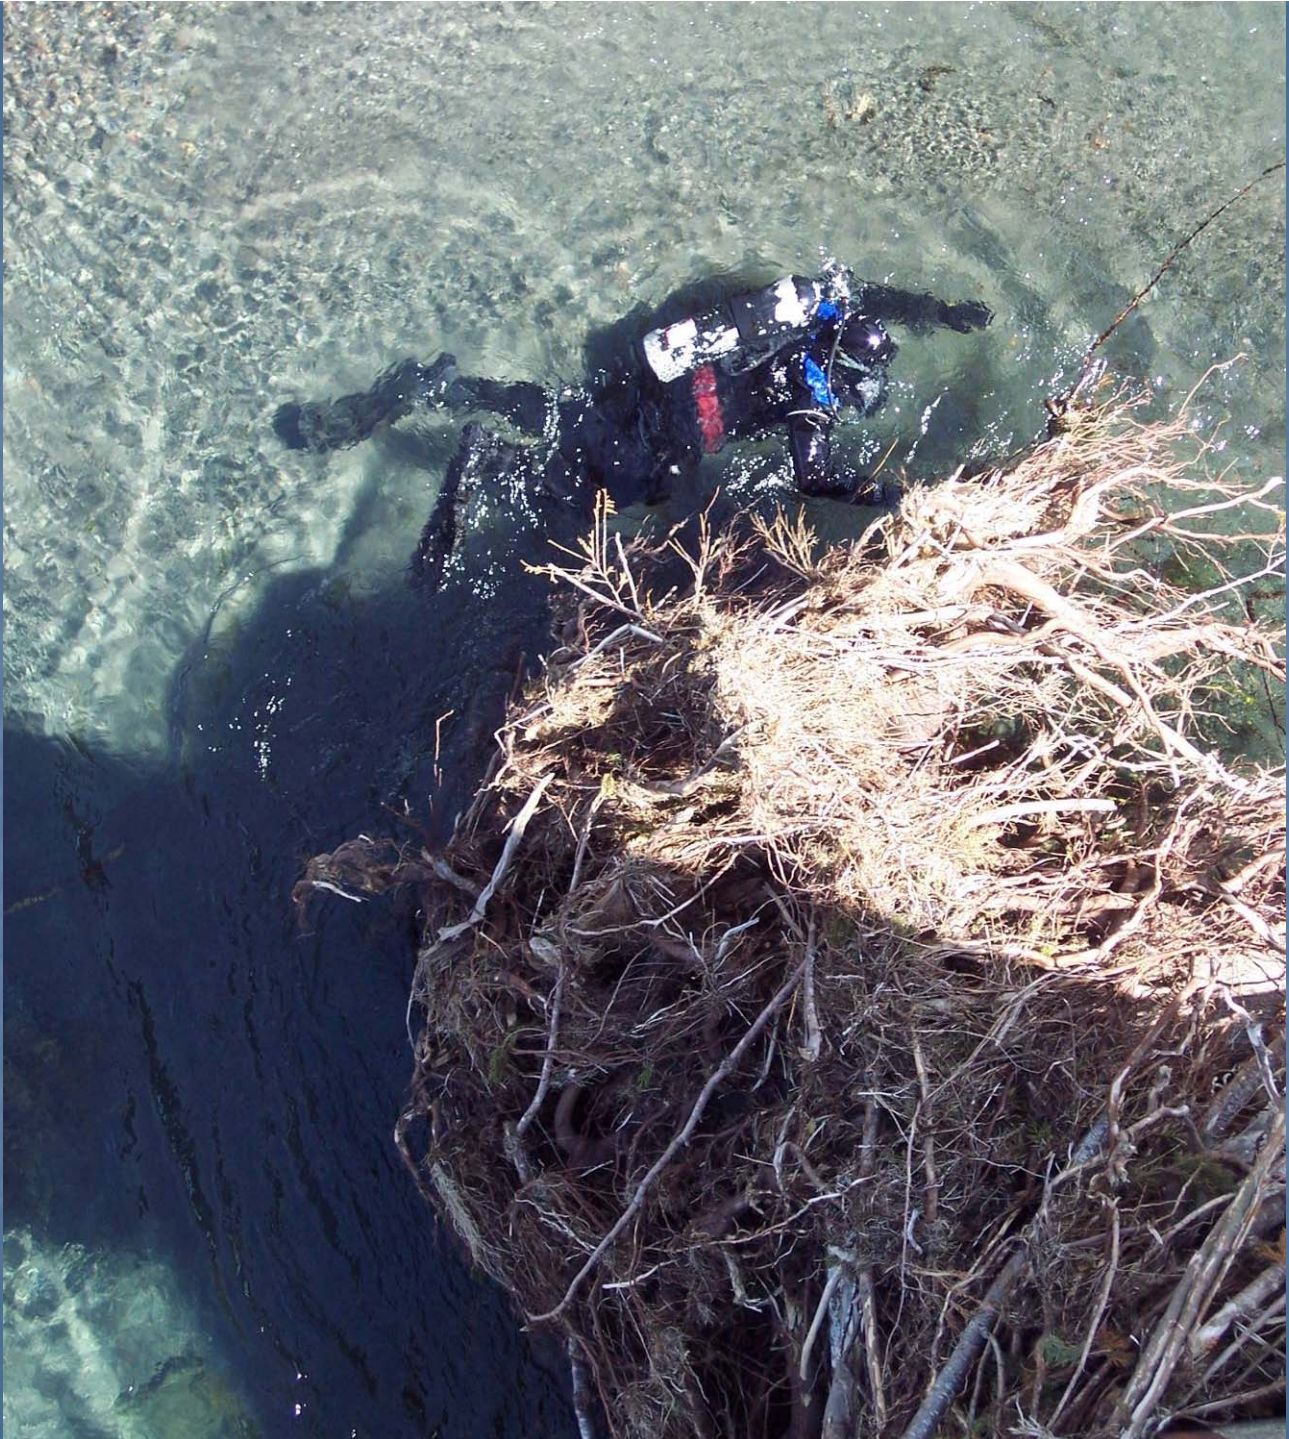
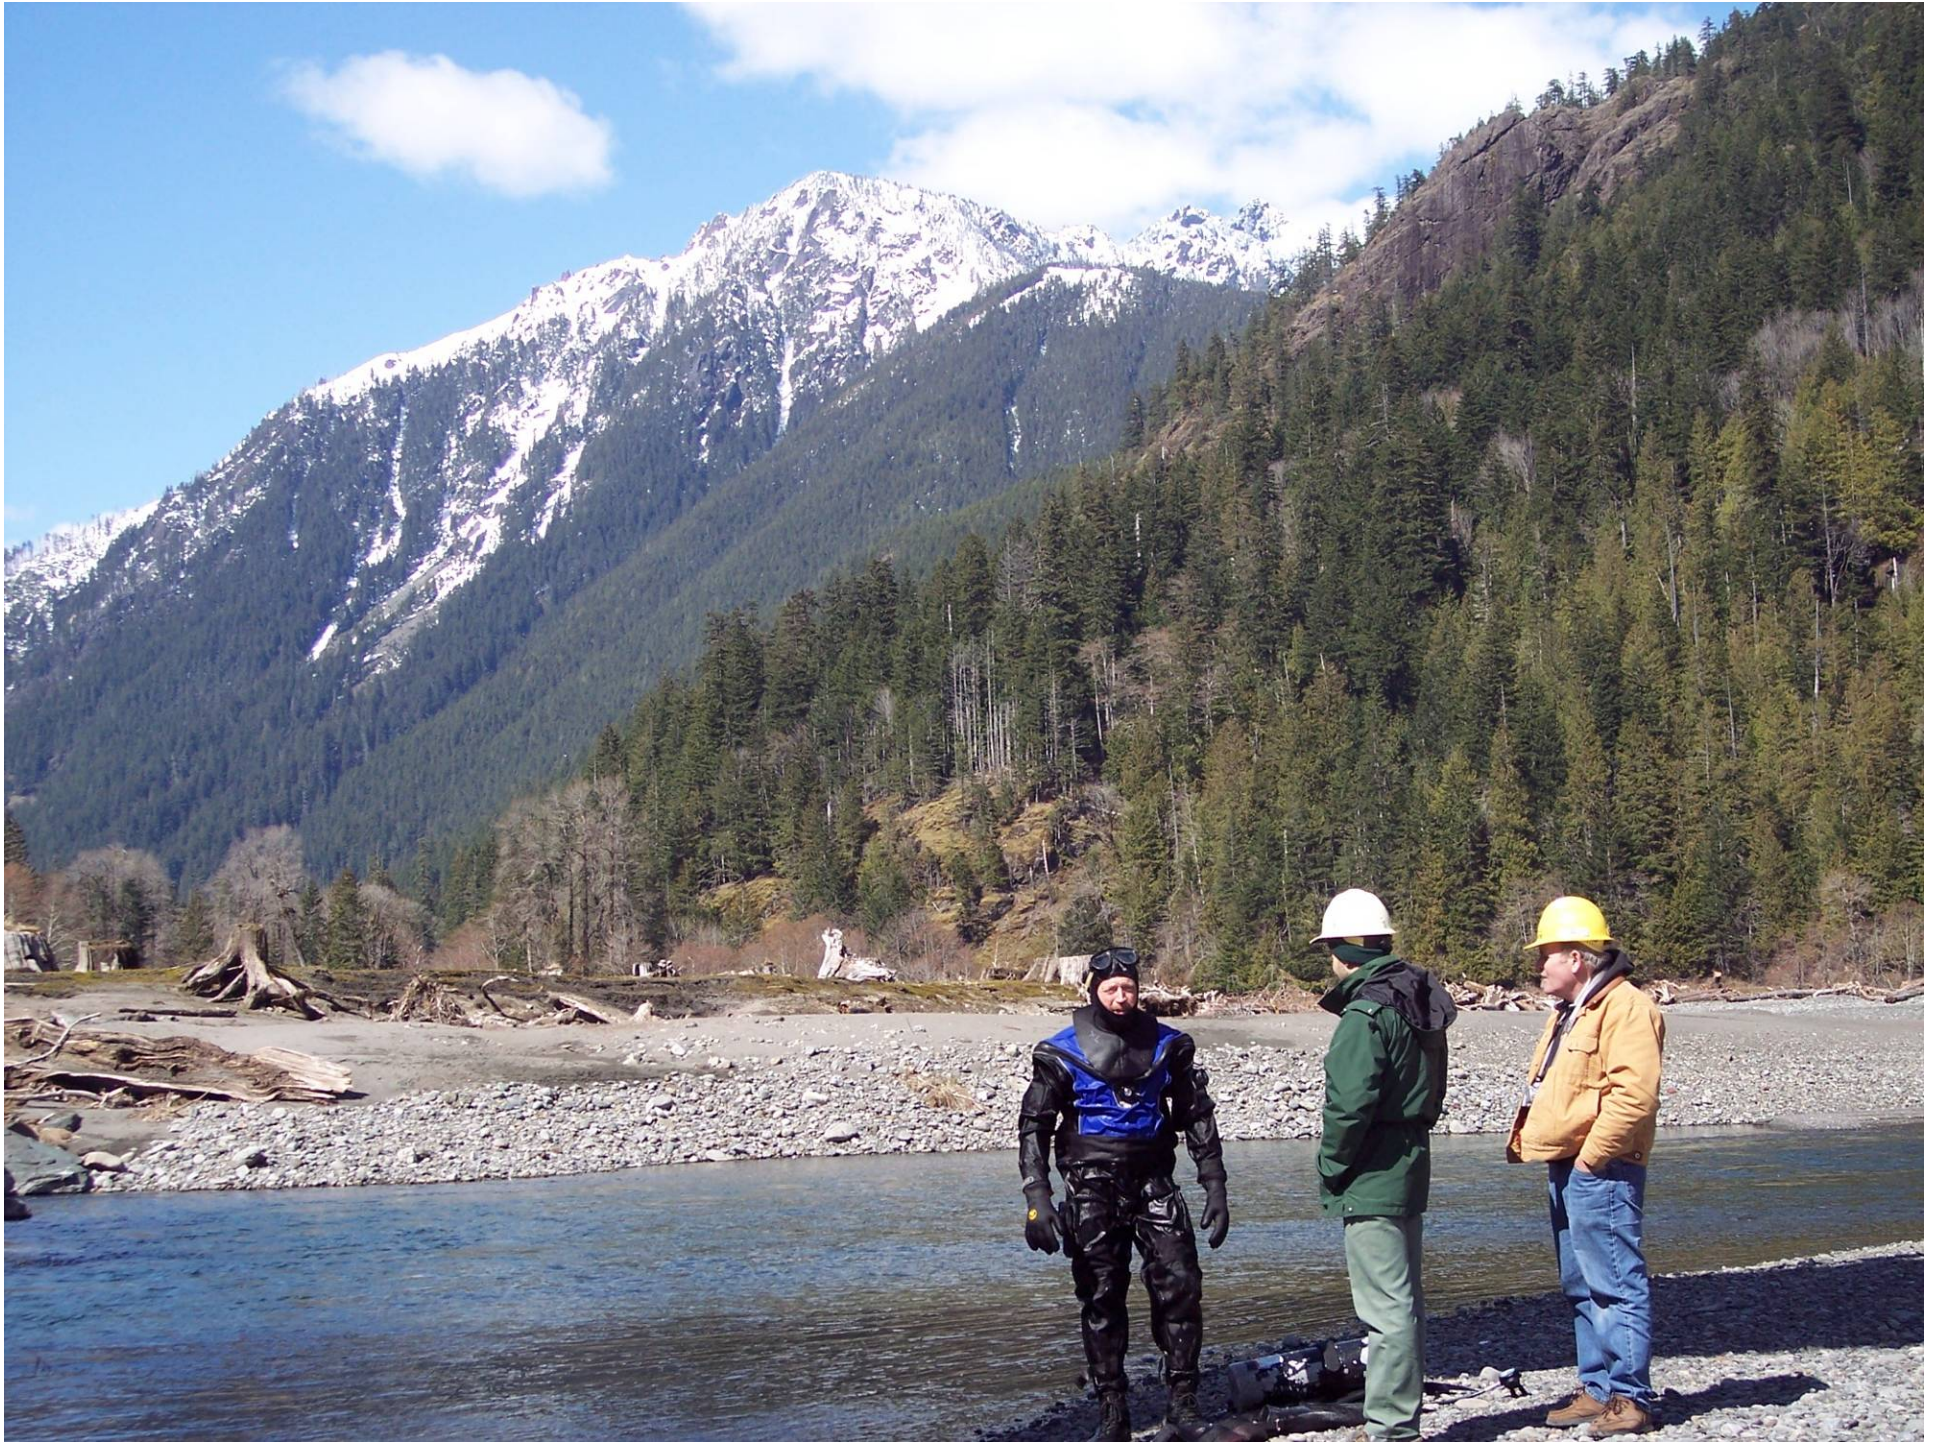
Underwater inspection and  
condition assessment of piles  
through diving.

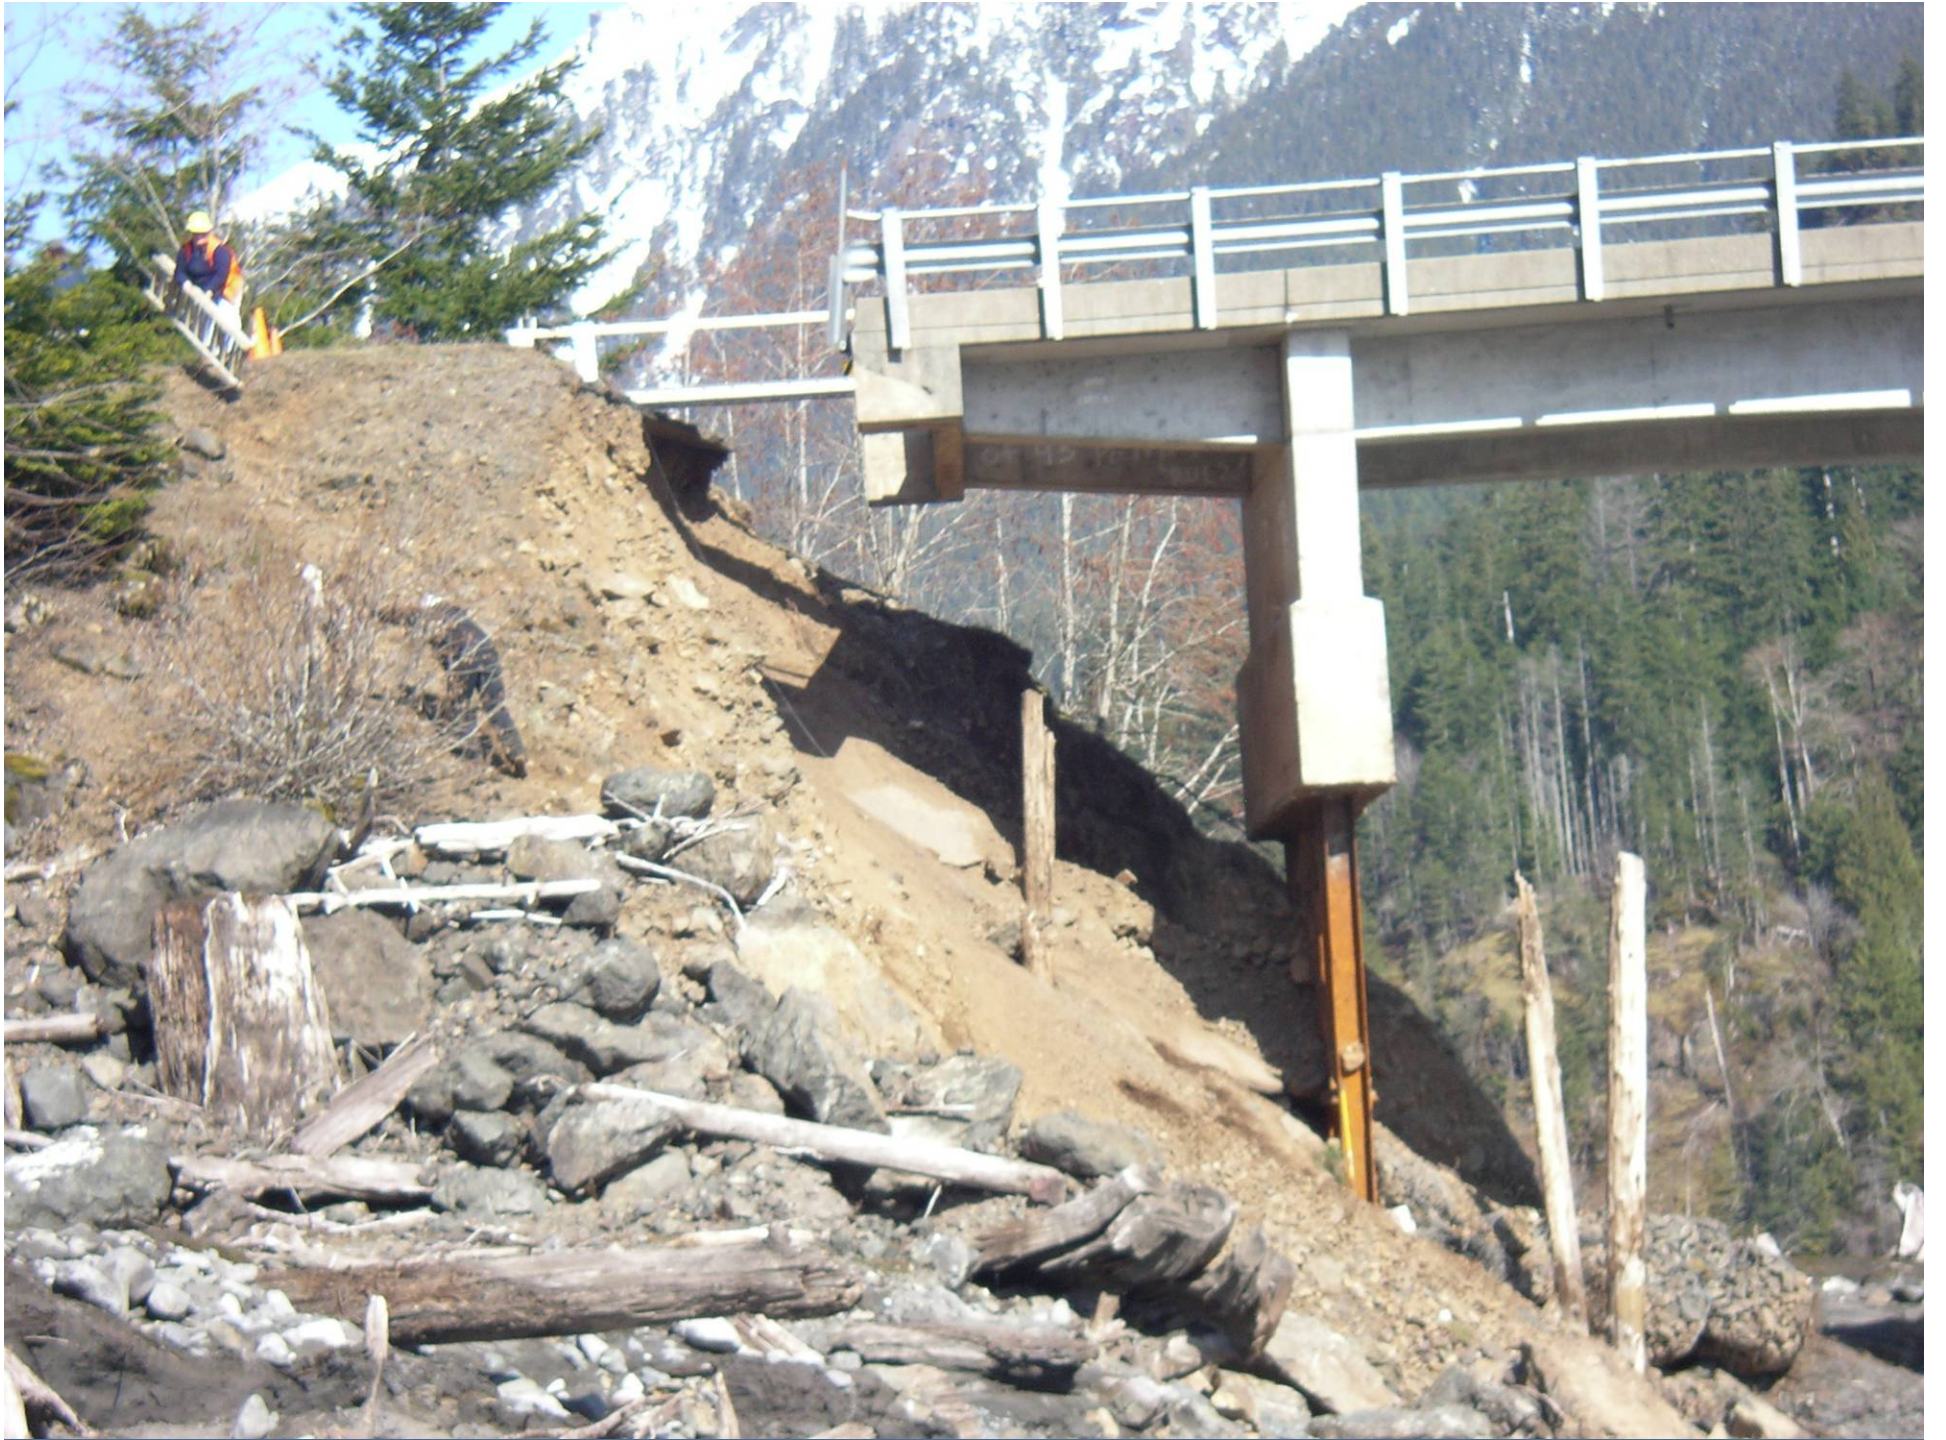
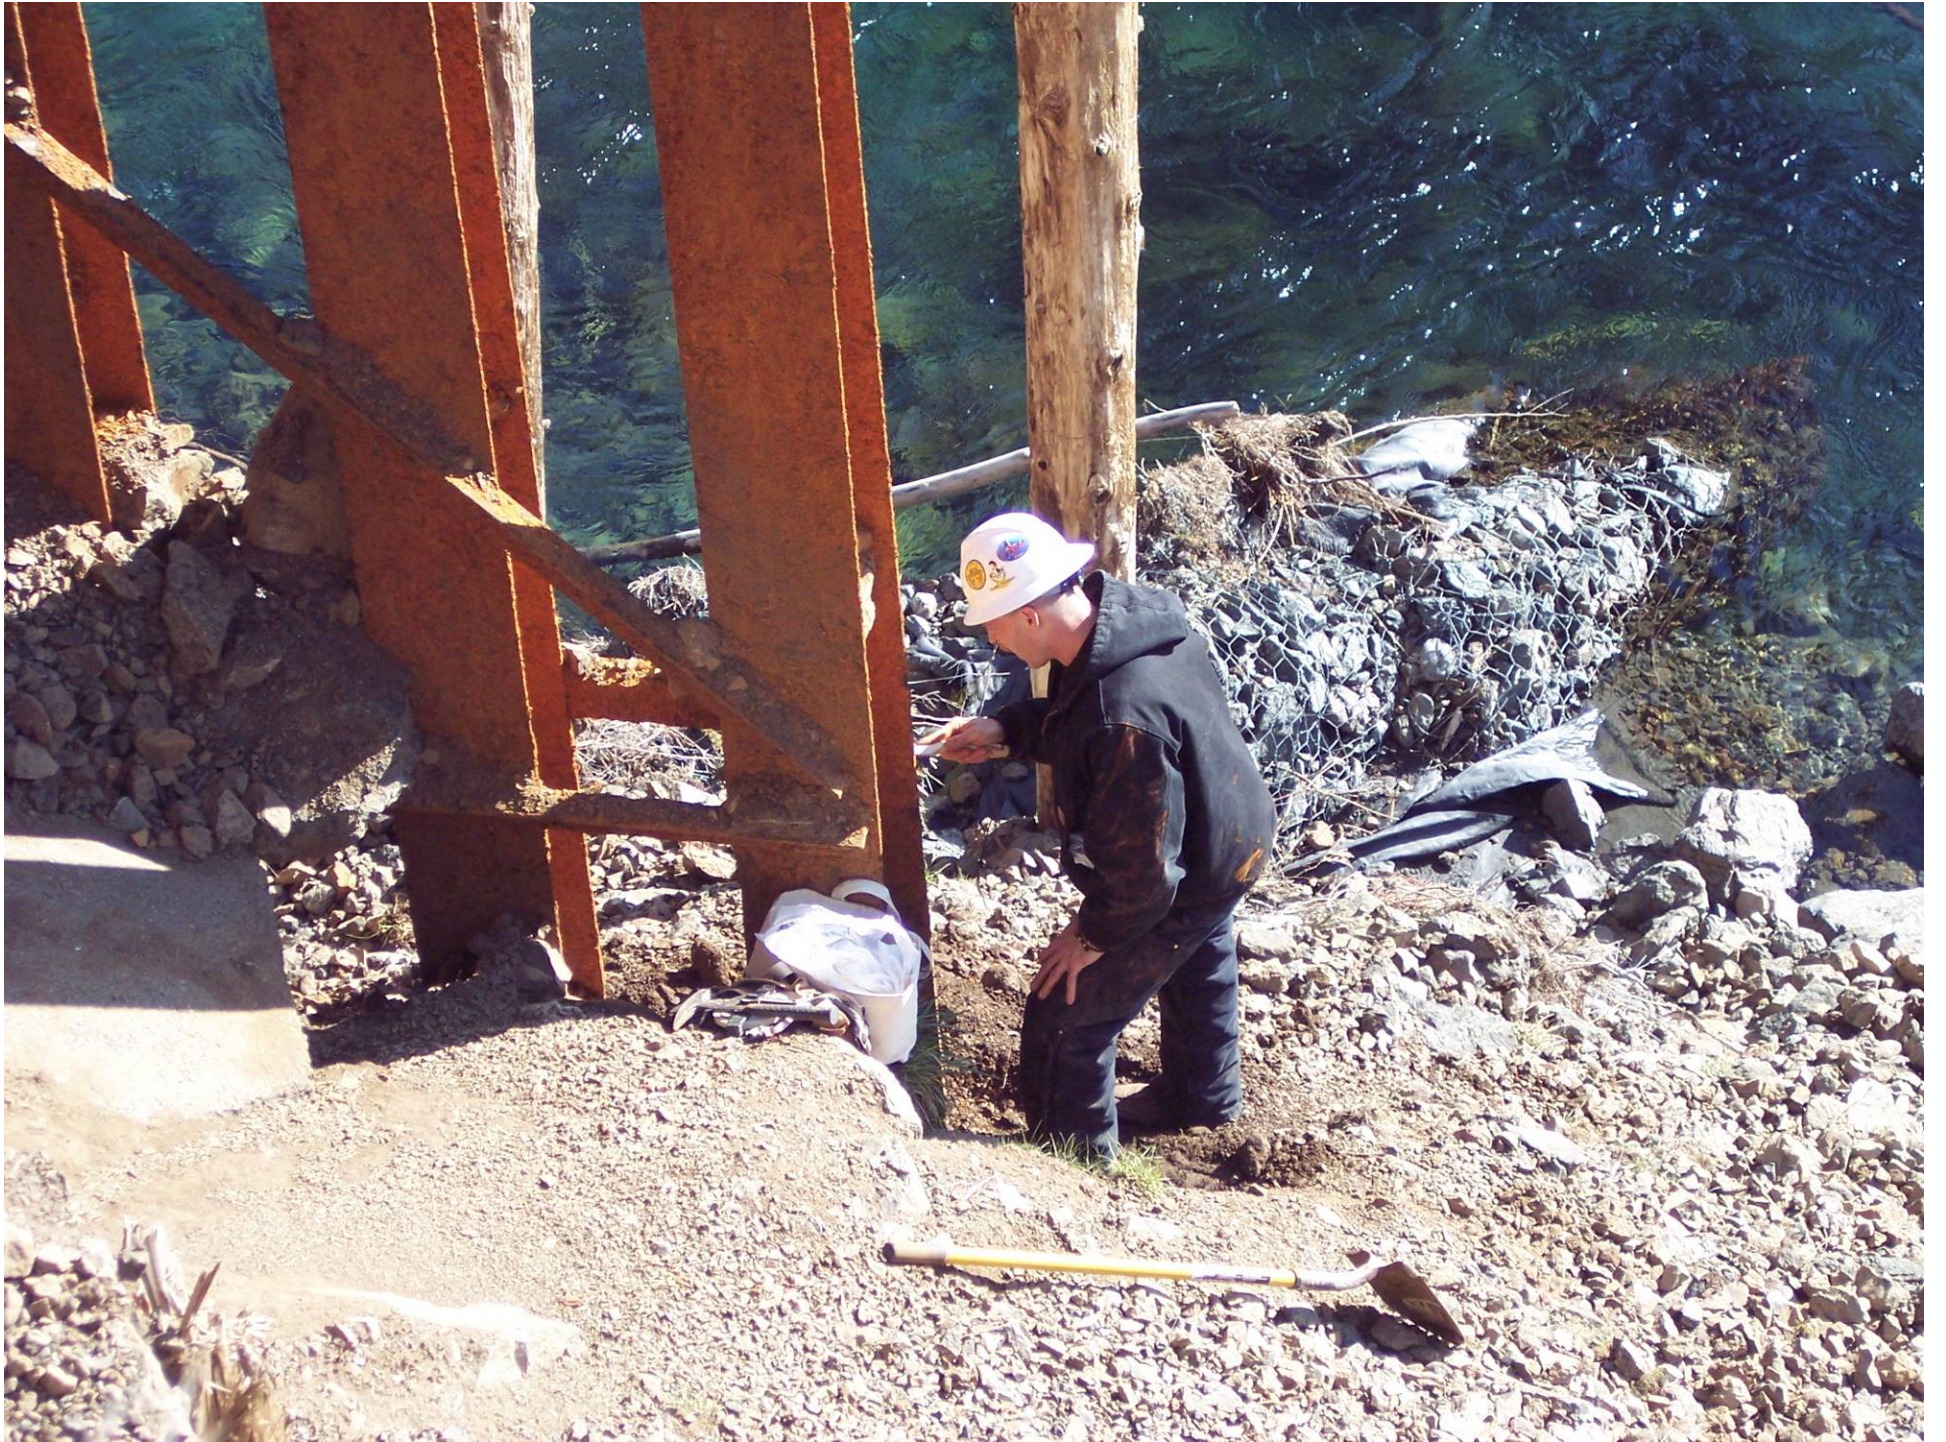
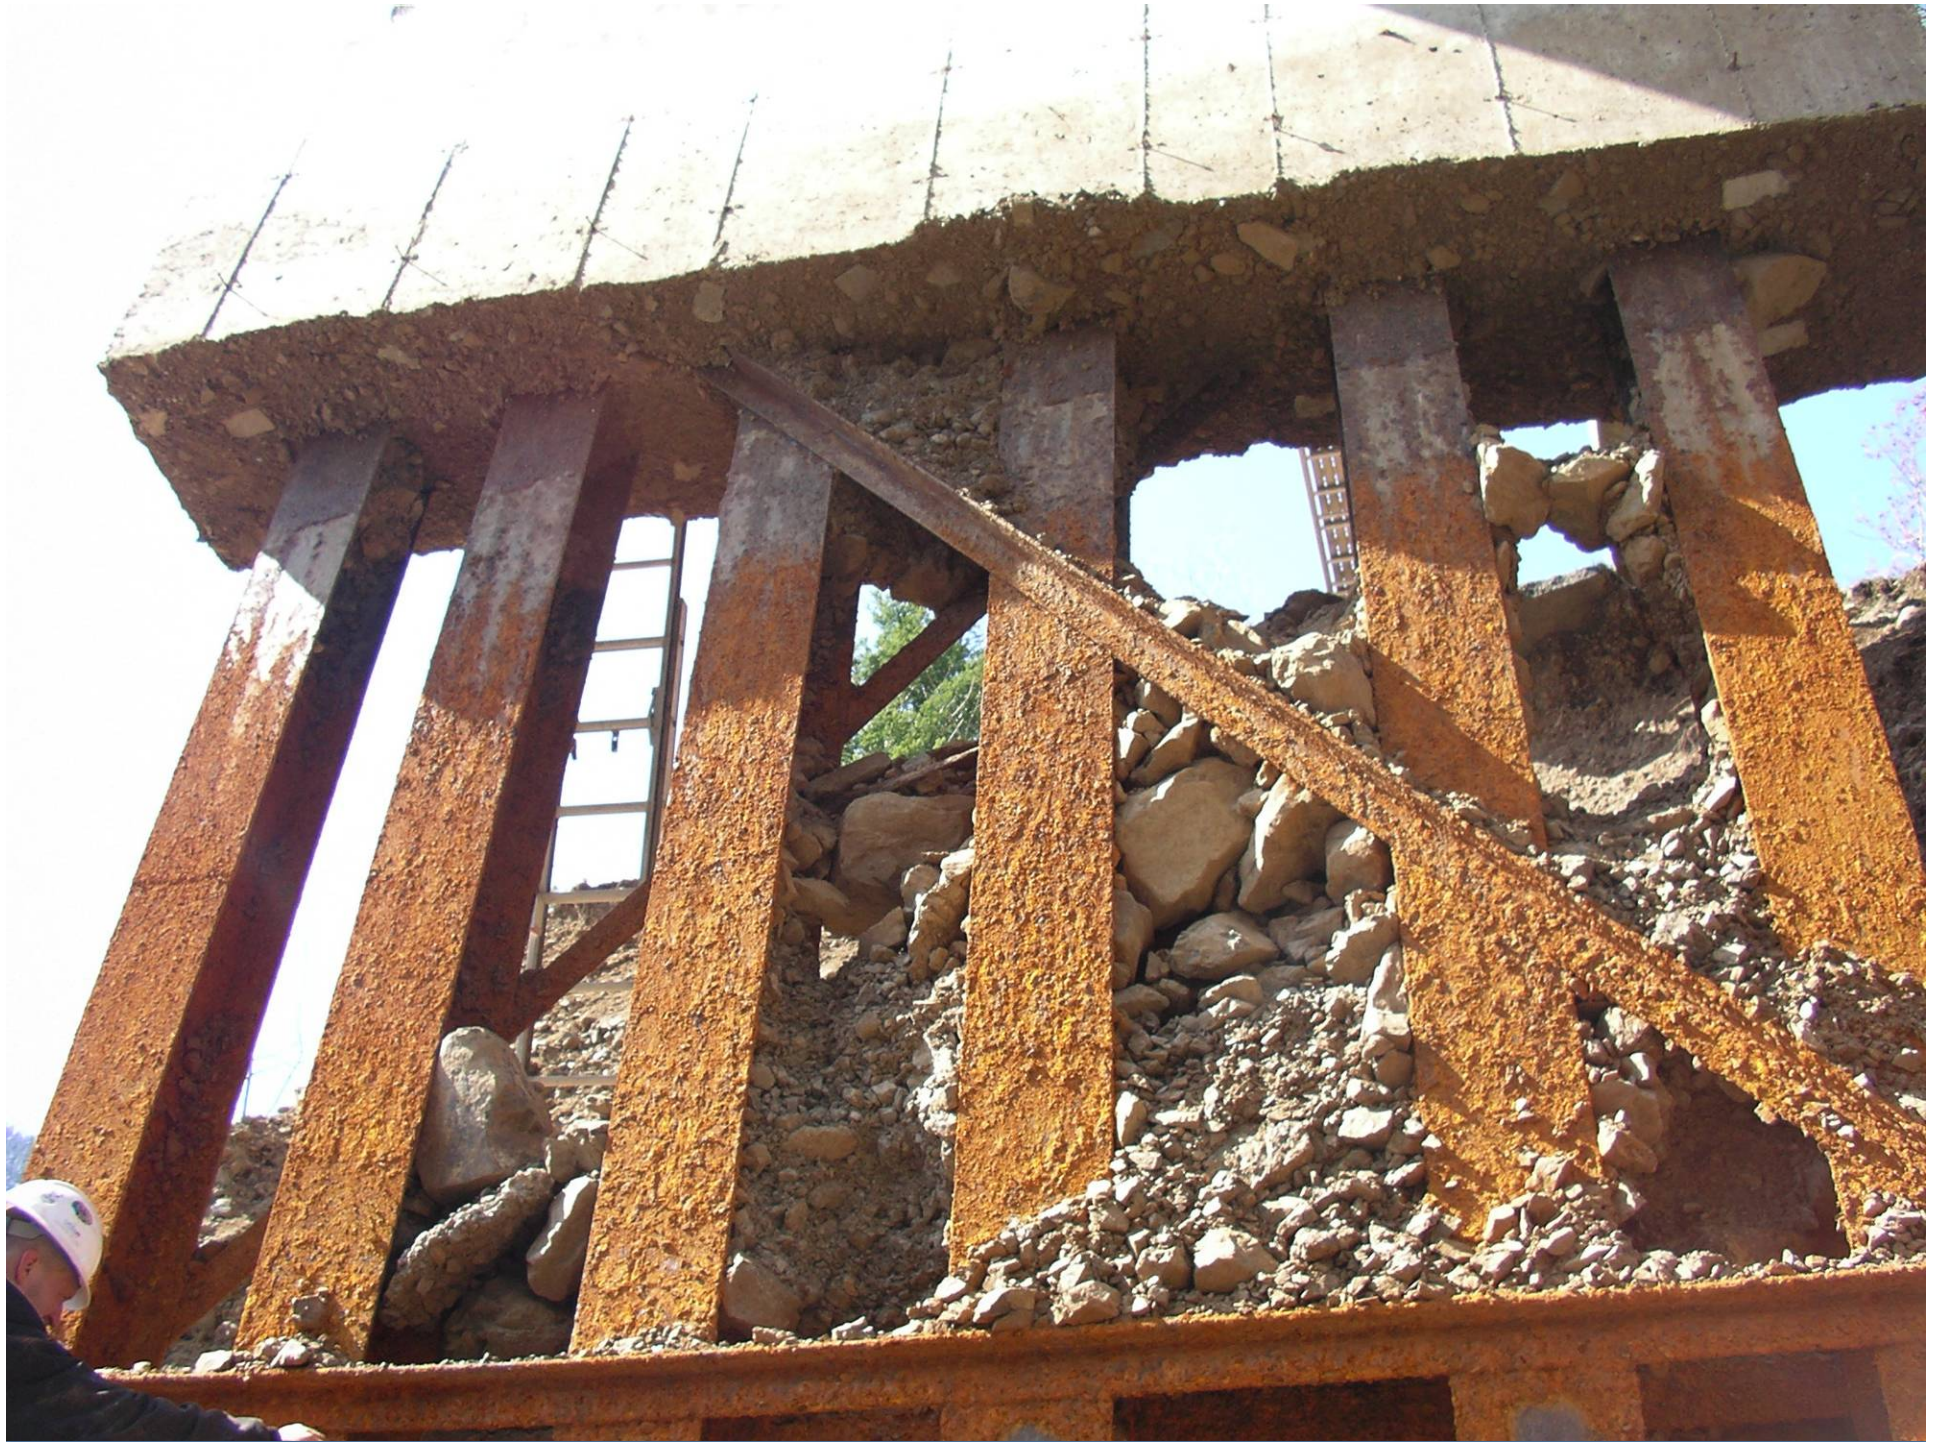
Above water inspection and  
condition assessment of piles  
through climbing and/or ladder  
access
