# Unknown Foundation Testing and Emergency Repairs for the Lake Cushman Bridge

Kathy Van Hecke, US Forest Service  
Dan Stromberg, Collins Engineers

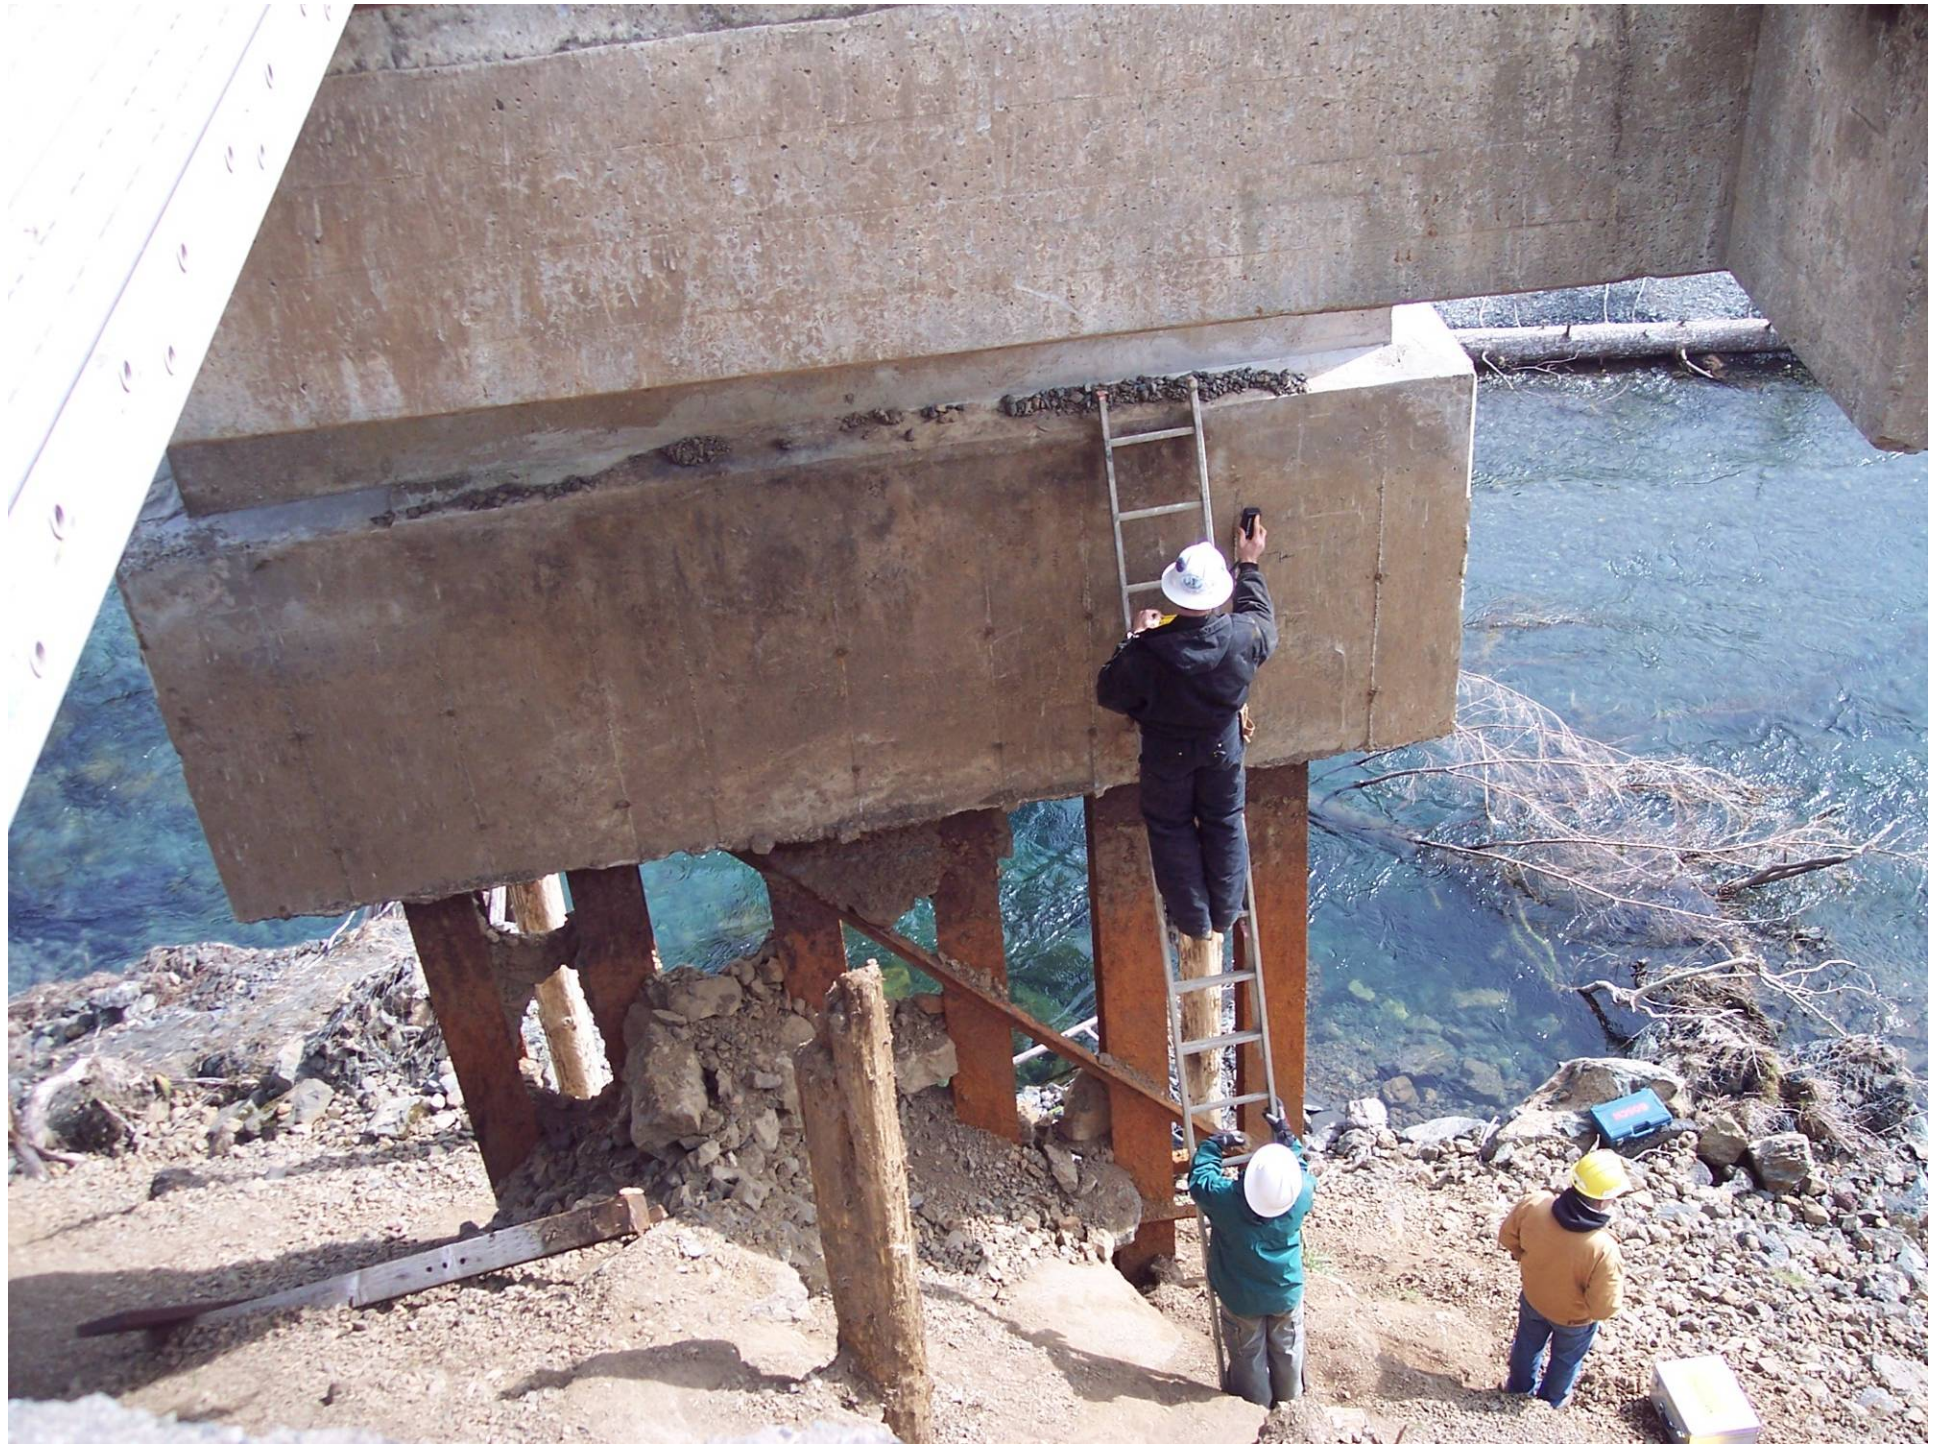
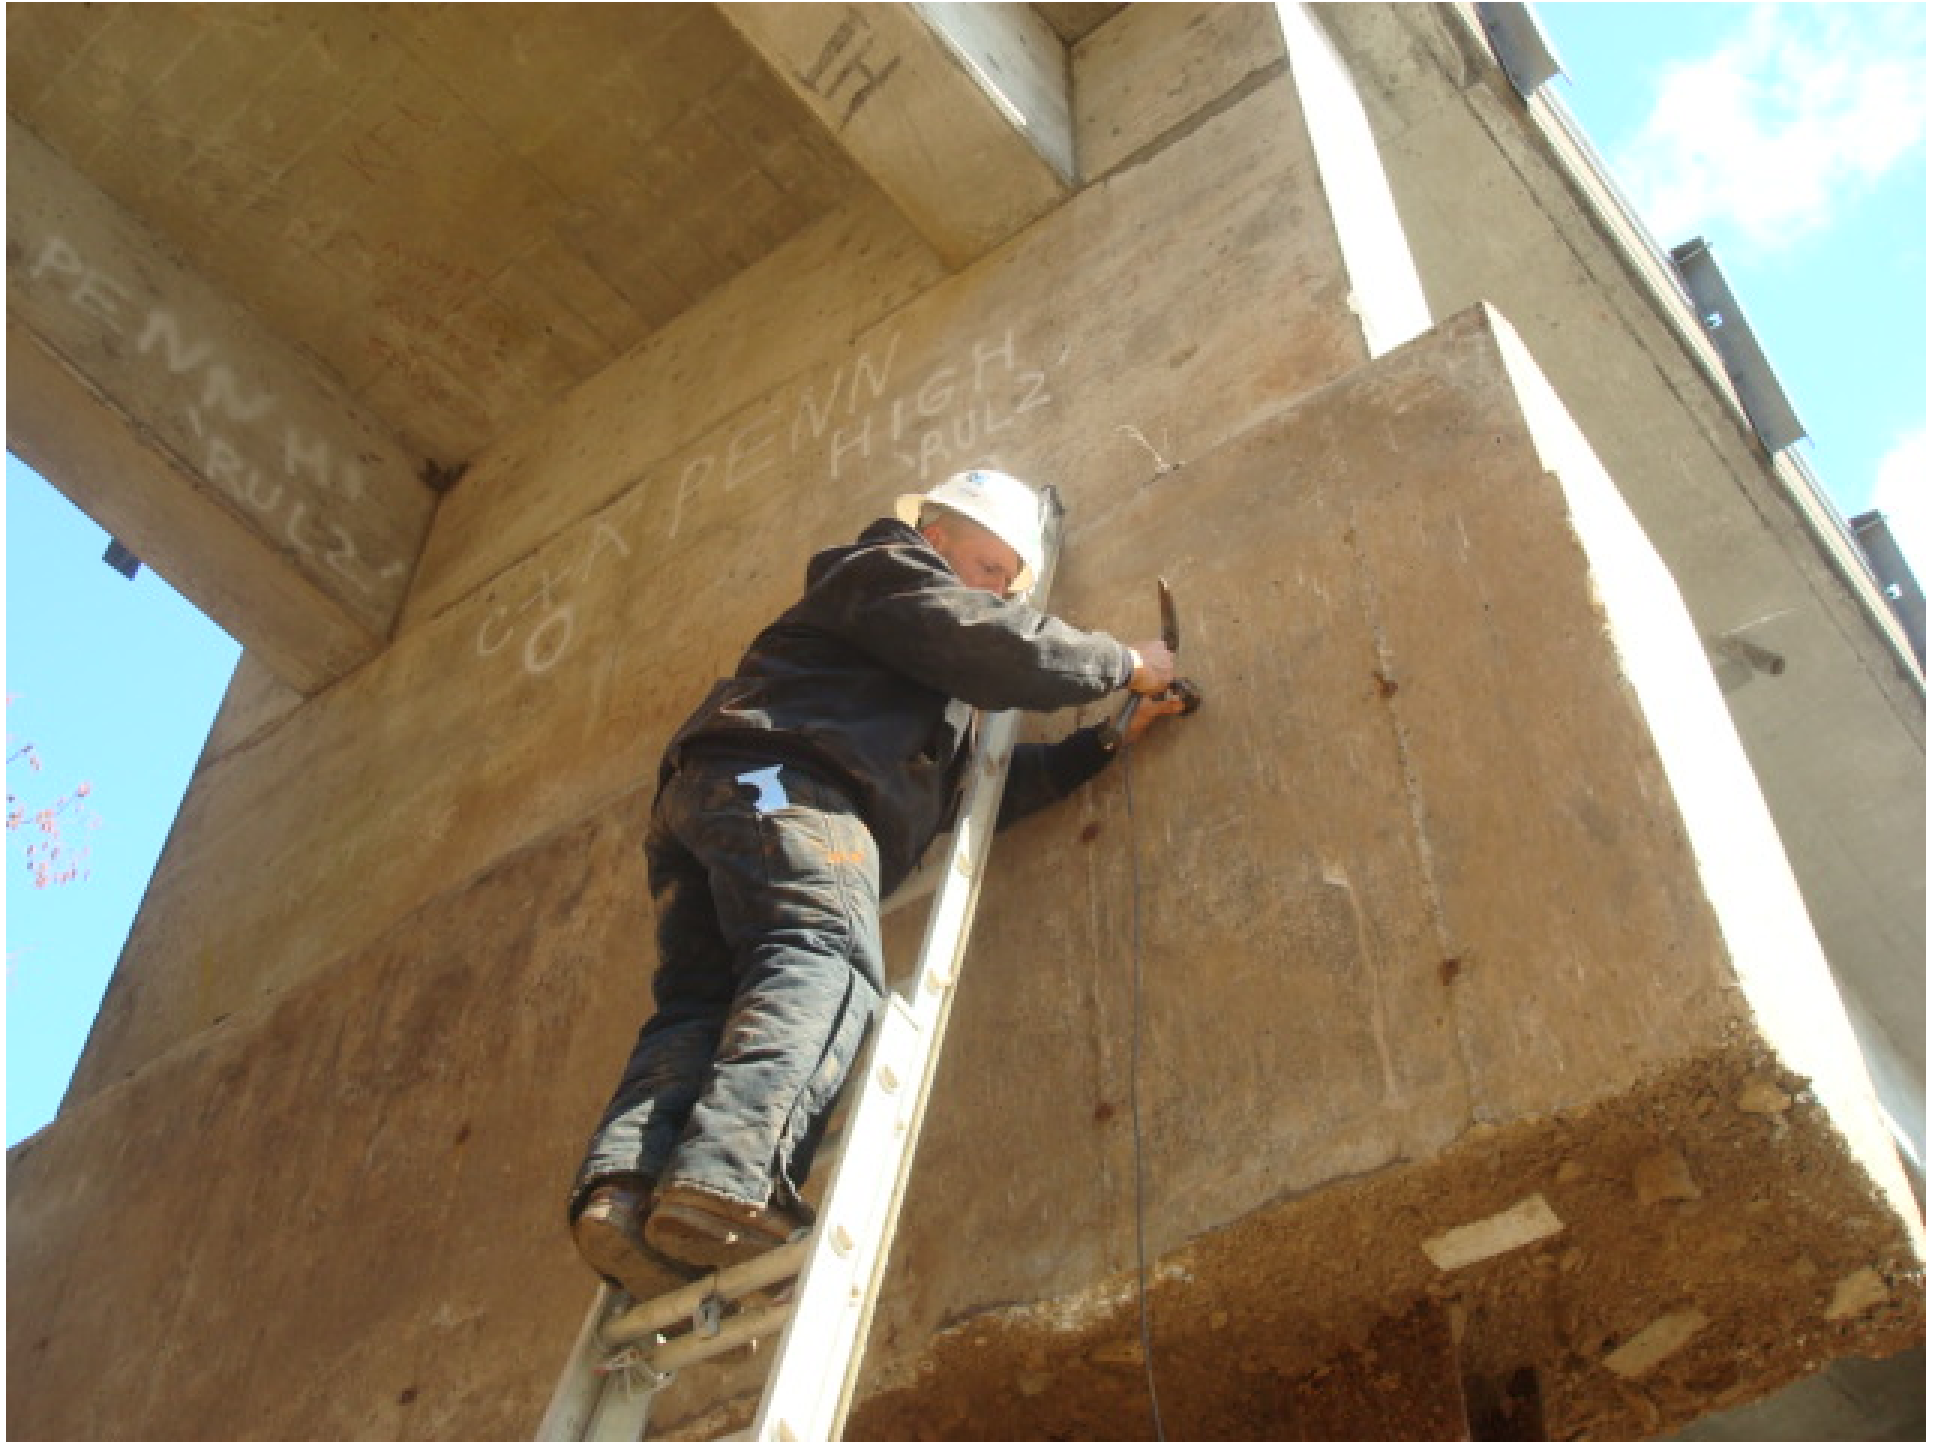
Gather as-built dimensions and perform non-destructive testing to determine the location of steel components embedded in concrete.
