Advanced Technology in the Decision Making Process for Major Bridge Repairs

David R. Reser, P.E. Project Manager

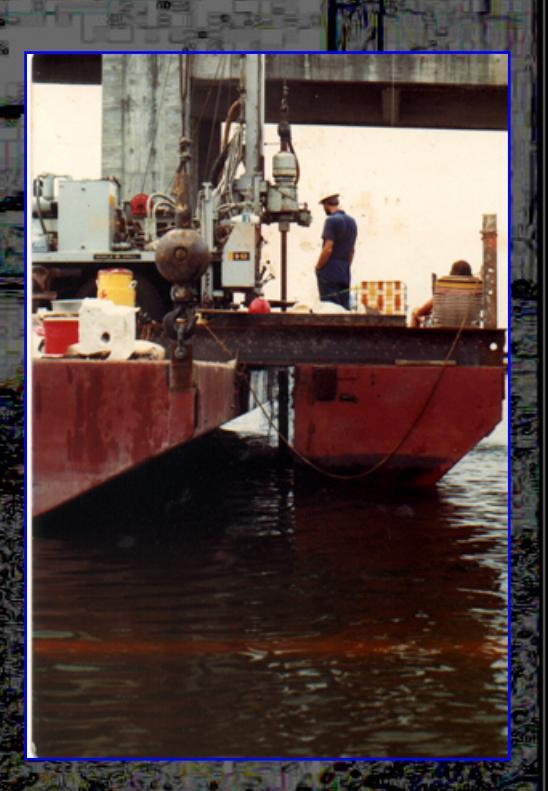
VISUAL INSPECTION RESULTS •All seals have seams of soft concrete with isolated areas of bare aggregate. Several vertical and horizontal cracks were bisected by the core barrel. The interface of the footing and seal concrete is generally good. Highly weathered and fractured foundation rock at Pier 2.
