## **Oregon DOT's FRP Bridge Decks**

### By Steven Lovejoy

Department of Transportation

### ODOT has 3 Bascule Bridges with FRP Decks

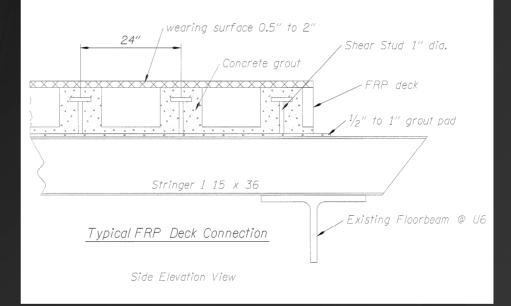
- The approved detail used shear studs welded to the stringers which were then encased in concrete grout
- Stringers spaced at 2'-9"

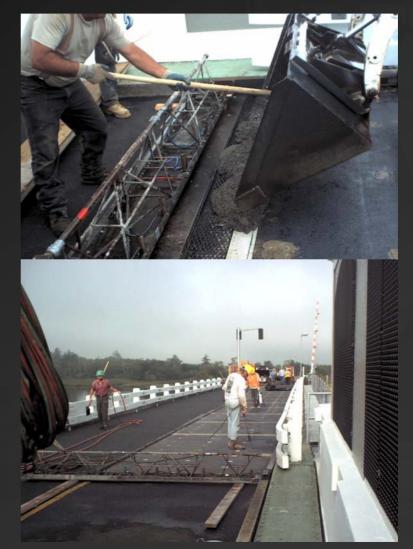
- An epoxy concrete was selected as the lowest risk system given the limited testing program
- A 2 inch thick wear surface was then installed
- 77,000 lbs of counter weight had to be added

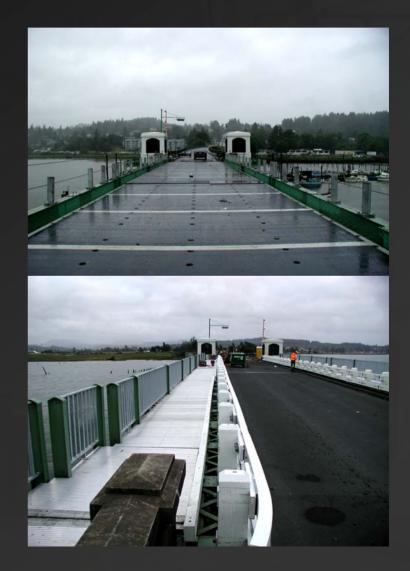
- Same deck to flooring system connection was used
- Geometry only required a <sup>1</sup>/<sub>2</sub>" thick wearing surface
- 30,000 lbs of ballast was required for each counterweight
