Arizona Department of Transportation

Emergency Rehabilitation of I-10 Mescal Road TI UP

Navaphan Viboolmate, PE
ADOT Bridge Group Design Section Leader

I-10 Mescal Road TI UP MP 297.17

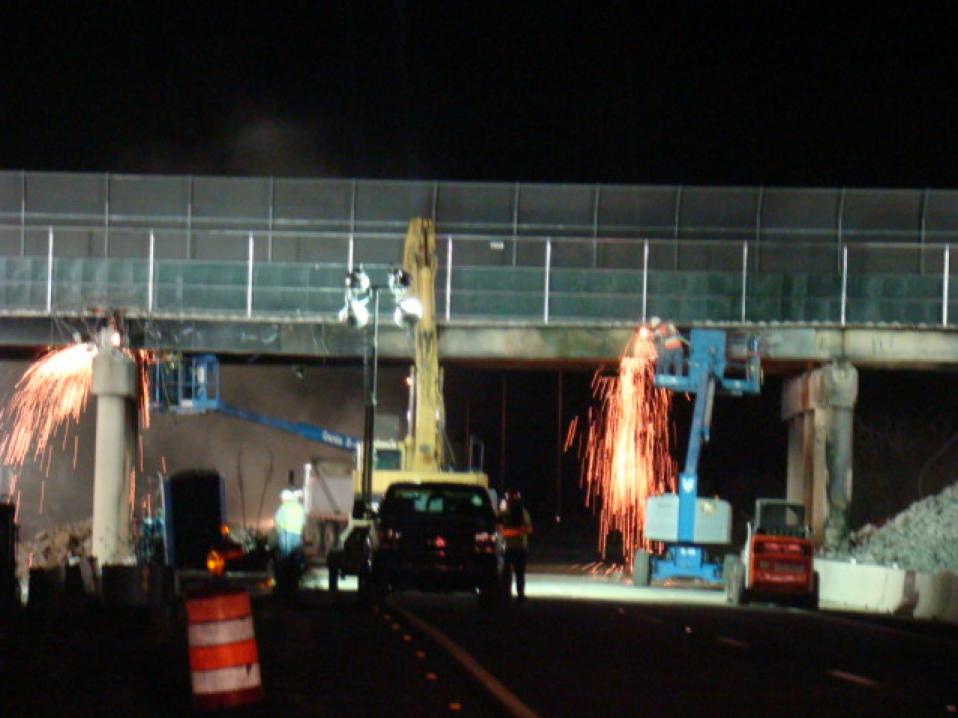
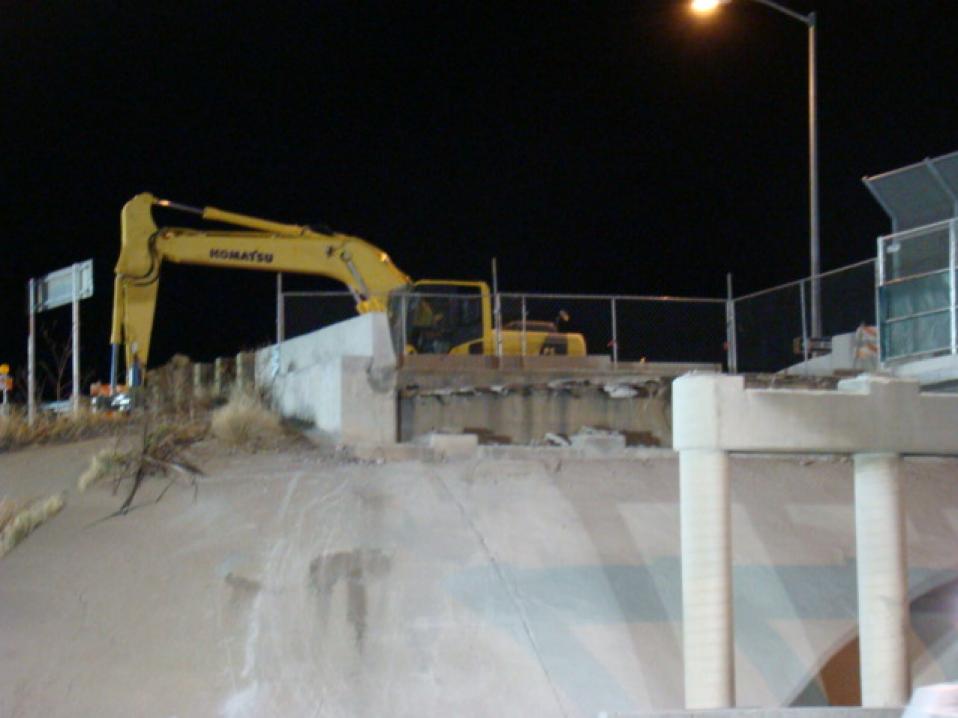
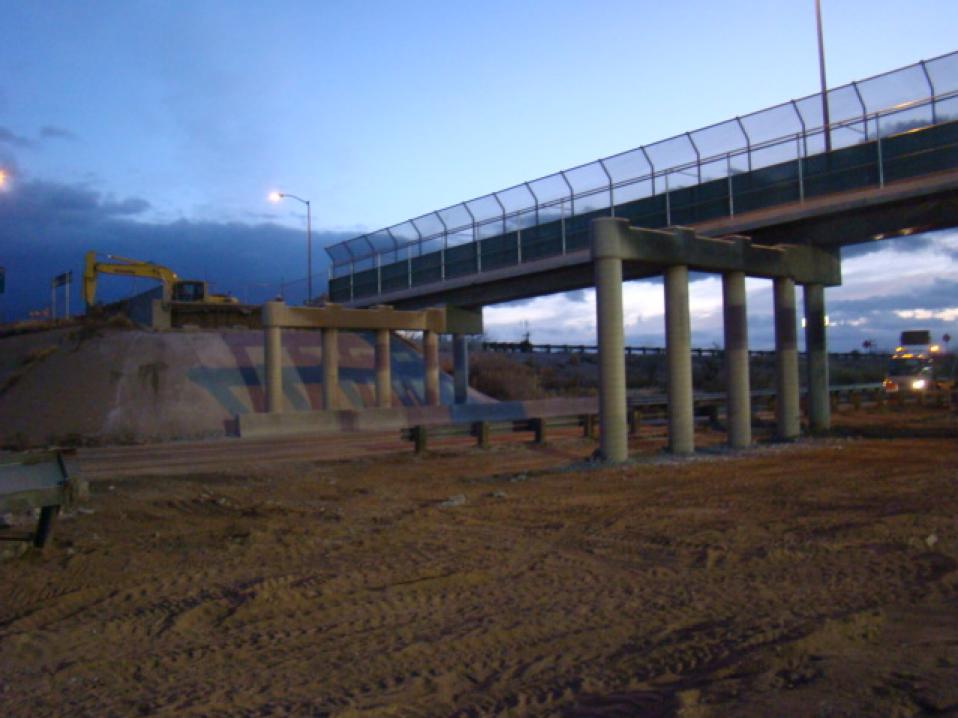
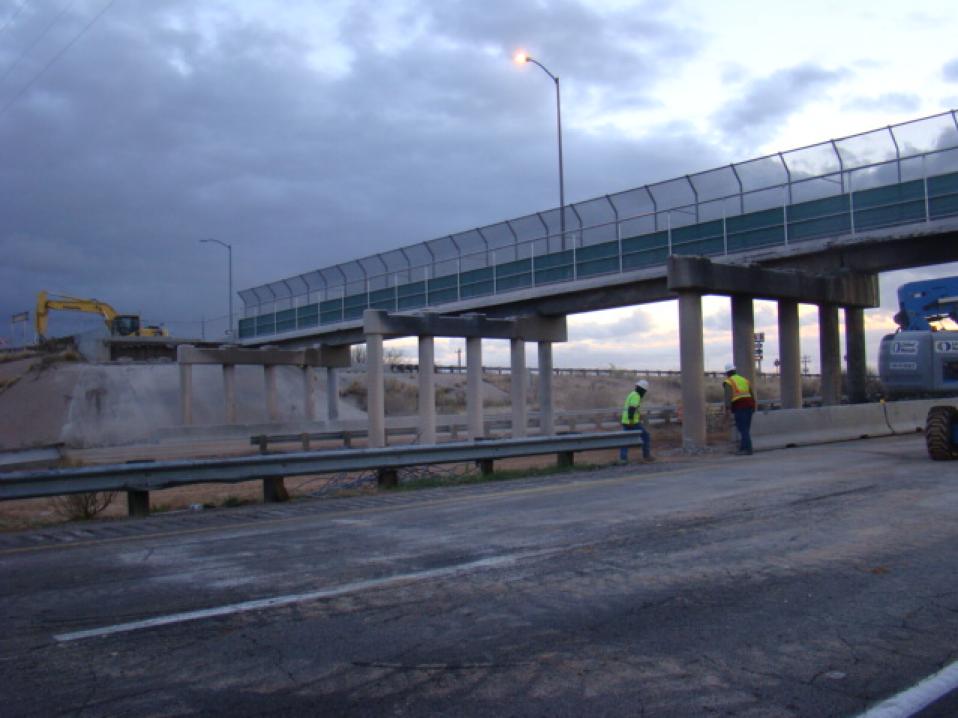
Friday April 8, 2011 (24 days after the incident)

- Install Temporary Concrete Barrier around the area
- Install Pedestrian Fence
- Set up a detour for locals
- Deck demolition
- Remove steel girders
- Remove south pier cap and columns
