The Feather River

A Case Study in Scour Analysis, Real-time Monitoring and Field Measurements of Active Scour

Western Bridge Engineers' Seminar
Phoenix, AZ
September 28, 2011

Br. No. 18-0009

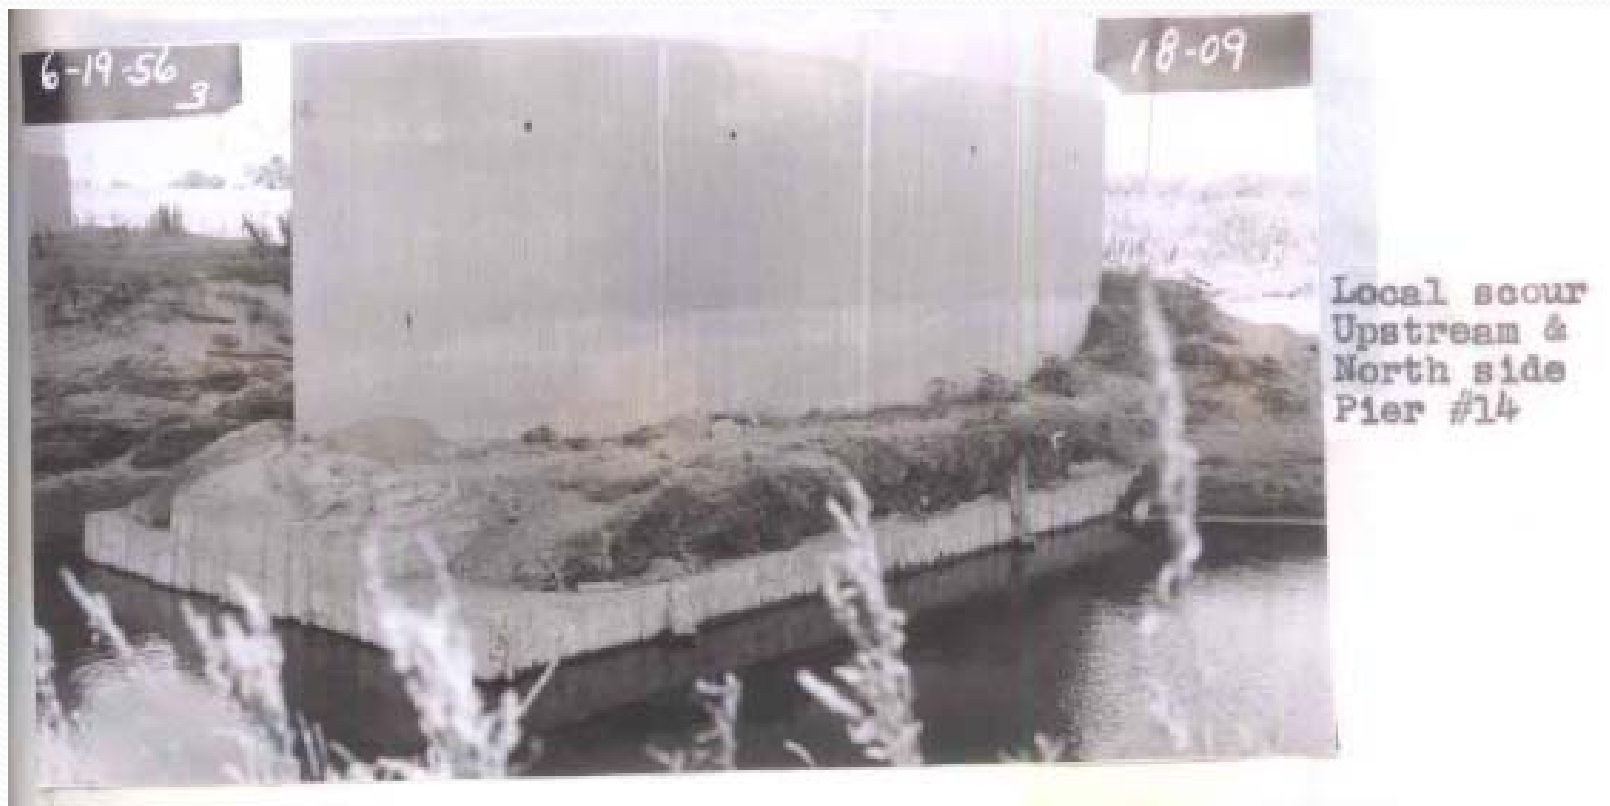
1955 Flood Damage in the Overbank

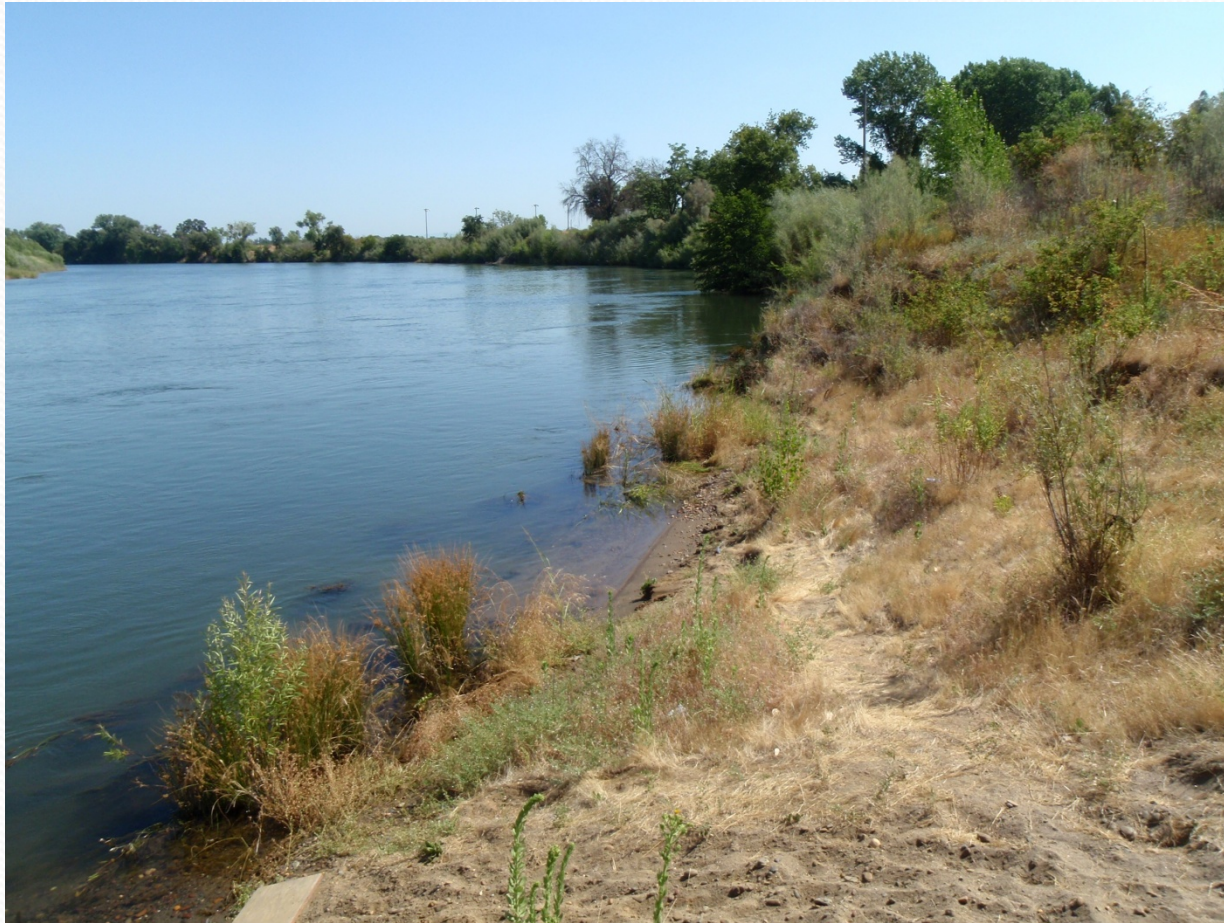
Bank Erosion Concern

Bank erosion between 1998 and 2009

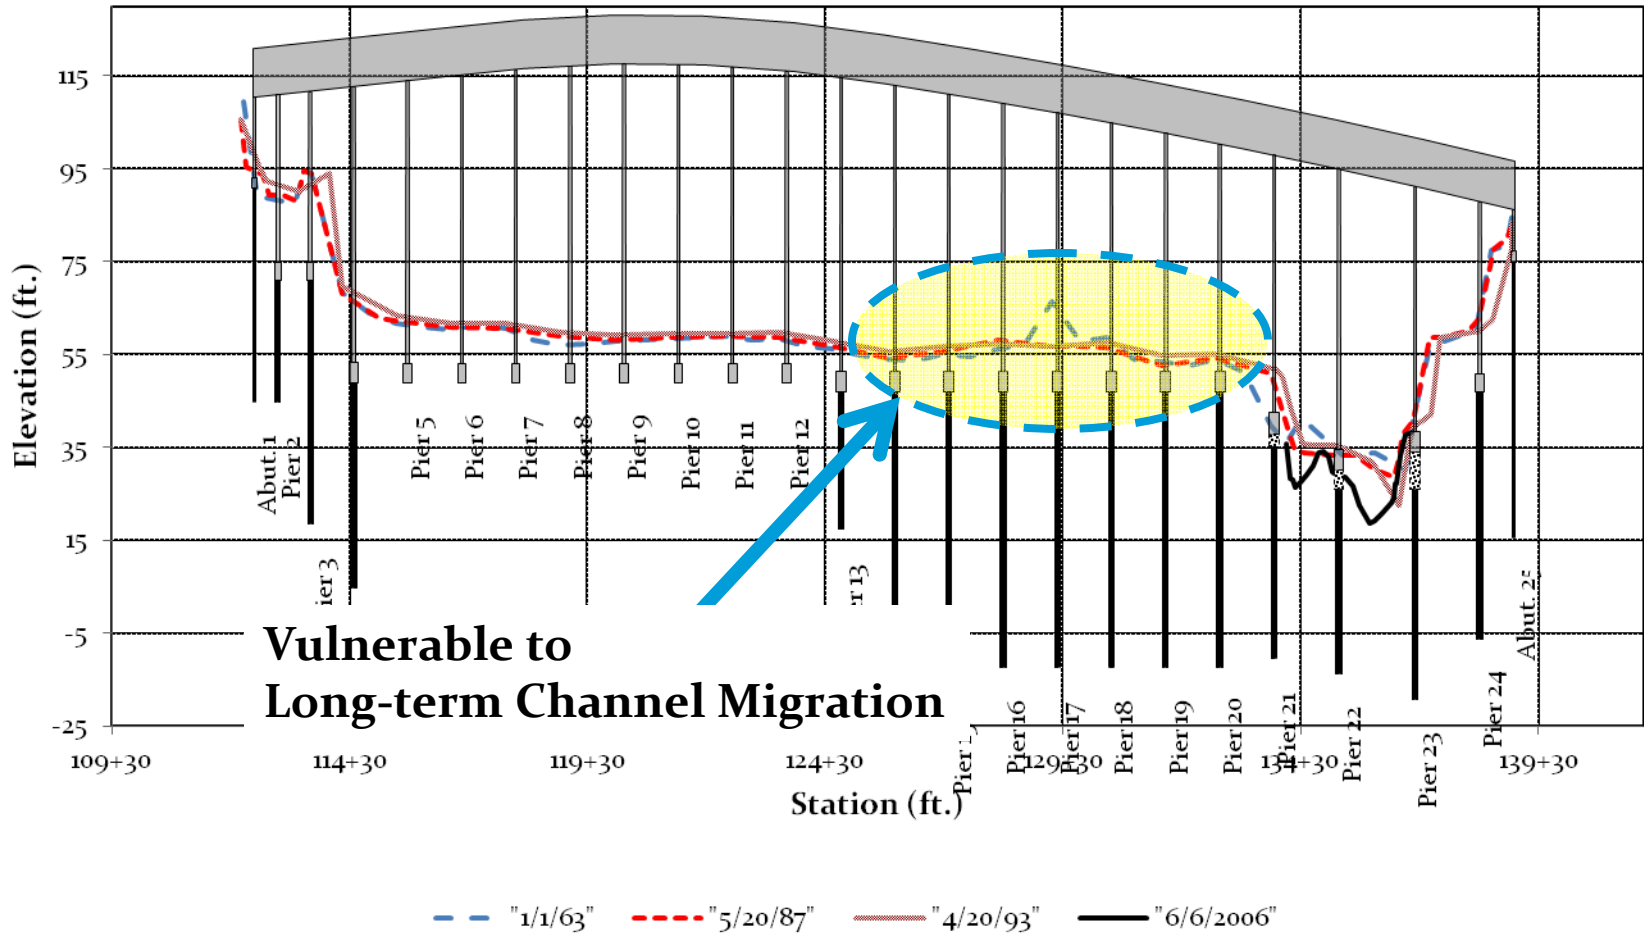
Bridge ID: 18-0009

Cross-sections show the river has deepened about 14 ft in the main channel , but been laterally stable

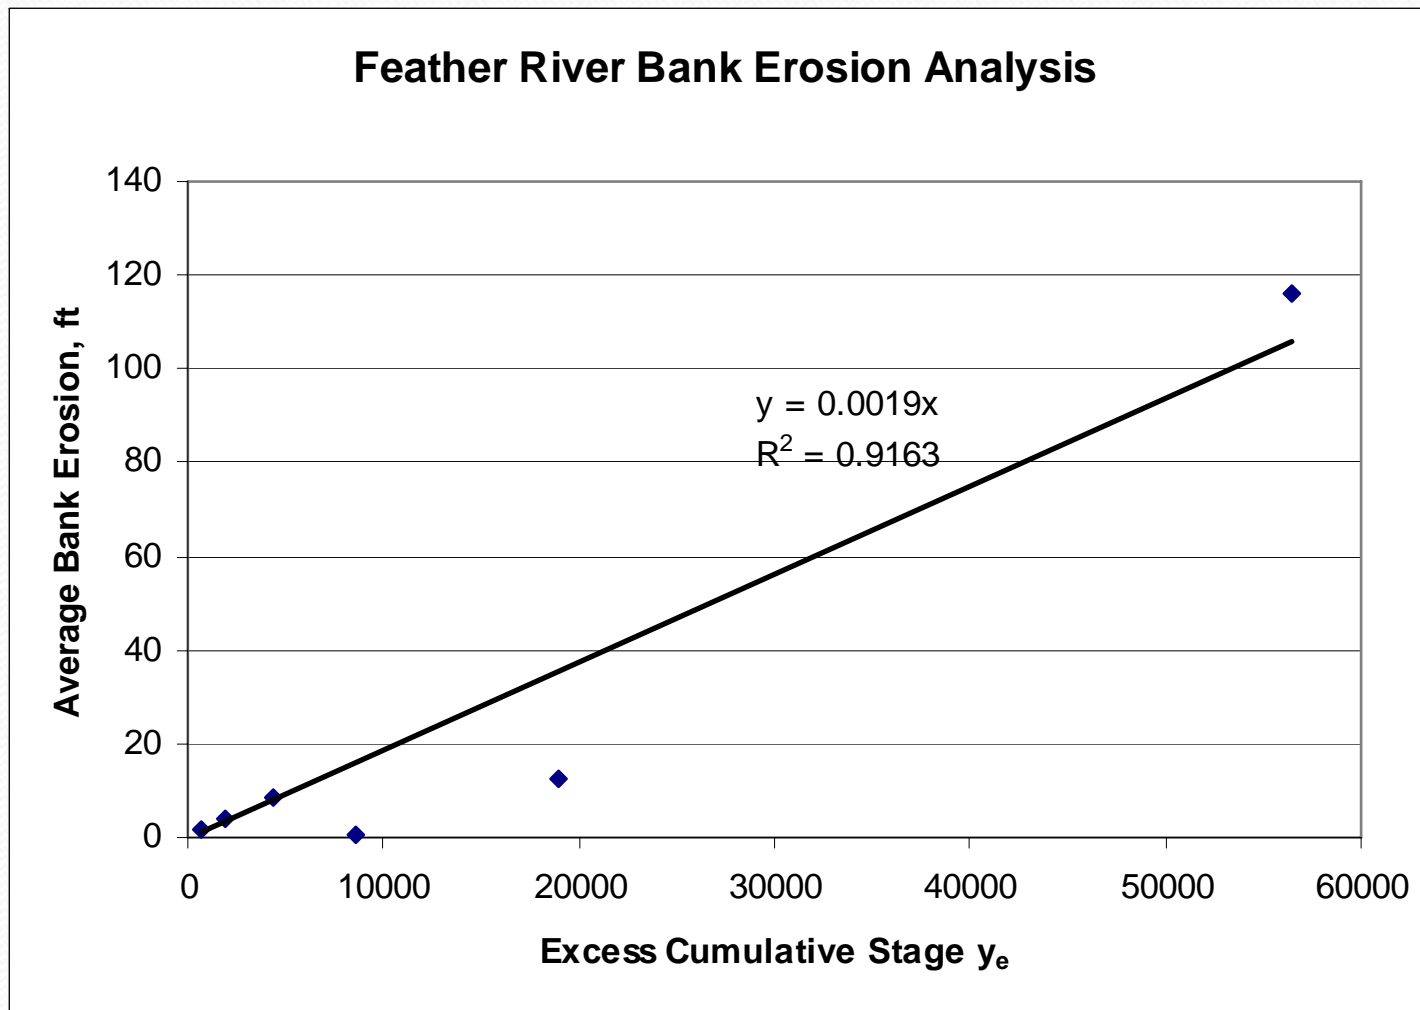
Cumulative Stage – Erosion Rate Relationship

1. A series of flows similar to those between 1993 – 1998 could reach Piers 19-21
2. Local erosion rates could be even greater
3. Long-term Piers 16-21 are also vulnerable (possibly more)

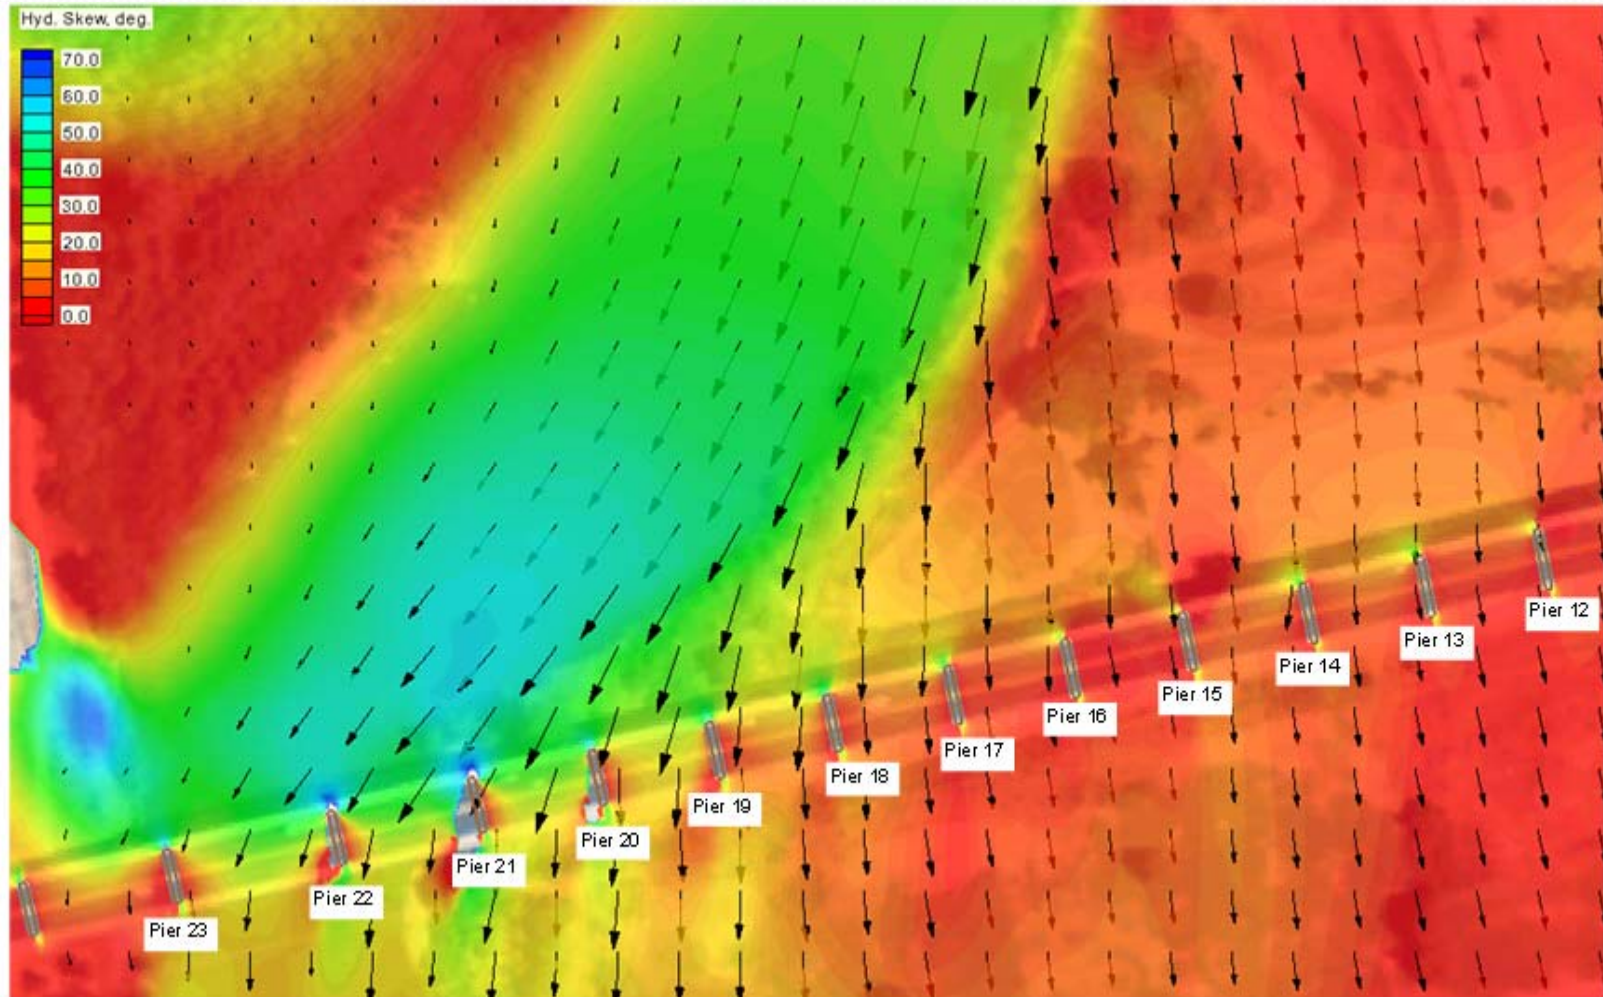
Shear Stress along the East Bank

→ Stress at the bank will exceed τ_{cr} and easily erode the bank

- Continue with Riprap Project for main channel piers
- Meet with outside agencies (City, County, USACE) to discuss interest in protecting the east bank
- Develop either a river training project or substructure retrofit or replacement project depending on cost/benefit analysis

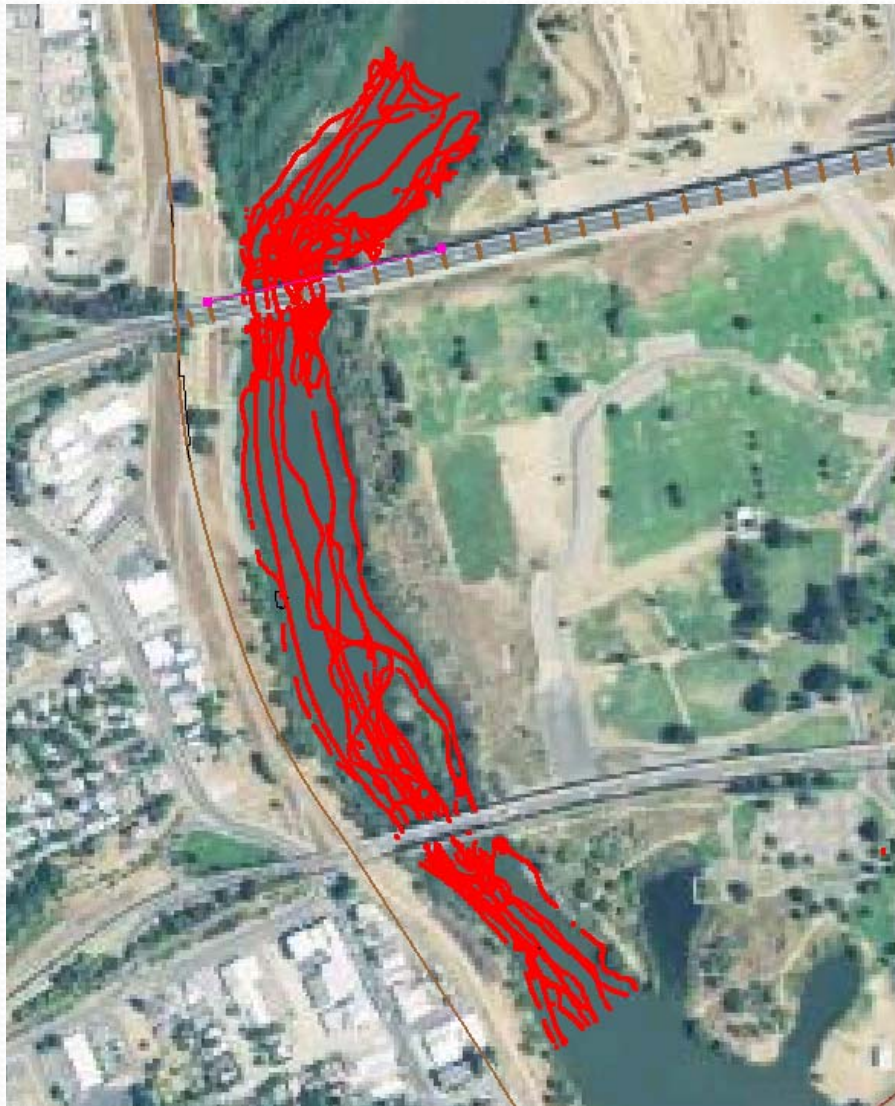
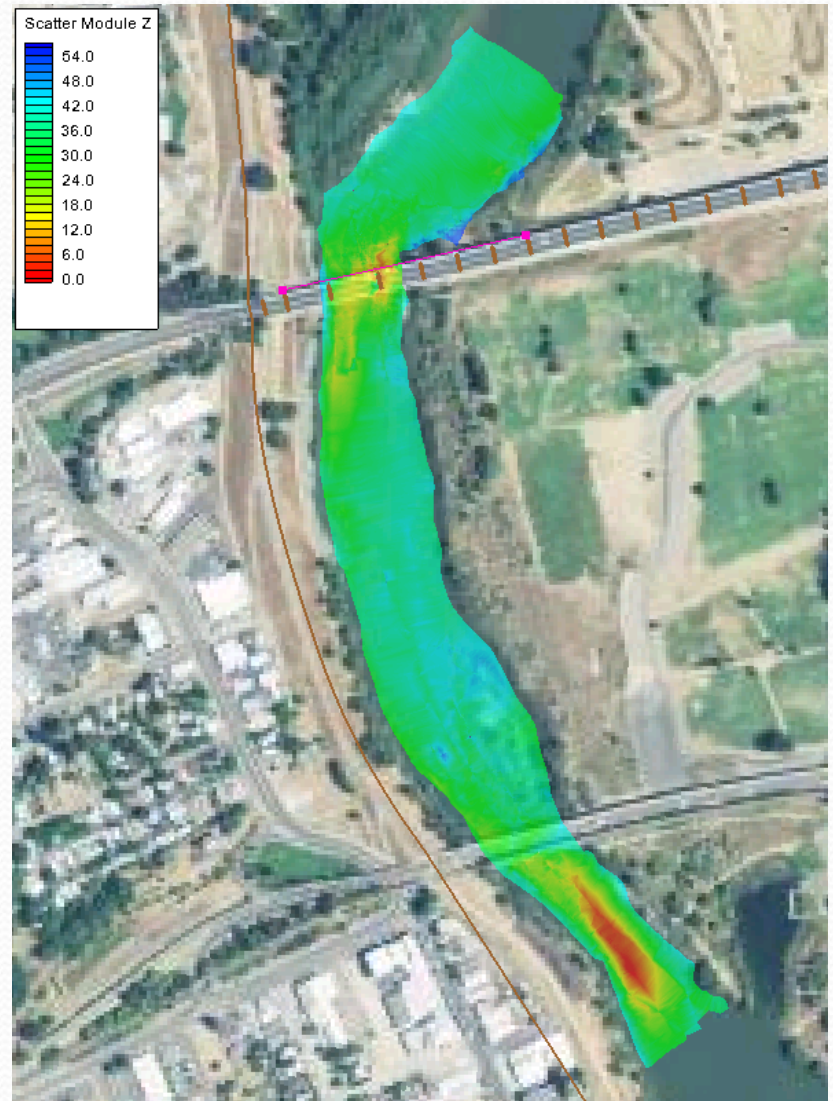
Survey on March 28, 2011

- Current Scour was approximately 5 feet above predicted 100-year Scour Elevation
- Pile Capacity was reduced to an unacceptable safety factor
- Structural Analysis indicated that the piles may be overstressed in compression at their maximum exposure length
- Recommendations:
 1. Multi-beam Sonar Survey
 2. Immediate Bridge Monitoring

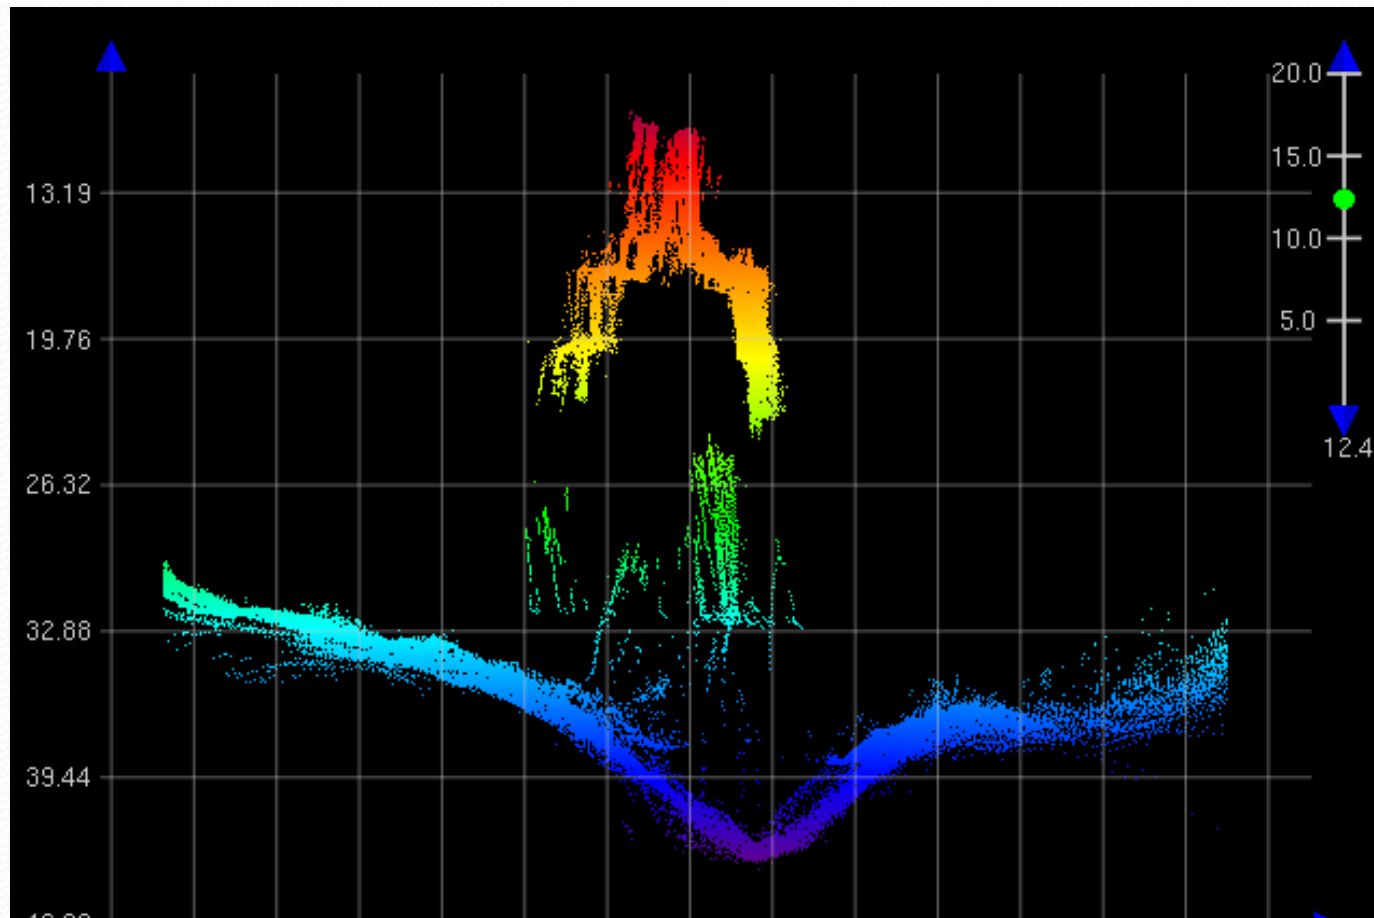
Upstream Section

- Survey confirmed 30 feet of scour present at upstream side of the pier
- Less scour at the downstream, west side which explained by structure was not showing signs of distress
- Monitoring and Mitigation was still justified

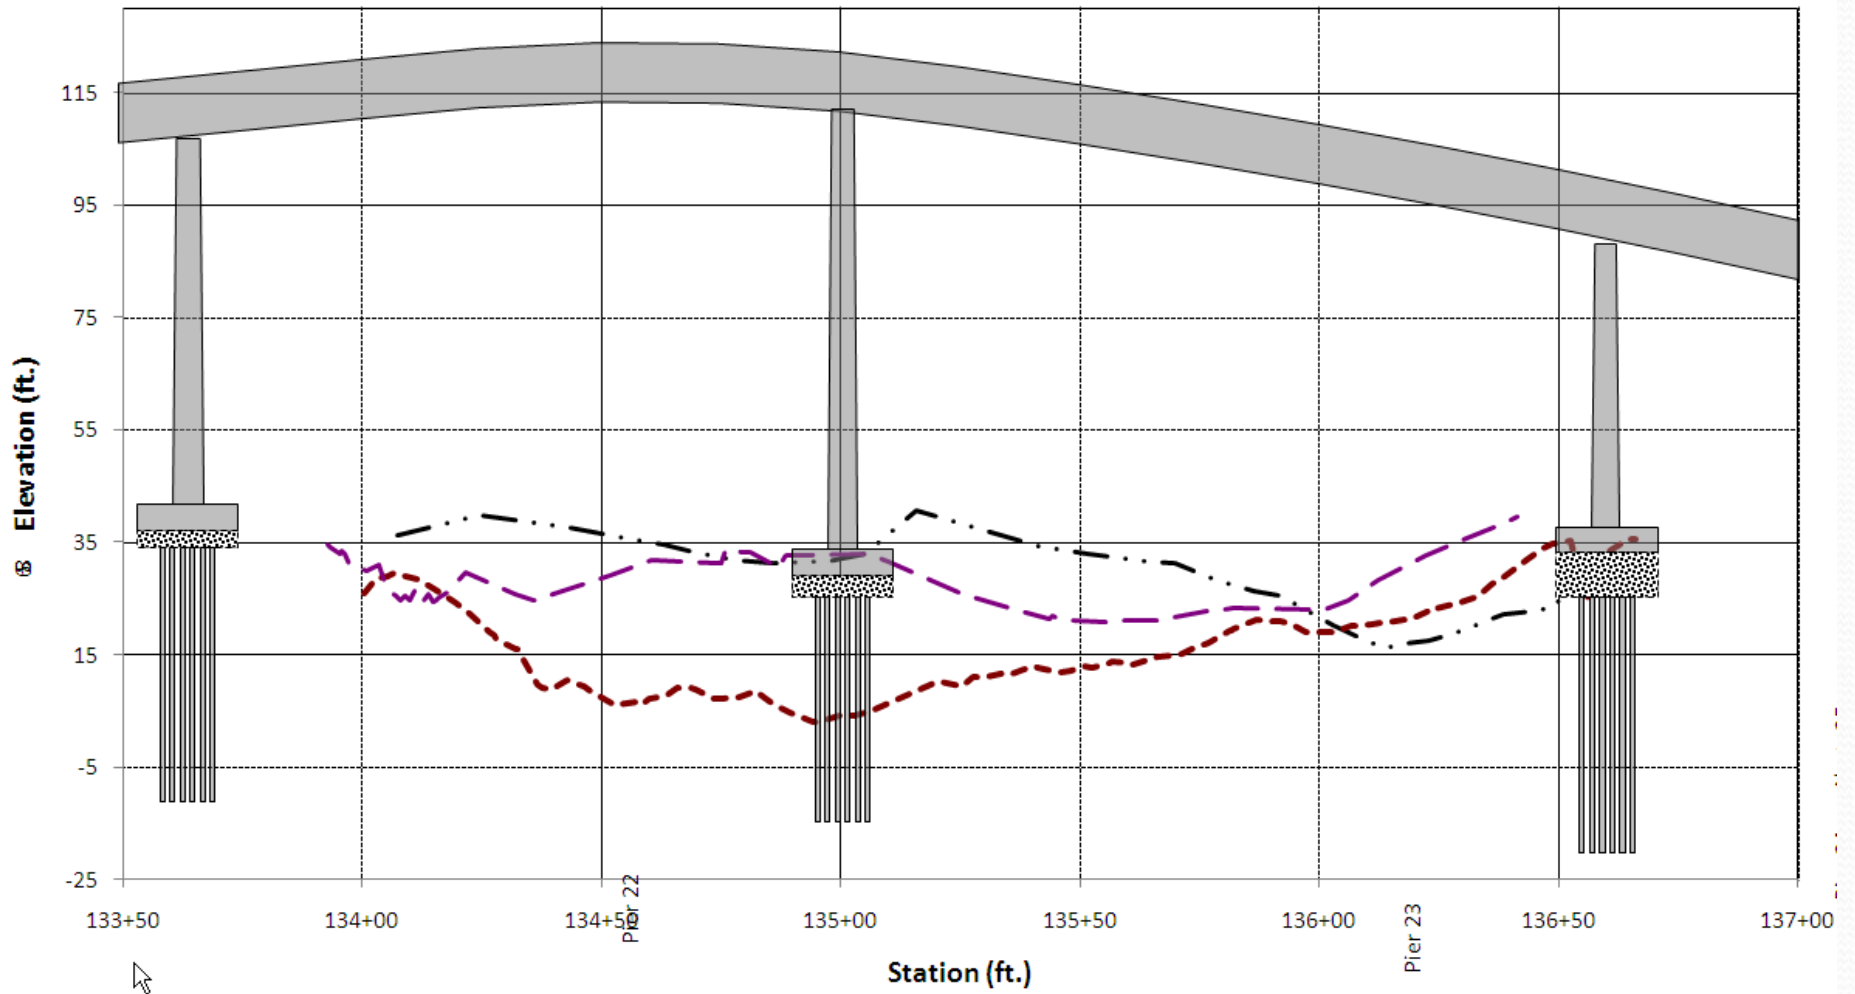
Bridge ID: 18-0009

May 28, 2011 Re-Survey
