2012 Hagwilget Suspension Bridge Refurbishment

New Hazelton, BC, Canada

By: Jeff Mellor, M. Eng

Refurbishment Works Summary

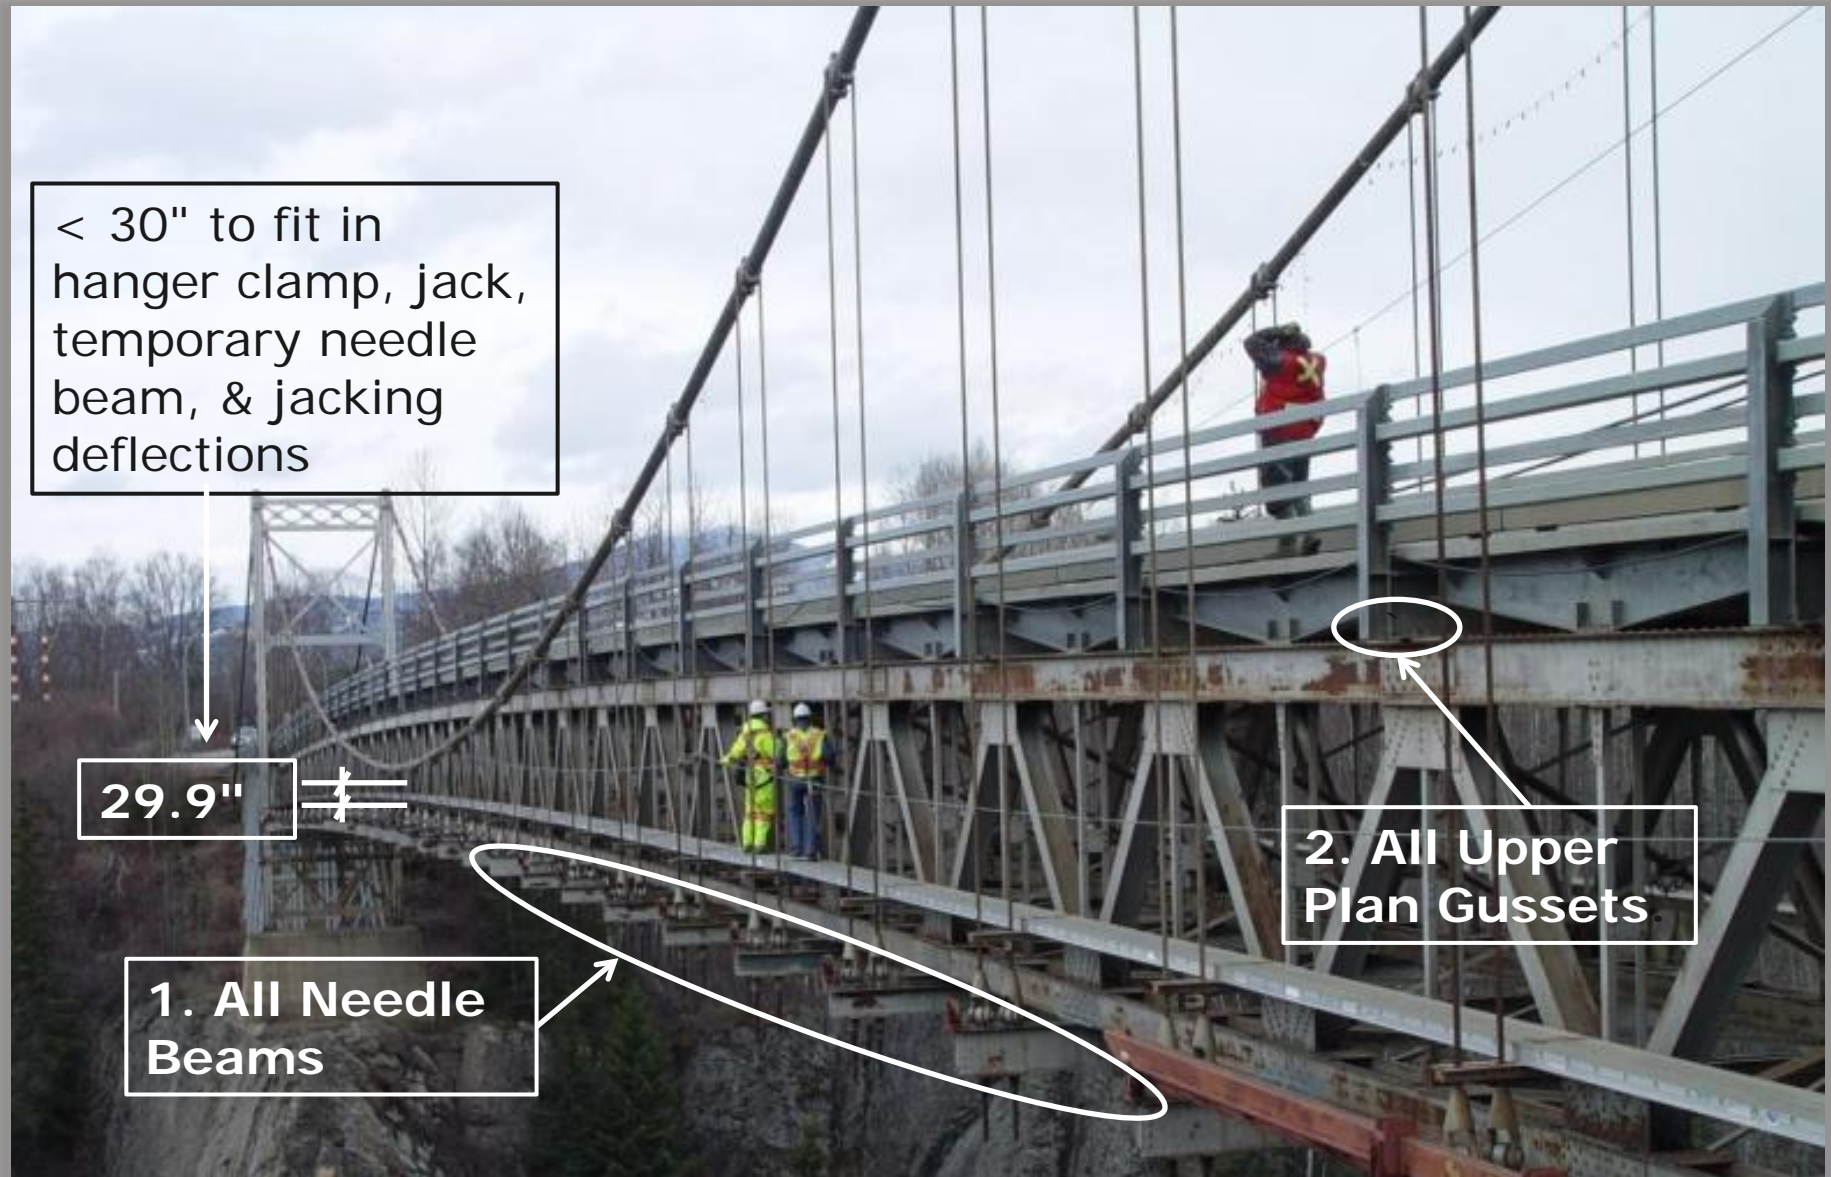
Needle Beams & Upper Gussets

- Significant section loss to flanges.
- Significant web section loss with through holes.
- D/C estimated 1.15-1.39 in worst areas.

- **Works Done with Live Traffic:**
 - Replace all 31 Needle Beams supporting truss.
 - Unwrap, wedge, inspect and re-wrap Main Cable at (10) locations.
- **Works Done with 15 Minute Closures:**
 - Replace all Upper Plan Gussets.
- **Two Night Closures Used:**
 - Remove & replace (6) hangers to check capacity by destructive testing.
- **Other Works:**
 - Replace all sway bracing.
 - Replace all upper plan bracing.
 - Replace cap beams at Bents 8, 9

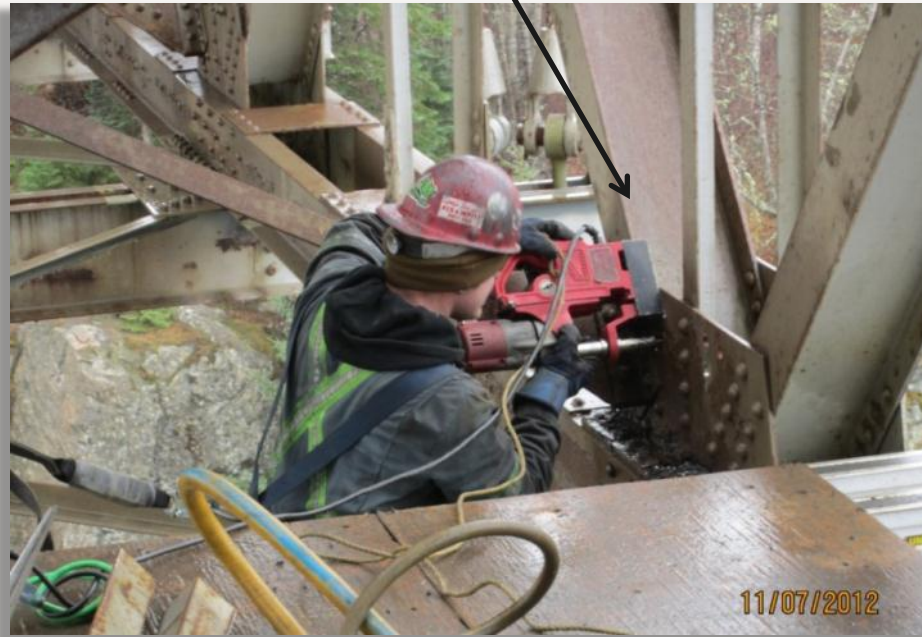
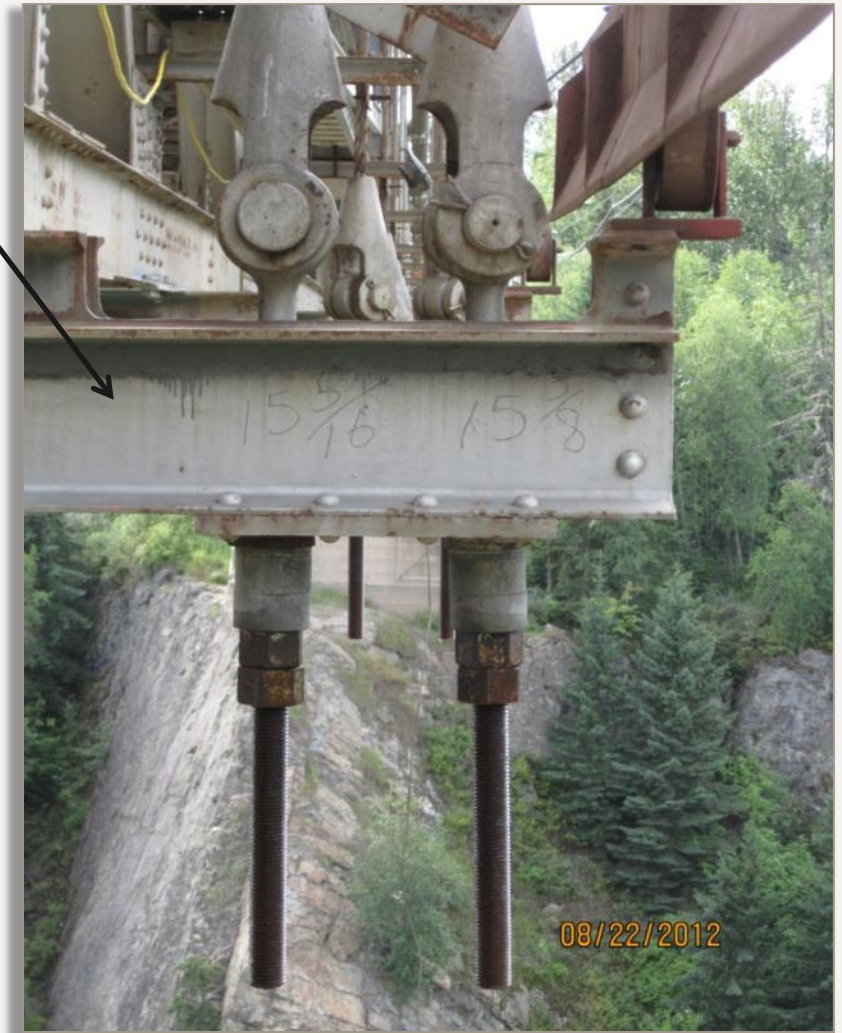
Needle Beams: Preliminary Works

- Measuring eyerod extension.
- Drilling vertical gussets for temporary needle beam connection.

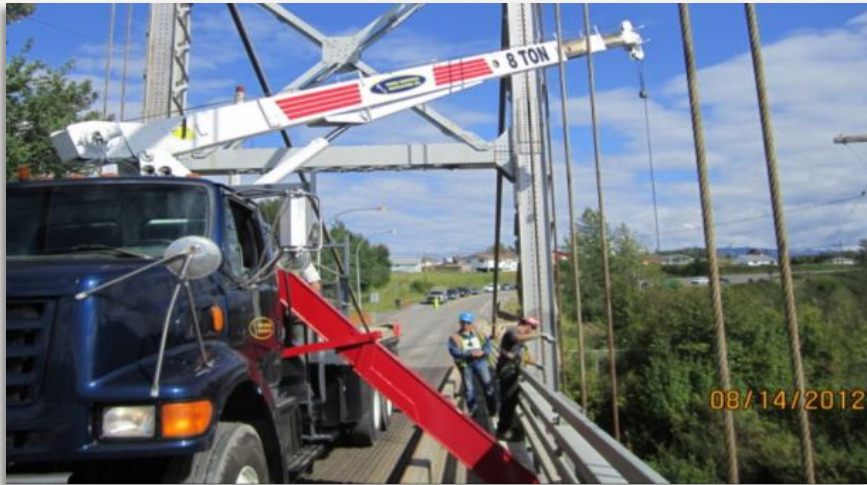
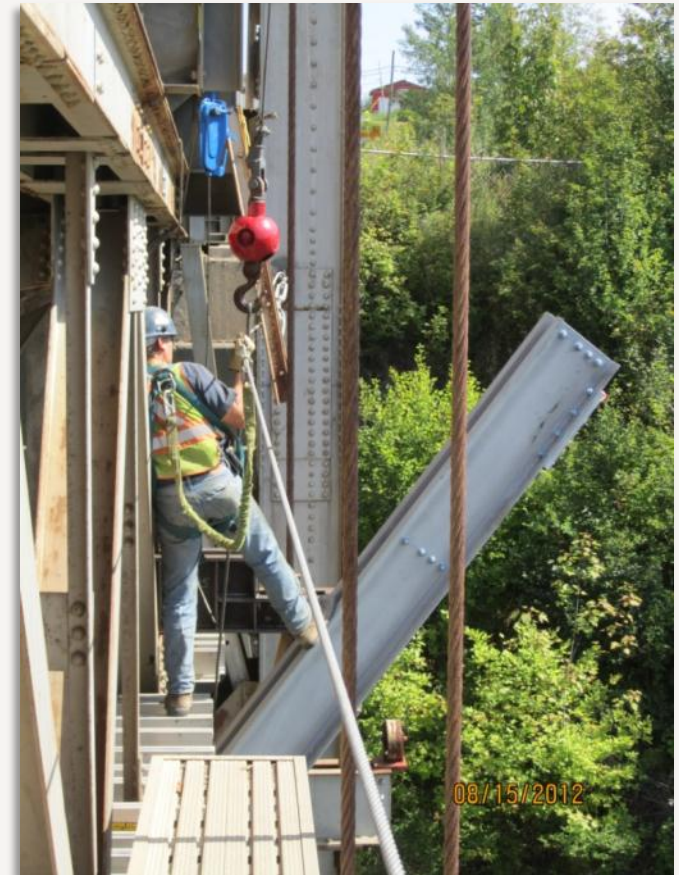
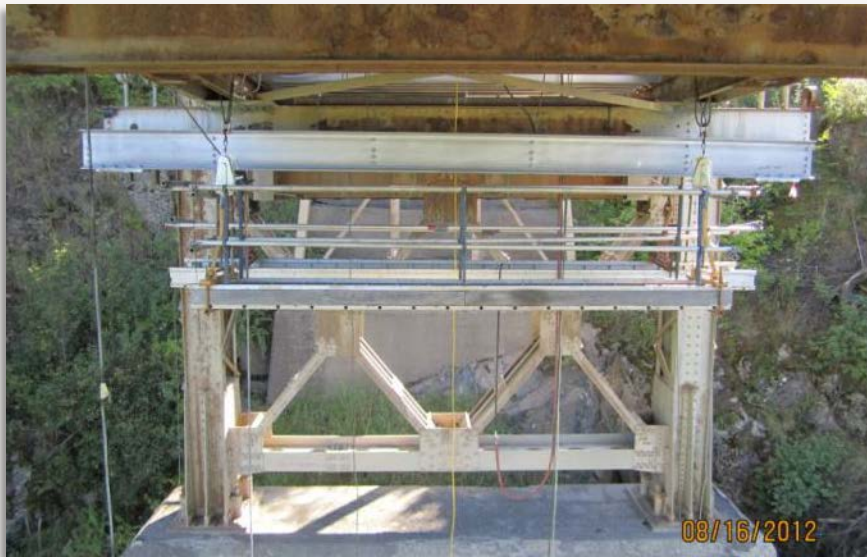
Lowering New Needle Beams Over the Side

- Bearing bar chamfered to clear spelters.
- Spelters up in between the 7" temporary needle beams.
- Varying hanger skew eccentrically positions spelters to centerline of the temporary needle beam.
- Box diaphragms between temporary needle beams visible.

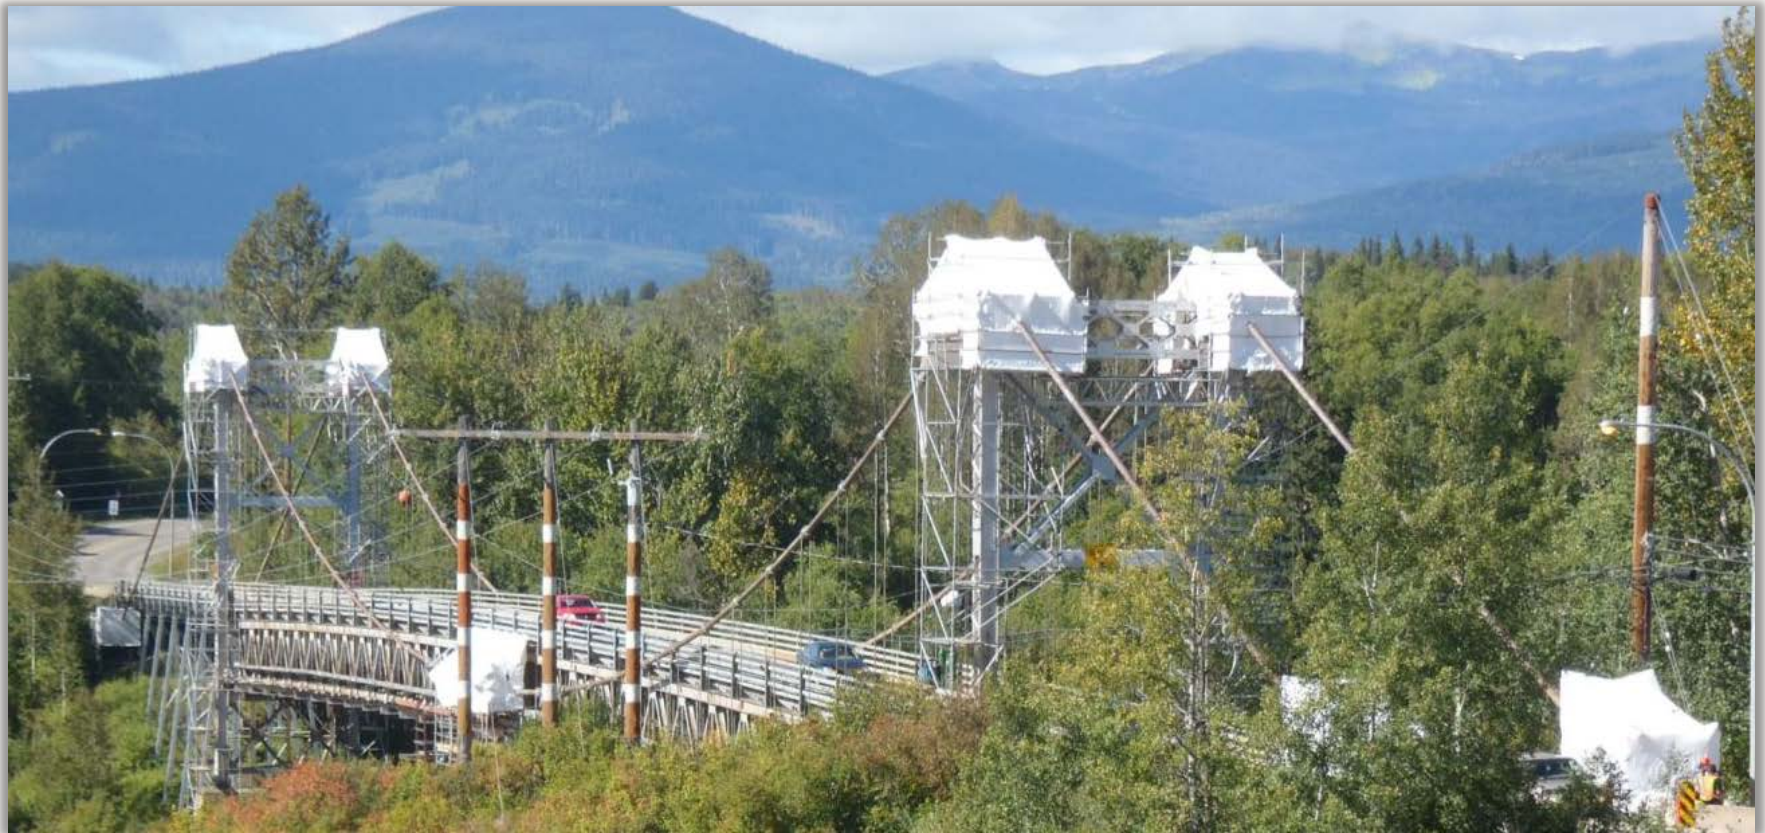
Main Cable Enclosures

- 130' inspected out of 1540' of main cable
 - 4 Anchorages
 - 4 Tower Saddles
 - 2 Midspan

- Un-galvanized 19 x 1-1/2" wire rope.
- Packed in raw linseed oil & graphite.
- Generally, minimal corrosion & pitting.
- Tower saddles showed most severe loss.

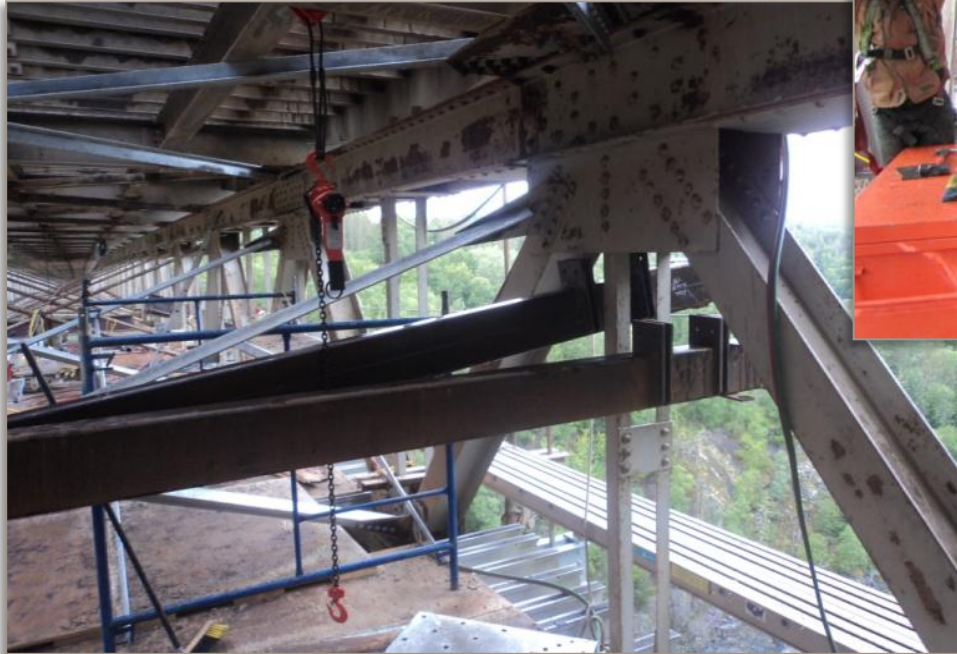
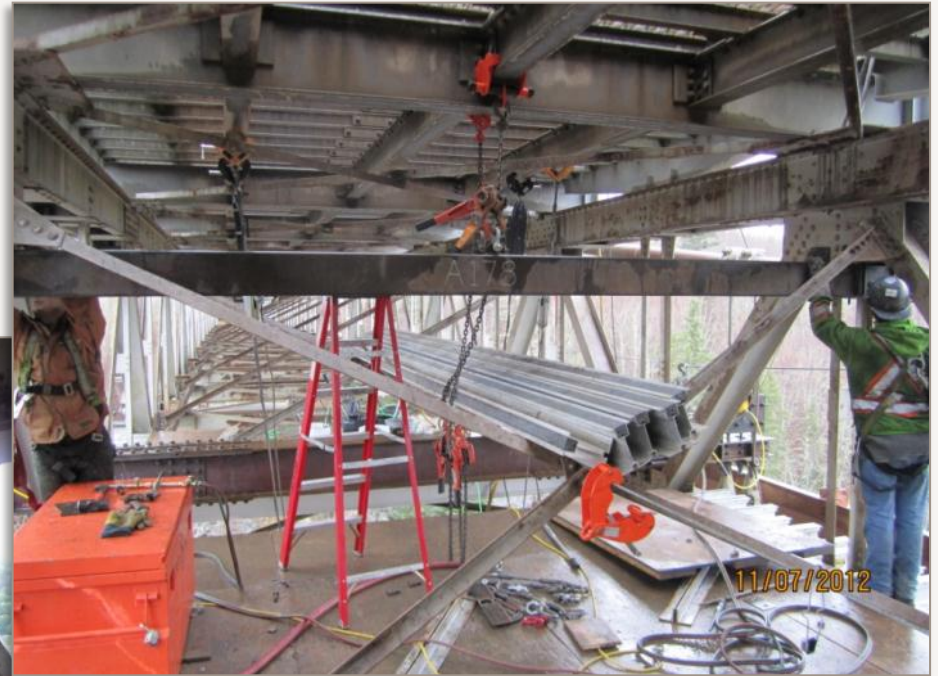
Upper Gusset Jacking Beam Installation

- Paired 8" x 4" HSS sections.
- Connected to new holes in the upper vertical gussets.

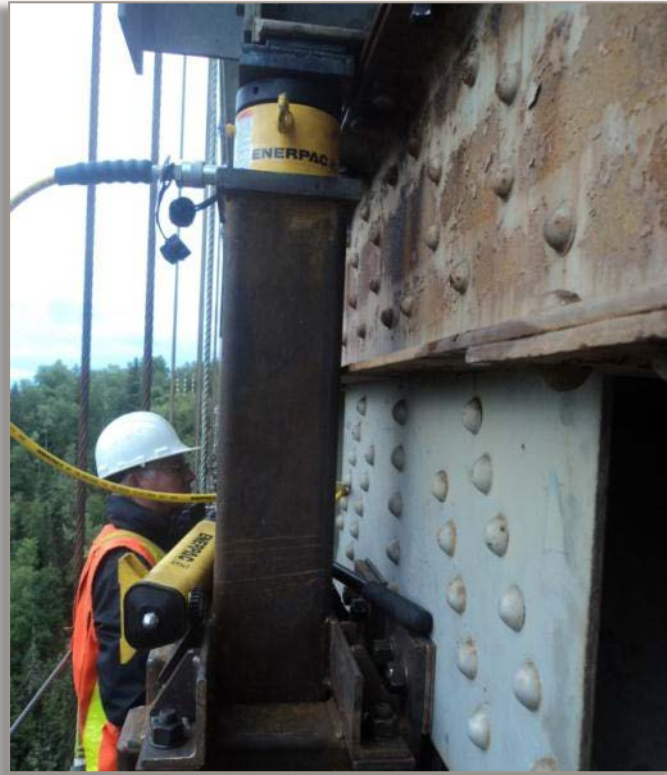
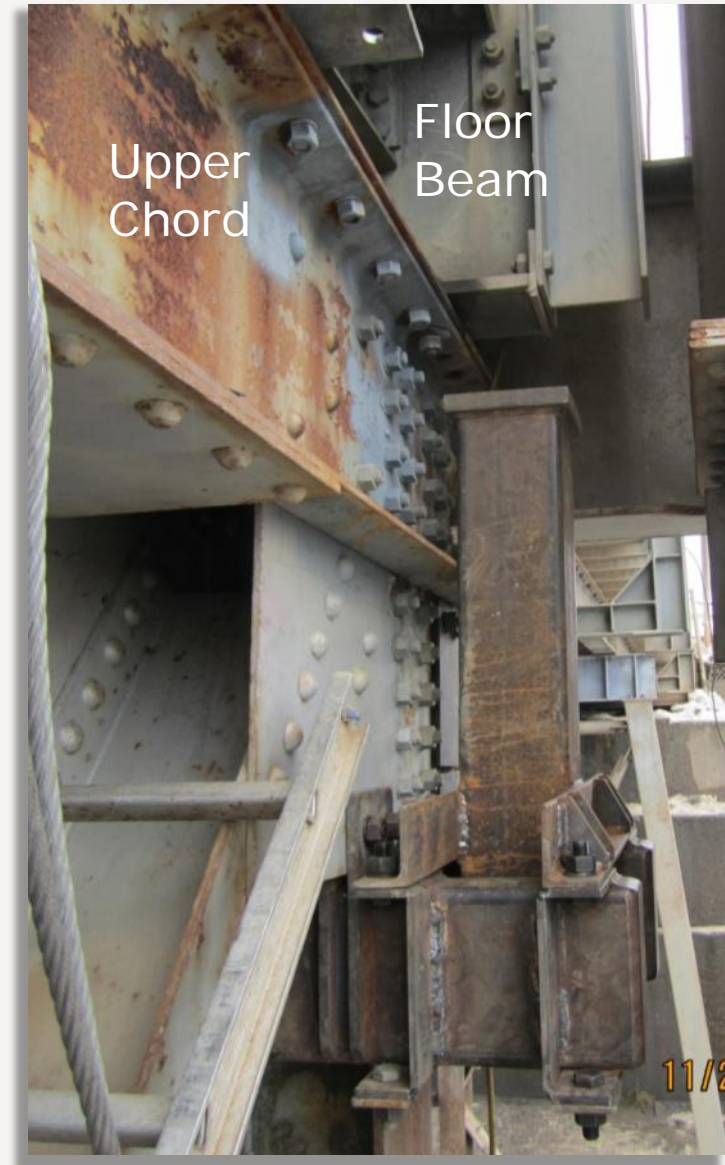
Jacking Post in Position

- Single jacking post fabricated for use on both truss lines.
- Jack raised end of floor beam $\frac{1}{4}$ " & elastically deflected the edge beams (stringers).
