# LAUREL STREET OVERCROSSING

## RETROFIT AND REHABILITATION

Western  
Bridge  
Engineers'  
Seminar

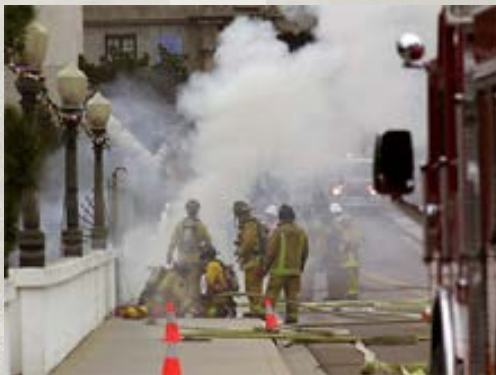
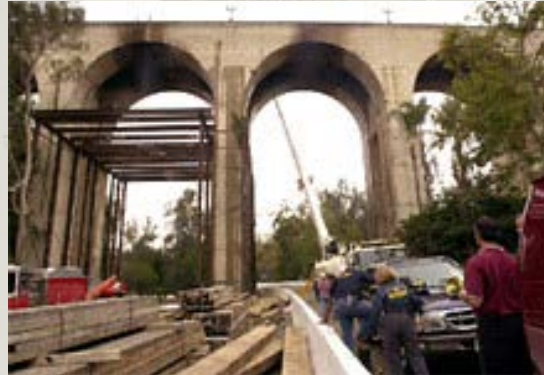
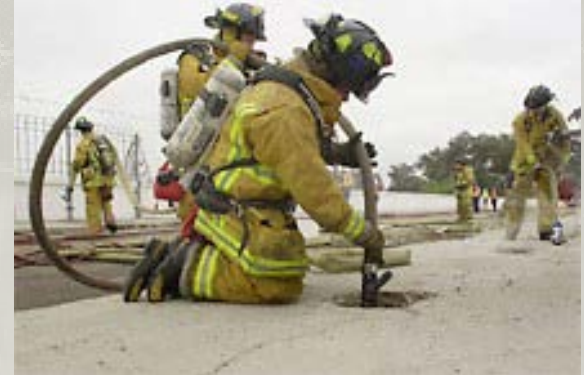
- 1) At 4:32 a.m., a caller reports a fire at the bridge. The fire appears to have started at the base of a column.
- 2) Fire spreads to the interior wooden structure.

- 3) Firefighters remove access-hole covers on the bridge sidewalks and pump in water and foam to douse the flames.
- 4) As the flames spread, crews drill holes in the sidewalk to pump in more water and foam.

The historic Cabrillo Bridge in Balboa Park caught fire early yesterday, burning inside its hollow structure. State Route 163 below the bridge and bridge access were closed while fire crews investigated and tackled the bridge's smoldering infrastructure. The fire was extinguished at 4 p.m.

- Wooden frame burned
- Original wood infrastructure
- Hollow interior
- Steel-reinforced concrete
- Access door

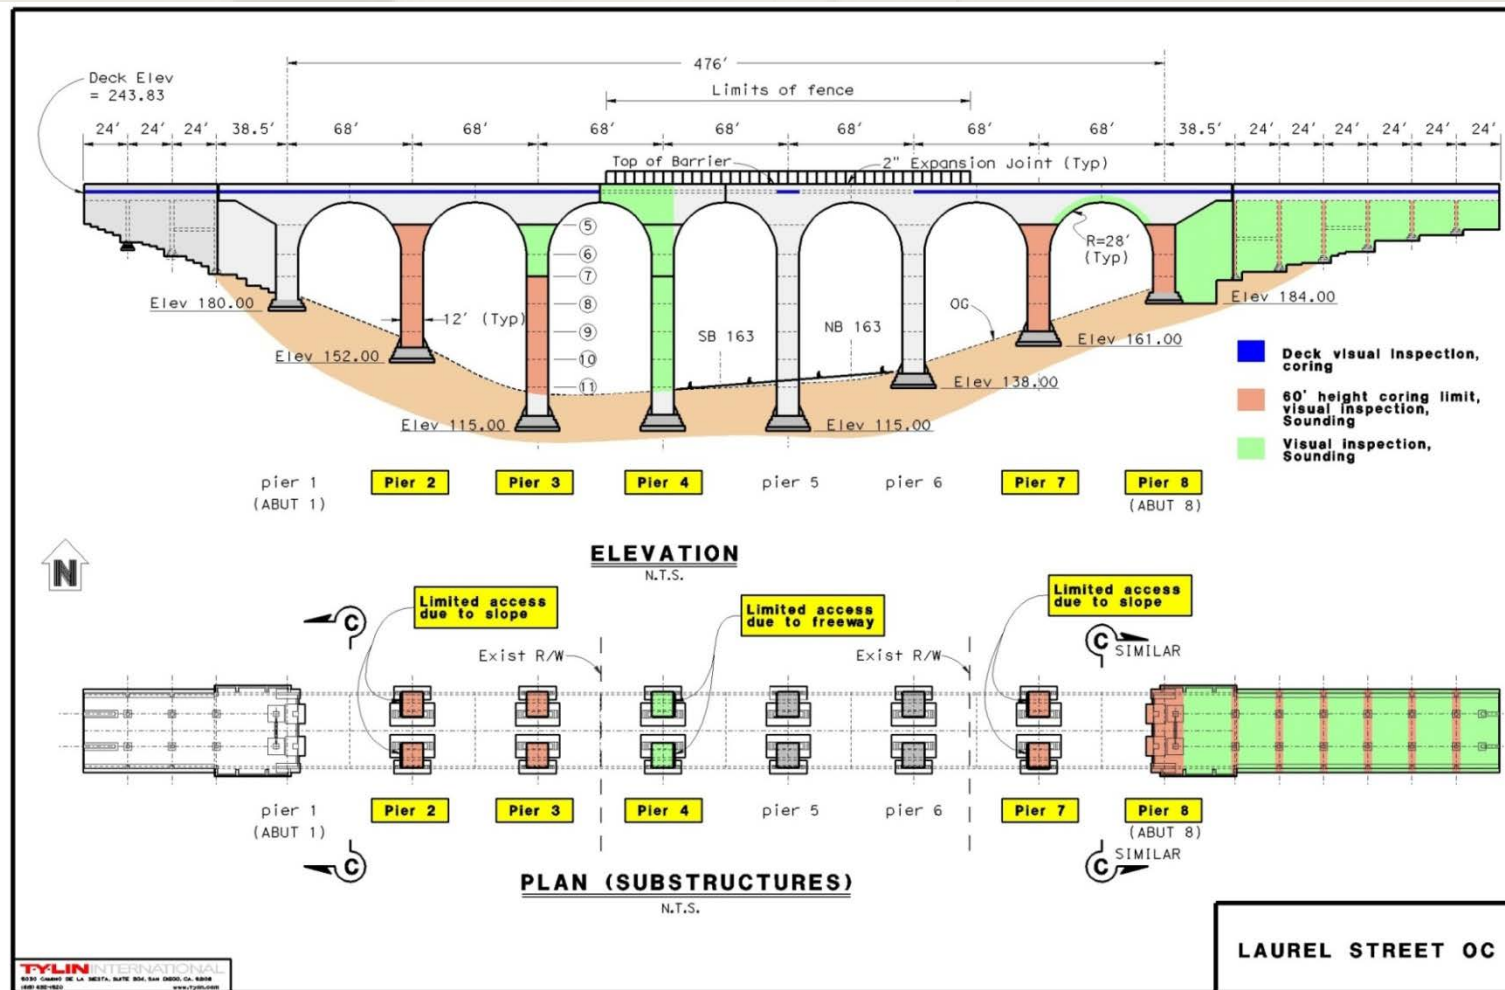
# INSPECTION ACCESS

- Recommendation from VE analysis
- Determine the types and locations of repair
- Limited inspection access
- Manlift, snooper truck & scaffolding

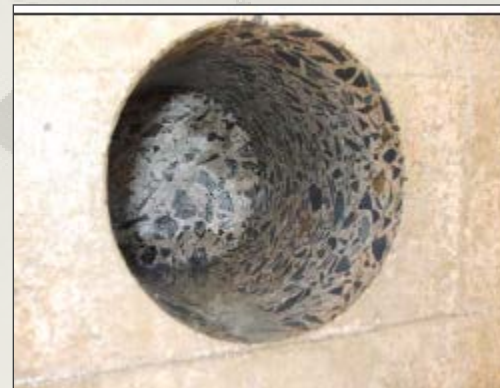
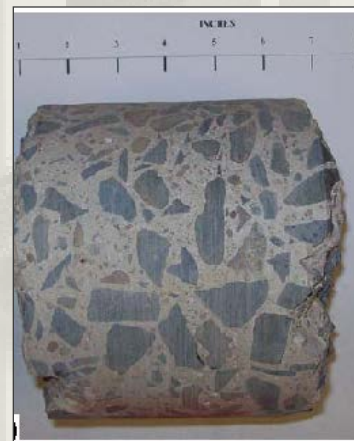
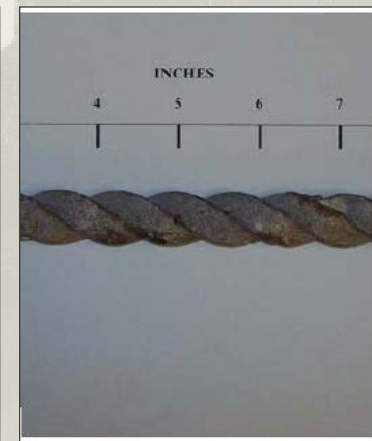
- Non Destructive Testing
  - Visual Inspection
  - Rebound Hammer
  - Ground Penetrating Radar
- Destructive Testing
  - 100 Concrete Core Samples
  - Compression Strength
  - Petrographic
  - Concrete Chemical
  - Rebar Tensile Strength

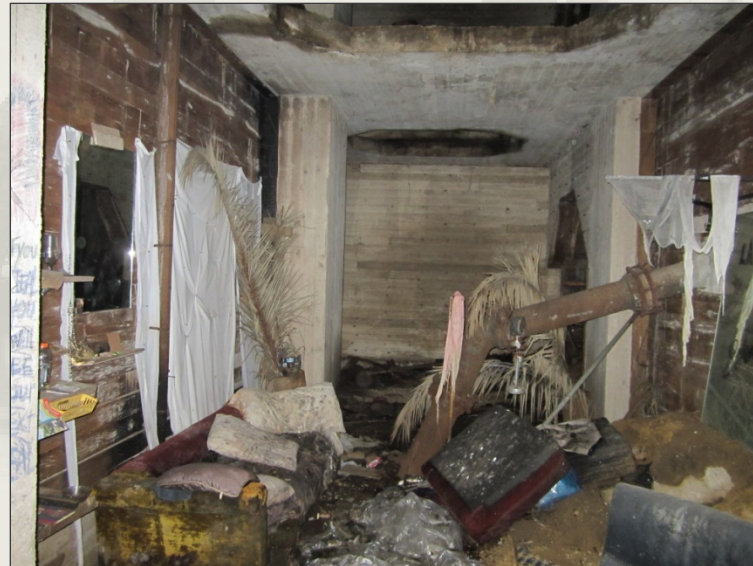
# ELECTRICAL AND ACCESSIBILITY IMPROVEMENTS

- High voltage distribution line on catwalk
- Electrical transformers in abutments
- Exposed wiring inside and outside bridge
- No interior lighting

- Remove catwalk and wood debris
- Remove transformers and high voltage lines
- New electrical system and interior lighting

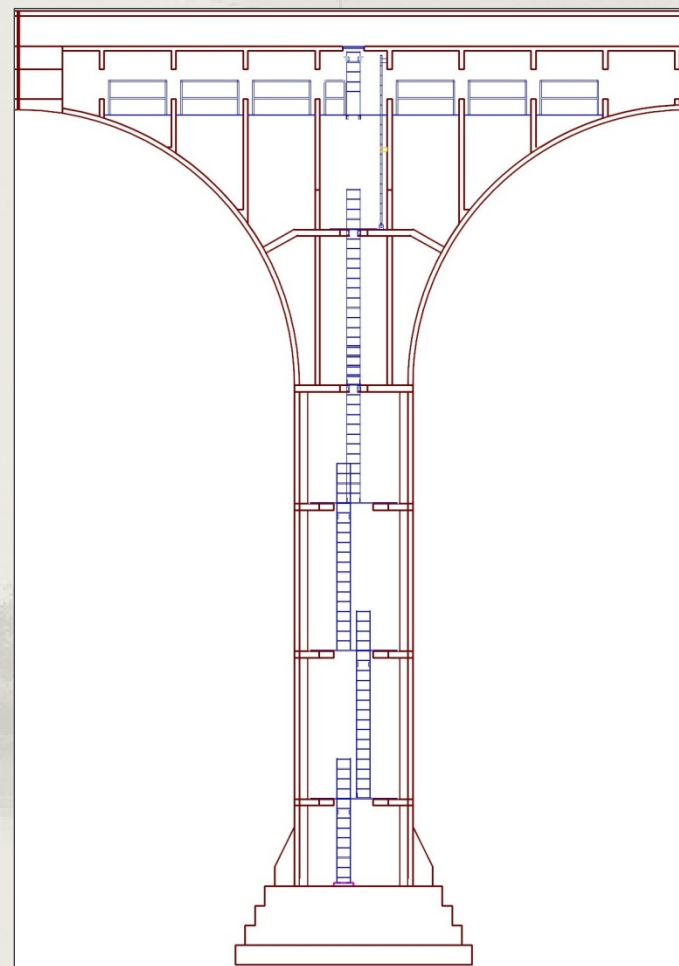
# ELECTRICAL AND ACCESSIBILITY IMPROVEMENTS

- Wood catwalk is deteriorated, no railings
- Some piers inaccessible
- Eroded interior abutment slopes
- Broken drain pipes
- Doors need replacement

- Install Cal/OSHA compliant ladders and catwalks
- Doors in all piers
- Grade abutment slopes
