# GOOD BRIDGES, BAD DETAILS, AND UGLY CRACKS

A STUDY IN TITANIUM ALTERNATIVES TO FIBER REINFORCED POLYMERS

By Paul Strauser, PE

### Str. No. 07626A Mosier WB Conn over Hwy 002

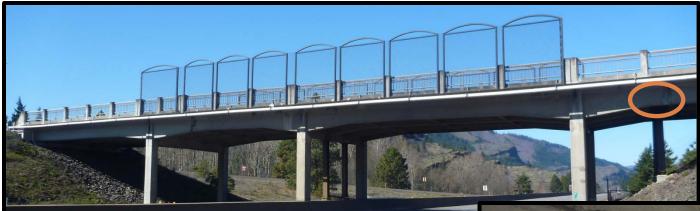
# June 4<sup>th</sup>, 2013

- □ John Adkins, PE R4 Bridge Inspector
  - Span 1 Interior Girders
  - "These cracks seem different from any other cracks I've seen on RCDG structures."
- ODOT Brainstorm
  - Load Rating, HQ, Inspectors
  - Region Notified Salem
    - Updated Load Rating
      - John Milcarek, PE

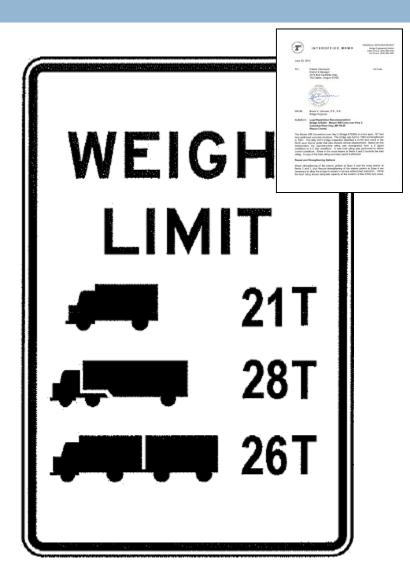
ODOT Load Rating Unit Update from 1995 Rating Low RFs Bents 2 & 3 Crossbeams Shear Moment Int. Girders Spans 2 & 4 Shear Moment Longitudinal Reinforcement Legal and Permit Vehicles Load Posting Recommendation

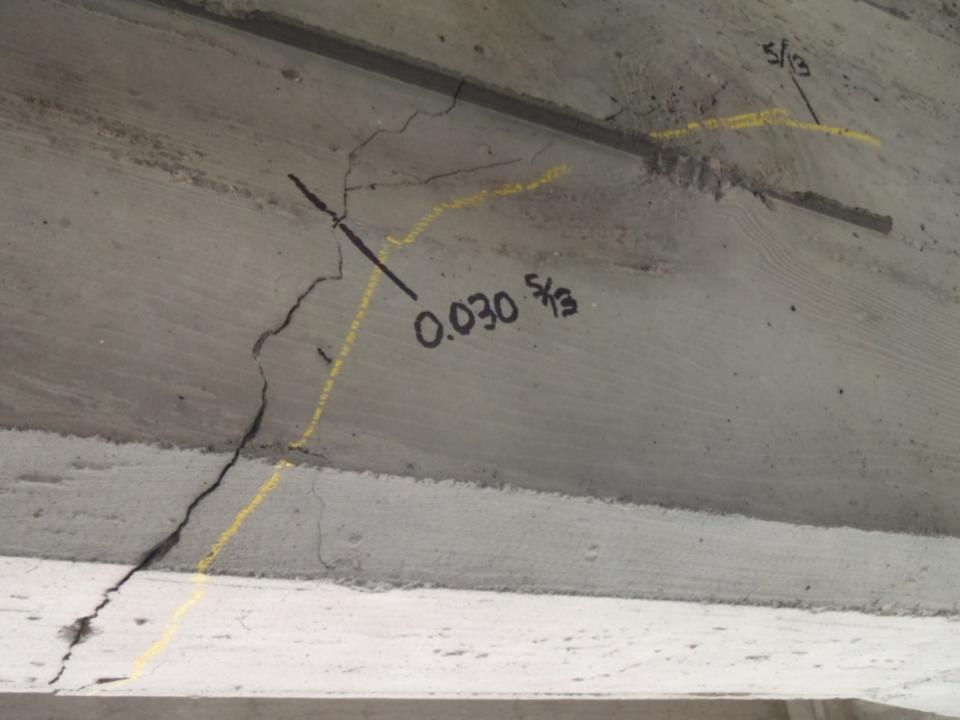
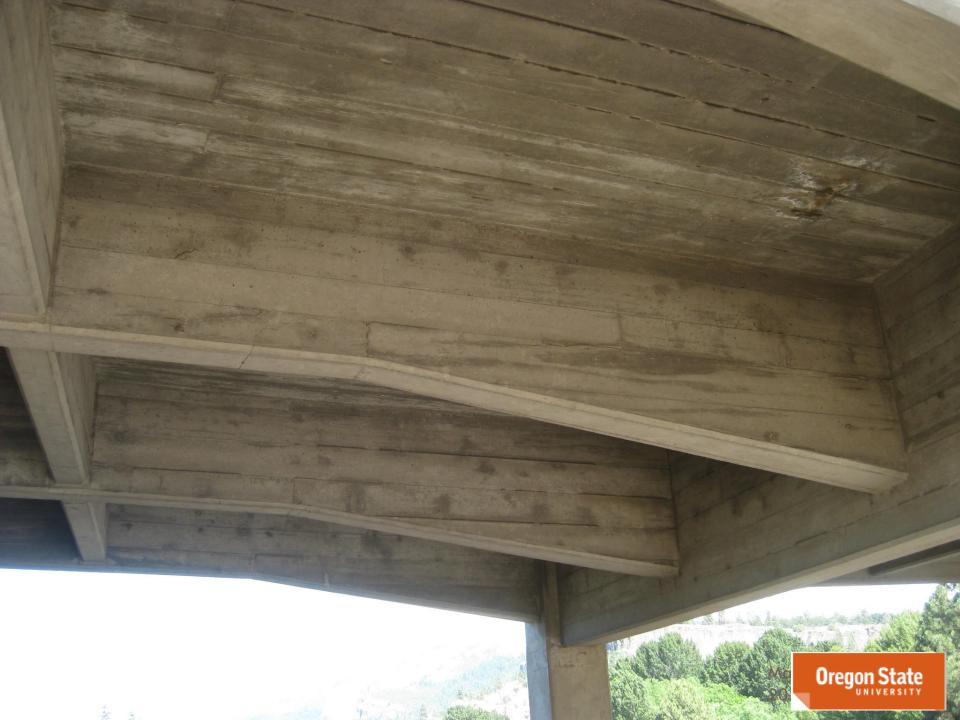
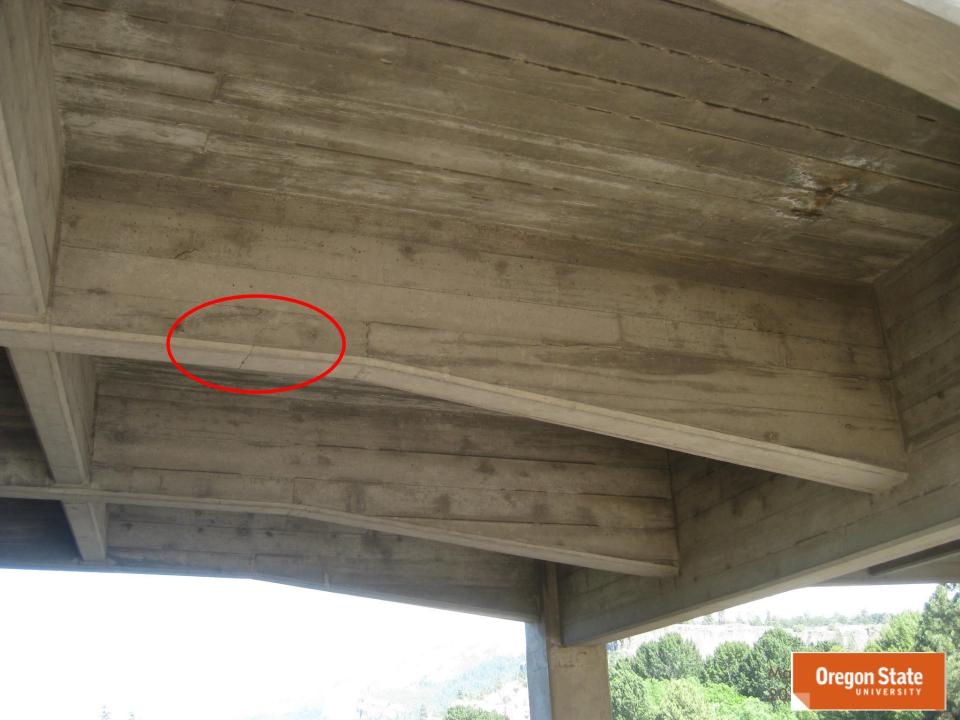
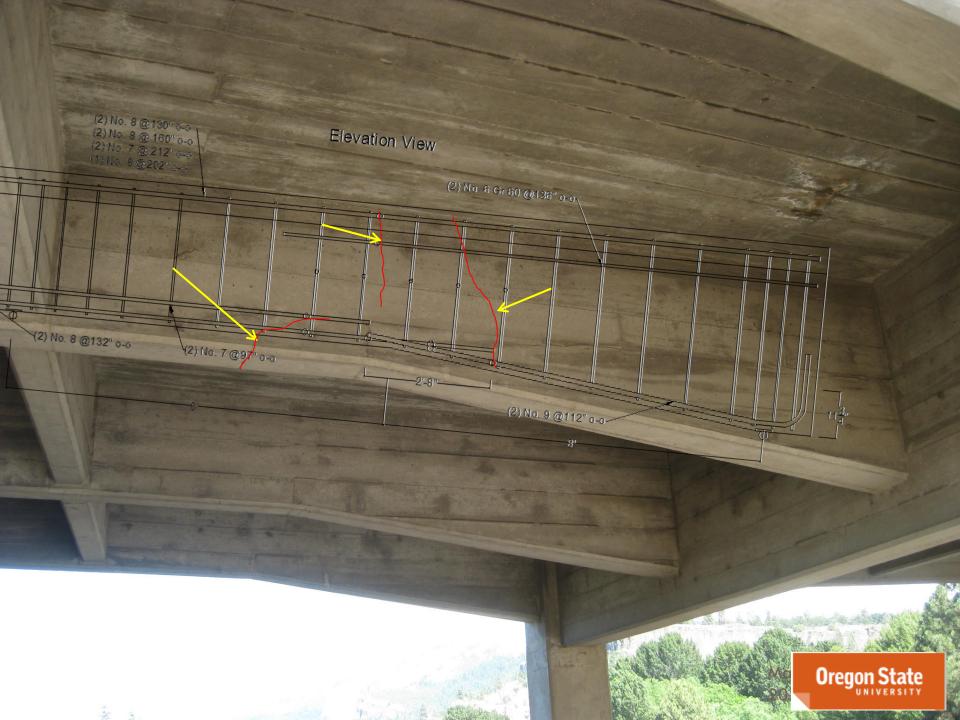
#### Limited Development

- Less than shown
- Vertical Crack Turns Horizontal
  - Anchorage Failure (Not Yield)
