Seismic Retrofit of Ogden Siphon Pipe Suspension Bridge

Western
Bridge
Engineers'
Seminar

Mark L. Reno, P.E.
September 11, 2015

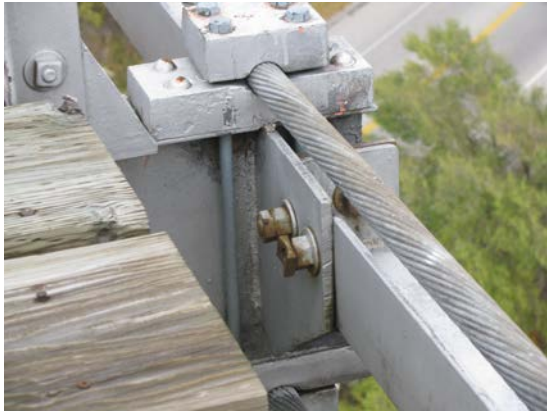
Edge Angle

Slotted holes at connections permit framing to adjust to changing cable length
