3 WESTERN BRIDGE SEMINAR 2017 INNOVATIVE LARGE SHAFT REPAIR

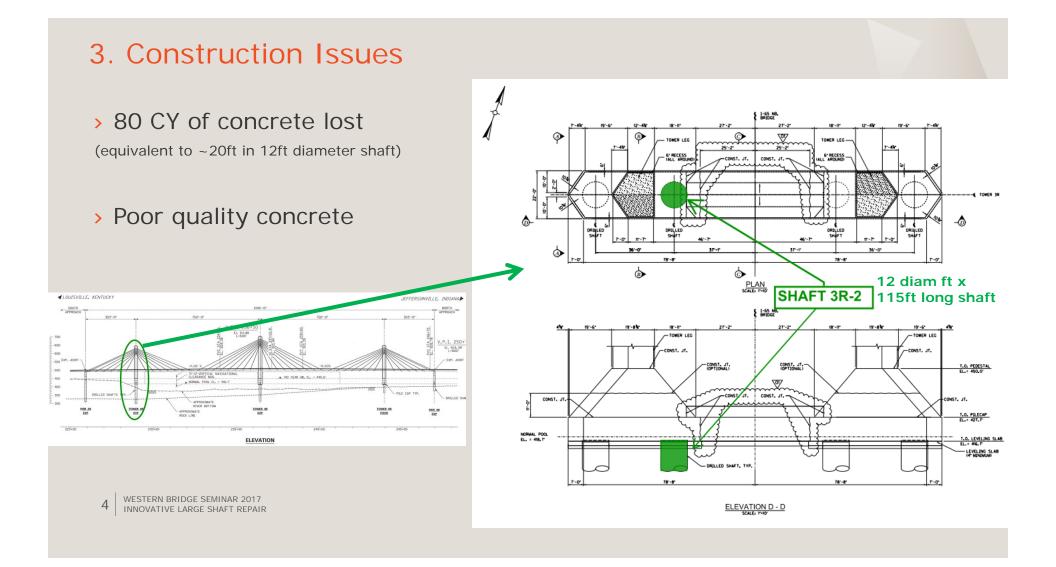
3. Construction Issues (cont.)

- > Coring samples
- > 1.7ksi average f'c in bottom part of the shaft

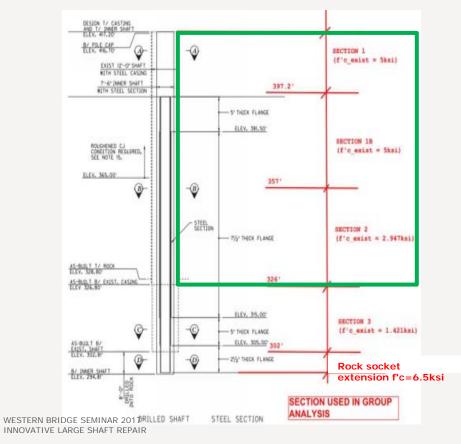
EI (kip-in2)					
	Longitudinal			Transverse		
	Original	Retrofitted	Ret/Orig	Original	Retrofitted	Ret/Orig
Section 1	9.82E+10	9.97E+10	101%	9.82E+10	9.97E+10	101%
Section 1b	9.82E+10	1.08E+11	110%	9.82E+10	1.01E+11	102%
Section 2	9.82E+10	8.90E+10	91%	9.82E+10	8.15E+10	83%
Section 3	5.80E+10	4.26E+10	73%	5.80E+10	3.51E+10	60%
Section 3b	-	1.55E+10			1.25E+10	-

For EI calculations:

- Retrofit Design Concrete f'c=6.5ksi
- Original Concrete f'c= 1.42 to 5 ksi

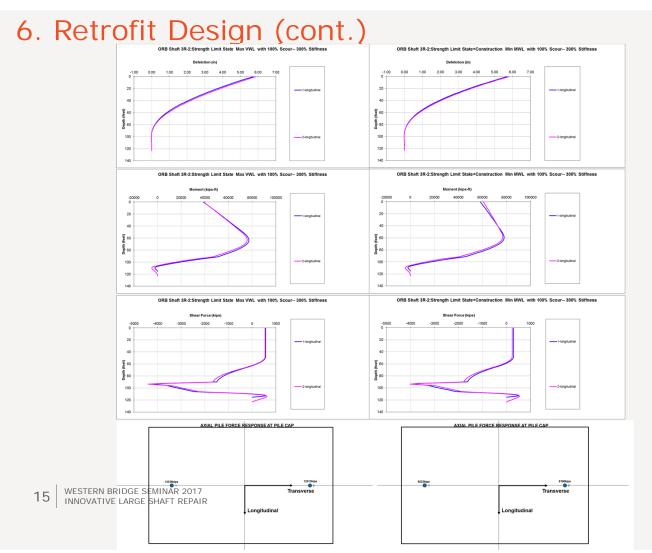
Longitudinal response

- Load redistribution is uniform longitudinally.
- Longitudinal bending stiffness matched closely to the existing adjacent shaft.
- Longitudinal direction is the dominant loading direction.

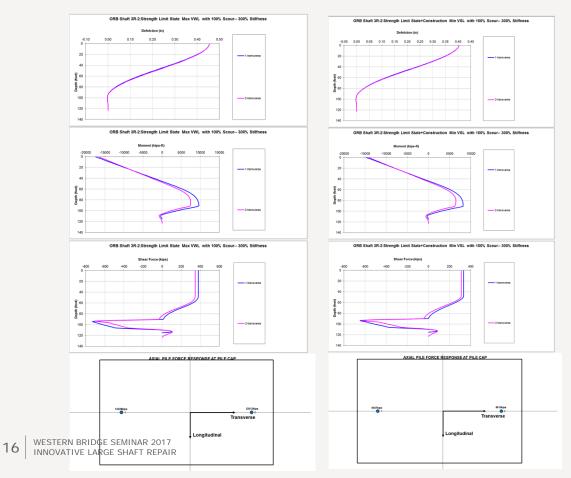
Transverse Response

- <u>Transversely, there is a</u> <u>slight load redistribution.</u>
- Due to the orientation of the embedded steel beam, the retrofitted shaft bending stiffness is slightly less stiff in transverse direction.
- Transverse direction is <u>not</u> the dominant loading direction.
