**Technical Presentation**

# Willow Creek Bridge No. 5 (I-40)

**ADOT Structure No. 1768**

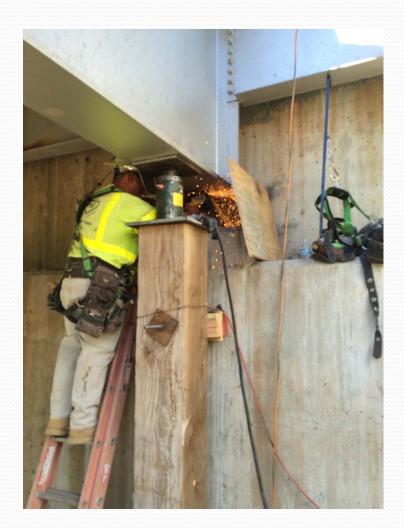
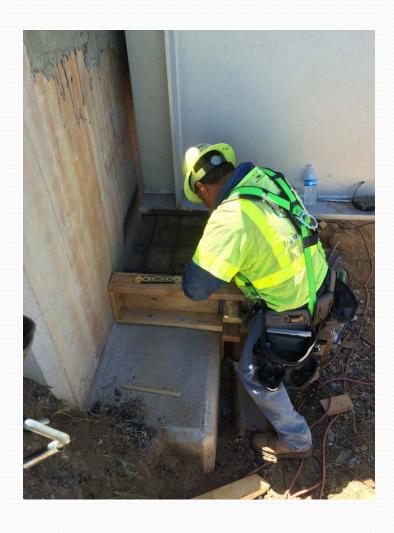
# **Abutment Bearing Replacement**

- Rocker bearings replaced with raised concrete pedestals, elastomeric bearing pads, and steel angles to restrain girder movement.
- Work was accomplished with temporary hydraulic jack supports.

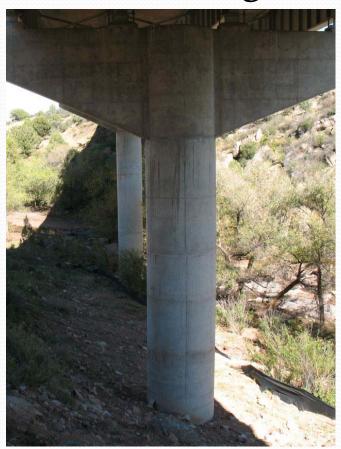
• Existing pier columns on Bridge No.5:

- Existing pier columns on Bridge No.5:
  - Single-column piers, large cantilevers (16'-9" pier overhangs)

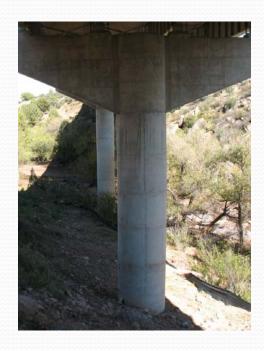
- Existing pier columns on Bridge No.5:
  - Single-column piers, large cantilevers (16'-9" pier overhangs)
  - Maximum height of 65'-4" (top of pier to bottom of footing) with a diameter of 7'-6"

- Existing pier columns on Bridge No.5:
  - Single-column piers, large cantilevers (16'-9" pier overhangs)
  - Maximum height of 65'-4" (top of pier to bottom of footing) with a diameter of 7'-6"
  - 2500 psi concrete

- Existing pier columns on Bridge No.5:
  - Single-column piers, large cantilevers (16'-9" pier overhangs)
  - Maximum height of 65'-4" (top of pier to bottom of footing) with a diameter of 7'-6"
  - 2500 psi concrete
  - Grade 40 steel

- Existing pier columns on Bridge No.5:
  - Not conducive to phased deck replacement!!

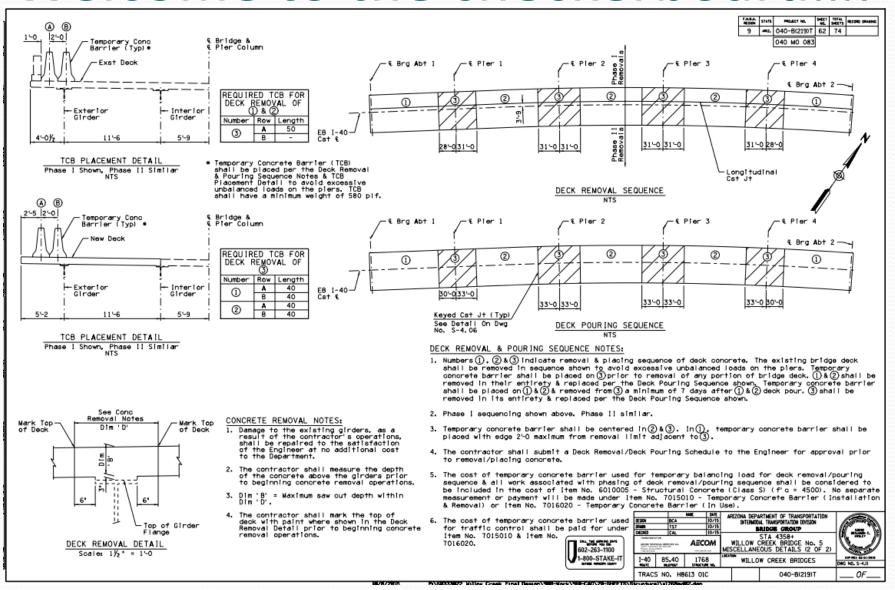
So what if we used the existing deck and remove it in a similar manner to how it was placed to provide the requisite counterbalance?

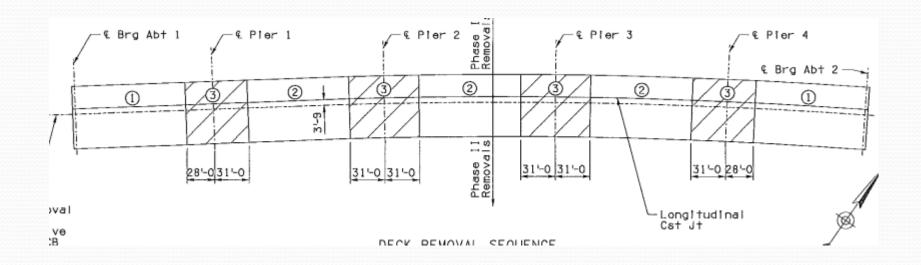
- The checkerboard utilized the following concept to provide the required counterbalance:
  - Portions of the deck (positive moment areas up to contraflexure points) were removed...

- The checkerboard utilized the following concept to provide the required counterbalance:
  - Portions of the deck (positive moment areas up to contraflexure points) were removed; however, this load was not QUITE enough to provide the requisite counterbalance.

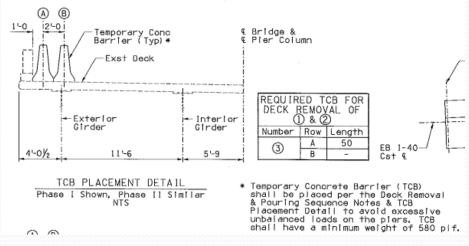
- The checkerboard utilized the following concept to provide the required counterbalance:
  - Portions of the deck (positive moment areas up to contraflexure points) were removed; however, this load was not QUITE enough to provide the requisite counterbalance. To make up for the extra load, rows of additional TCBs were placed on the negative moment

portions of the deck.

- The checkerboard utilized the following concept to provide the required counterbalance:
  - Portions of the deck (positive moment areas up to contraflexure points) were removed; however, this load was not QUITE enough to provide the requisite counterbalance. To make up for the extra load, rows of additional TCBs were placed on the negative moment portions of the deck.
  - Once the new positive deck portions were poured and cured, TCBs were shifted to the cured sections while negative moment sections were removed then poured.

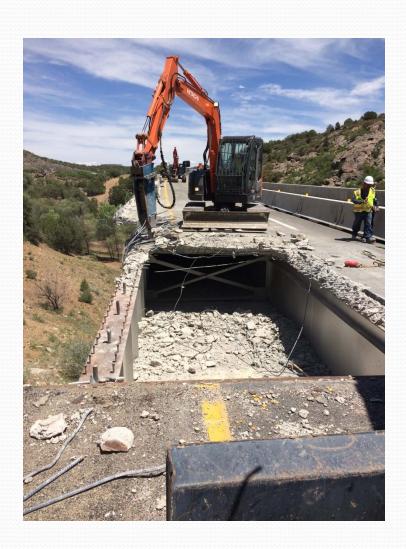
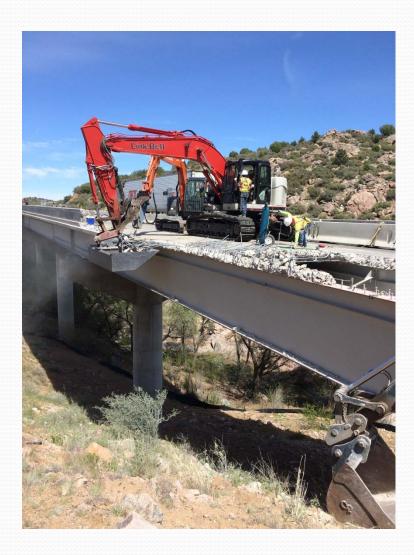
- What about debris in the wash?
- The contractor prevented debris from entering the wash successfully by placing plywood between bottom girder flanges.
- Overhangs were removed gradually using a bucket to catch debris off to the side as it was removed as shown in the next slide.
