Boeing Access Road Bridge Seismic Retrofit & Rehabilitation

**Western
Bridge
Engineers'
Seminar**

Kevin Kim, PE, SE, P.Eng.
Hana D'Acci, PE

Portland, OR
September 6, 2017

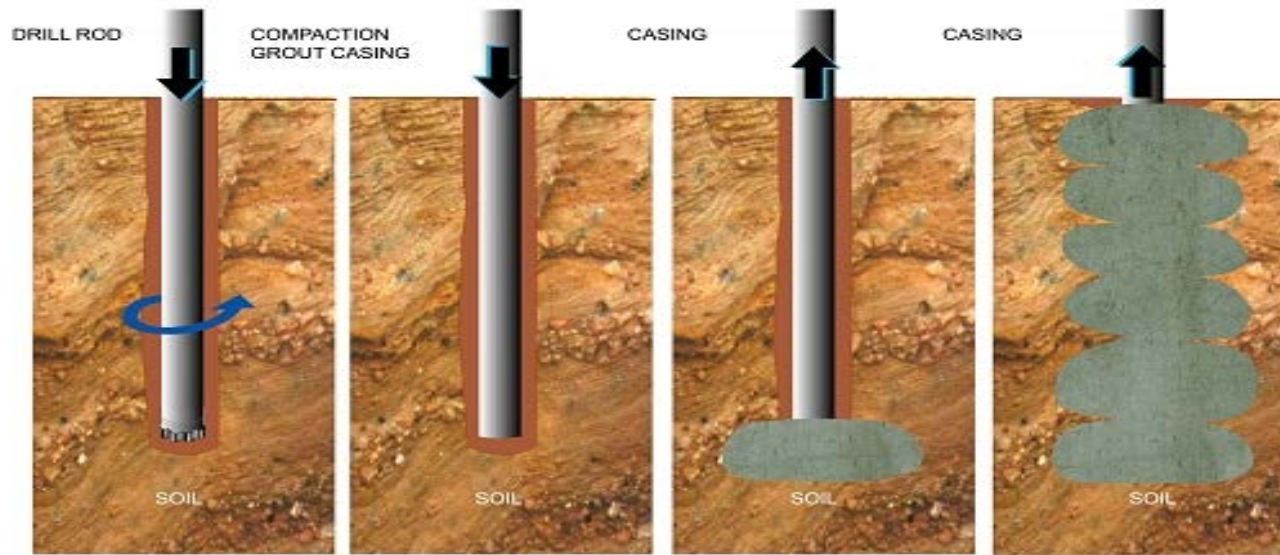
Compaction grouting for ground improvement

Challenge:
Steep Slope with Liquefiable Soils

STEP ONE:
 PREDRILLED COMPACTION
 GROUTING HOLE TO
 DESIRED DEPTH.

STEP TWO:
 INSERT COMPACTION
 GROUT CASING IN
 PREDRILLED HOLE.

STEP THREE:
 BEGIN PUMPING
 LOW SLUMP COMPACTION
 GROUT MIX IN STAGES
 AND WITHDRAW AT
 CONTROLLED RATE.

STEP FOUR:
 WITHDRAW CASING
 AS STAGES ARE COMPLETE
 UNTIL THE HOLE IS COMPLETE

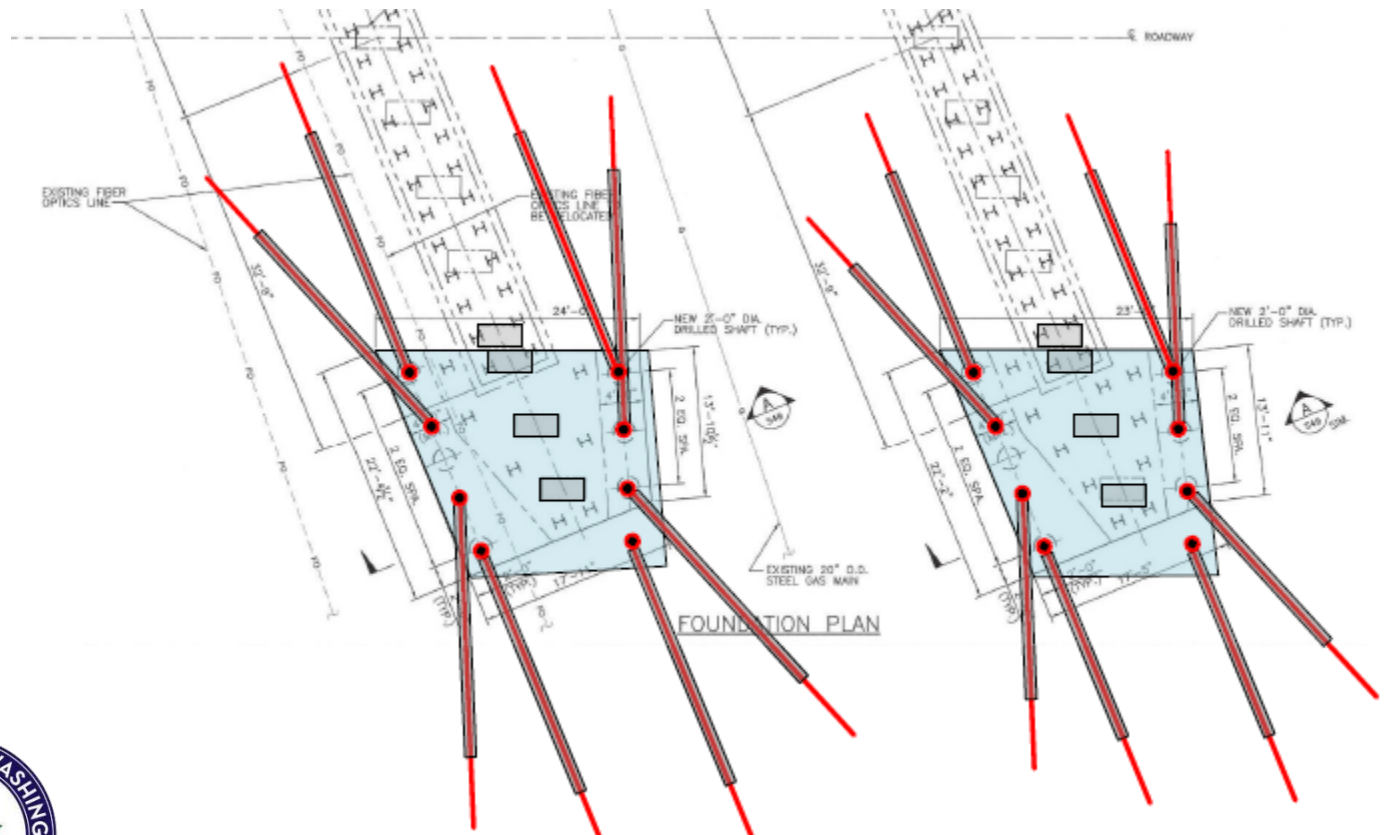
Foundation Retrofit at Piers 4 & 5 - Micropile

Challenge:
Inadequate Pier Seismic Details and Foundations

- Solution:**
- Install steel- or carbon-fiber column jackets to improve column shear strength and ductility performance.
 - Upgrade foundation capacities by installing additional piles/shafts.
 - Investigate bridge base isolation as an alternative to column and foundation retrofit to minimize work near Piers 4 and 5 (over railroads).

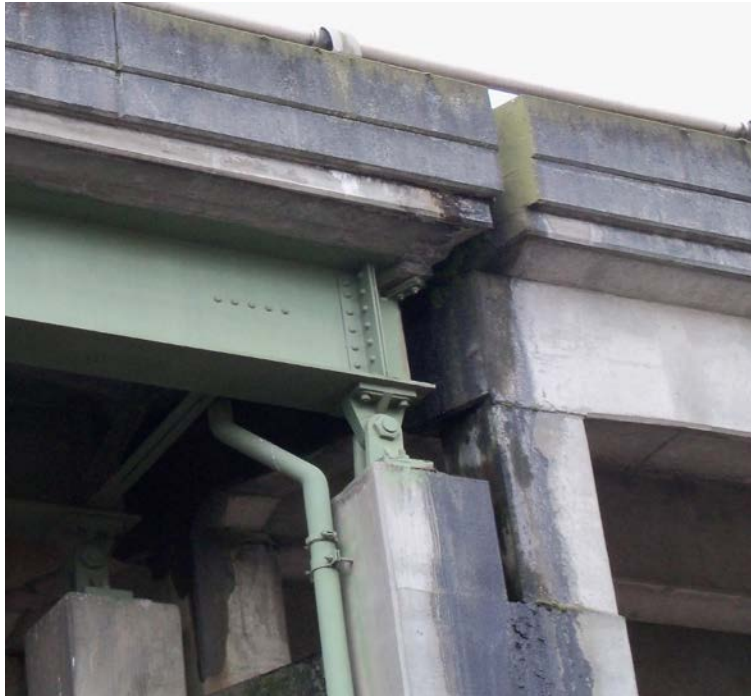
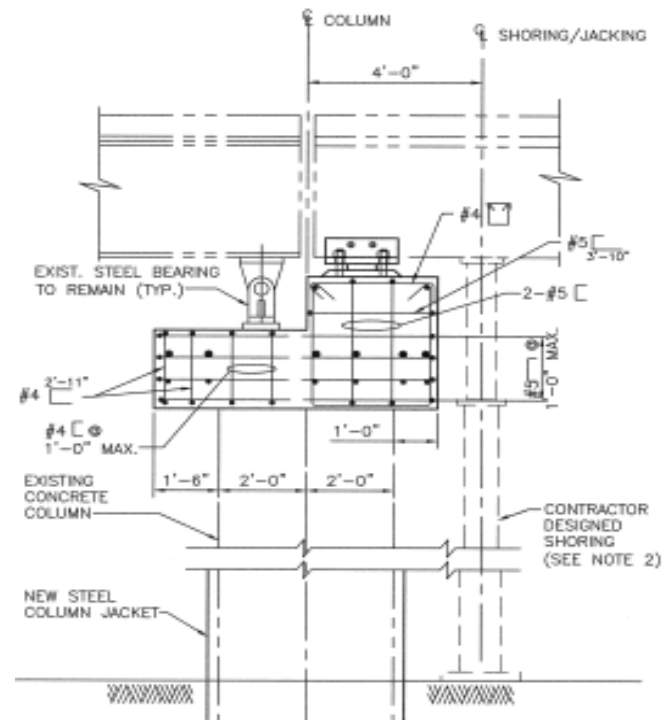
Pier 4 Bearing Replacement & Seat Extension

Challenge:
Poor Seismic Connectivity at Piers

Seat Width																		
Seat Width (in.)	N/A	N/A	N/A	N/A	N/A	N/A	N/A	N/A	N/A	22	25.6	0.86	N/A	N/A	N/A	N/A	N/A	N/A

- Solution:**
- Upgrade concrete pedestals, rocker bearings, steel end diaphragms, longitudinal seismic restrainers, and seat extensions.

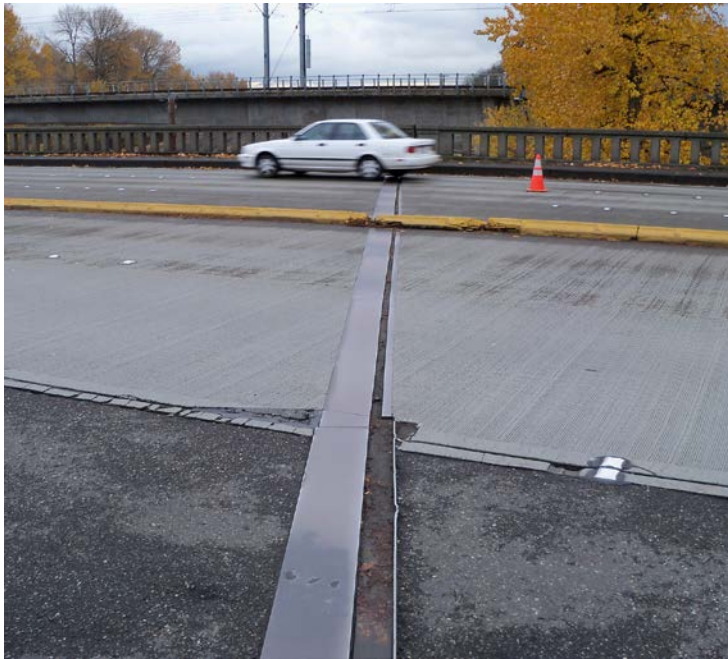
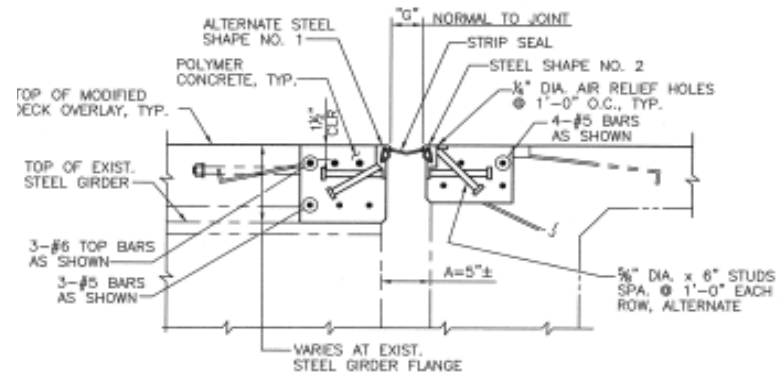
Expansion Joints

Challenge:
Failing Transverse Expansion Joint/Leaking Longitudinal Joint

- Solution:**
- Repair or replace transverse expansion joint to meet current standards.
 - Seal longitudinal joint to minimize future maintenance.

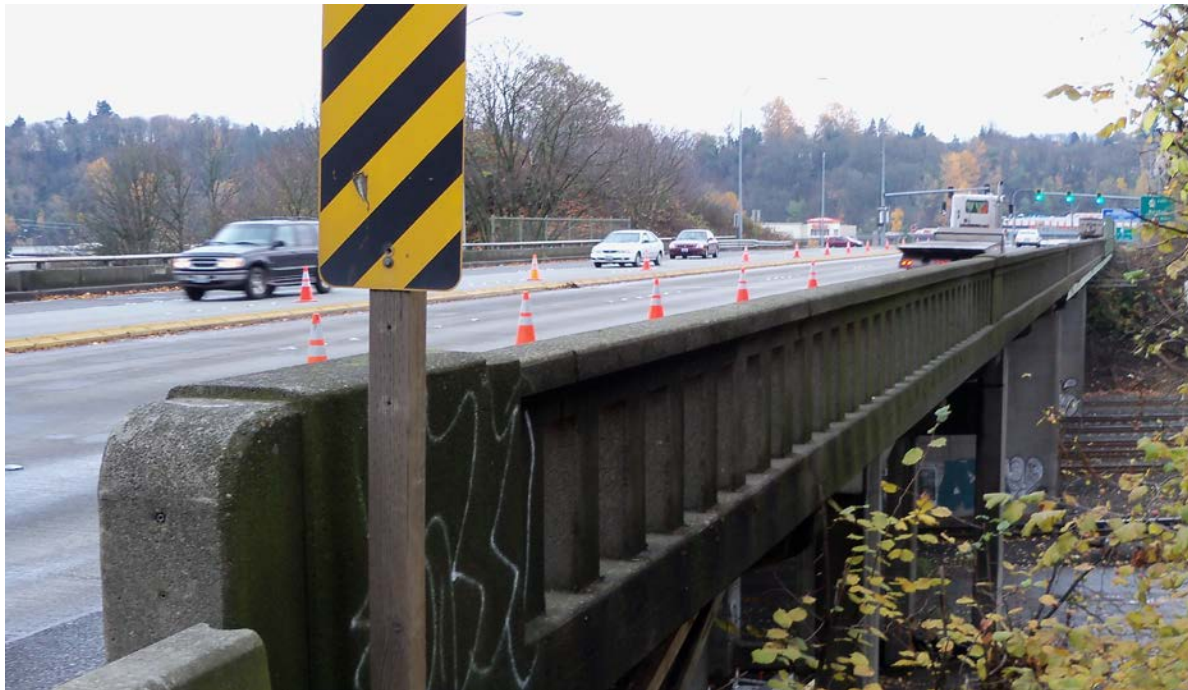
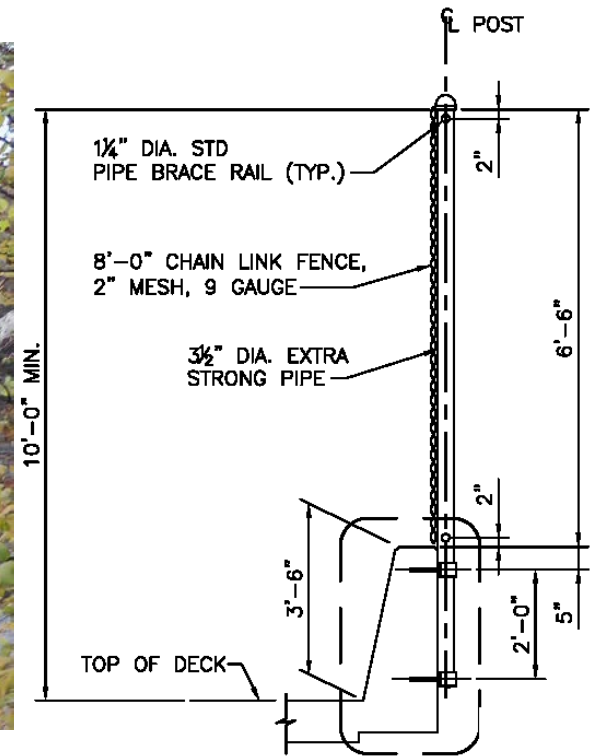
New Traffic Barrier with Fence Railing over Railroad

Challenge:
Damaged Concrete Barrier

- Solution:**
- Repair with appropriate materials to increase barrier longevity.
 - Replace traffic barrier as part of the bridge widening, if necessary.

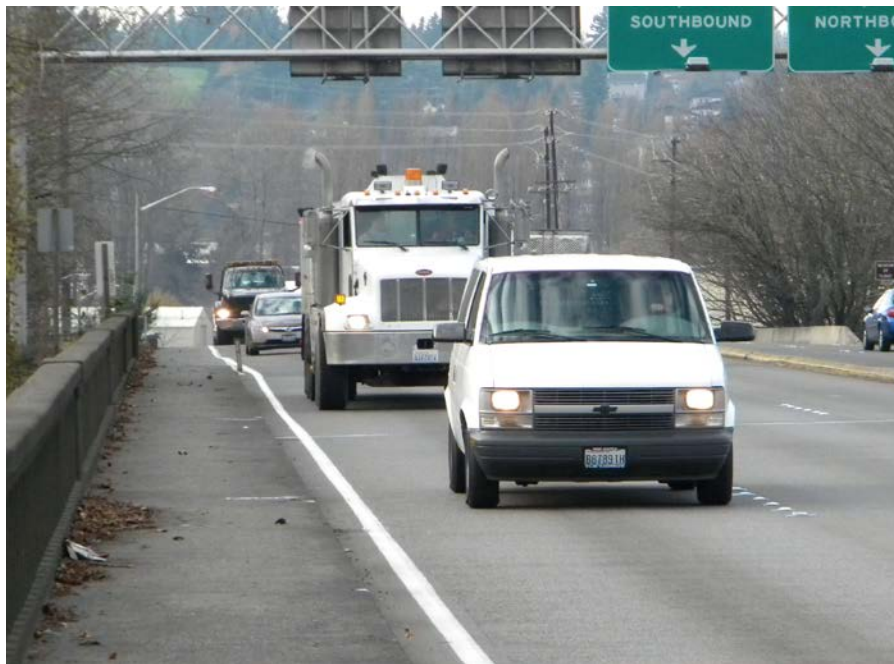
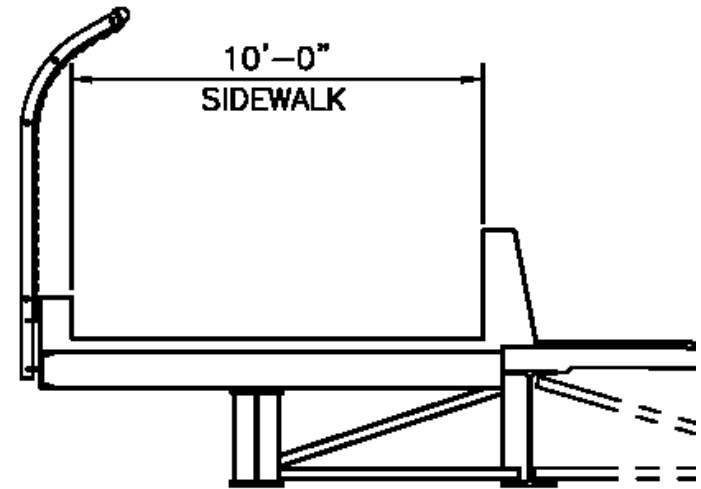
New Widening Section

Challenge:
Limited Sidewalk Width

- Solution:**
- Narrow 4 of the 6 existing lanes to establish a new traffic barrier at the existing southern curb line.
 - Replace barrier on south side with 10-foot pedestrian/bicycle path and railing.
