Repair of A Large Diameter Non-Redundant Drilled Shaft

2017 Western Bridge Engineers' Seminar

September 7, 2017

Alan Marchman, PE and Kuan Go, PE, SE

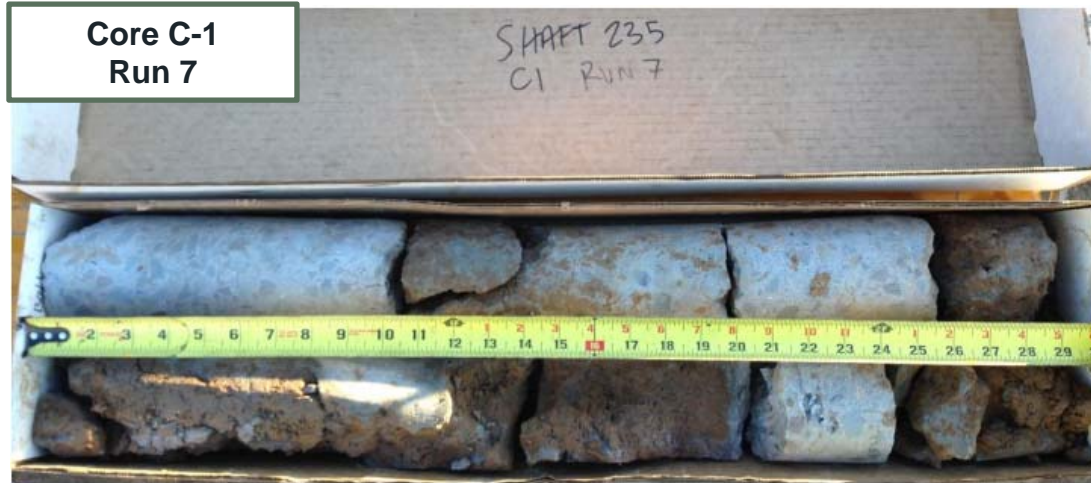
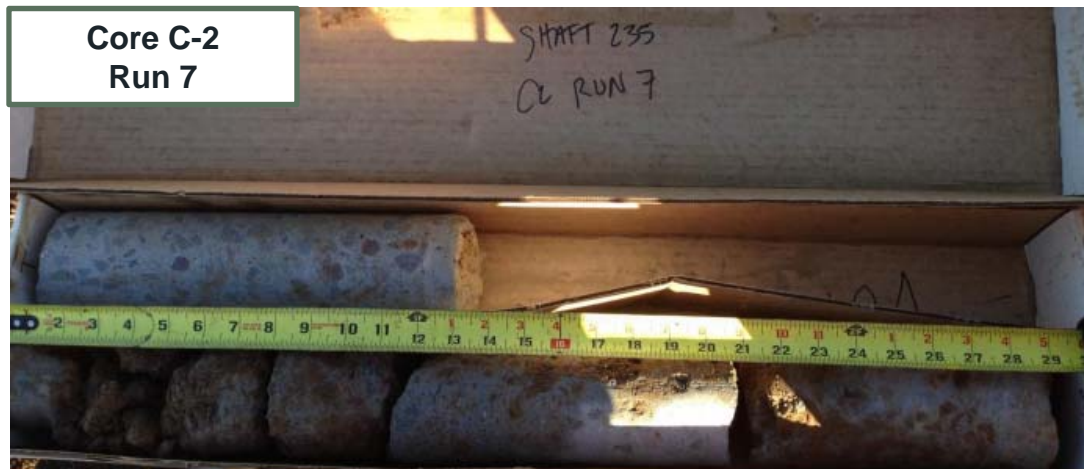
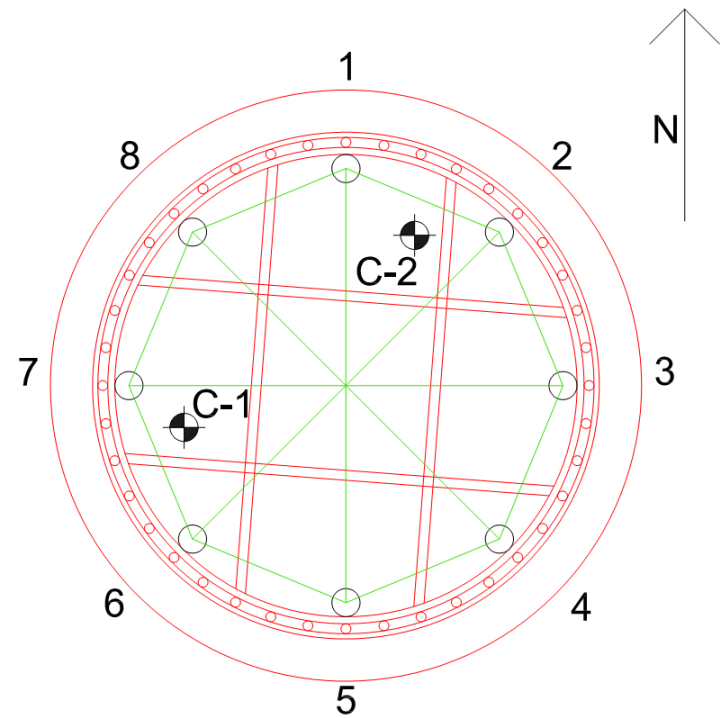
Shaft 235 Repair: Challenges

- Small Working Footprint
- Erection Truss Schedule Demands
- Long Lead Times & High Costs For Moving Materials And Equipment On Island
- High Water Table
- Non-redundant Shaft Means Repaired Shaft Must Meet Original Design Criteria

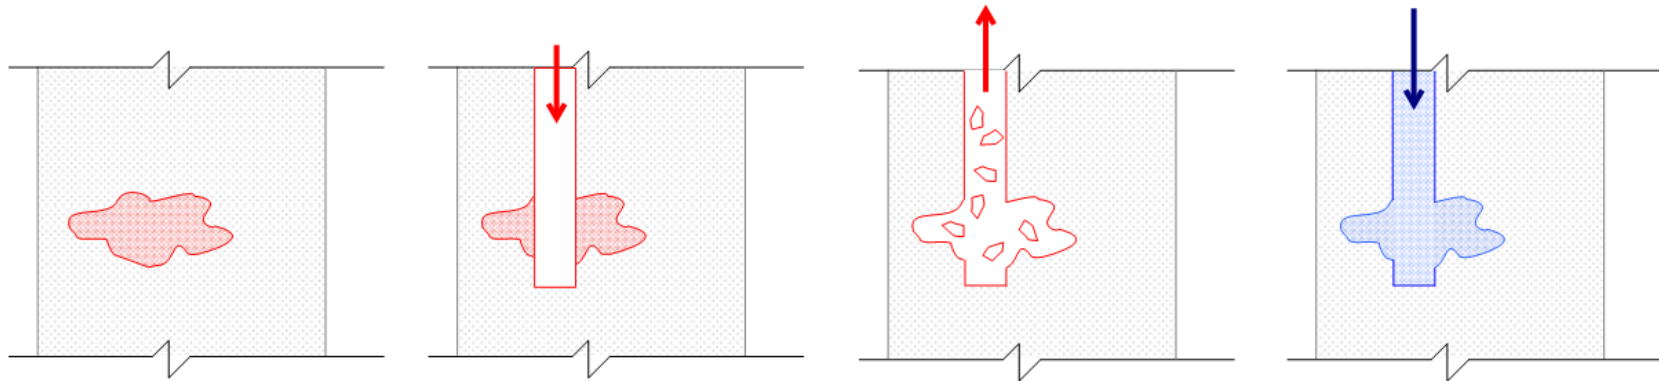
- Hydro-demolition And High Pressure Grouting
 - Successful At Other Shafts
 - Anomaly Too Large, Risk Pressure Loss
 - QA Difficulties

Shaft 235 Repair: Options

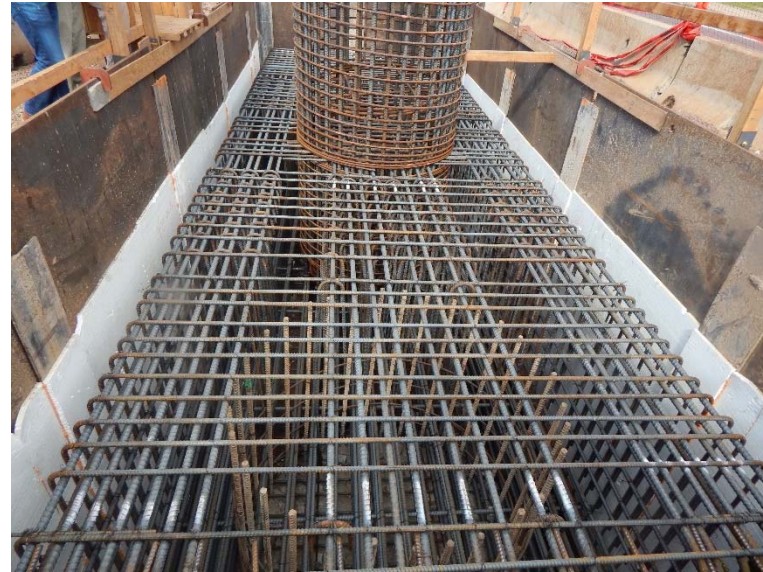
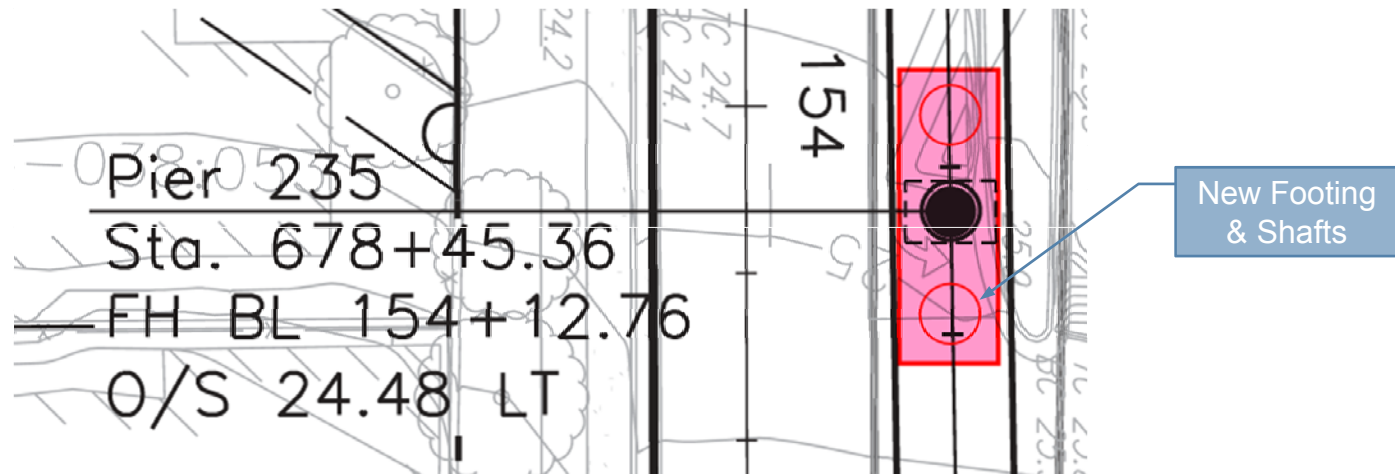
- “Sister” Shafts With Cap
 - Limited Footprint
 - Load Distribution Impacts
 - Long Material Lead Times
 - Cost & Schedule Prohibitive

Shaft 235 Repair: Options
