DAVID EVANS
AND ASSOCIATES INC.

Finding the Right Solution for Two Different Bridges

Presented by
Travis Kinney

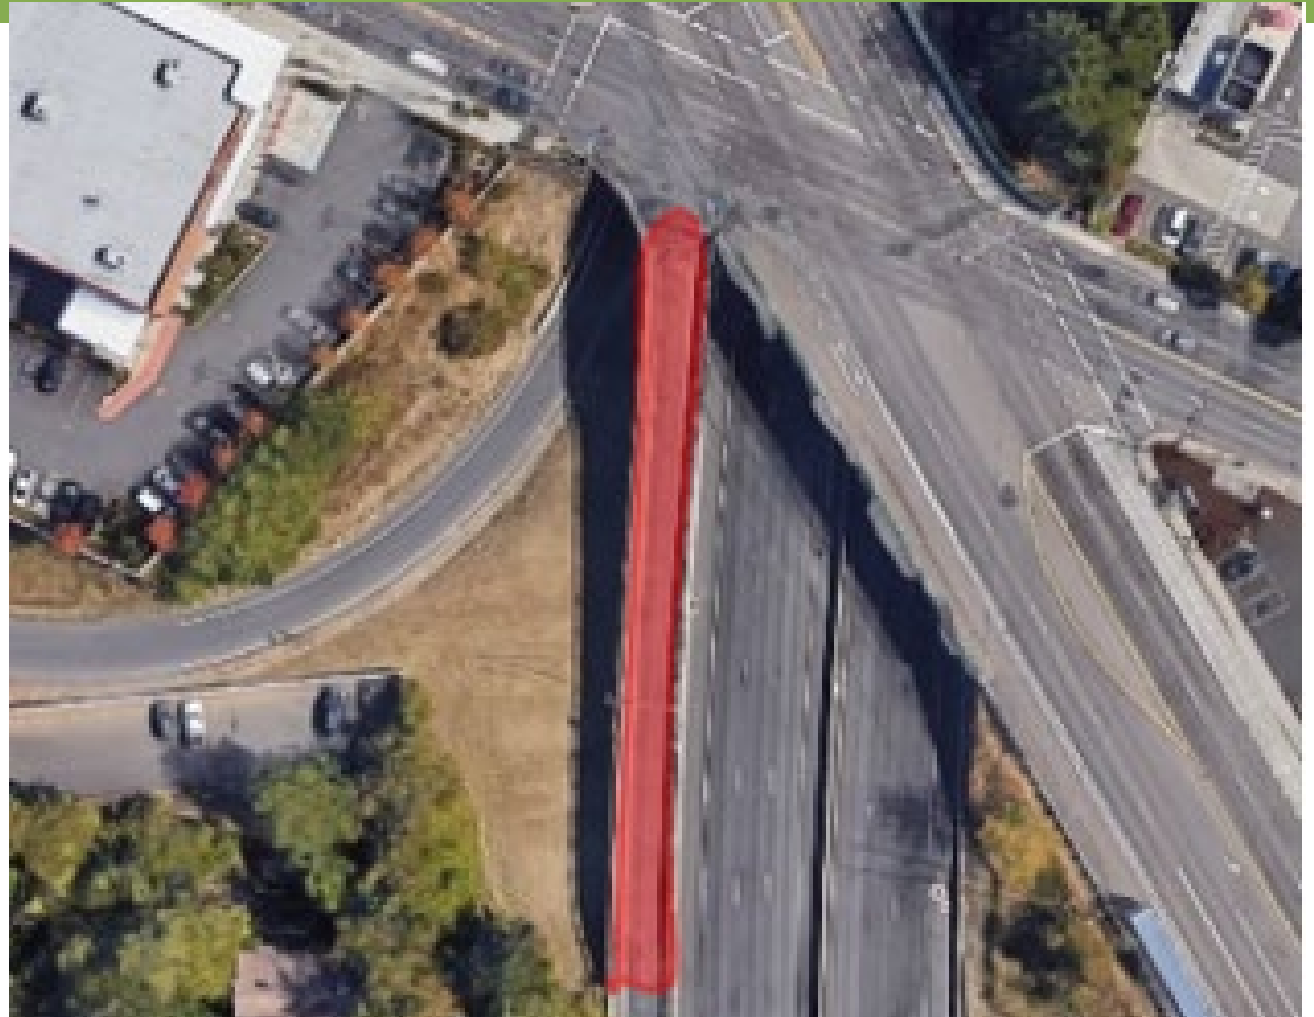
Deck Condition - Capitol

Element	Structure Unit	Environment	Quantity	Units	CS 1	CS 2	CS 3
16-Re Conc Top Flange	1	3	6503	(SF)	1468	2349	2686
1080-Delamination/Spall/Patched Area	1	3	30	(SF)	0	0	30
1090-Exposed Rebar	1	3	204	(SF)	0	200	4
1120-Efflorescence/Rust Staining	1	3	780	(SF)	0	360	420
1130-Cracking (RC and Other)	1	3	4021	(SF)	0	1789	2232

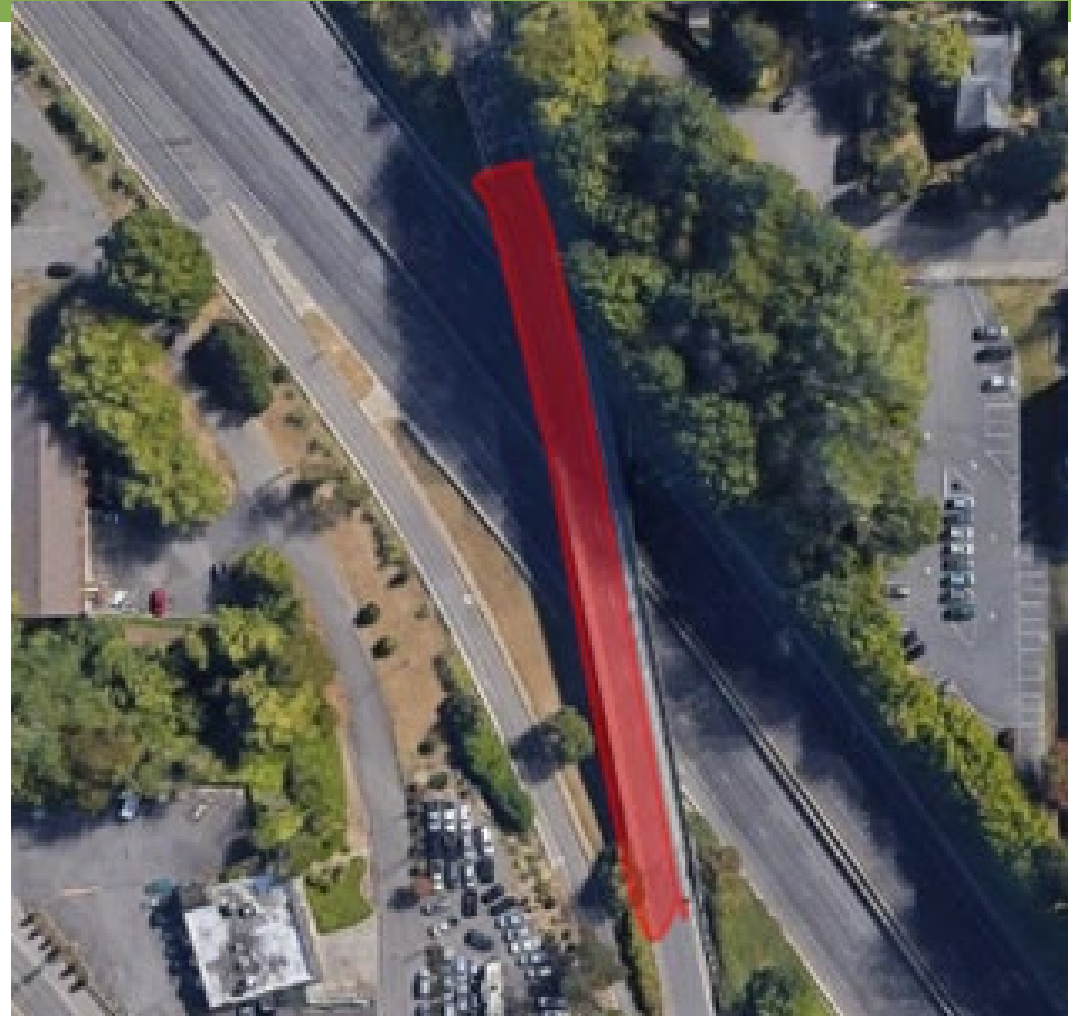
Deck Condition – Multnomah Hwy

Element	Structure Unit	Environment	Quantity	Units	CS 1	CS 2	CS 3	CS 4
12-Re Concrete Deck	1	3	9065	(SF)	4483	1533	3049	0
1120-Efflorescence/Rust Staining	1	3	520	(SF)	0	493	27	0
1130-Cracking (RC and Other)	1	3	7505	(SF)	4483	0	3022	0
1131-Soffit Cracking (RC, PSC)	1	3	1040	(SF)	0	1040	0	0
521-Conc Prot Coating	1	3	7770	(SF)	7770	0	0	0
16-Re Conc Top Flange	1	3	5074	(SF)	2475	820	1779	0
1081-Soffit Spalls/Delams/Patches	1	3	2	(SF)	0	1	1	0
1090-Exposed Rebar	1	3	2	(SF)	0	0	2	0
1120-Efflorescence/Rust Staining	1	3	304	(SF)	0	219	85	0
1130-Cracking (RC and Other)	1	3	4166	(SF)	2475	0	1691	0
1131-Soffit Cracking (RC, PSC)	1	3	600	(SF)	0	600	0	0
521-Conc Prot Coating	1	3	4349	(SF)	4349	0	0	0
