# Clarence L. Gosse Memorial Bridge Rehabilitation

Christopher R. Dyck, M.Sc., P.Eng.  
Senior Bridge Specialist

Western Bridge Engineers Seminar, Phoenix AZ, December 5-8, 2023

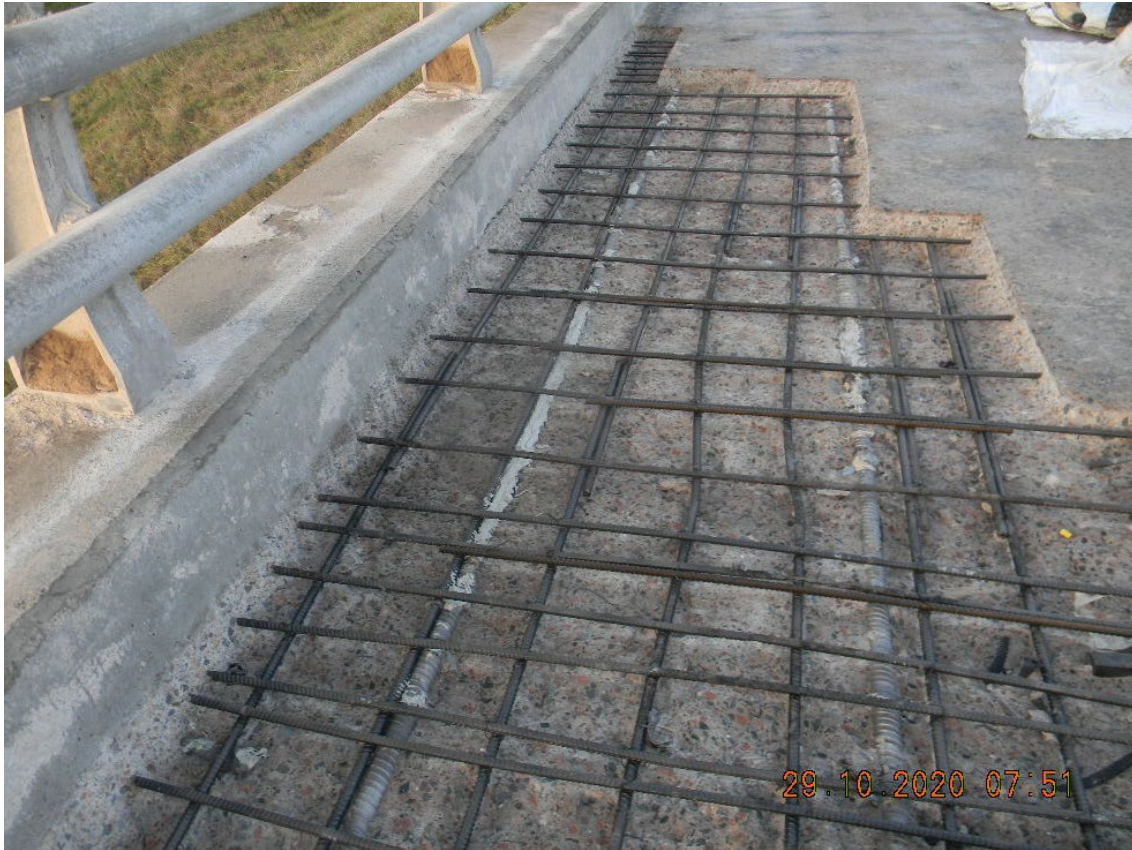
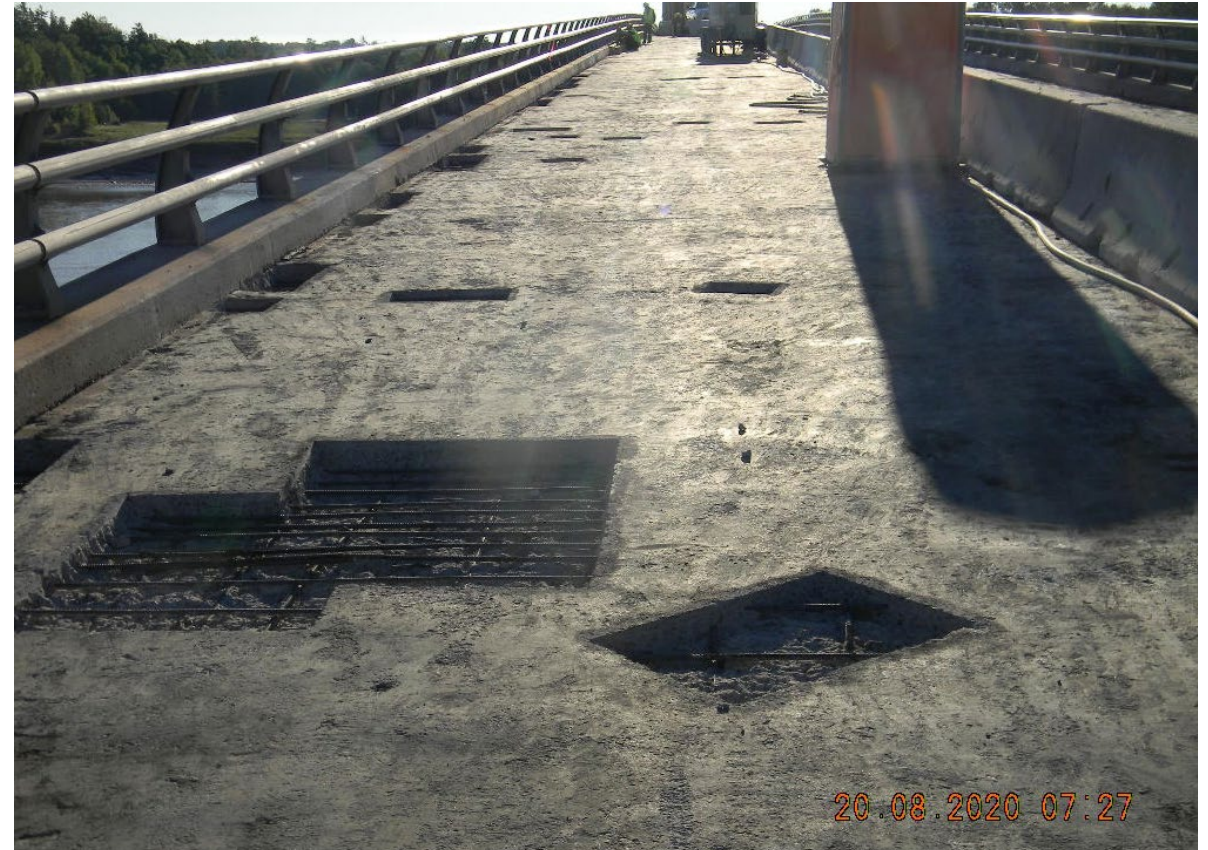
- Chain sounding of entire deck by NSDPW and Contractor
  - 3700 Sq.ft. of main deck repaired = 8% of total deck area
  - 2000 Sq.ft. of curb repaired
- Special Mix Design
  - Small aggregate
  - Low shrinkage
  - Congestion
- Tendon Protection
  - Duct perforations & exposed tendons repaired with epoxy suitable for cold climate
  - 15lb Hammers
  - Extreme caution around all tendons

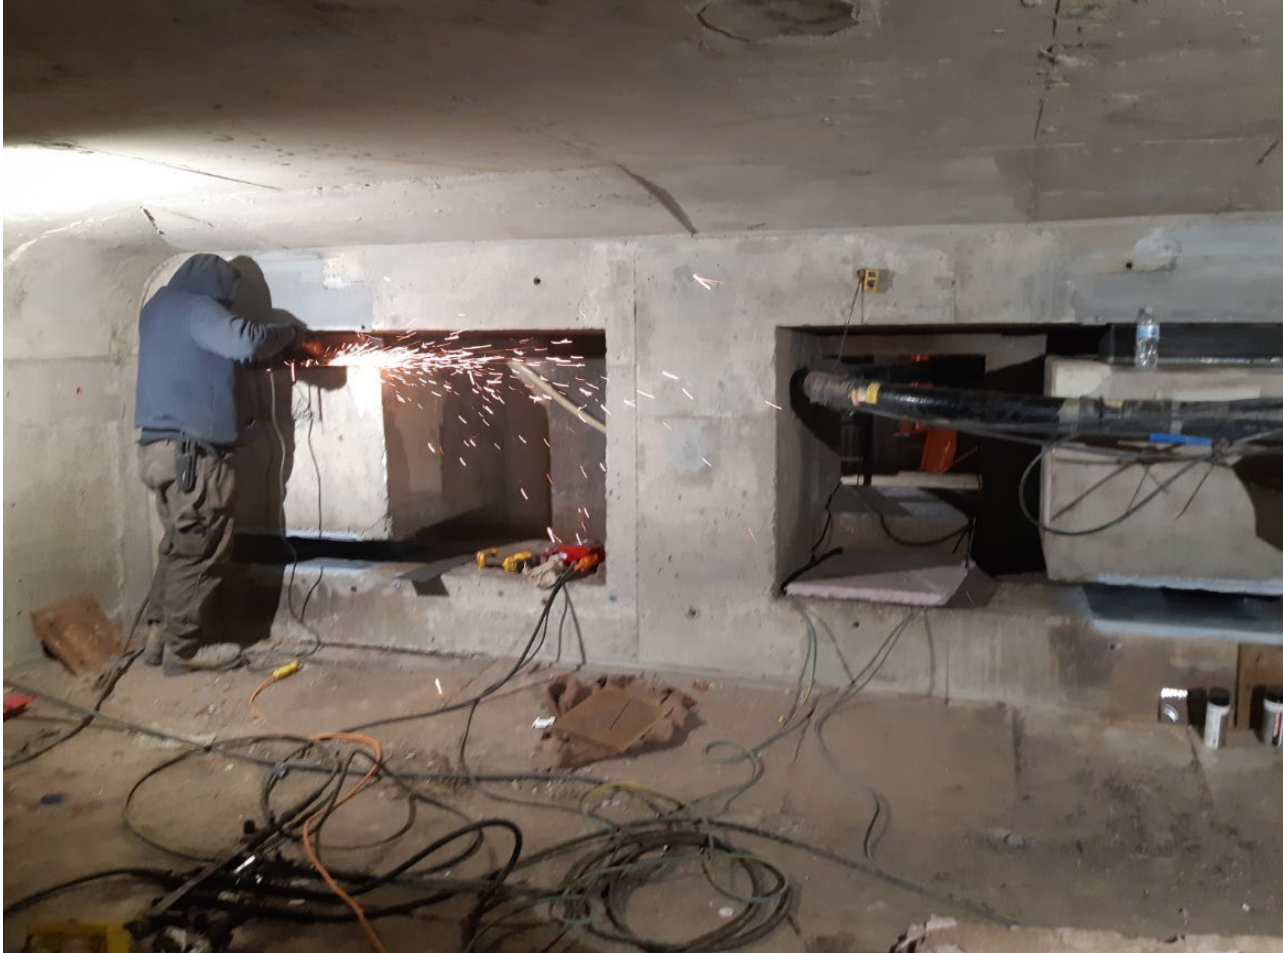
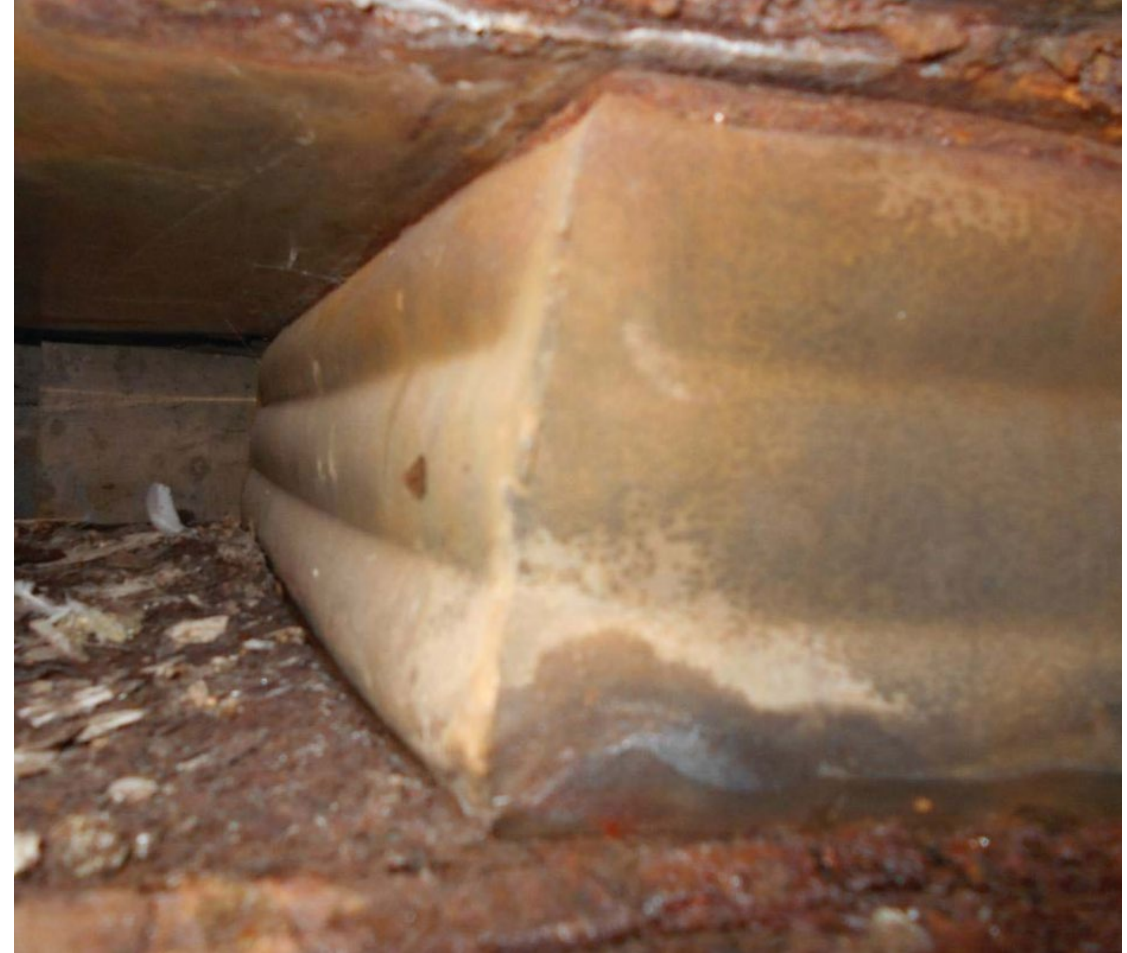
# Midspan Joint Bearing Block Replacements

- Midspan Joint General Layout

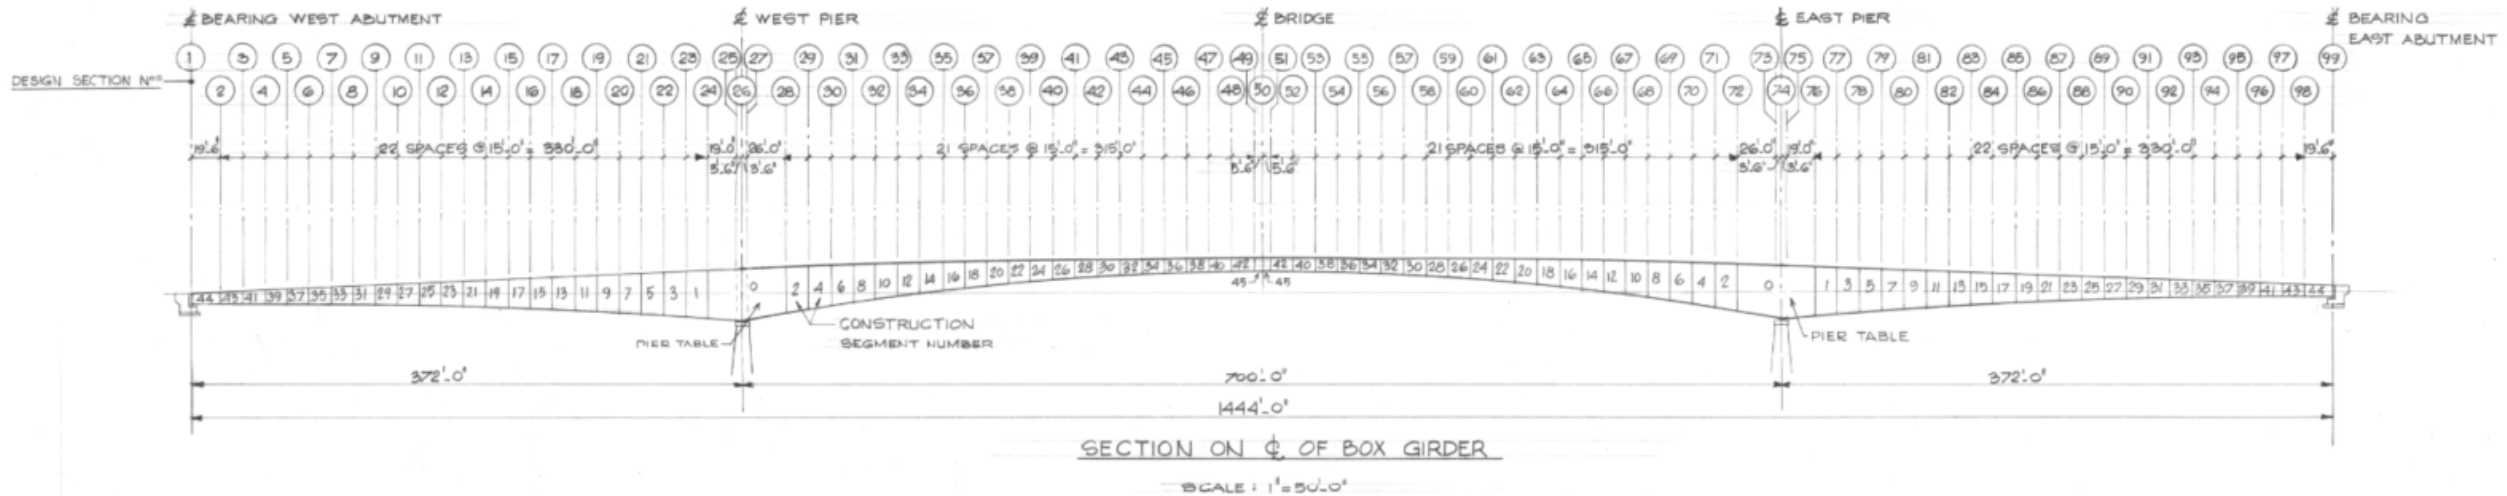
# Midspan Sag Assessment

- DYWIDAG consulted (original designer from 1970s)
- All sections of cantilevers structurally stable and in equilibrium

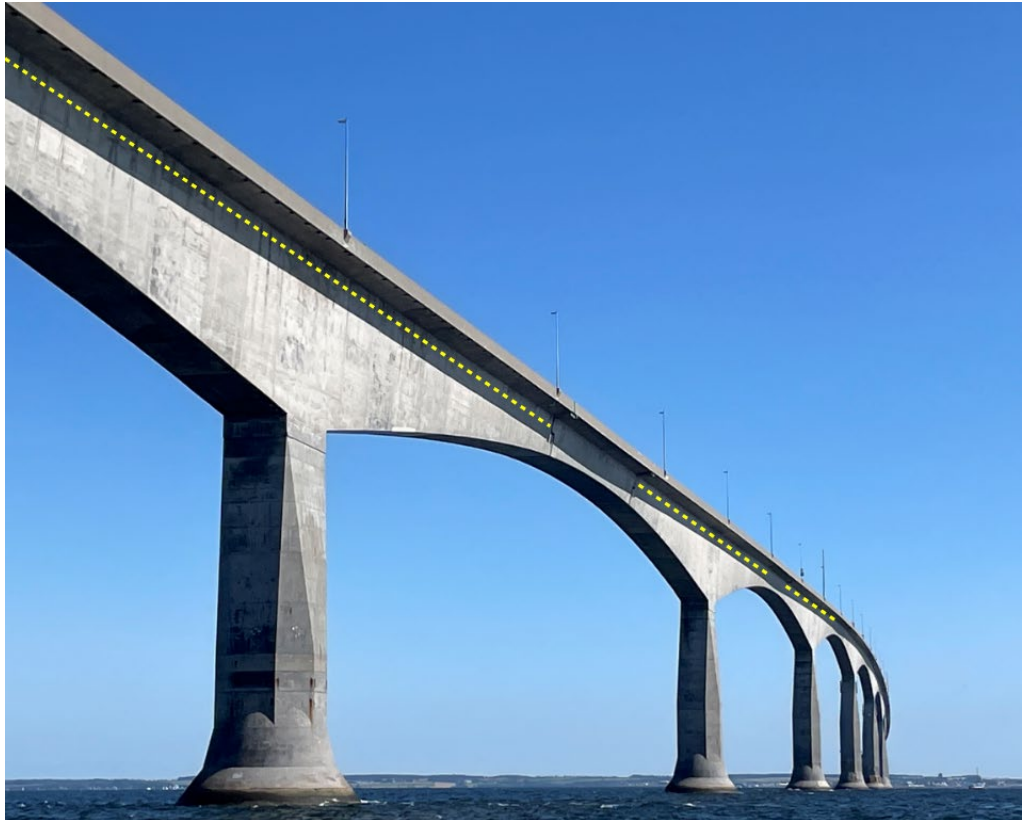
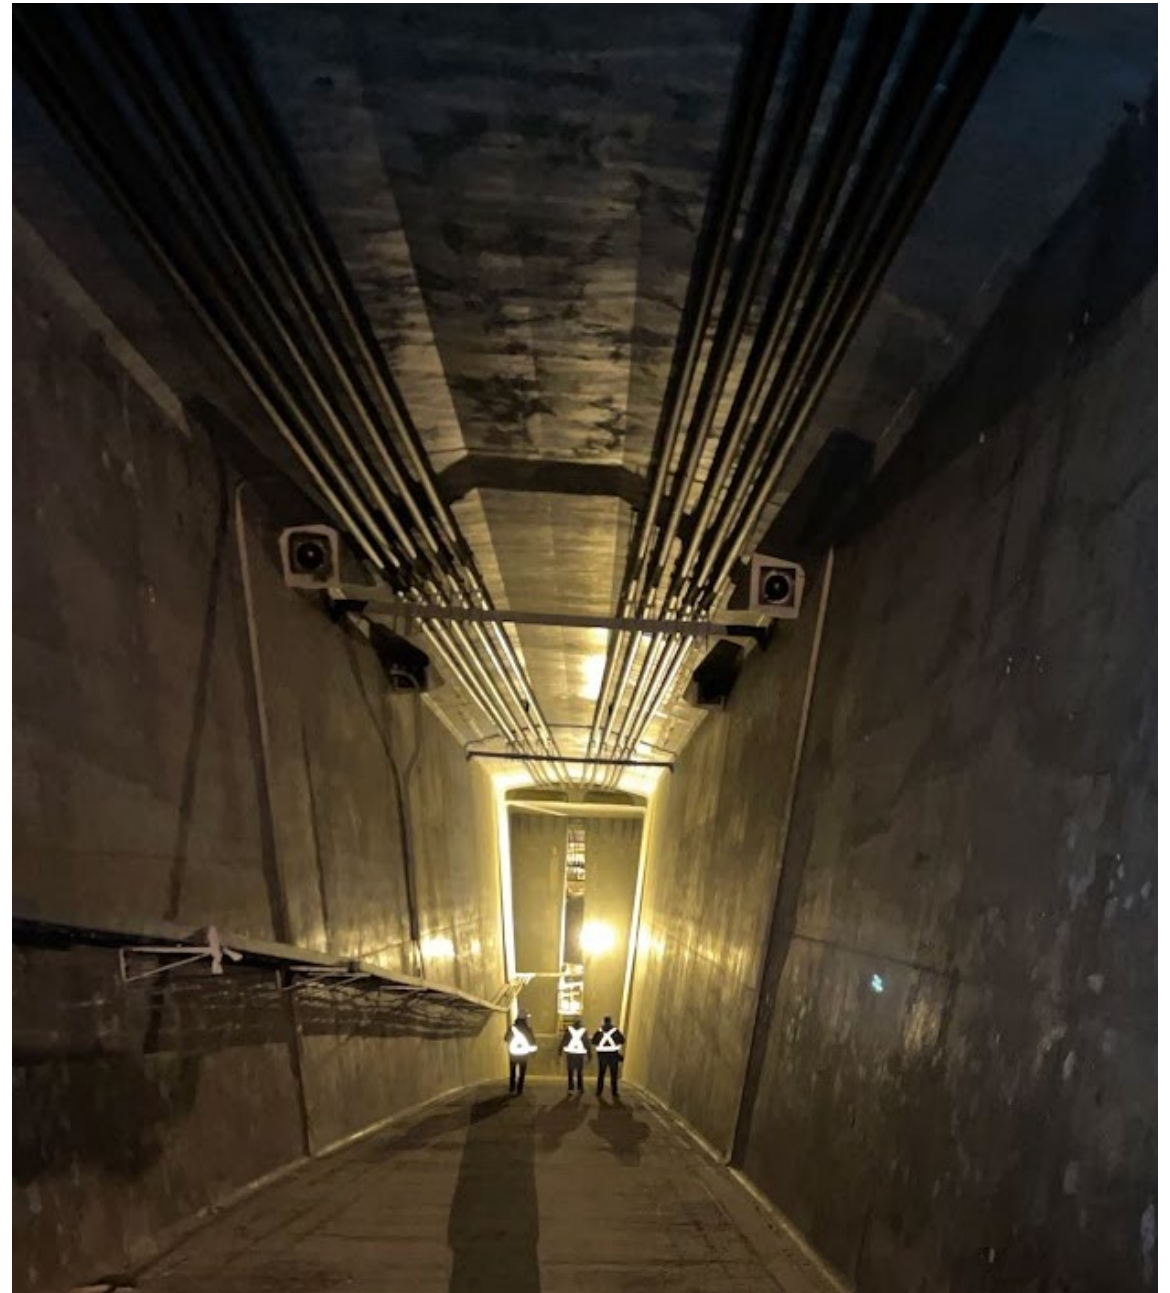
# Midspan Sag Assessment

- External PT considered to compensate for midspan sag

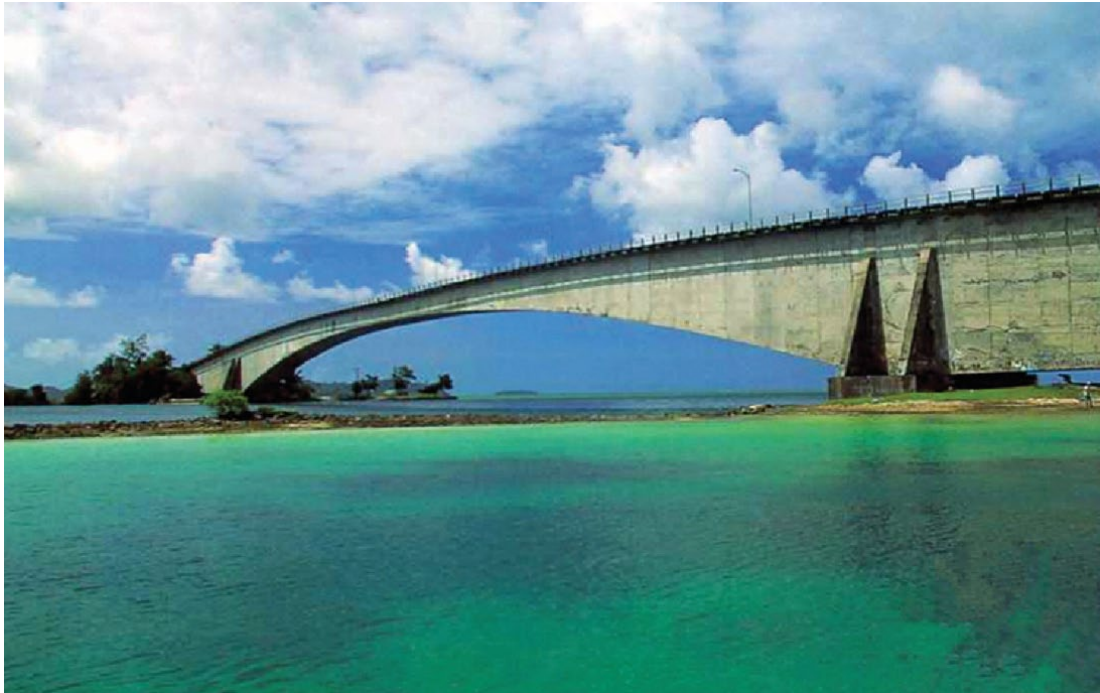
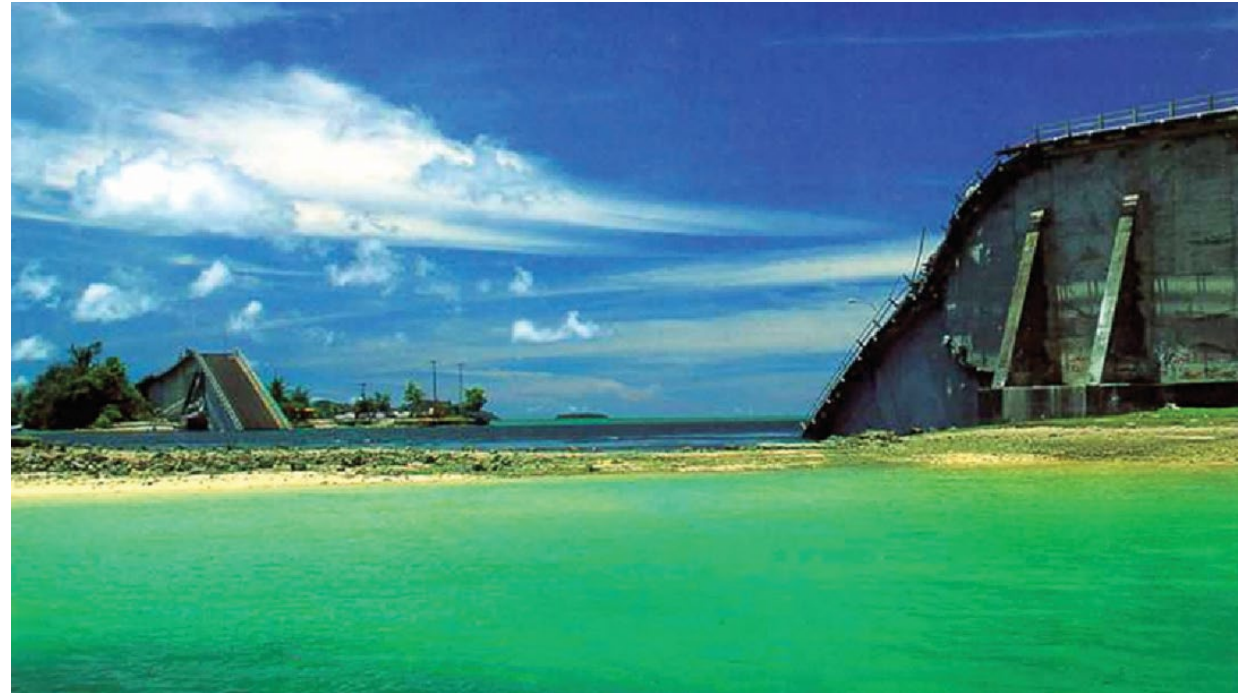
# Midspan Sag Assessment

- External PT considered to compensate for midspan sag
  - Sufficient doubt introduced when studying the available information from the Koror–Babelthuap Bridge collapse in 1996 in Palau (Western Pacific)

- Conclusion: Sag primarily service issue to be monitored for remaining bridge life
