SR 99: ALASKAN WAY VIADUCT & SEAWALL REPLACEMENT PROGRAM

Hazardous Materials Technical Memorandum S. Holgate Street to S. King Street Viaduct Replacement Project Environmental Assessment

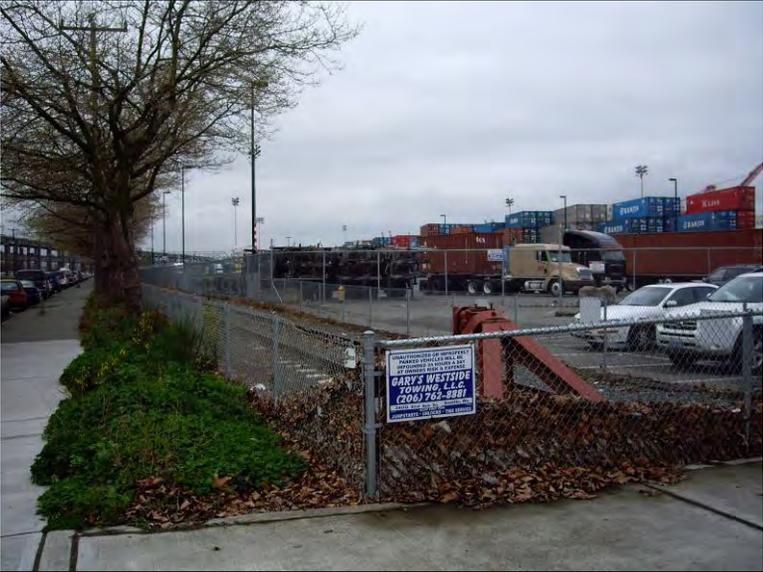
<p align="center">BLOCK NO. 360.1</p>	<p>Bounding Streets: Terminal 46 (S. King Street), Alaskan Way S., S. Royal Brougham Way, and Elliott Bay.</p>

<p>Property Description: The block is occupied by Terminal 46. The administrative building is located at approximately Site 360.1-4. An entrance is located across from S. Dearborn Street. The site is paved and used as a container terminal. A single-track rail line is located between the sidewalk on the west side of Alaskan Way S. and the terminal fence. Storm drains are visible on the east side of the tarmac.</p> <p><u>Acquisition Plan:</u> Partial; the east side of the block will be acquired.</p>
<p>Photo Description: Looking southwest at railroad track and containers at Terminal 46.</p>

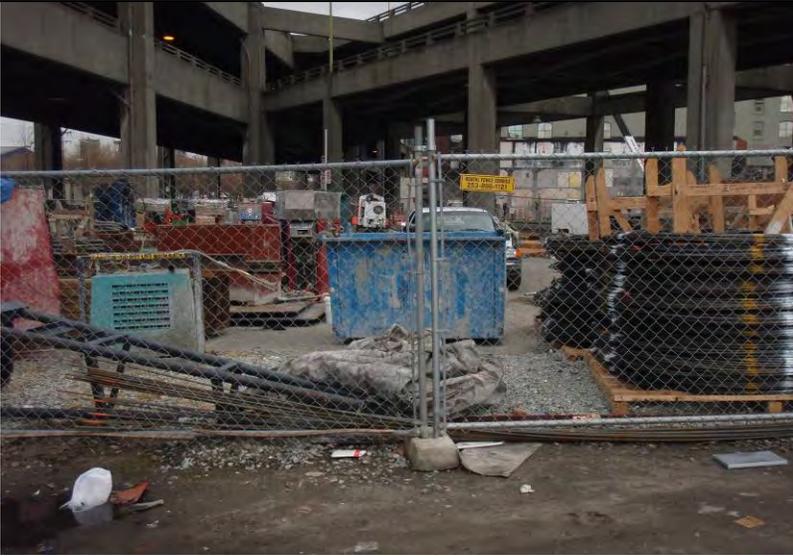
<p align="center">BLOCK NO. 360.15</p>	<p>Bounding Streets: Railroad Way S., S. Dearborn Street, Alaskan Way S.</p>

<p>Property Description: The south end of the block is unpaved and used as a parking lot. The north end of the block, which is partially paved and fenced, is used as a laydown area for the construction site located across the street (directly east of the block; Sites 360.2-2,-3, -4). Ecology blocks, pipe, spools of wire, and timbers were observed in the fenced area.</p> <p><u>Acquisition Plan:</u> Full. The block has been acquired by WSDOT for the Project. A Phase I ESA was conducted prior to purchasing the property.</p>
<p>Photo Description: Looking north at construction laydown area.</p>

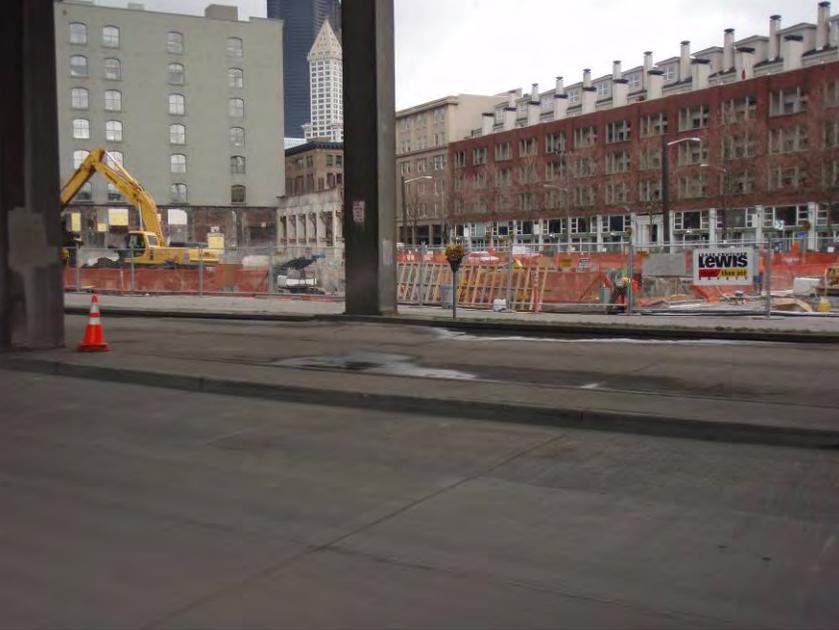
BLOCK NO. 360.2	Bounding Streets: S. King Street, First Avenue S., and Railroad Way S.

<p>Property Description: The middle portion of the block is a construction site. A brick building is located at the southern end of the block. The excavation at the time of the windshield survey was approximately 25 feet deep. No standing water was observed in the excavation. The material being removed from the excavation consisted of a dark silty sand and wood debris and timbers (approximately 50% wood debris).</p> <p><u>Acquisition Plan:</u> No, Block 360.2 is located adjacent to the WSDOT property (Block 360.15).</p>
Photo Description: Looking northeast at construction area.

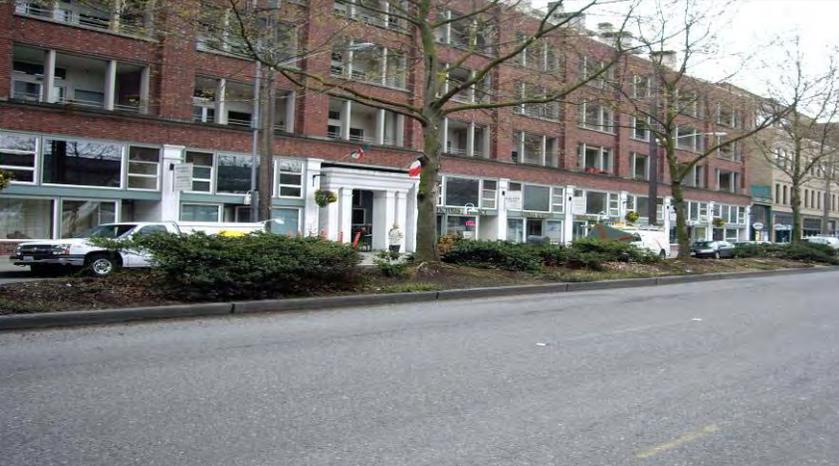
BLOCK NO. 360.3	Bounding Streets: S. King Street, Occidental Avenue S, and Railroad Way S., First Avenue S.

<p>Property Description: Block 360.3 is a mix of newer and old buildings (four stories). Good housekeeping practices were observed outside these buildings.</p> <p><u>Acquisition Plan:</u> No, Block 360.3 is located two blocks east of the project footprint.</p>
Photo Description: Looking southeast at mix of new and old brick buildings, retail and residential.

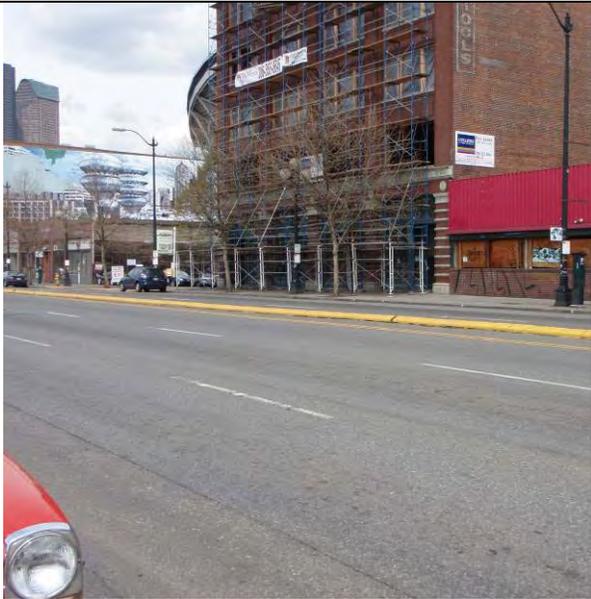
Avenue S., S. Royal Brougham Way, and First Avenue S.

<p>Property Description: The block is a mix of new buildings and older brick buildings. Good housekeeping practices were observed outside of the buildings.</p> <p><u>Acquisition Plan:</u> No, the block is located across the street from Block 370.1, which has been acquired as a laydown area and diagonally across the intersection (northeast) of the project footprint.</p>
<p>Photo Description: Looking northeast at older brick buildings.</p>

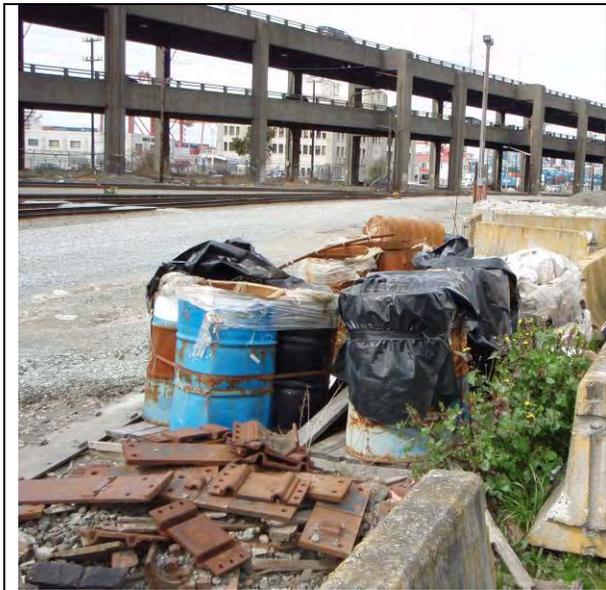
BLOCK NO. 390.2

The area is unpaved and sparsely vegetated. Ecology blocks are used to block access to the property. The east edge of the property is unpaved and used for parking (along Colorado Avenue S.). The southeast corner of the block is being used as a storage area. A pallet of boxes containing nuts and washers and a pallet with drums containing iron bolts were observed. Railroad ties, bags of sand, and plastic sheeting are also stored in the area. On the western edge of the block, a few scattered piles of debris, including wooden boxes, plastic sheeting, and garbage, were observed. A few small mounds (3 feet high) of gravel were also observed on the east side of the block. The project footprint is on the east, north, and west sides of this block.

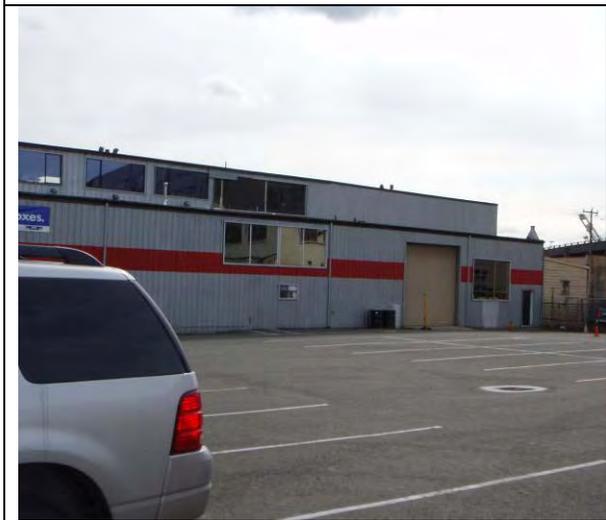
BLOCK NO. 390.3

The north end of the block is used by Sound Produce. Site 390.3-2, fronting on First Avenue S., has a paved parking area. It appears that the site is undergoing a site investigation. Drums containing soil cutting are stored on-site. The drums appear to be in good condition. In addition, spray-painted boring locations were clearly visible on the asphalt. The boring locations were midblock and closer to Utah Avenue S. than Colorado Avenue S. The southern end of the block is occupied by a fully fenced substation.

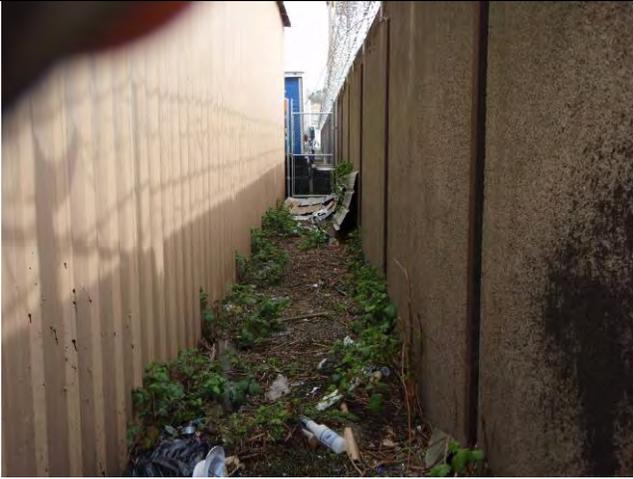
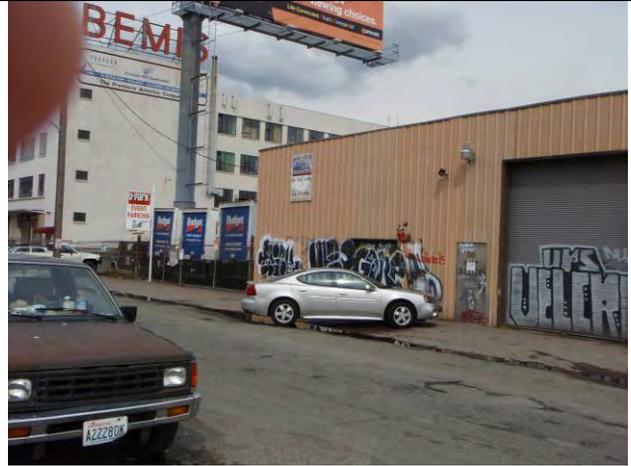
BLOCK NO. 390.3 (Continued)

Photo Description: Looking east, at gap between building and substation on the east side of Colorado Avenue S.

Photo Description: Looking northeast at the east side of Colorado Avenue S.; parking area for Budget trucks.

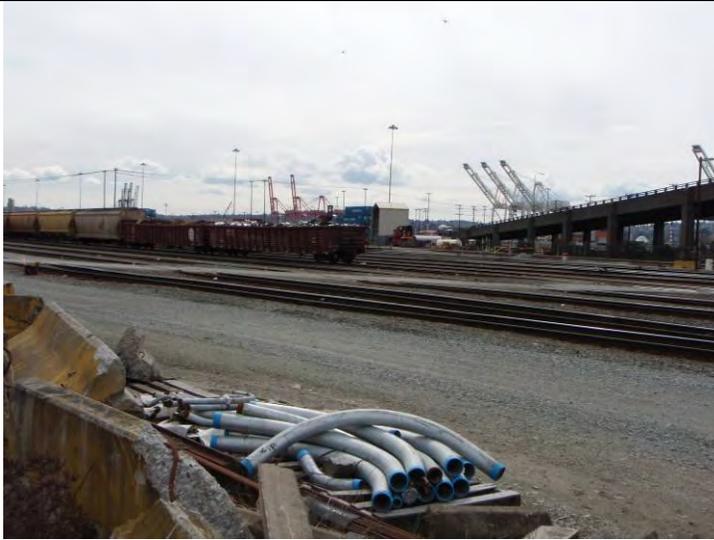
BLOCK NO. 400.2

The block is unpaved and used by the railroads. Numerous rail lines are located on the block. A storage area is located on the west side of the block and extends north to Block 390.2. The west side of the block fronts on Alaskan Way S.

Photo Description: Looking southwest at laydown area and railyard.

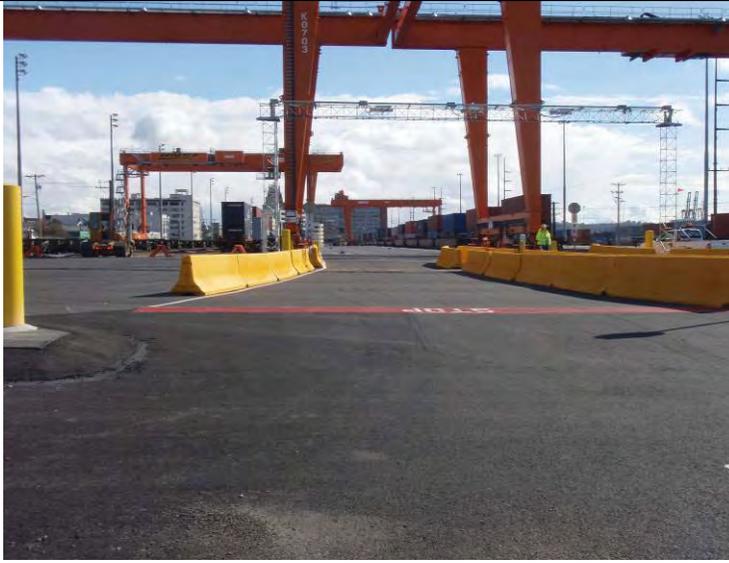
BLOCK NO. 400.3

Property Description:
 The property is a container loading terminal where containers are transferred from trucks to rail. The railyard is paved.

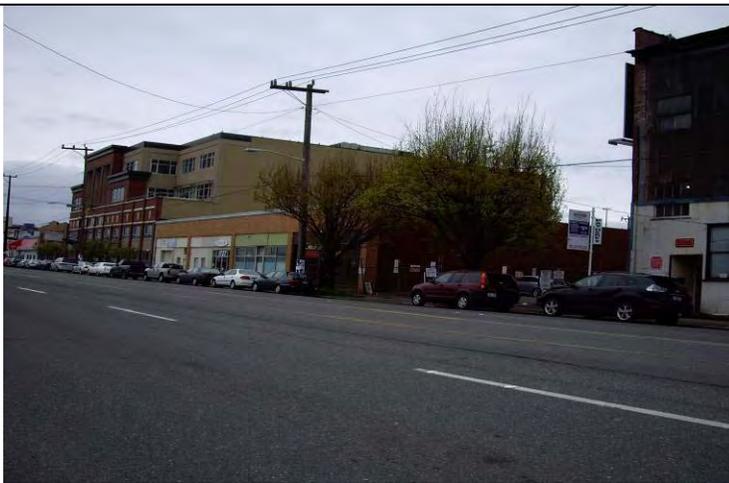
BLOCK NO. 400.4

Property Description:
 The property is occupied by older one-to four-story retail and warehouse type buildings and parking lots. Good housekeeping practices were observed outside these buildings.

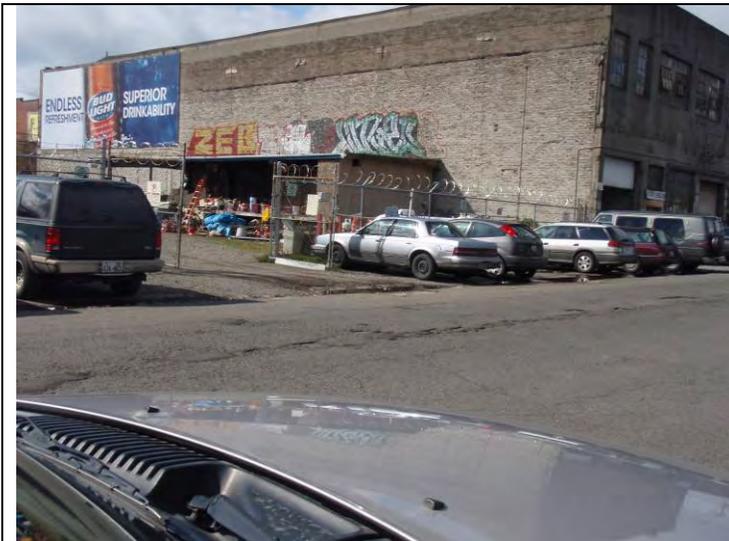
BLOCK NO. 400.5

Older retail and warehouse buildings were observed. Poor housekeeping practices were observed, approximately midblock at 1711 Occidental Avenue S. (Queen City Sheet Metal and Industrial Rebuild). Portable gasoline cans, buckets, mastic cement, fire extinguishers, and tarps were observed in a covered loading dock. The site is unpaved. Large propane tanks were located under a lean-to shed.

Photo Description: Looking southwest at Queen City Sheet Metal and Industrial Rebuild loading dock.

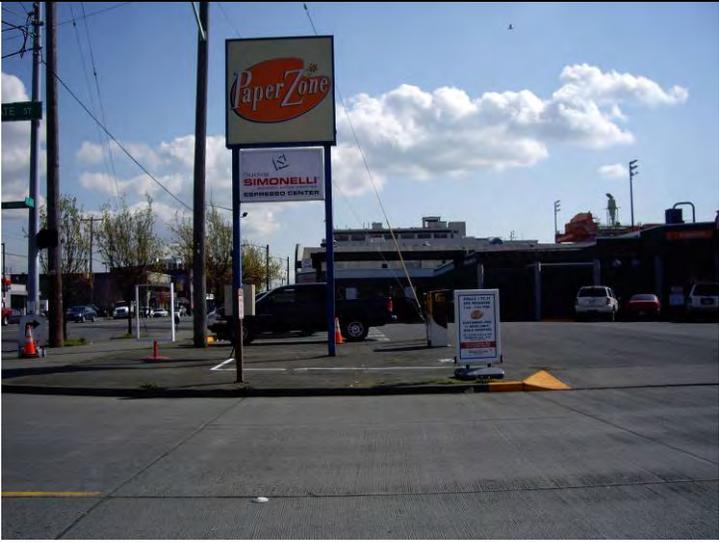
<p align="center">BLOCK NO. 410.4</p>	<p>Bounding Streets: S. Holgate Street, First Avenue S., S. Walker Street, and Utah Avenue S.</p>

<p>Property Description: Older retail, warehouse buildings, and parking lots were observed. Dumpsters were located on Utah Avenue S. Good housekeeping practices were observed outside of these buildings.</p> <p><u>Acquisition Plan:</u> No, the block is located three blocks east of the project footprint.</p>
<p>Photo Description: Looking south at retail business.</p>

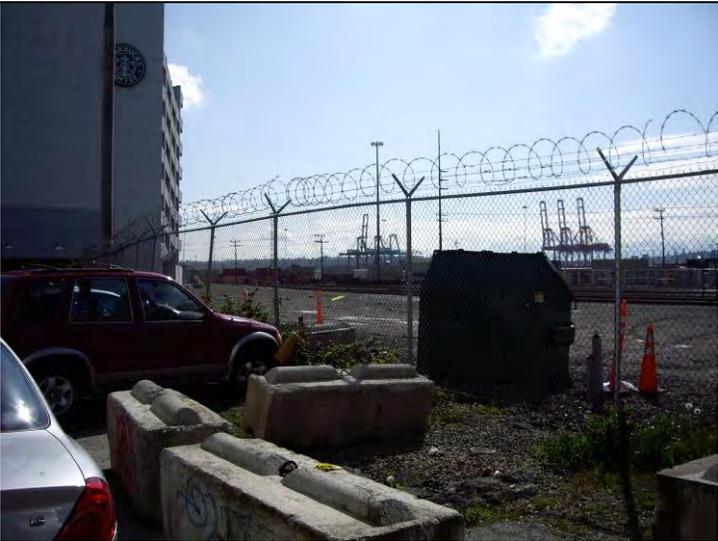
<p>BLOCK NO. 420.1</p>	<p>Bounding Streets: Railroad tracks (S. Walker Street), Utah Avenue S., railroad tracks (S. Stacy Street), railroad tracks.</p>

<p>Property Description: Starbucks parking garage and SIG Railyard.</p> <p>Acquisition Plan: No, the block is located two blocks southeast of the project footprint.</p>
<p>Photo Description: Looking southwest at SIG Railyard.</p>

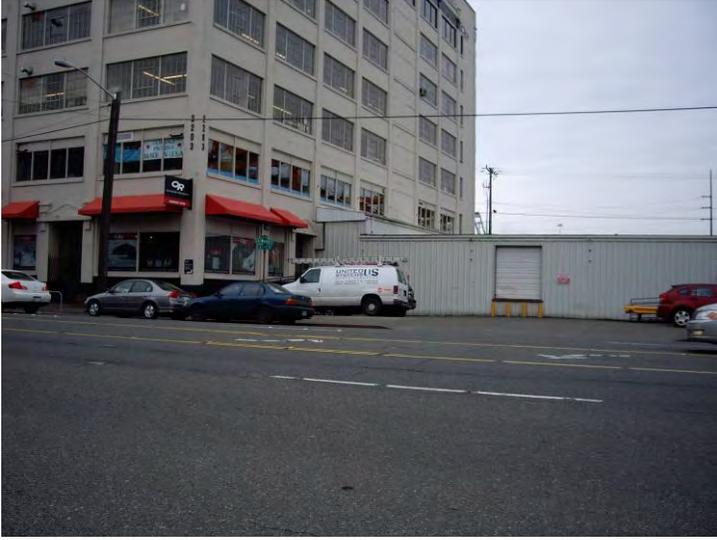
<p>BLOCK NO. 420.2</p>	<p>Bounding Streets: S. Walker Street, First Avenue S., S. Stacy Street, and Utah</p>
-------------------------------	--

<p>Avenue S.</p> <p>Property Description: Older retail buildings and warehouses were observed. Good housekeeping practices were observed outside the buildings.</p> <p><u>Acquisition Plan:</u> No, Block 420.2 is located three blocks southeast of the project footprint.</p>
<p>Photo Description: Looking southwest at older retail building.</p>

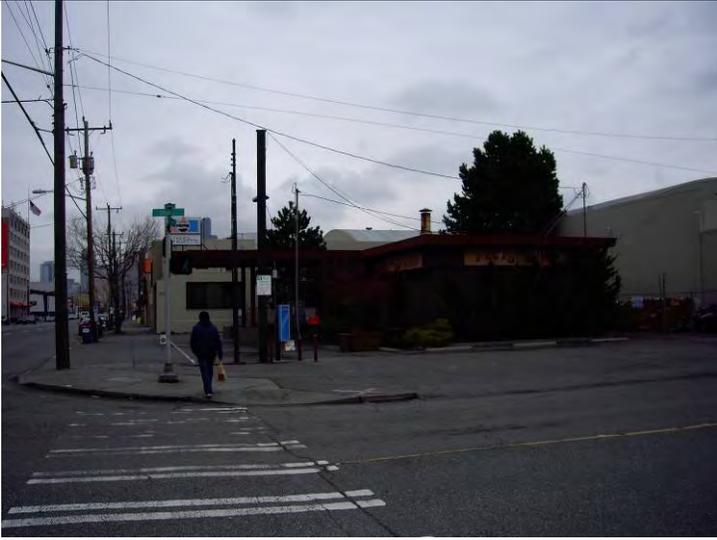
<p>BLOCK NO. 420.3</p>	<p>Bounding Streets: S. Walker Street, Occidental Avenue S., S. Stacy Street, and First Avenue S.</p>

<p>Property Description: Older retail buildings and warehouses were observed. Good housekeeping practices were observed outside the buildings.</p> <p><u>Acquisition Plan:</u> No, located four blocks southeast of the project footprint.</p>
<p>Photo Description: Looking north at a retail building.</p>
