Unfunded Preservation Needs

Adams County

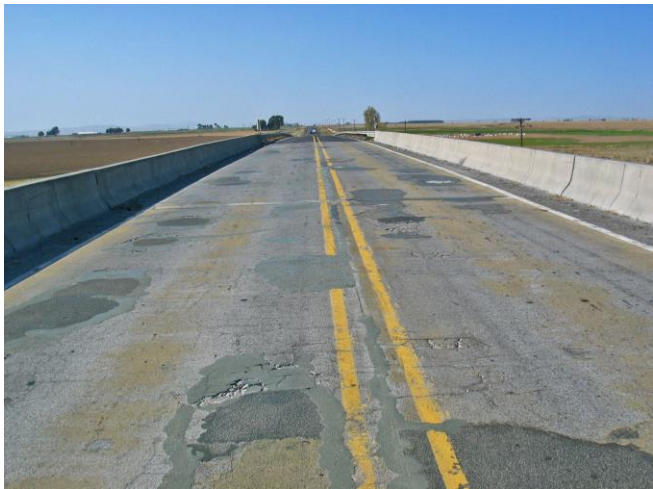
This bridge over the Koren Railroad is deteriorated with patching, cracking and spalling throughout.

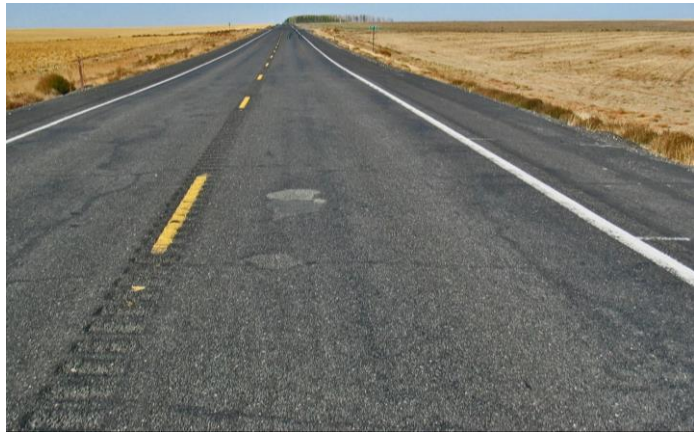
Pavement is rough, rutted and deteriorated. To restore structure, heavier rehabilitation like Cold-In-Place recycling is needed.

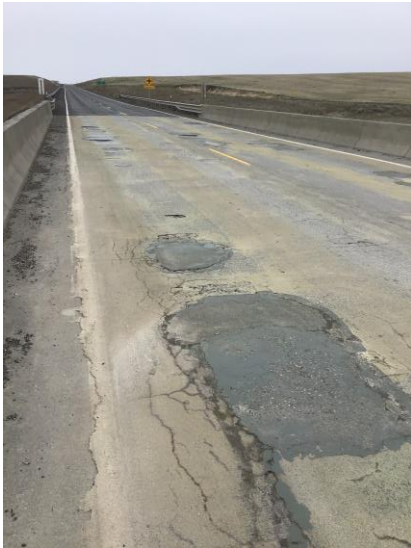
The Providence Coulee Bridge deck is deteriorated, with patching, cracking and spalling throughout. Replacing the top 3” of concrete will extend the bridge life. Left unaddressed exposes the entire deck to more deterioration, and the entire deck will need to be replaced.

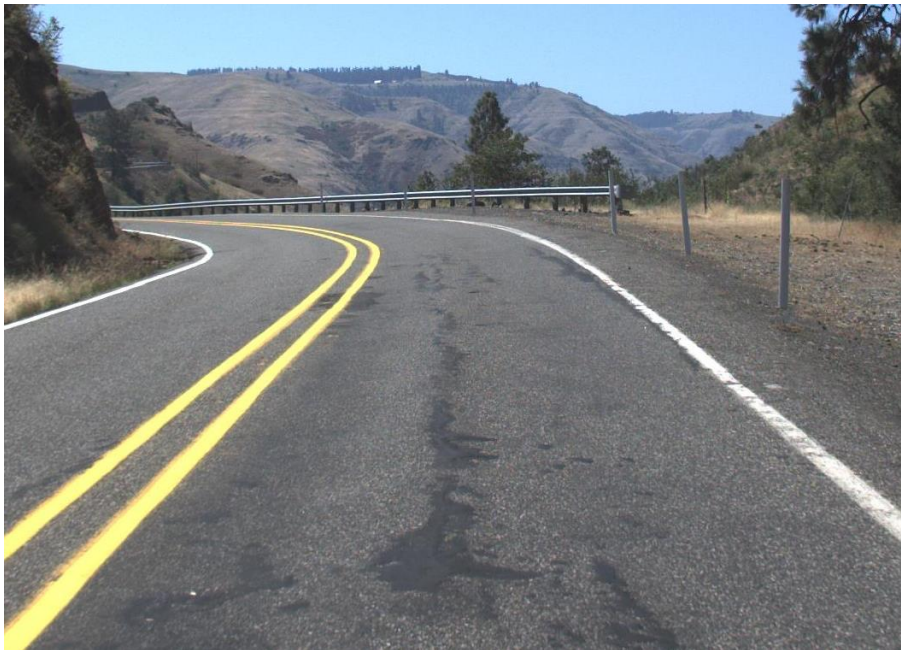
WSDOT has been cost-effectively managing this corridor for 70 years through chip seal surfacing. The first ten miles are rougher than WSDOT standards. Not chip sealing and repairing rough sections during the next ten years makes it very likely much of this route will need major rehabilitation or reconstruction.

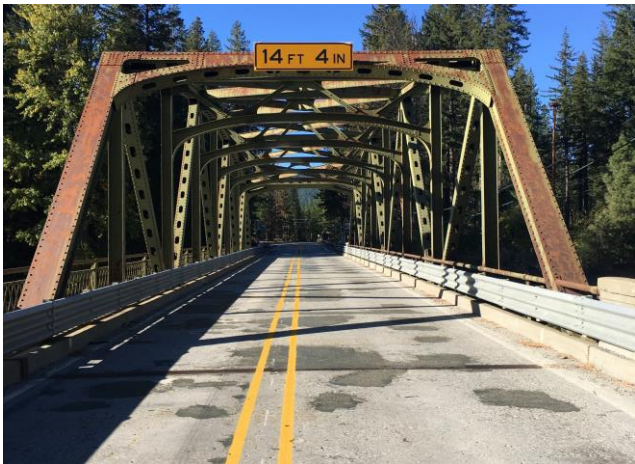
The Wenatchee River Bridge on State Route 207 shows significant rust on its superstructure and steel members. It has extensive patching and cracking in the deck. It needs painting and deck resurfacing.

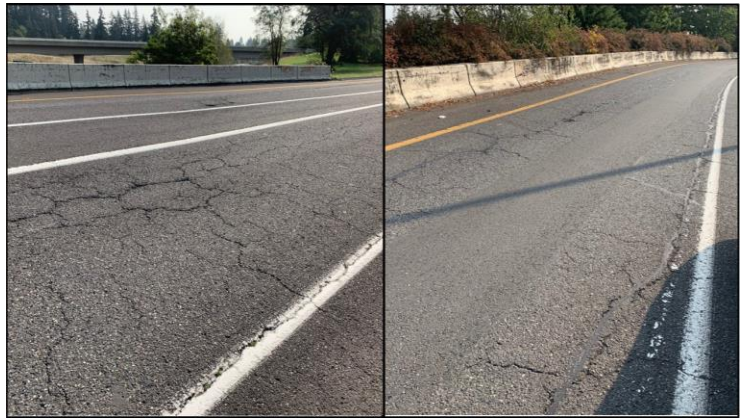
There are numerous ramps that are a part of interchanges in Clark County. Here are examples of extensive crack on just two of them.

Even though ramps have lower speeds, deteriorated ramps will make it more difficult to accelerate to highway speeds for on-ramps, and distressed off-ramps will require alert drivers to manage the change in condition as they transition from smoother pavements on T-1 freight mainlines, like I-5 and I-205. The longer they are left to deteriorate, the more extensive and expensive the fix will be.

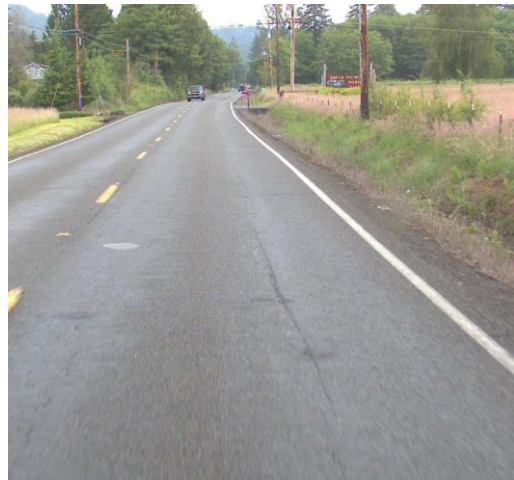
State Route 500 is showing early cracking and potholes, after it was last resurfaced with chip seal in 2016. This chip seal was applied late to try to preserve the pavement without more expensive asphalt resurfacing, but the pavement was more distressed than ideal conditions. WSDOT only used a late chip seal approach due to Preservation underfunding. This is an example of why WSDOT cannot continue to try to “hold together” roadways with less than 50% of the funding required.

Moreover, this section may benefit from centerline rumble strips according to a statewide screening. Installing these rumble strips in conjunction with the proper pavement preservation will cost vastly less than installing them in failed pavement.

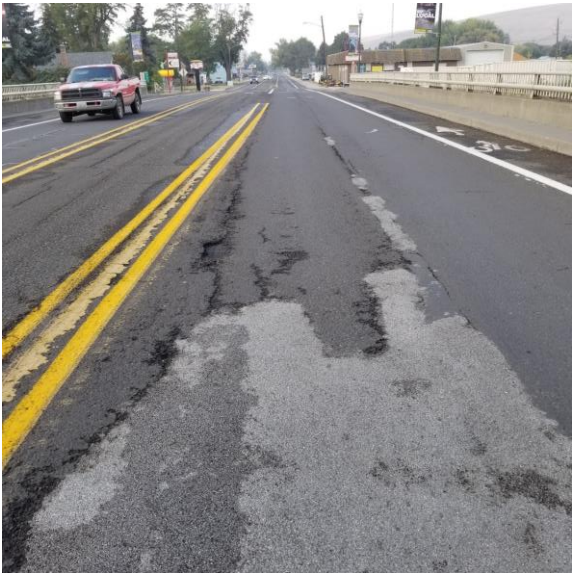
US 12 in Dayton pavement deterioration including rutting, longitudinal cracking and multiple patches.

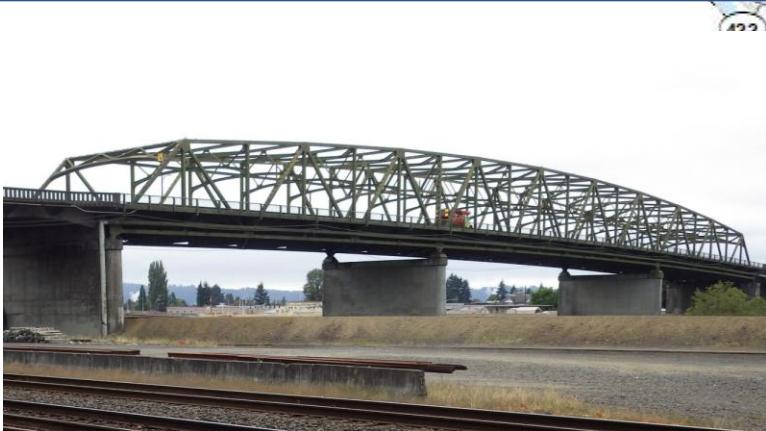
The Cowlitz River bridge on State Route 4 in Kelso is in need of painting and expansion joint repair.

Painting steel bridge members on time reduces the amount of corrosion, and therefore steel repair, if a late paint job is done. Delaying painting too long will cause extensive corrosion, require major replacement activities.

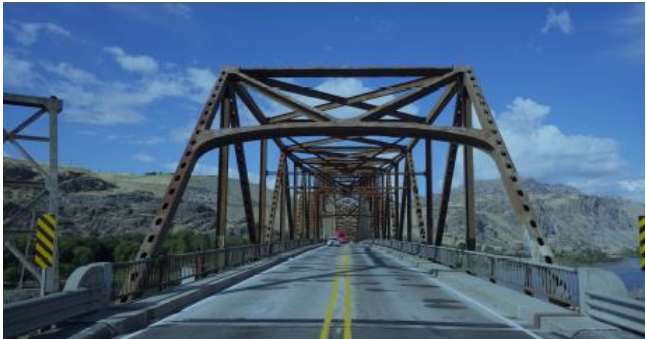
The US 97 Columbia River Beebe Bridge has extensive patching in the deck. The steel surfaces are weathered and deteriorated, allowing corrosion to occur.

This bridge needs painting and a deck resurfacing.

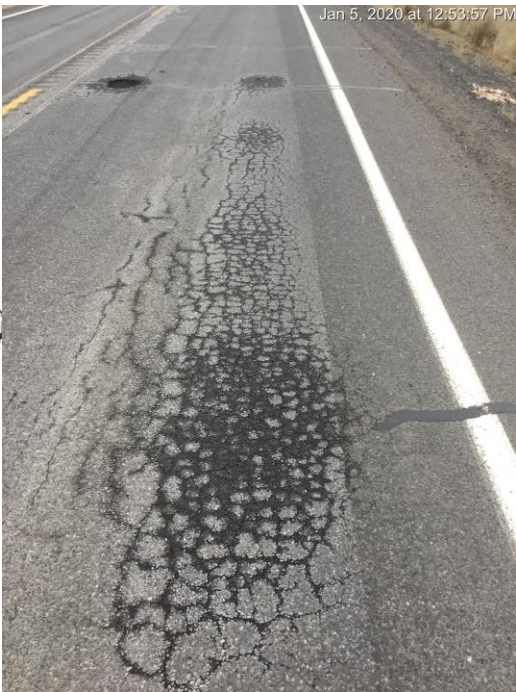
On State Route 17 Leahy West, the pavement is cracked and rutted.

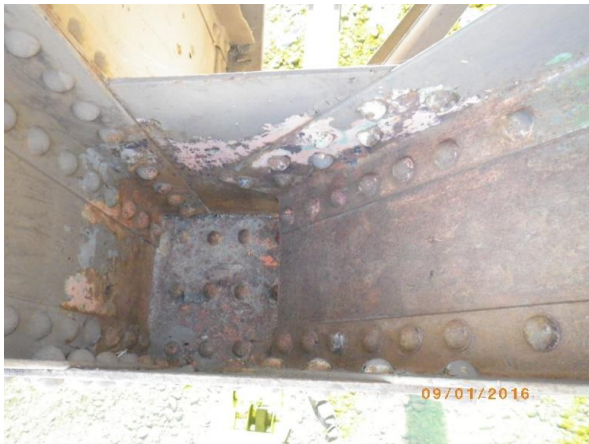
The Kettle River Bridge on State Route 21 has extensive rust on its structural members, due to being overdue for painting. It also has expansion joints that need to be replaced. When painting is missed, the steel rusts and corrodes, making the next paint job much more costly. If not painted after some years, the corrosion will require all the steel structure to be replaced.

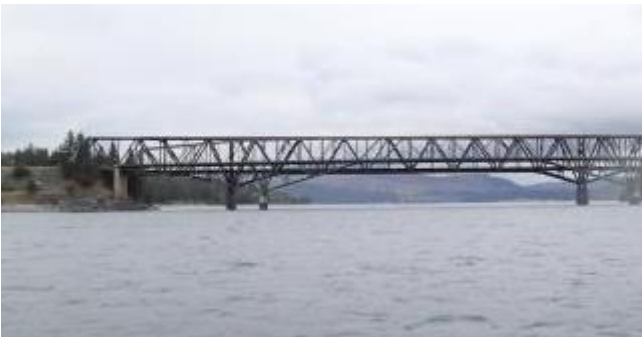
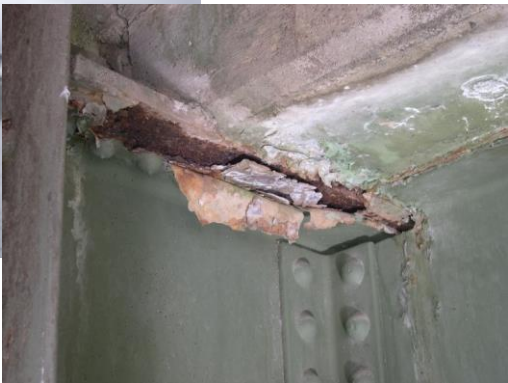
The Columbia River bridge near Kettle Falls on US 395 on the eastern edge of Ferry County has extensive rust on its structural members, due to being overdue for painting. It also has expansion joints that need to be replaced.

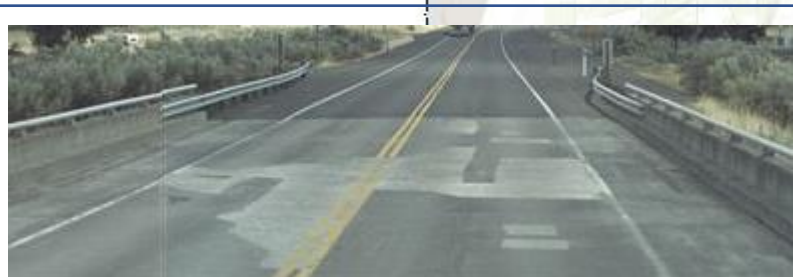
There is substantial patching on the Dry Wash Bridge in Khalotus on State Route 260, causing it to be in poor condition.

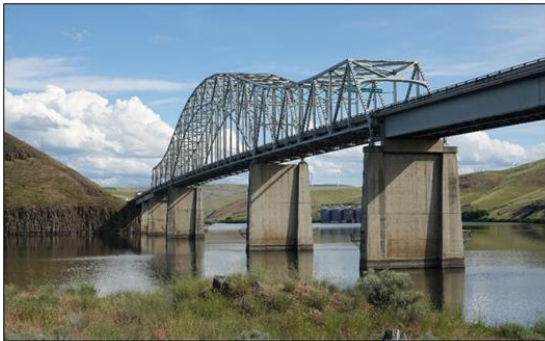
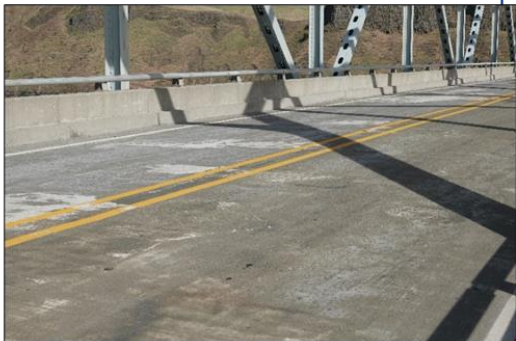
The Elmer C. Huntley Bridge on State Route 127 deck is deteriorating requiring frequent repairs by maintenance to fill holes. The steel portions of the bridge are also rusting and need to be painted.

In 2019, WSDOT made a temporary fix to try and extend the life of the bridge until the bridge deck can be replaced, however new issues develop every day. At current funding levels, it will not be replaced.

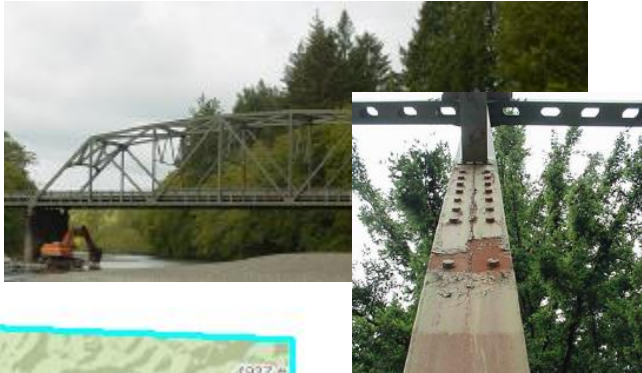
The Humptulips River bridge on US 101 has several areas of peeling paint and rust blooms scattered throughout the truss. It has been 29 years since it the last painting and it is due for painting.

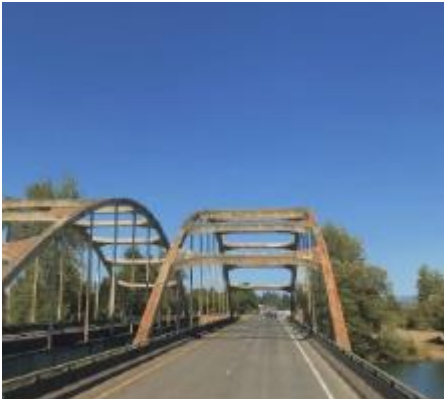
Both Satsop River bridges on State Route 12 are due for painting, with minor pack rust, cracked paint and rust stains. Additionally, the northern structure is due for deck resurfacing.

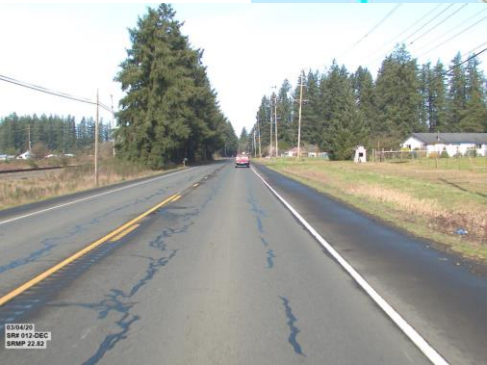
Extensive crack sealing on US 12.

This section could have been chip sealed as a more cost-effective approach to preserve, but prioritized needs pushed it to now need asphalt resurfacing. The project to resurface it with asphalt in 2025 is on the edge of what WSDOT can fund – the number of T-1 bridges WSDOT estimates that need preservation is higher than the budget, and this work may be un-programmed to get more T-1 bridge work completed.

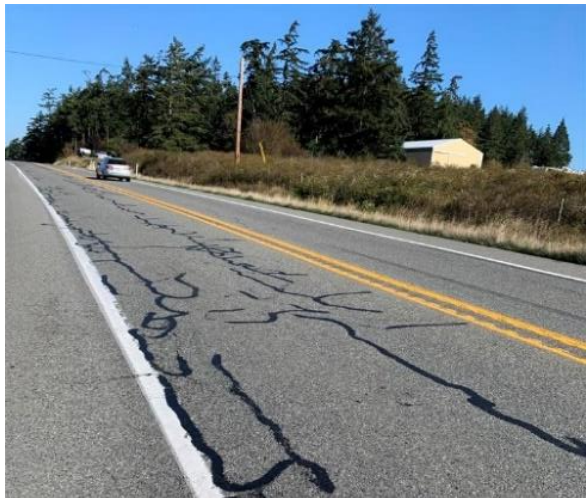
Last paved 20 years ago, the pavement is distressed and deteriorated south of Oak Harbor. Crack sealing has been applied.

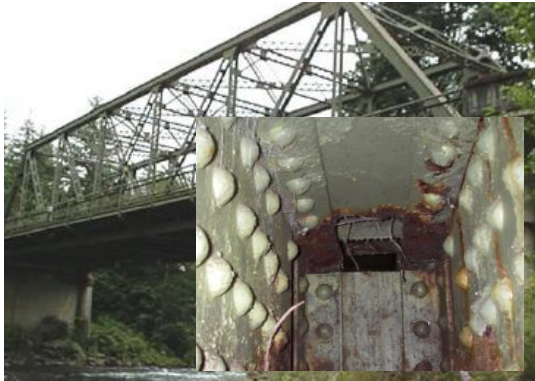
The Big Quilcene River bridge on US 101 was last painted 30 years ago and the paint is peeling off. Additionally, the deck needs resurfacing and joints need to be repaired.

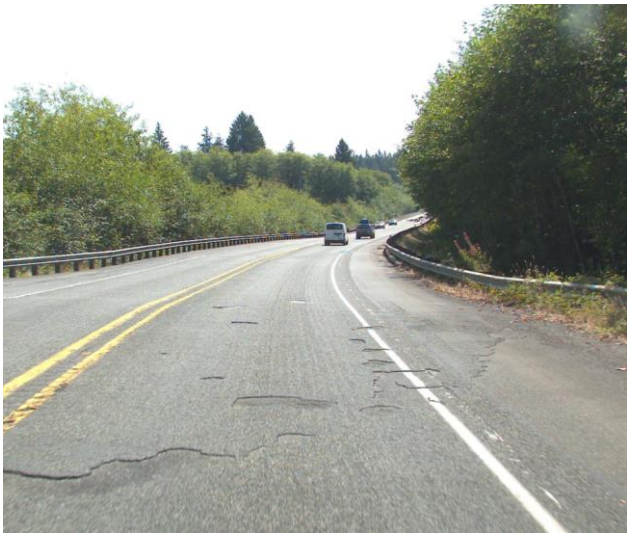
Delamination of chip seal on US 101 near Queets. The rate of delamination of existing chip seal will increase each subsequent winter until the roadway is resurfaced. Water will inevitably enter the pavement structure and compromise its integrity, which will require more extensive rehabilitation or reconstruction to repair.

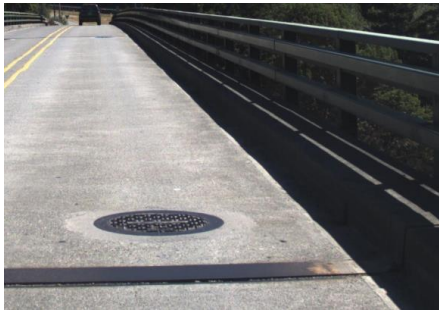
On the State Route 116 Portage Canal bridge, the steel has numerous rust blooms coming through the paint and has failed on the edges. It is due for painting and joint repair.

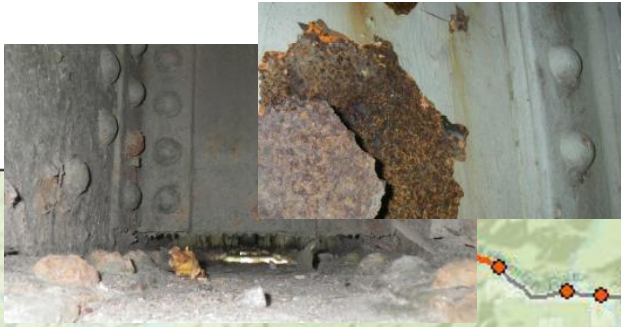
The bridges on State Route 202 over the Snoqualmie and South Fork Snoqualmie need steel painting. Paint is peeled and cracked throughout and there are rust in steel members.

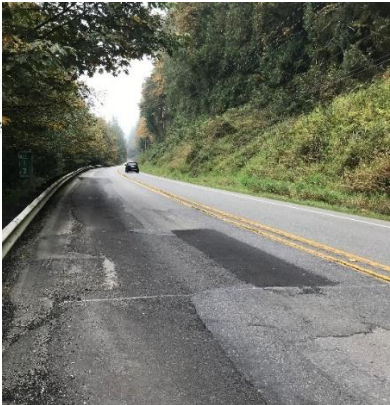
Extensive cracking, deterioration, settlement and maintenance patching of the pavement on State Route 202.

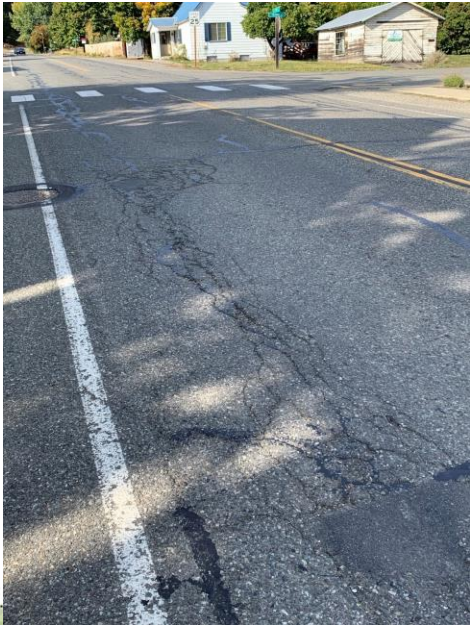
Extensive alligator cracking with some patching and crack sealing on SR 903 in Roslyn.

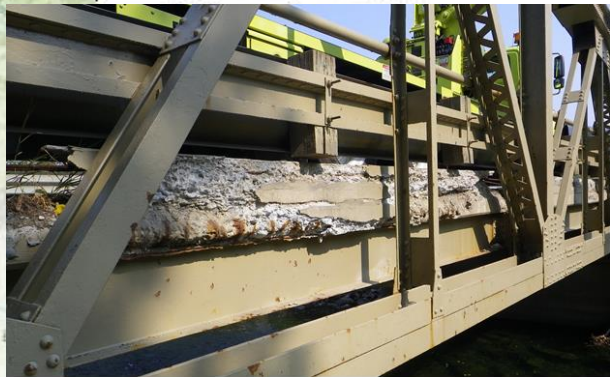
The 90-year-old Teanaway River bridge on State Route 10 is in poor condition, is showing signs of severe deterioration and needs to be replaced.

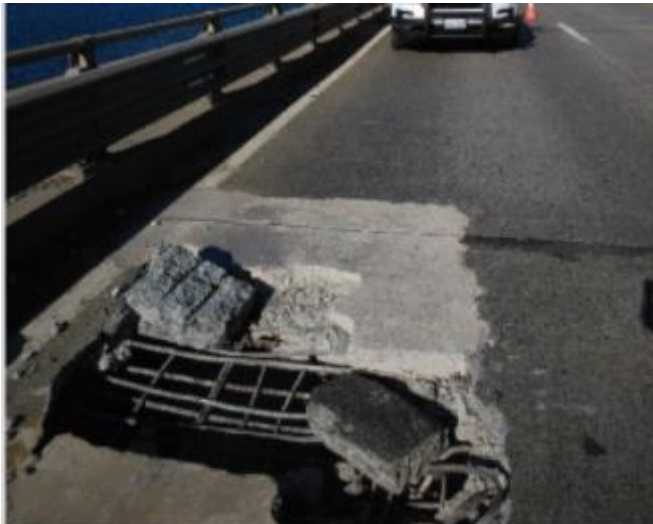
The Vantage Bridge experiences frequent blow outs creating holes in the deck requiring unplanned emergency repairs resulting in long traffic . Patches that were meant to be temporary have failed, and WSDOT is replacing the patches in this lane with patches expected to help the deck last until it is able to be funded for full deck rehabilitation. It is estimated to cost about \$40 million to rehabilitate this vital bridge deck.

While WSDOT has been deferring this work to try and keep the entire state highway system operational, it can no longer be ignored without dire consequences. As such, WSDOT has taken a priority approach that recognizes that it is impossible to keep the entire state system functional at the current budgeted levels. It will still be a few years before WSDOT will be able to fund this deck rehabilitation at these funding levels.

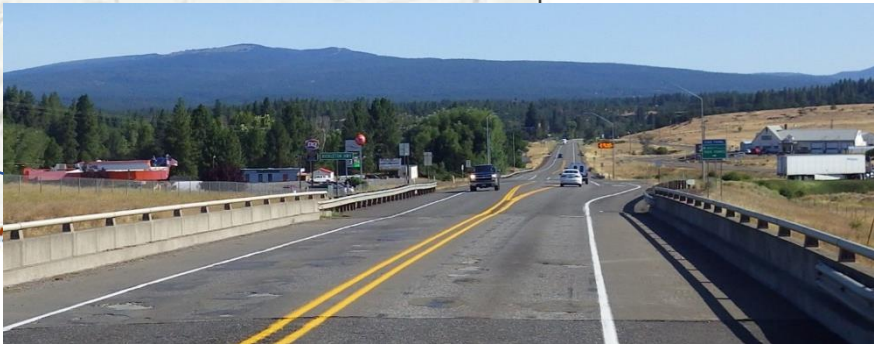
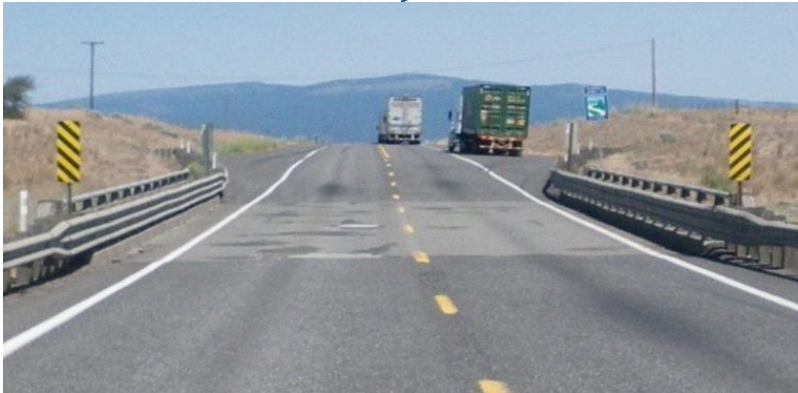
Extensive cracking and patching on the Swale Creek bridge deck and Bickleton Road bridge deck on State Route 97. Deck resurfacing is needed not only for a smooth, pothole free driving surface, but to protect the underlying bridge structure. Left unaddressed the entire deck may need to be replaced.

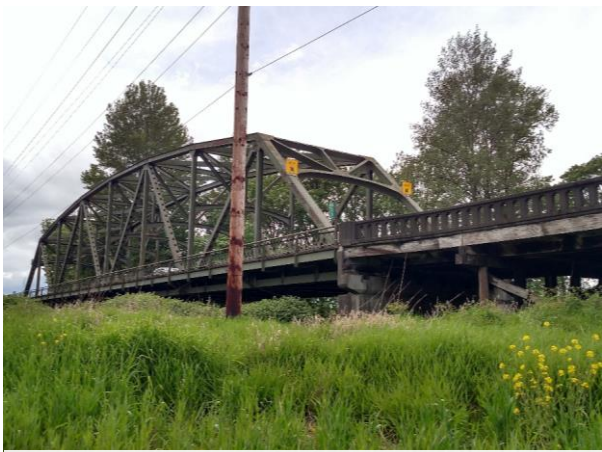
The Chehalis Riverside is a timber bridge on State Route 6 was built in 1939. It is currently load restricted and needs to be replaced.

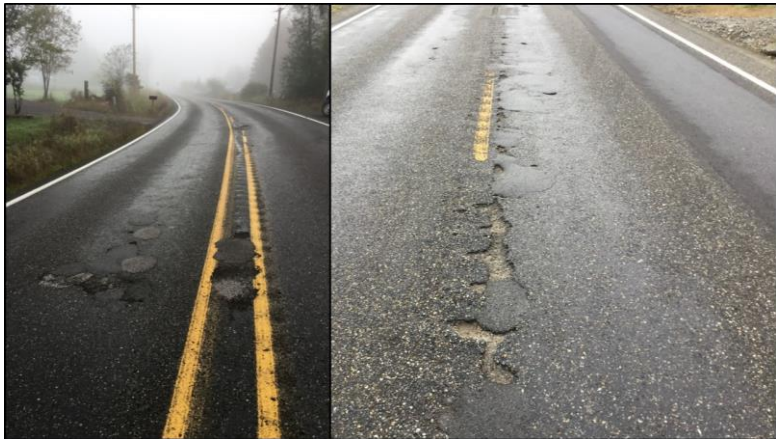
Cracking and delamination on State Route 508. In addition to the pavement structure being at risk, deteriorated pavements make it much more costly or even prohibitive to keep rumble strips in place. Major rehabilitation will be required if not addressed in ten years, and the need for full reconstruction is likely.

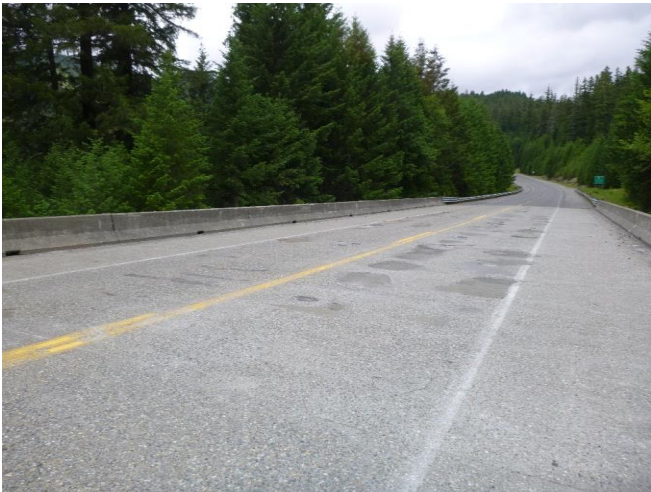
This bridge on US 12 over the Clear Fork of the Cowlitz River shows patching and potholing and needs resurfacing.

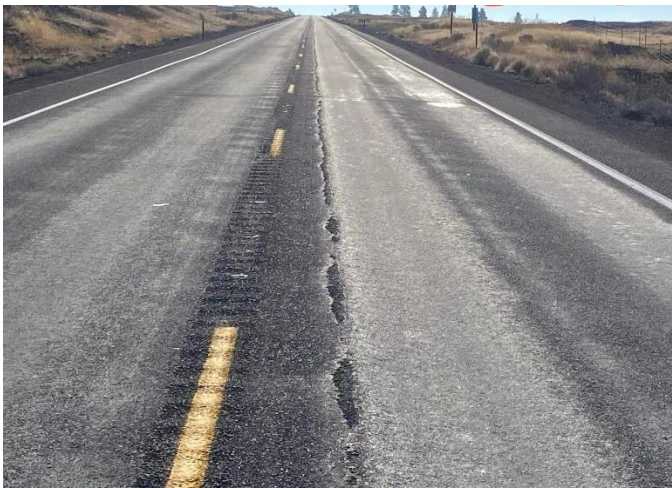
Delamination and rutting on US 2.

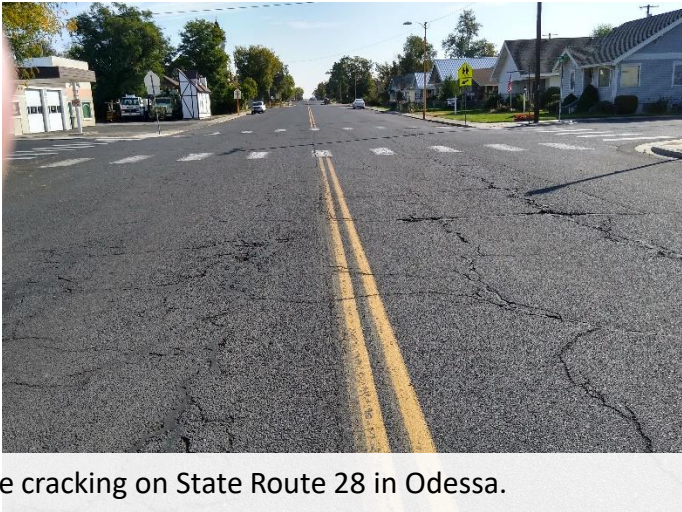
Severe cracking on State Route 28 in Odessa.

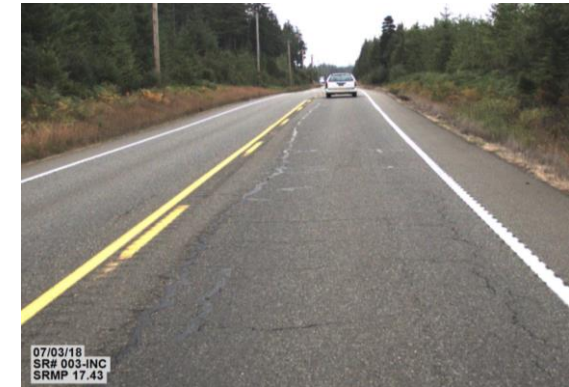
Severe cracking on State Route 3. The surface cracking is widening and rapidly expanding. This will cause the pavement to deteriorate more quickly and result in significantly increase pavement repair costs at the time of the next resurfacing project.

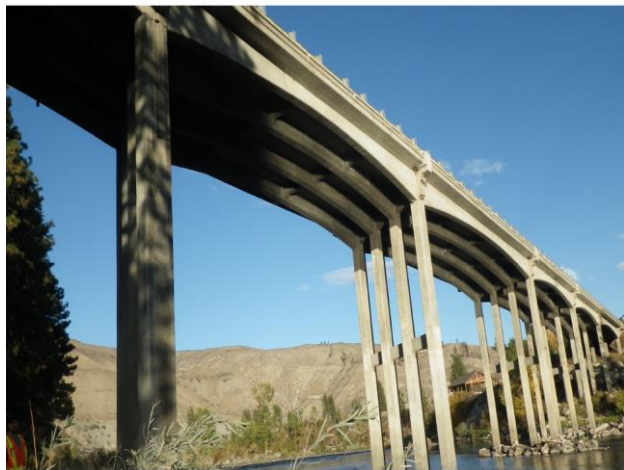
There are eight bridges over the Methow River on State Route 153 that need to be replaced. From 2016 to 2019 there have been increased structural and deck repair projects to keep these bridges operable. Critical structural repairs to portions of struts and columns have been accomplished to keep them operable. Decks have recently had only critical rehabilitation work to replace the worst decay with protective membranes and asphalt replaced for protection. Two of these bridges have had their walkways closed due to concerns over the deterioration of the concrete baluster rail, tripping hazards, and overall structural integrity of the walkway. Closures of several other walkways are anticipated soon. All bridges are in poor condition.

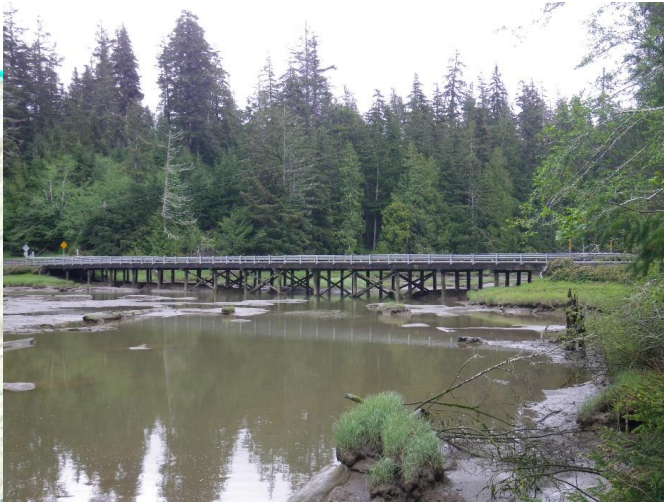
The Teal Slough bridge on US 101 is a timber structure built in 1934. It needs to be replaced.

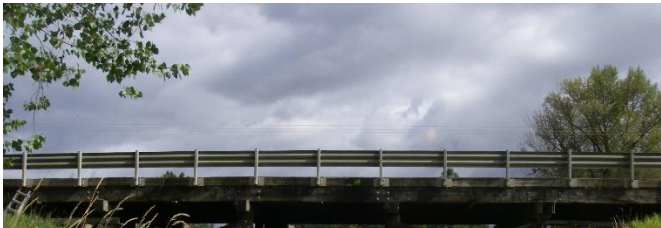
The Davis Creek and Lost Creek bridge are timber structures that were built in the mid-1930s. The timber portions are rotting, and the bridges need to be replaced.

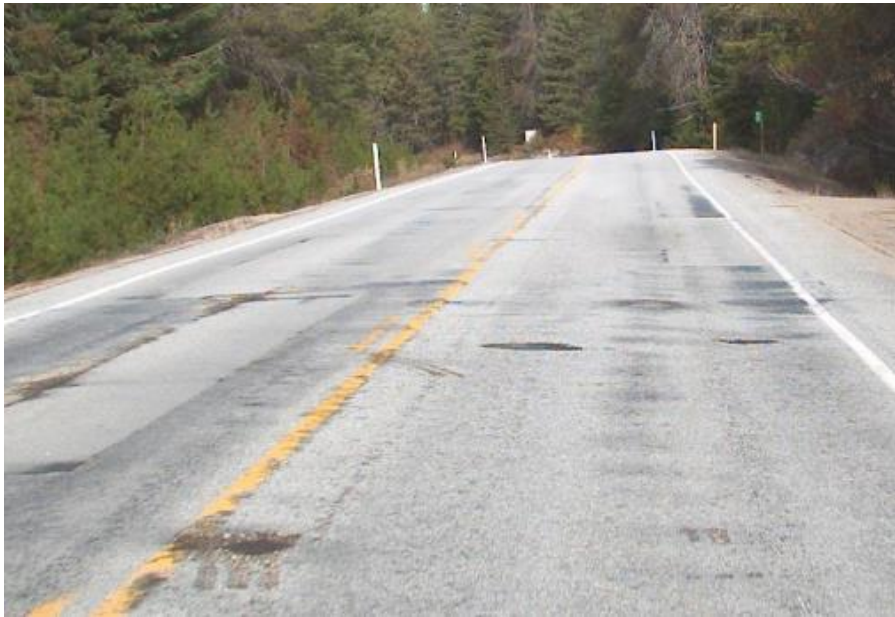
There is extensive patching through State Route 211. Some additional potholes have formed at this location and require patching.

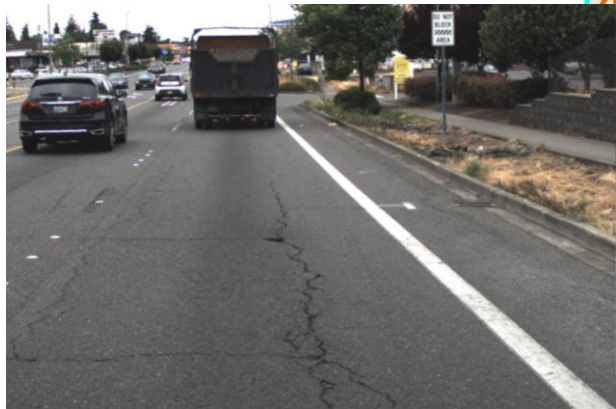
SR 7: Pavement cracking and potholes have reached a point where rehabilitation is needed now. There are also multiple expansion joints needing replacement at the north end of SR 7.

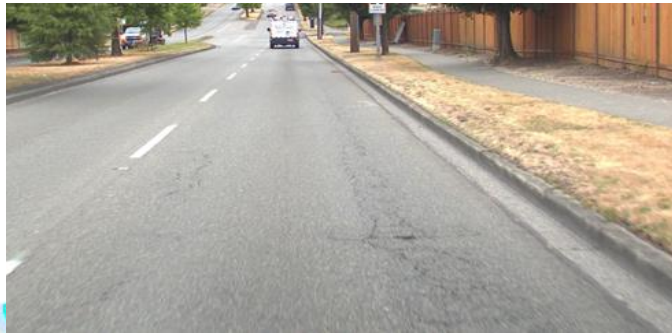
SR 163: Pavement cracking and potholes have reached a point where reconstruction is likely.

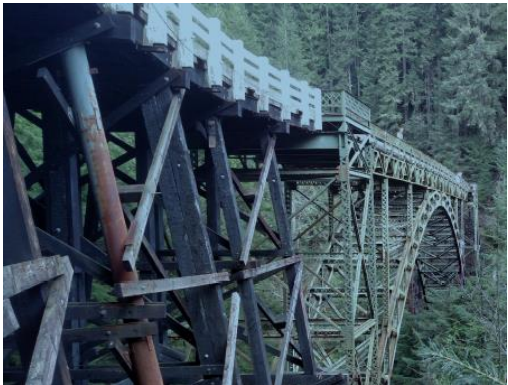
SR 165 Carbon River Bridge: Steel components need painting. Rust blooms throughout the rivets and plates, with some starting on stringers and floor beams. This sections also needs paving in the next ten years.

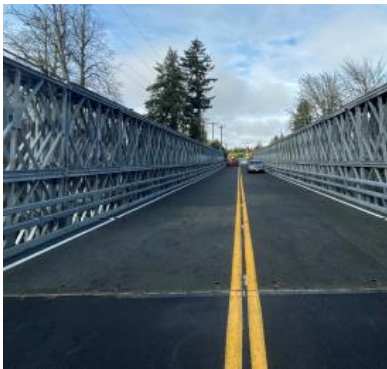
SR 162 Spiketon Creek Bridge: Bridge was closed in 2018, and an acrow temporary bridge was installed over the existing bridge in 2019 for \$3.6 million. The old bridge still needs to be removed and replaced. This work does not prioritize at current funding levels, but may be required in conjunction with adjacent fish barrier corrections.

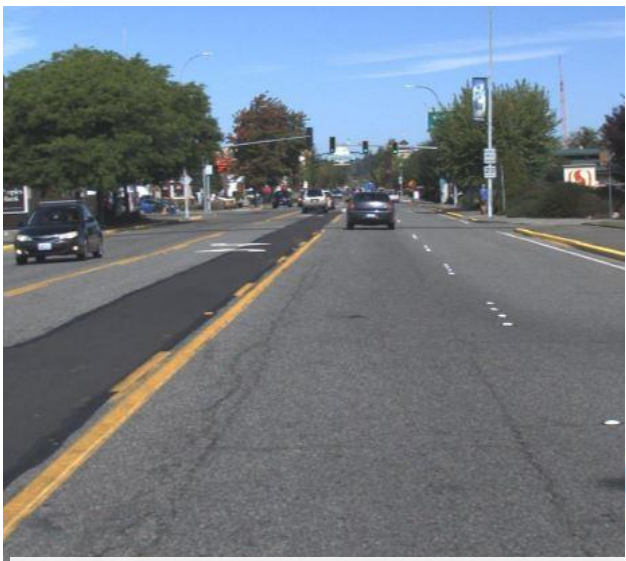
Last paved in 1997, extensive cracking and patching on State Route 20 Spur through Anacortes.

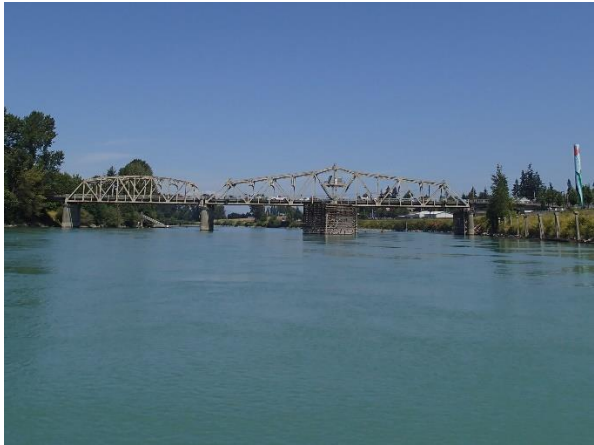
The Skagit River bridge on State Route 536 is overdue for painting. It also has expansion joints in need of replacement. It requires frequent attention by Maintenance staff to clear debris that collects at its piers, and also to tighten previously moveable features that are locked into place.

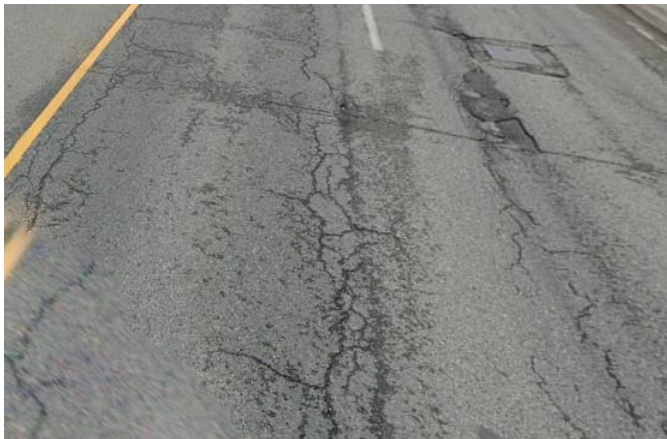
State Route 538 was last paved between 1980 and 2002. Cracking and deterioration is prevalent, with some sections delaminating and spalling.

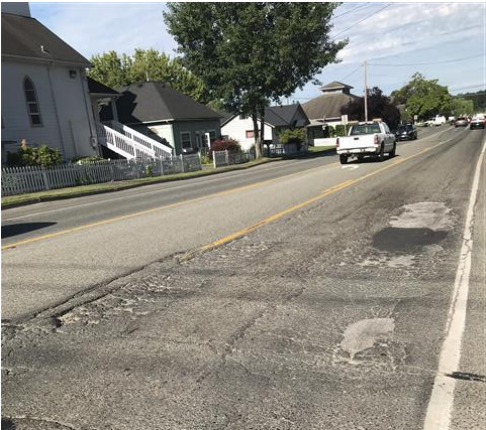
Potholes and full width cracks on State Route 530 in Arlington. This section needs to be reconstructed.

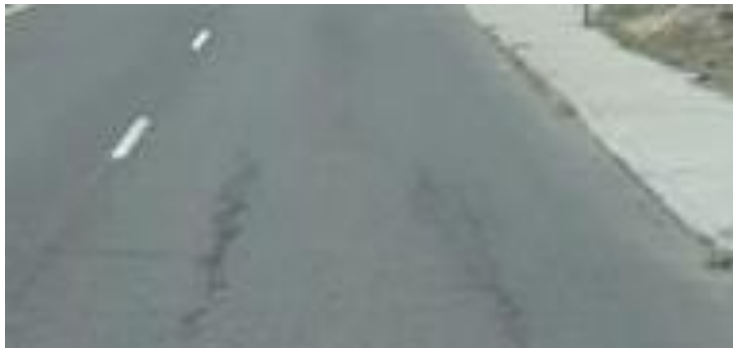
Pavement cracking in wheel paths on State Route 291.

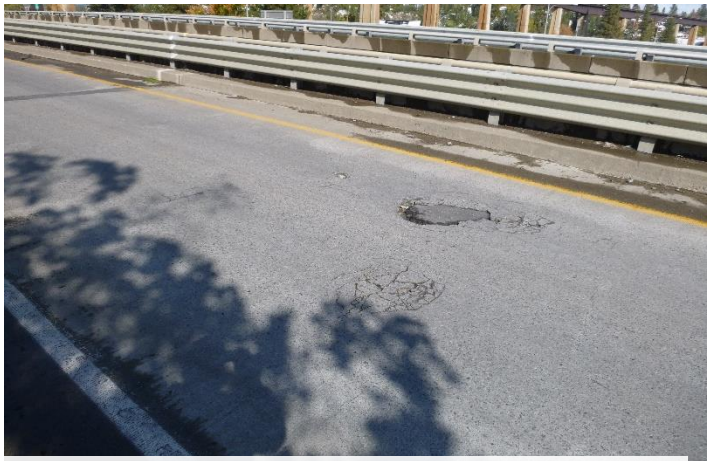
Cracking and patching on the US 195 bridge over I-90. The deck will need to be resurfaced in the next few years.

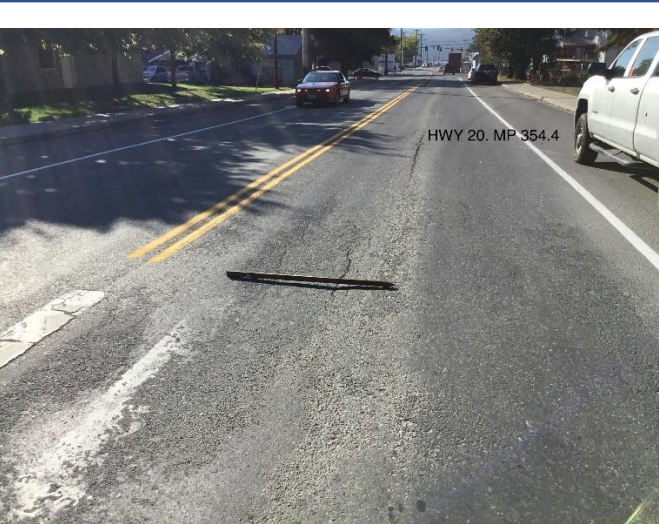
Pavement cracking and rutting on State Route 20 in Colville.

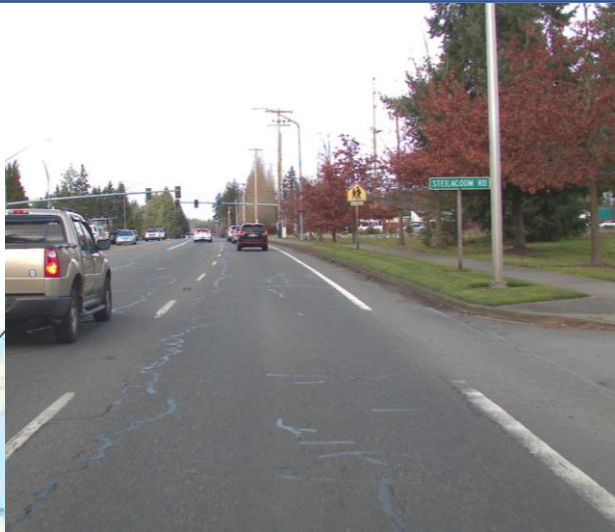
State Route 510 has had crack sealing and patching, and new cracking continues to show.

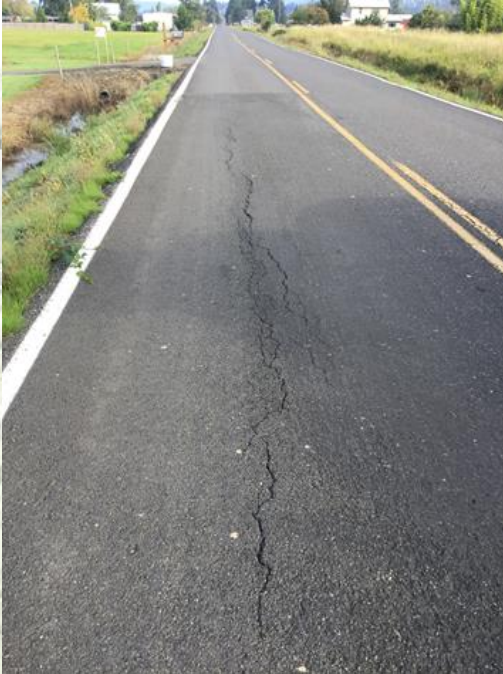
Severe longitudinal crack on State Route 409. WSDOT will crack seal this type of cracking, but this section missed the opportunity for cost-effective chip seal surfacing. An asphalt resurfacing is now needed in the next five years, and if left unaddressed the section will need major rehabilitation or reconstruction.

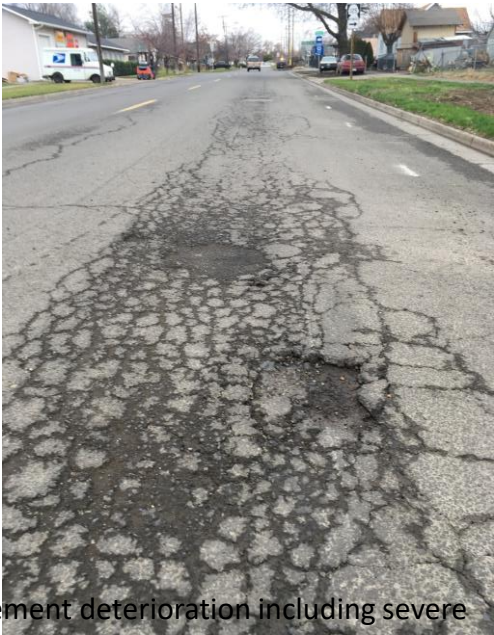
Pavement deterioration including severe cracking and potholing on State Route 125 in Walla Walla.

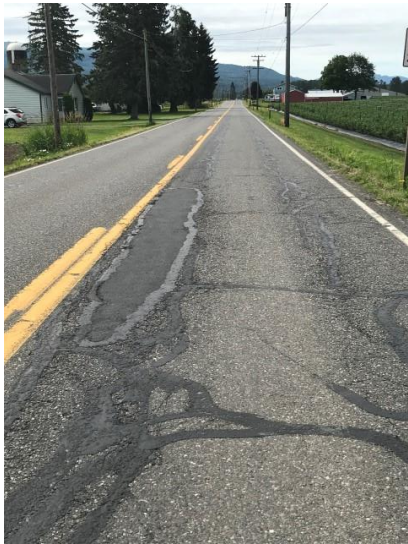
Pavement failure on State Route 9 in both wheel paths, with patching and crack sealing, is frequent. This section is likely to pothole and cause immediate issues without full resurfacing.

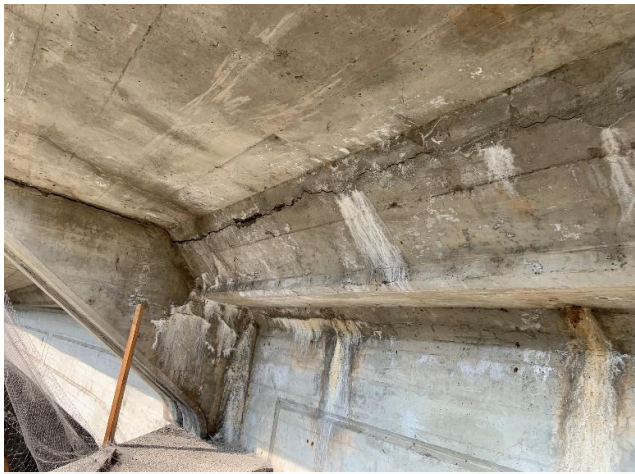
The Palouse River Bridge on US 195 in Colfax has deck deterioration and cracks and the sub-structure (shown). This bridge was built in 1931 and is due for replacement.

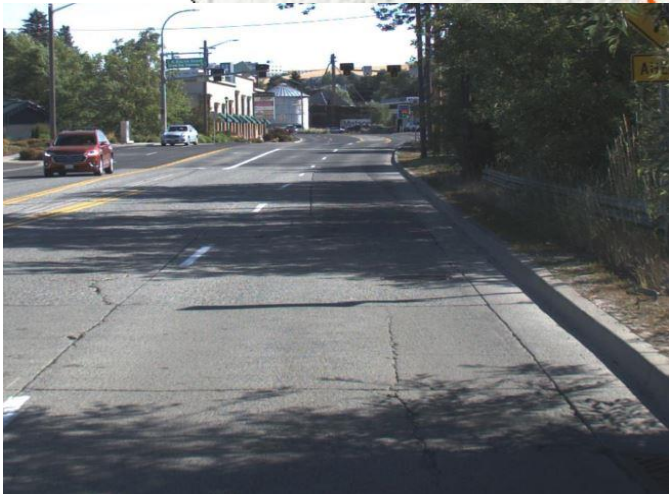
Cracked concrete panels on State Route 27 in Pullman, originally constructed in 1955.

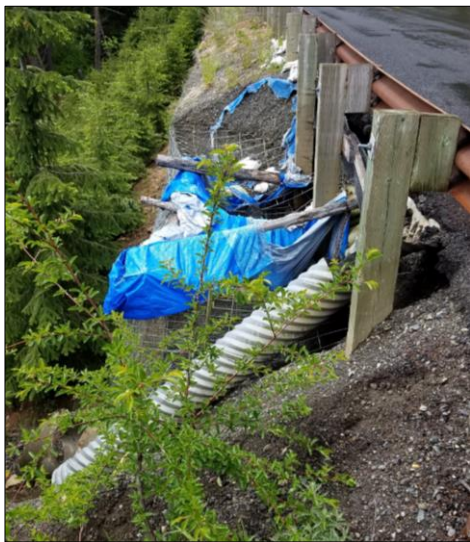
Drainage system failure has undermined gabion wall resulting in risk to highway embankment on State Route 410 in Chinook Pass. The roadway remains at risk because a long-term fix is unfunded at current Preservation amounts.

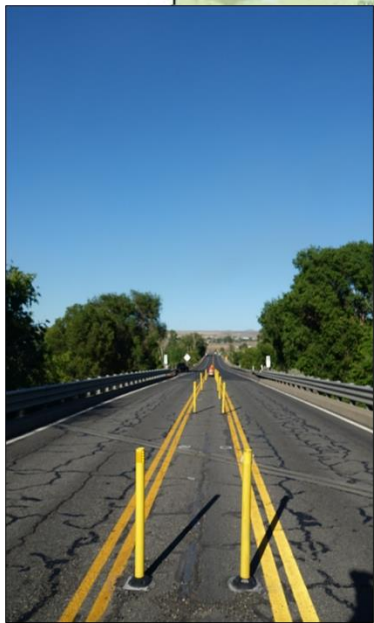
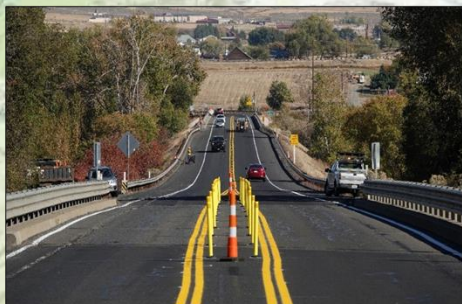
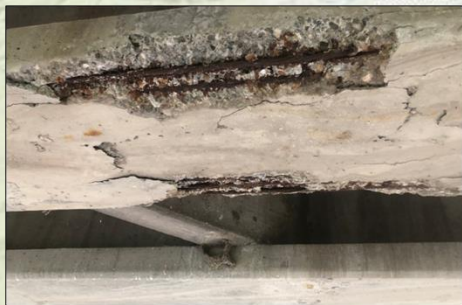
Severe corrosion discovered during October 2019 inspection resulted in WSDOT shifting traffic away from the damage girder in center of the Harrison Road bridge on State Route 823 near Selah.

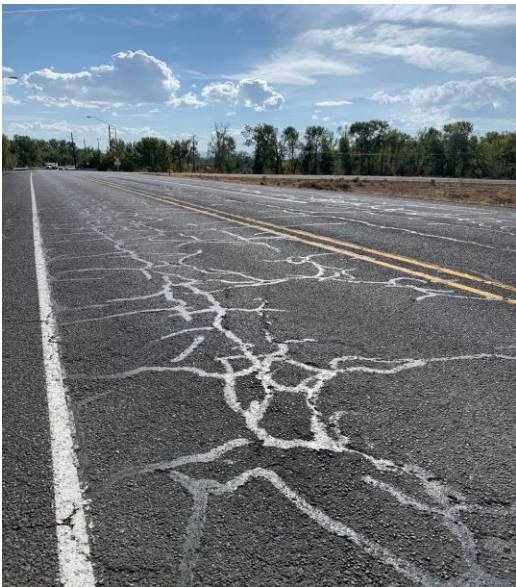
Severe pavement deterioration at the I-82 Donald Rd interchange near Wapato.
