ARIZONA EASTERN RAILWAY GILSON WASH BRIDGE REPLACEMENT

Western Bridge Engineer's Seminar

- Owner: Arizona Eastern Railway (AZER) (Recently sold to the Genesee & Wyoming Railroad. Formerly owned by Iowa Pacific Holdings, Chicago, Illinois)
- Location: San Carlos Apache Nation, near Globe, AZ
- Contractor: Ames Construction, Inc. (Scottsdale, AZ)
- Original Bridge: 200-foot long steel deck girder bridge
- New Bridge: 288-foot long precast double cell box beam bridge supported on drilled shaft foundations

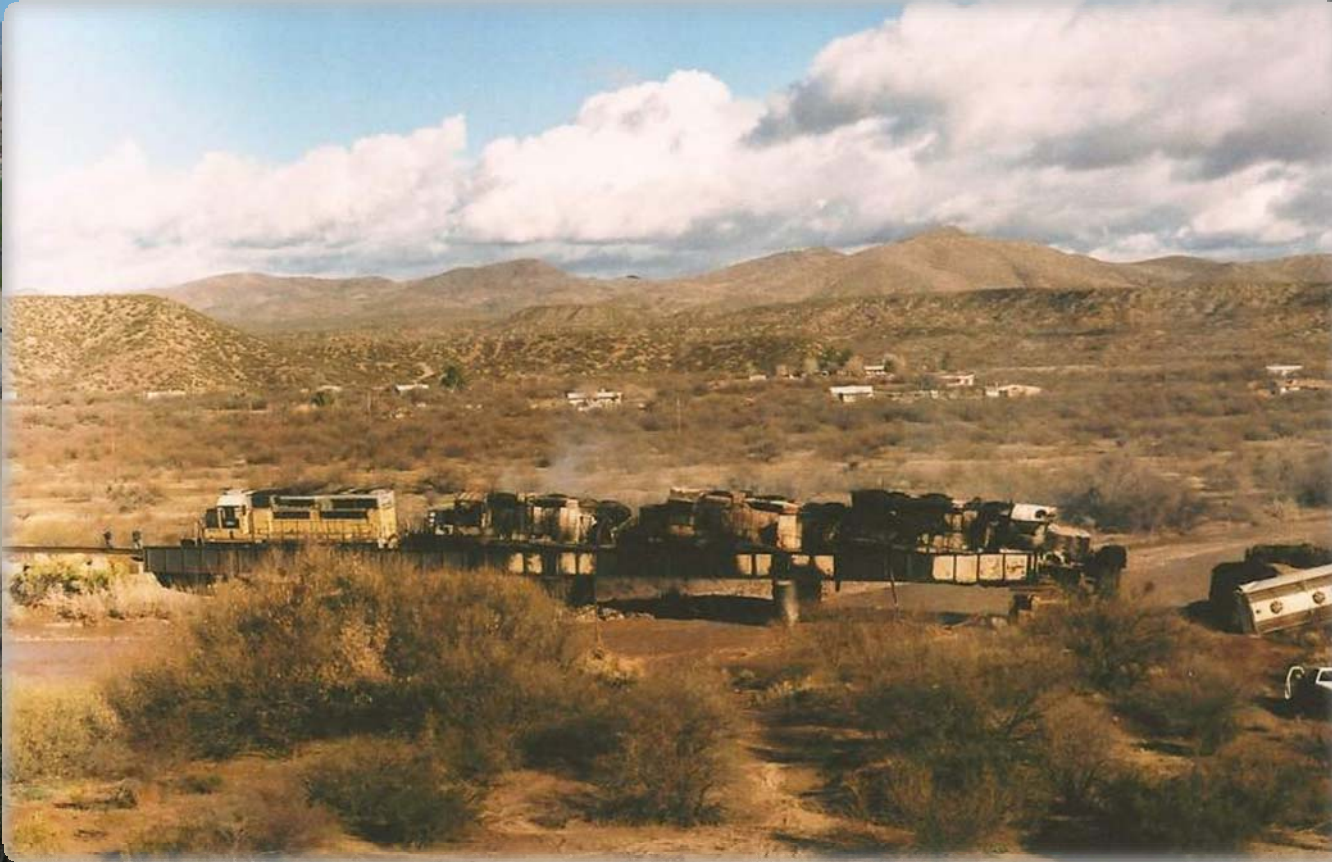
**Flash flood on
January 28, 2008**

**Scour undermined
east abutment**

**Diesel fuel spilled
and locomotives
burned on bridge**

**Bridge
superstructure and
locomotives
destroyed due to
heat from the fire**

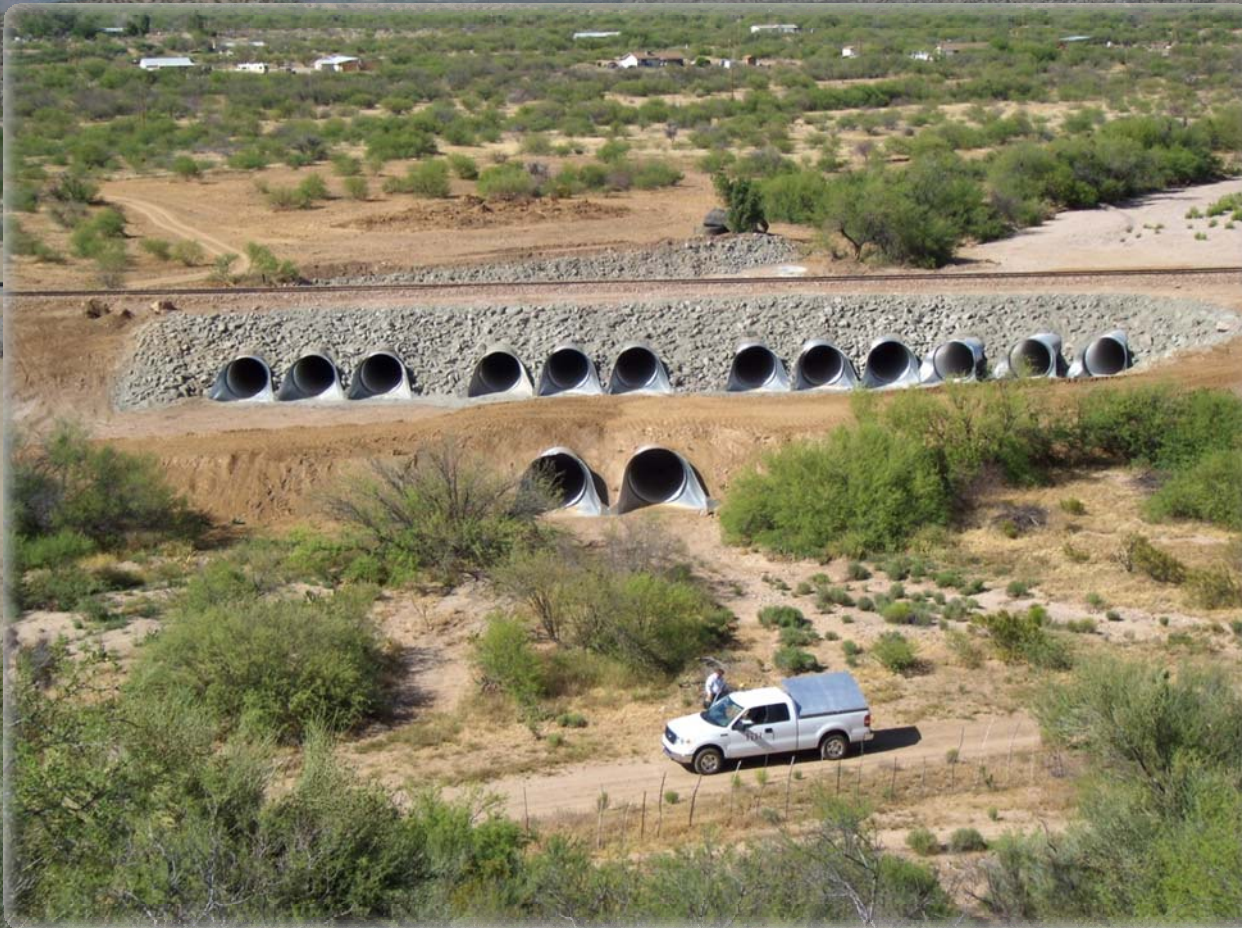
Temporary Crossing

**Twelve 96" diameter
CMPs**

**12,000 cubic yards of
fill**

**Grouted riprap
armoring**

**Hydraulic capacity is
less than a 10-year
storm event**

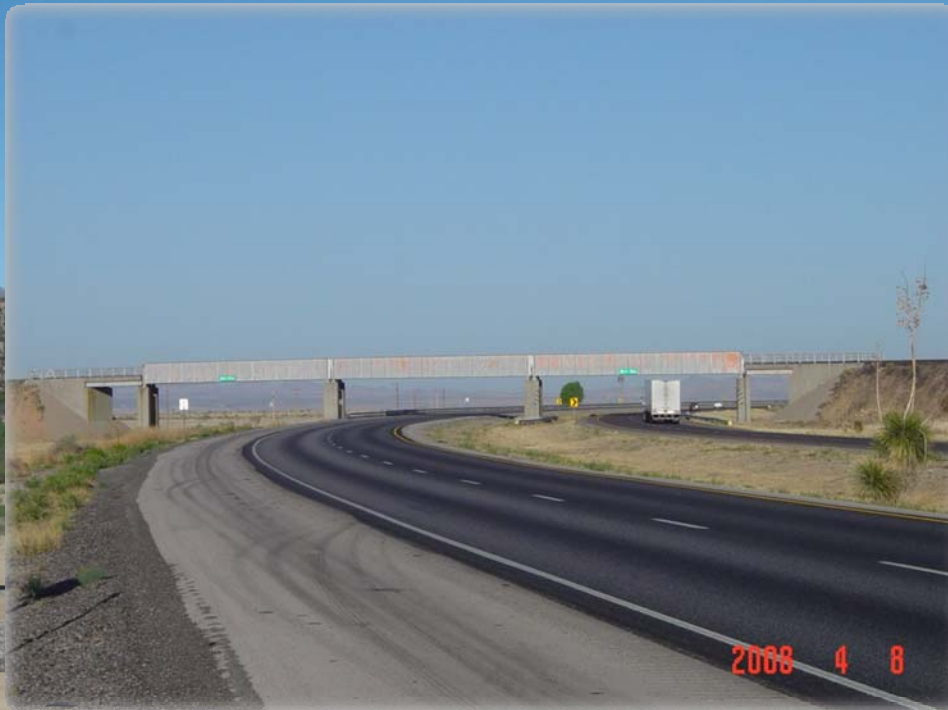
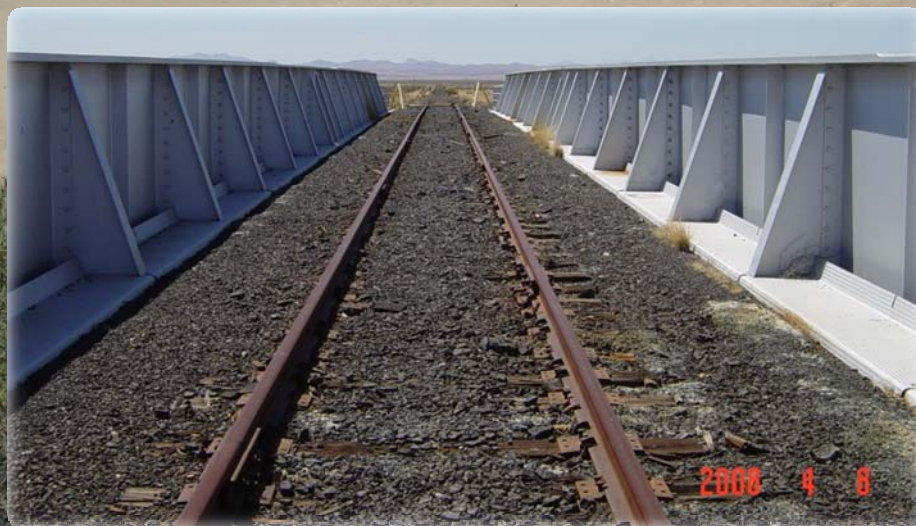
Steel Through Girder

- Relocate Through Girder Bridge from Separ, New Mexico (Built in 1974)

- 3 main spans of 93 feet = 279 feet (Fits nicely between existing culverts)

- Skew = 20 degrees in wrong direction!

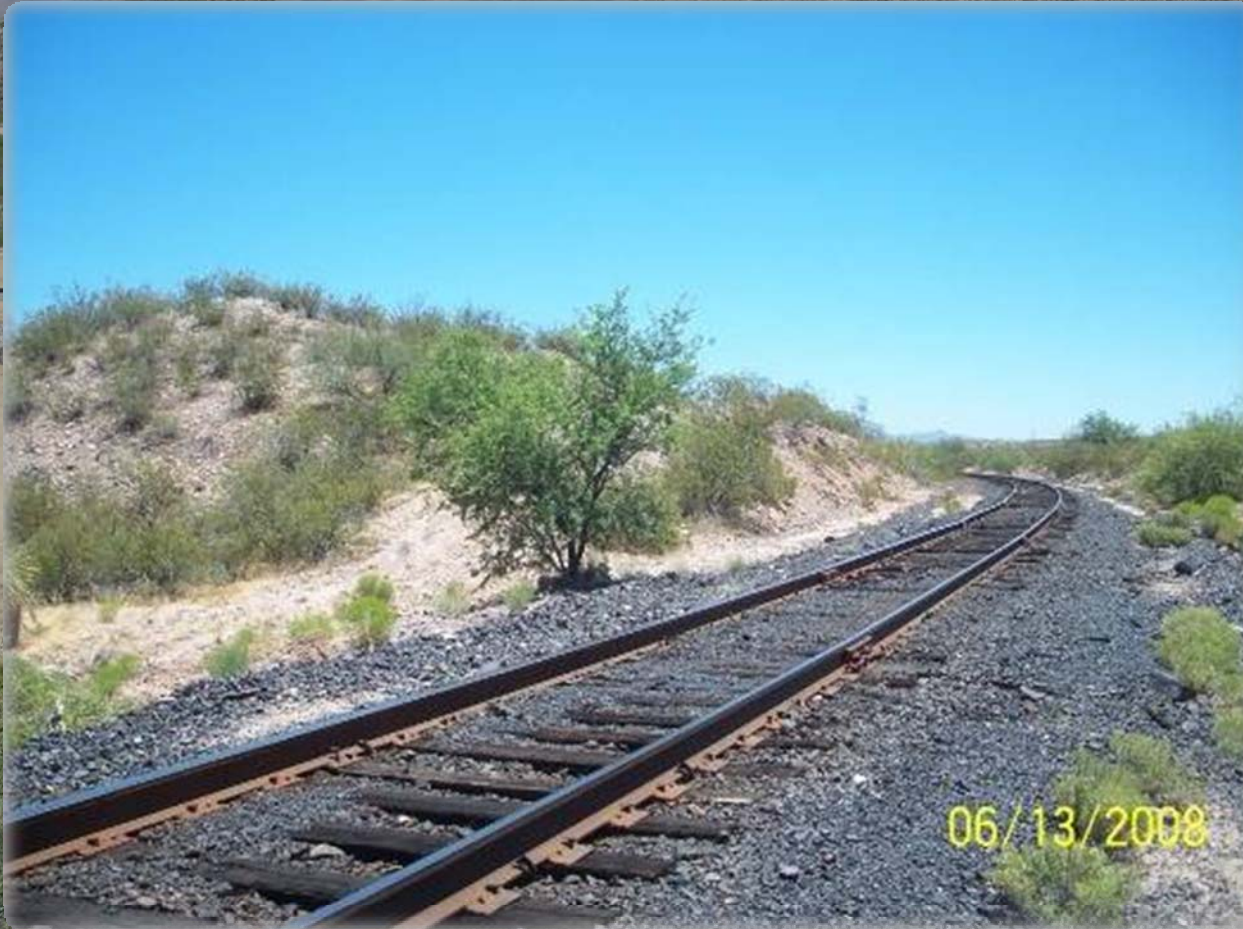
Channel, terrace & floodplain alluvium overlying weakly consolidated sedimentary rock (conglomerate, sandstone & siltstone).

Hill and cut-slope located north track-side, about 1,000 feet east of Gilson Wash

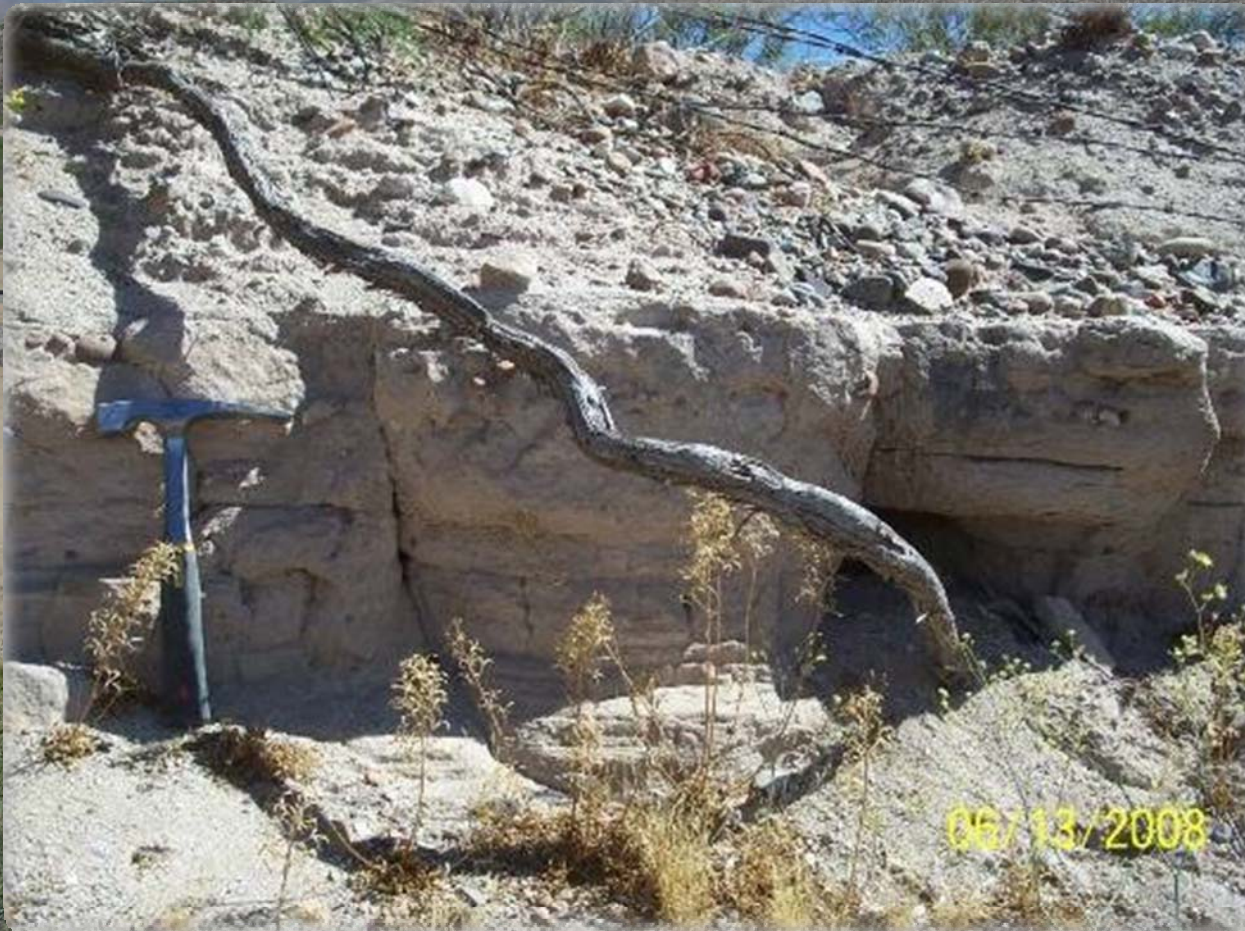
Moderately to highly weathered sedimentary rock (sandstone and conglomerate) in slope face about 1,000 feet east of Gilson Wash

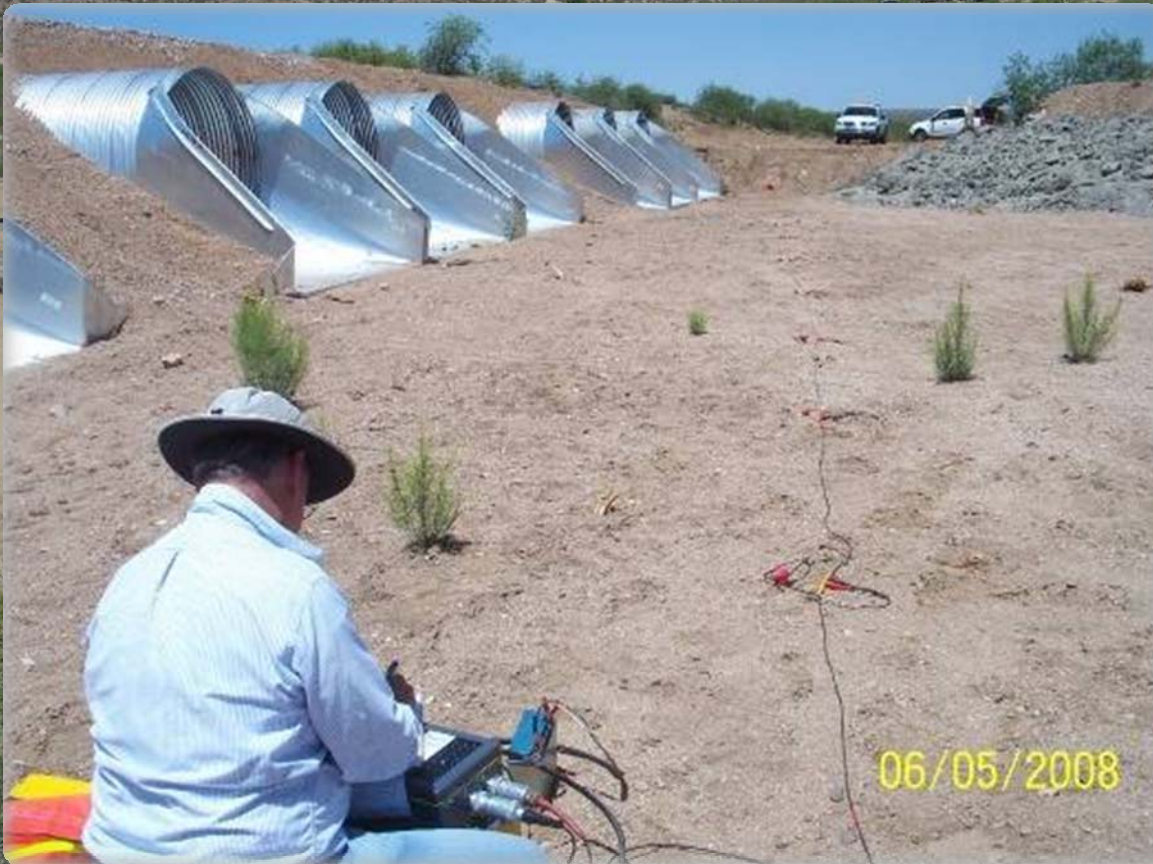
Seismic Refraction & ReMi Surveys – measured both compression & shear wave velocities of subsurface materials

**Phase I
investigation:
seismic survey line
in active channel**

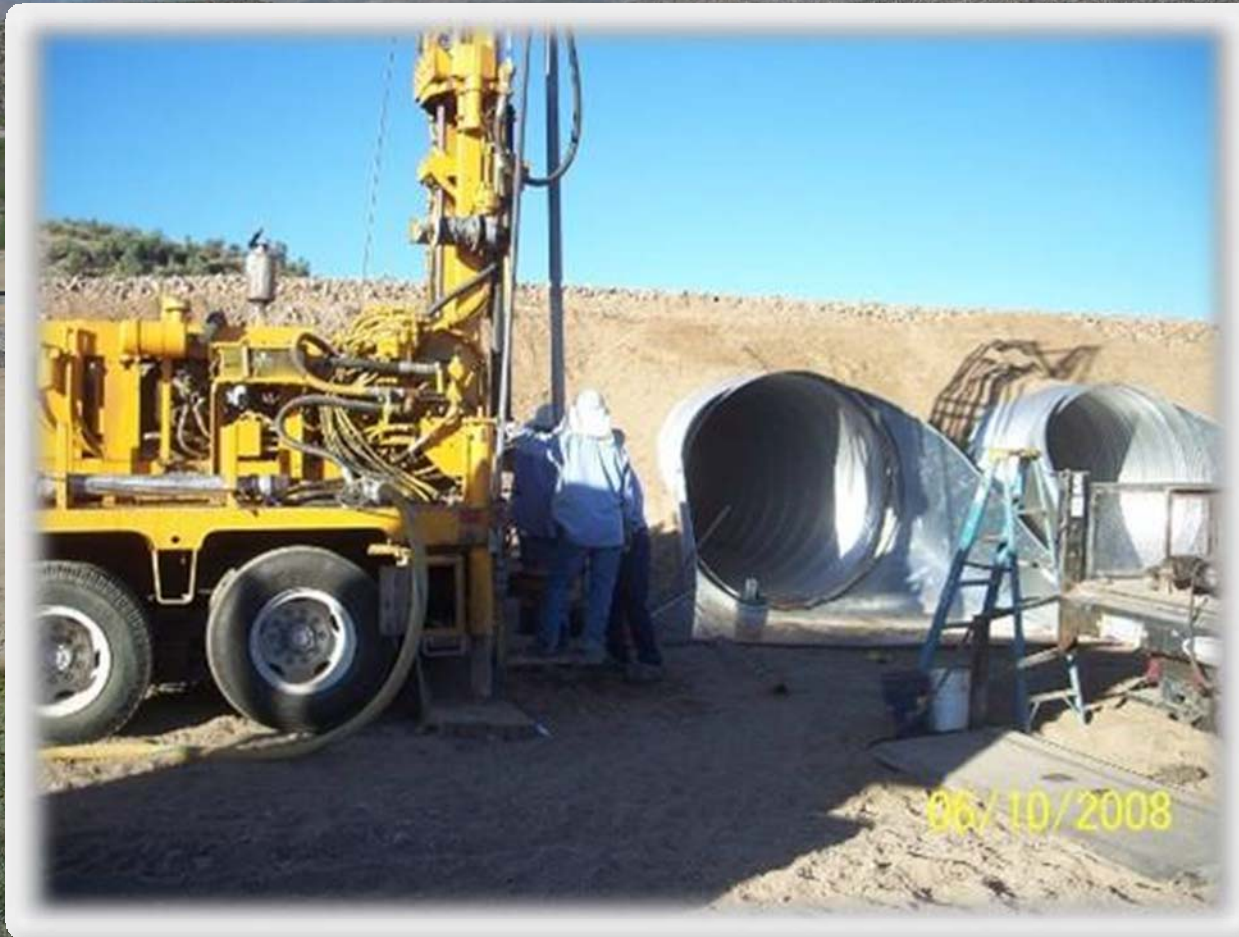
**Phase I
investigation:
Rotary-percussion
drilling of Boring
B-2 on downstream
side of temporary
crossing**

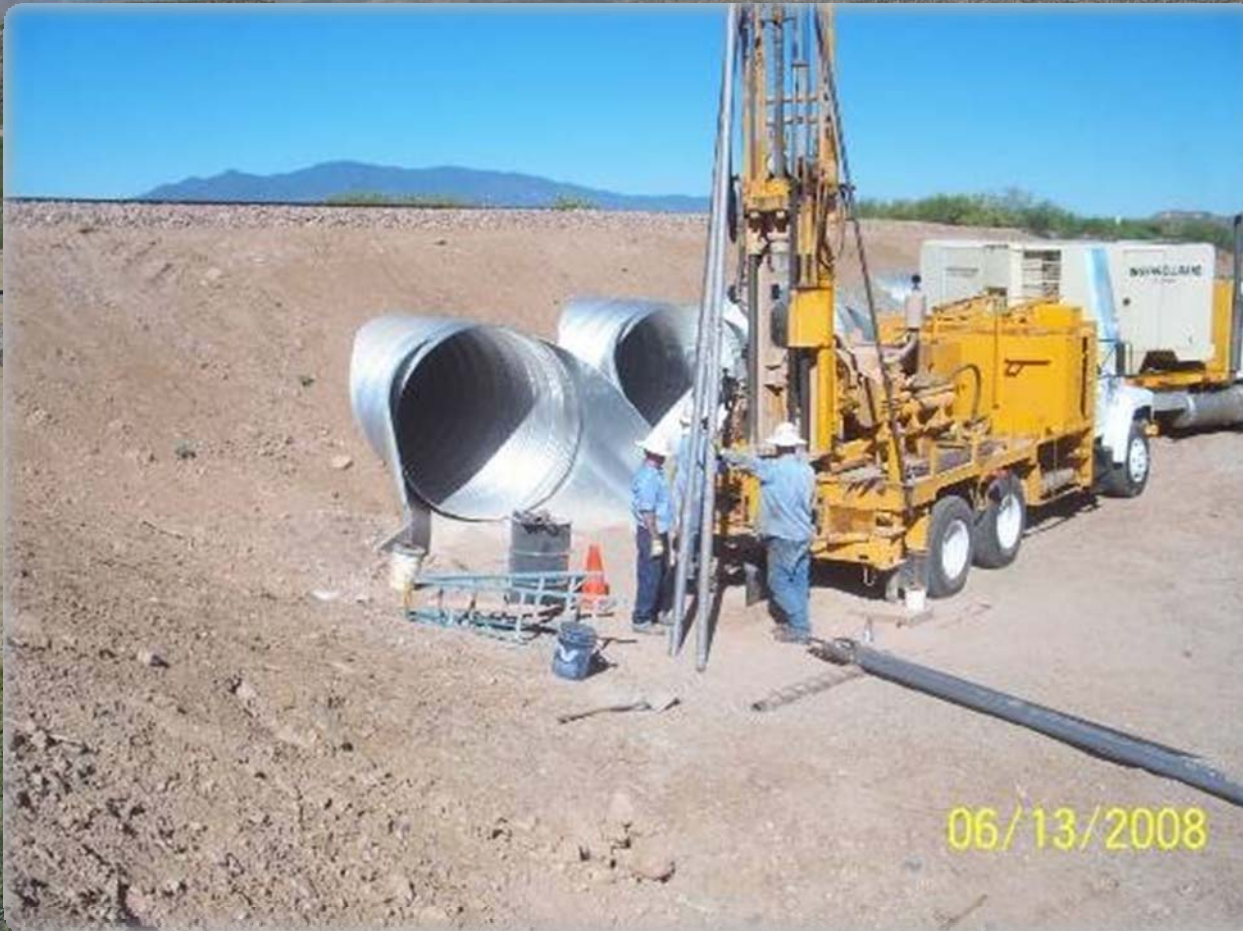
**Phase I
investigation:
Rotary-
percussion
drilling of
Boring B-4 on
downstream side
of temporary
crossing**

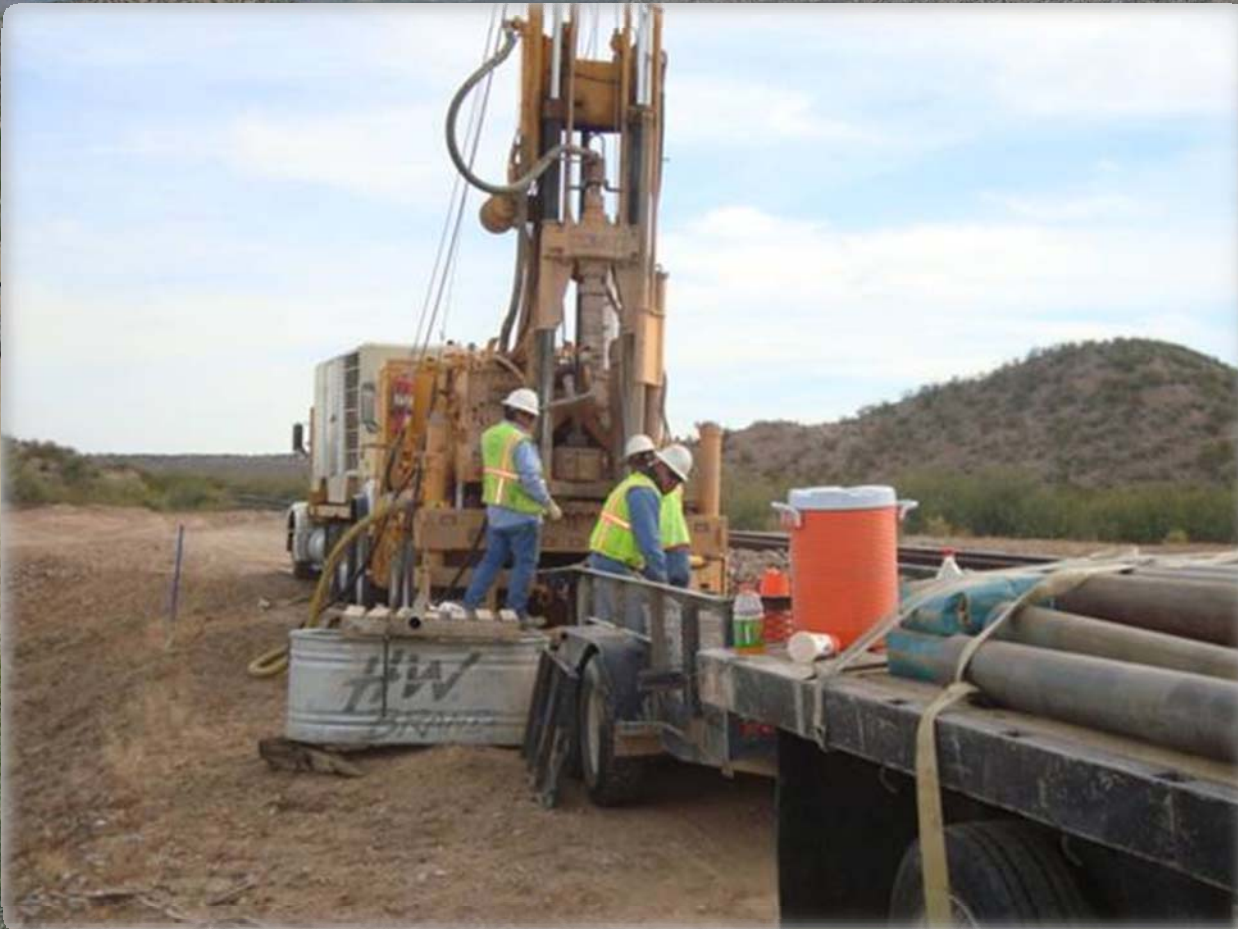
HQ-size triple-tube core drilling of sedimentary rock during Phase II investigation, from atop temporary crossing

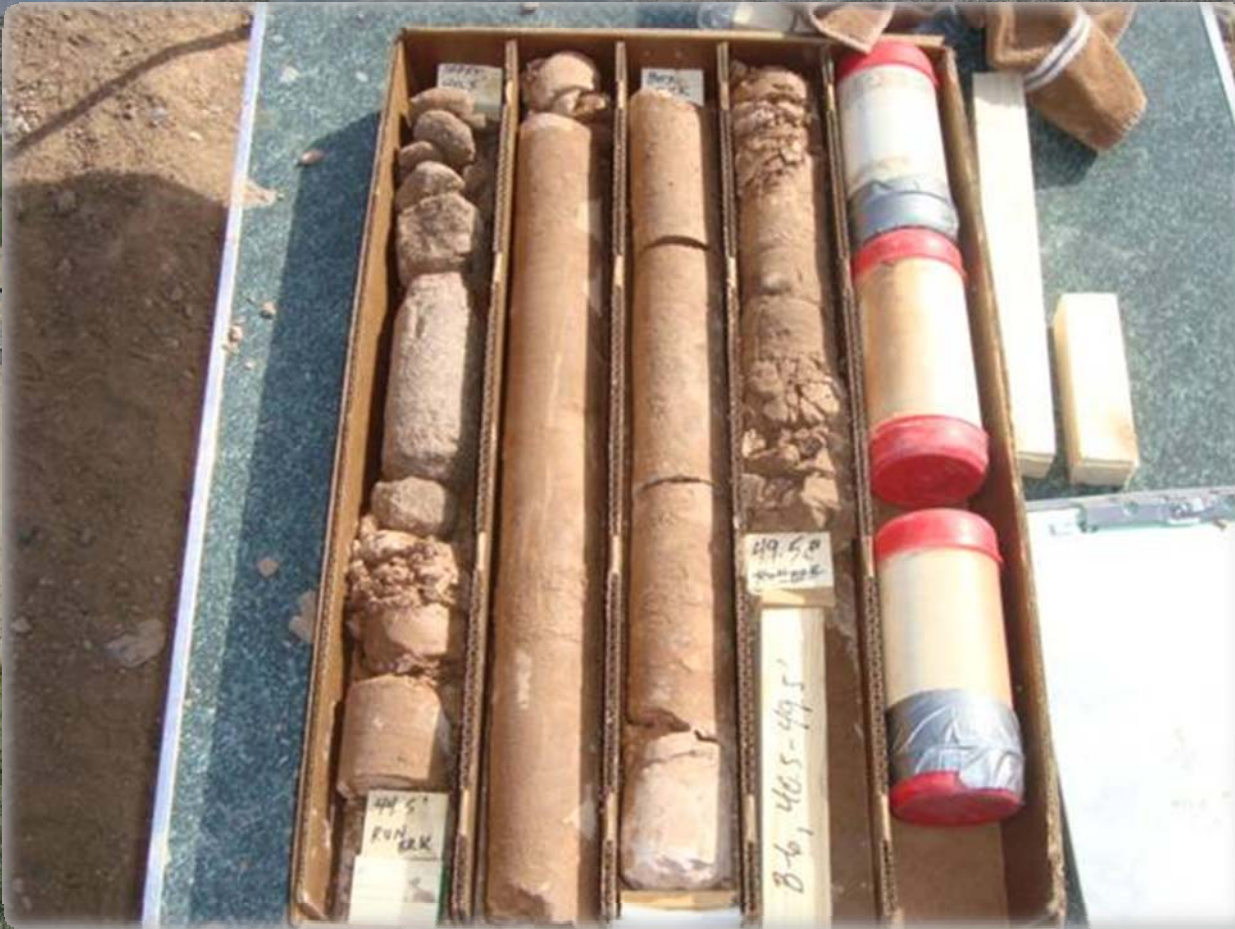
Core samples of
rock from
Boring B-6, 40.5
to 49.5 feet bgs.

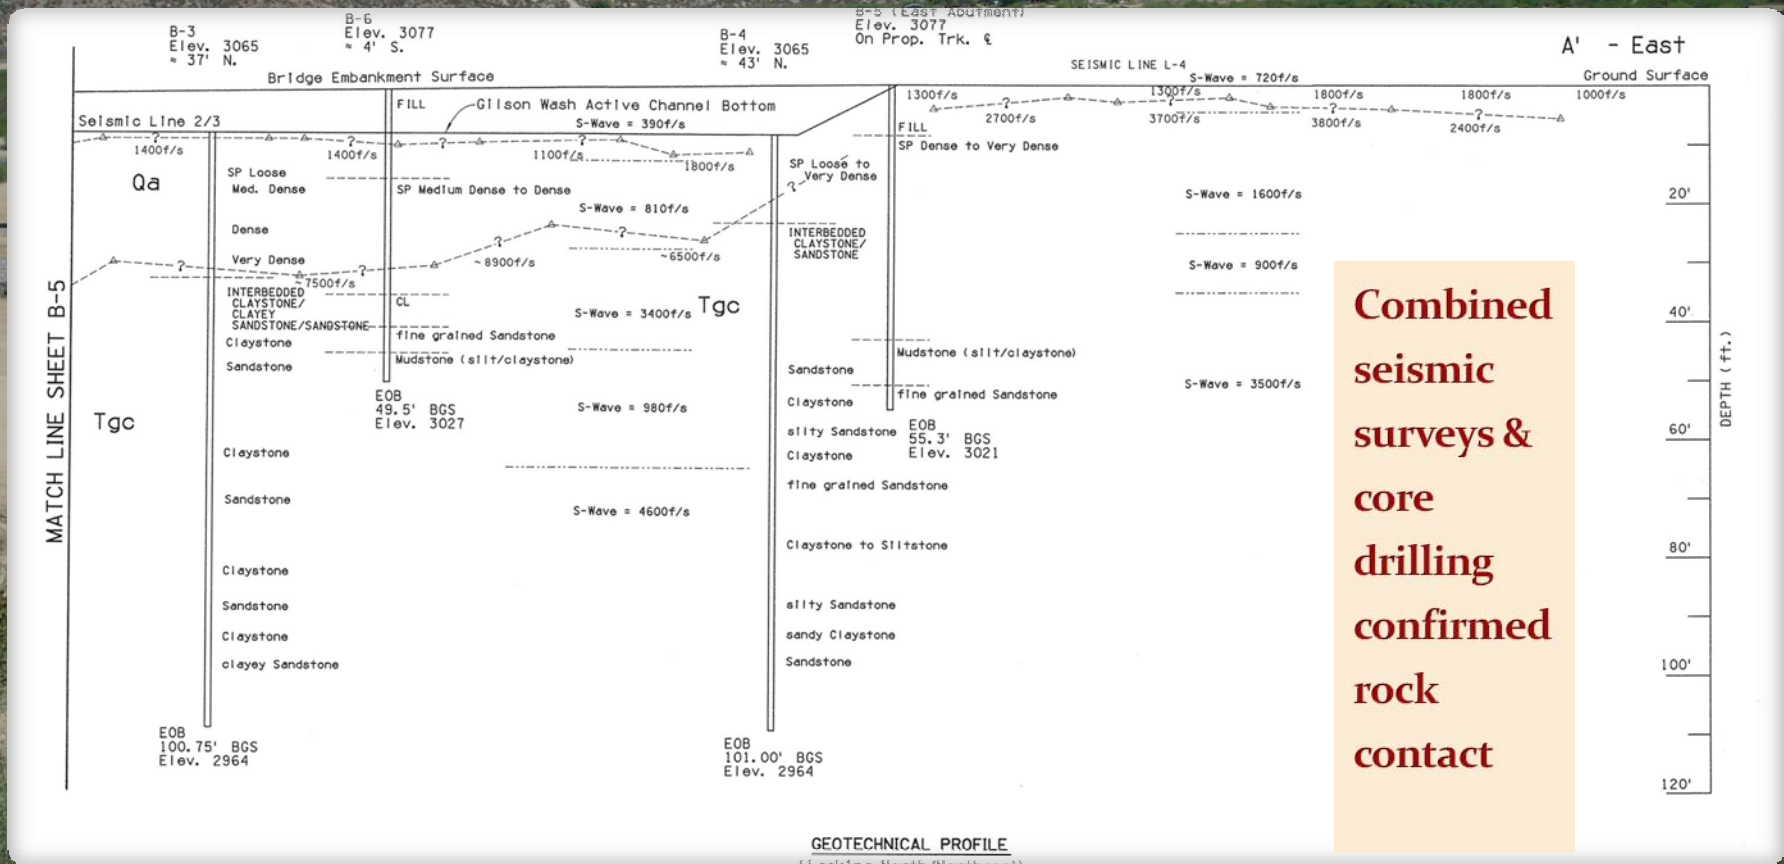
Geotechnical profile with boring & seismic survey results

Combined seismic surveys & core drilling confirmed rock contact

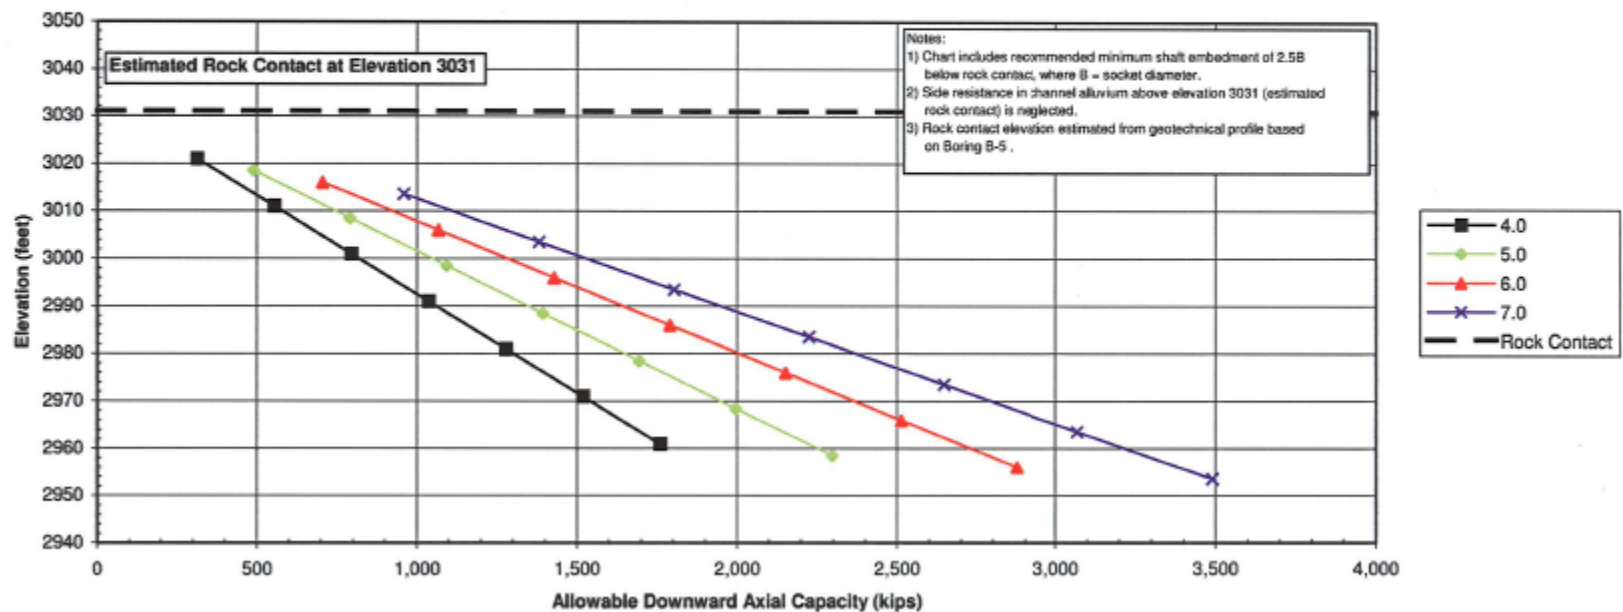
Drilled shaft rock socket capacity chart - Abutment 1 (east)

Figure D-1
AZER Gilson Wash Bridge
Alternative 3 (8-span) - Abutment 1 (East Abutment)
Allowable Axial Capacity of Drilled Shaft Rock Sockets
AASHTO Method (AASHTO, 2002)

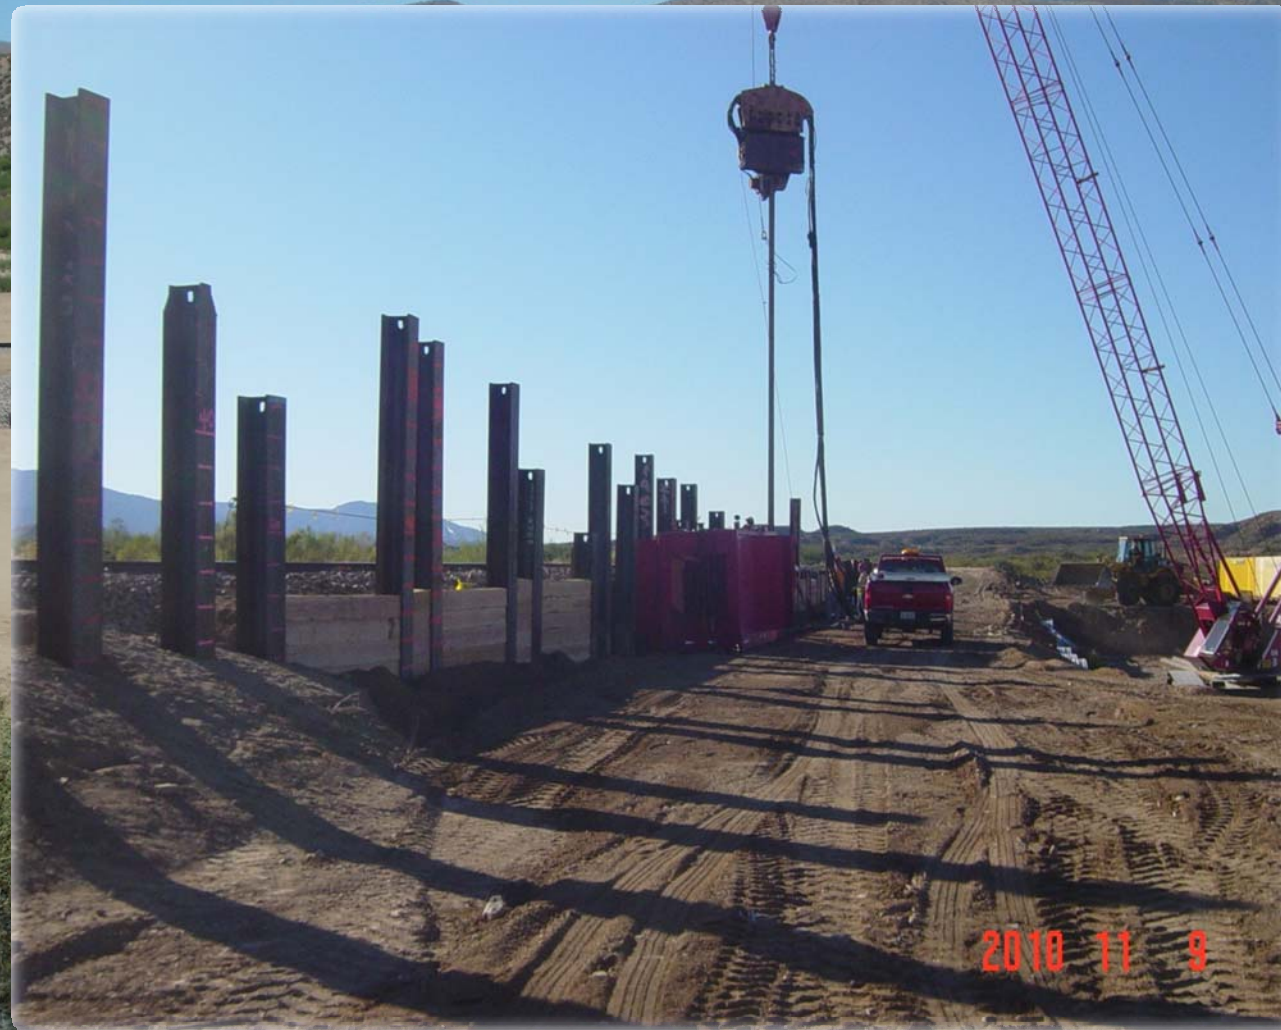
Temporary Shoring

Due to rock depth, piles were driven to varying depths

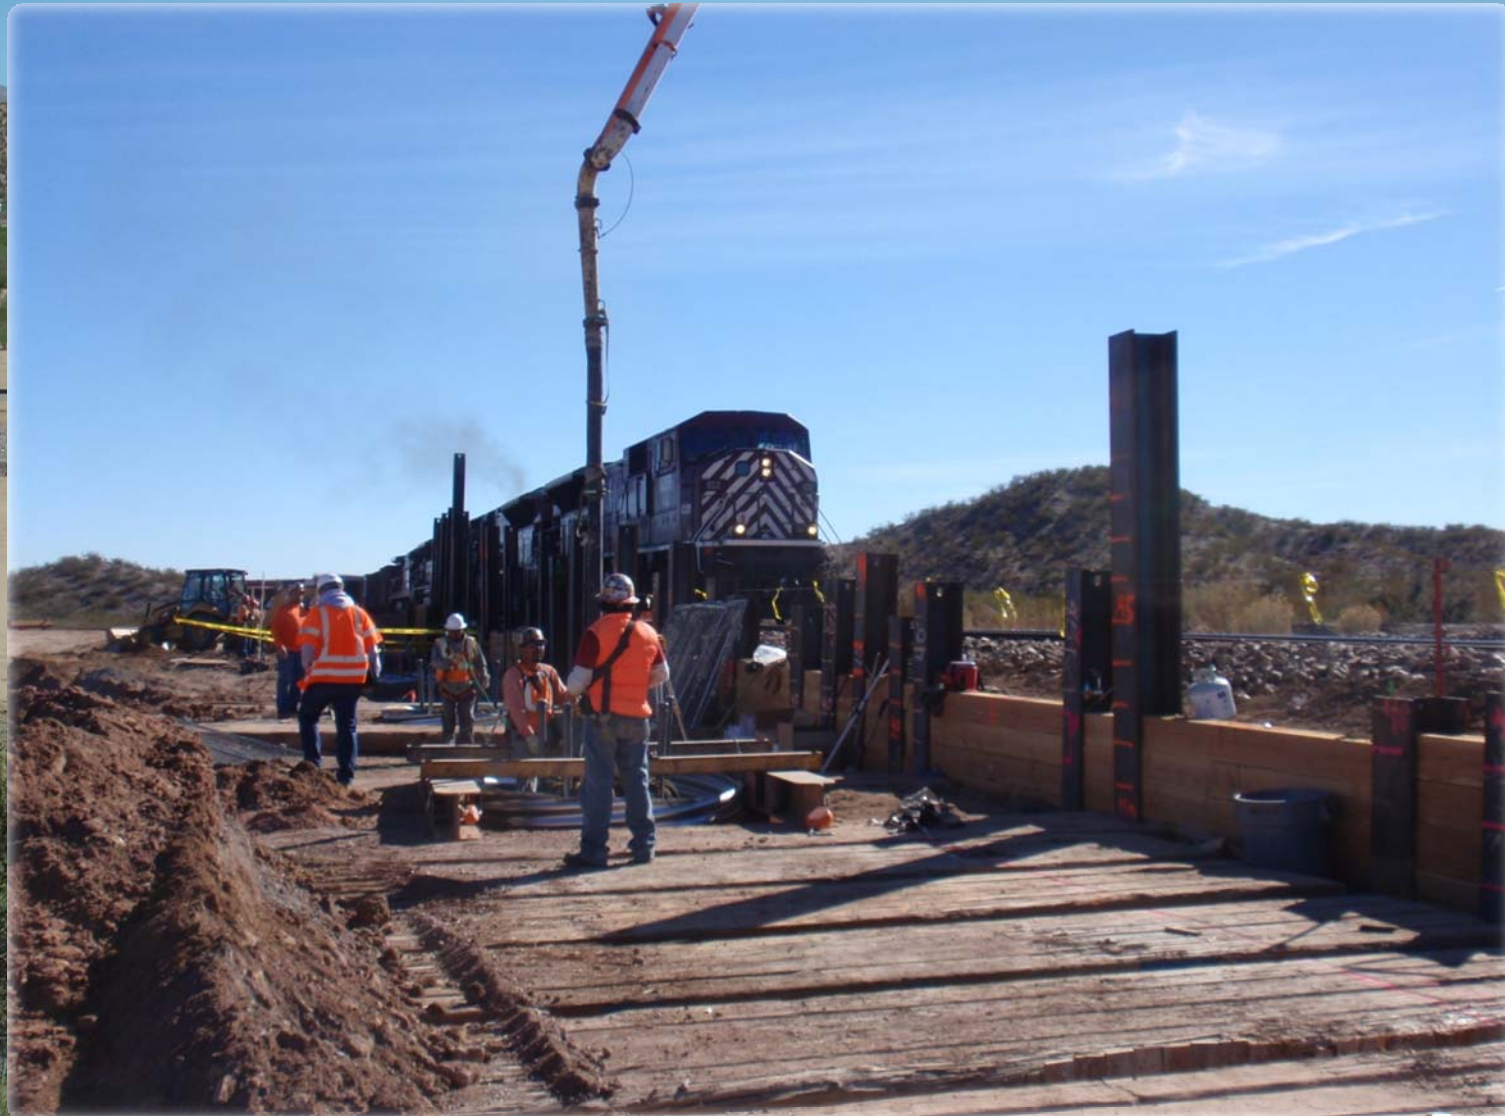
Temporary Shoring

Rail traffic was not affected by bridge construction

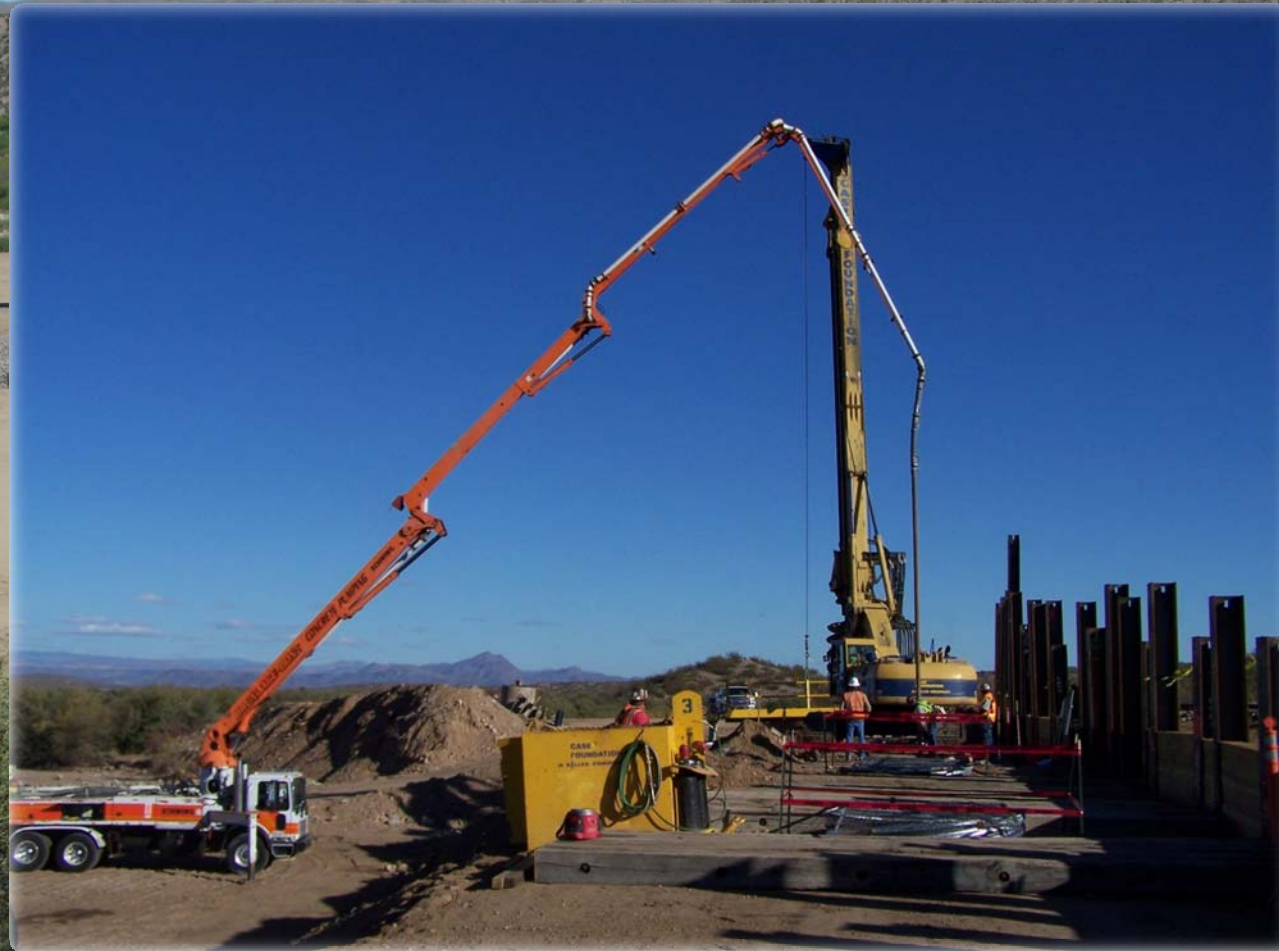
Drilled shaft construction in rock & soil

5'-0" diameter , length varies from 50 ft to 91 ft

Rock socket lengths vary from 0 ft to 26 ft

Rock contact elevation was within a few feet of the predicted elevation except at two of the shafts

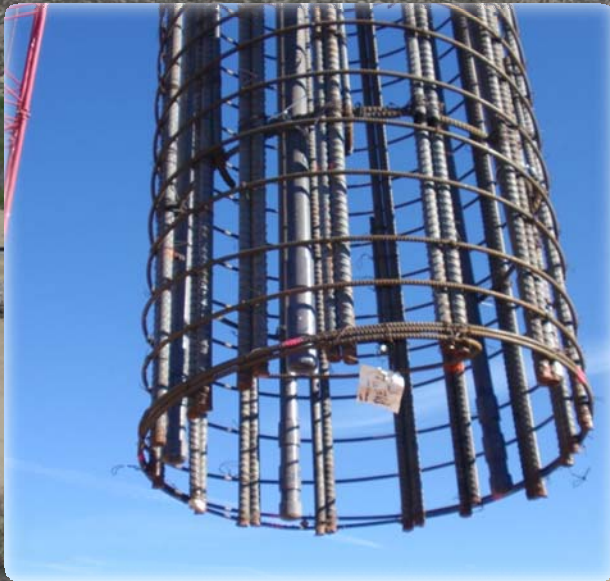
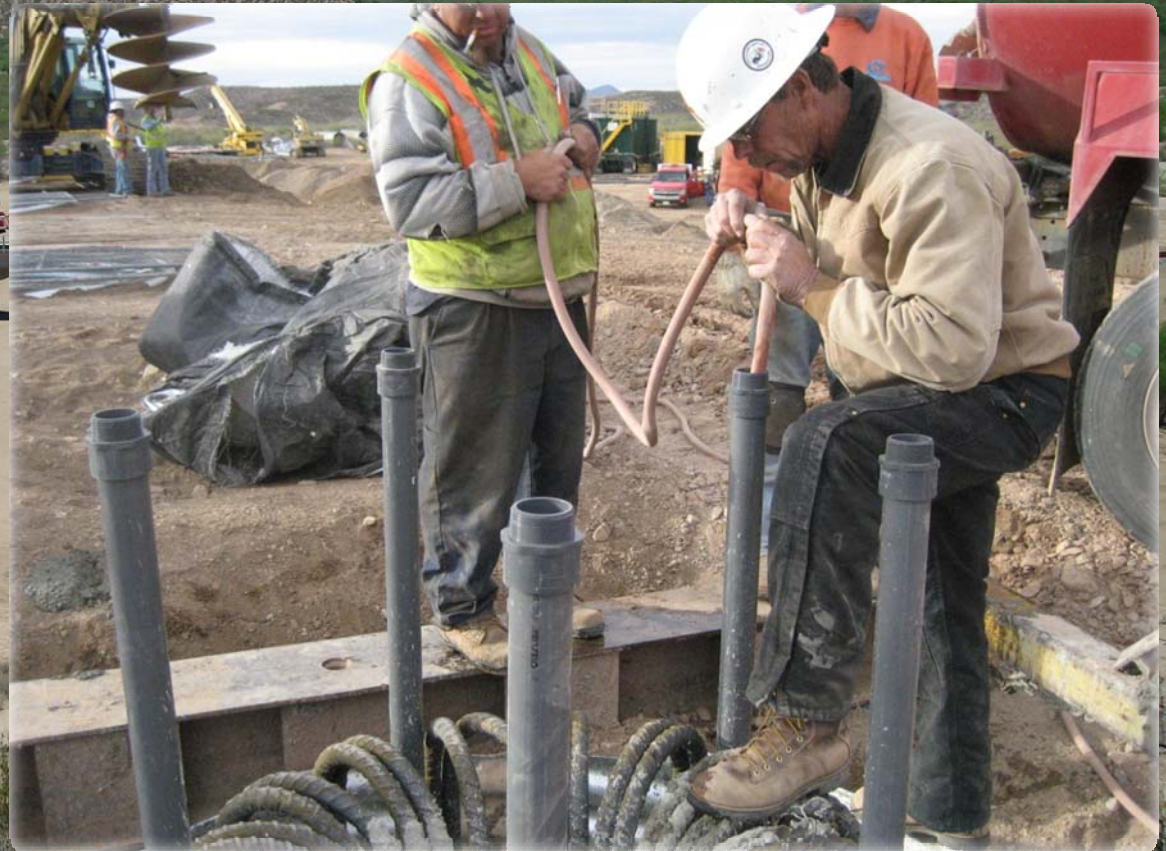
Drilled Shaft Integrity Testing

Cross-holesonic logging and gamma density logging in each shaft

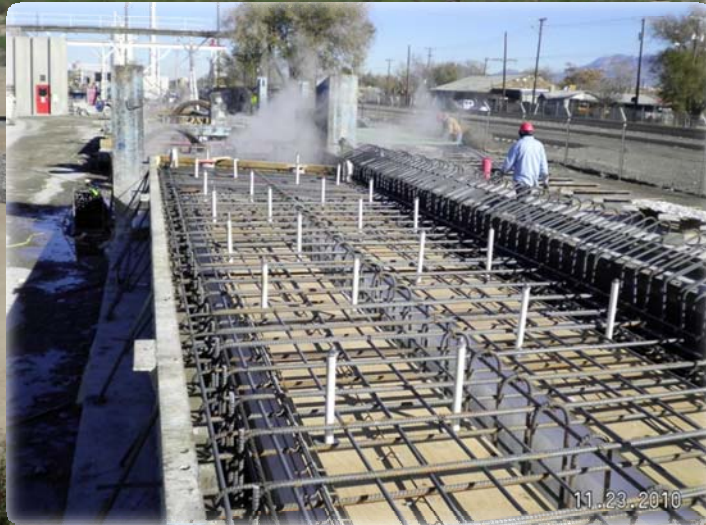
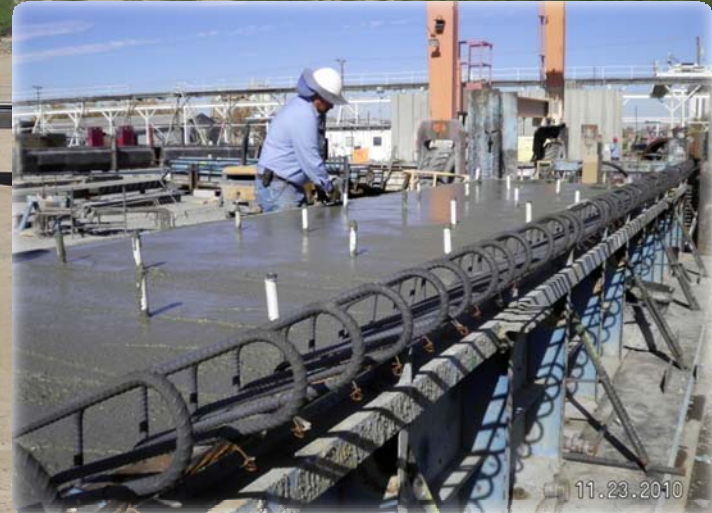
Precast Double-Cell Box Beams

Manufactured by Coreslab Structures, Albuquerque, New Mexico

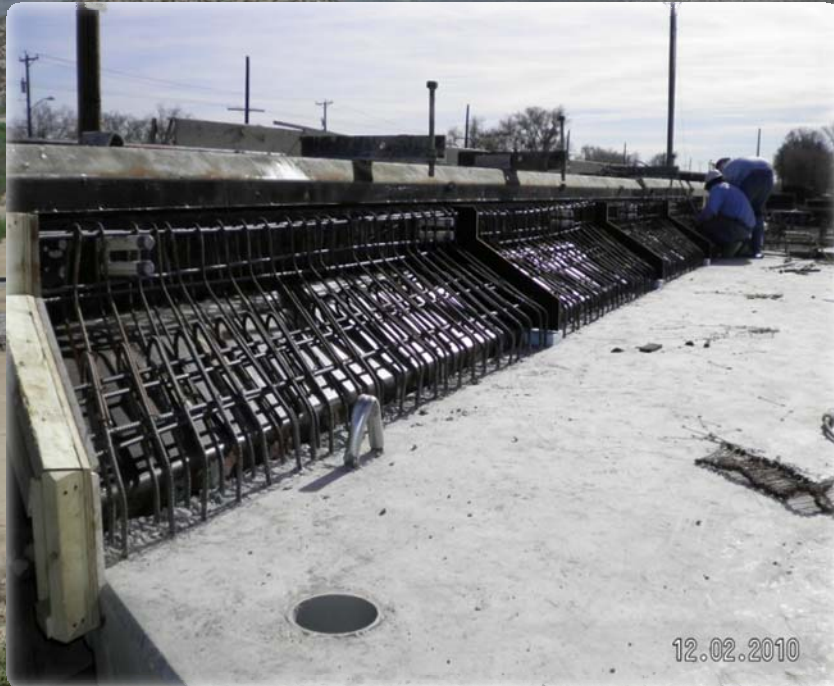
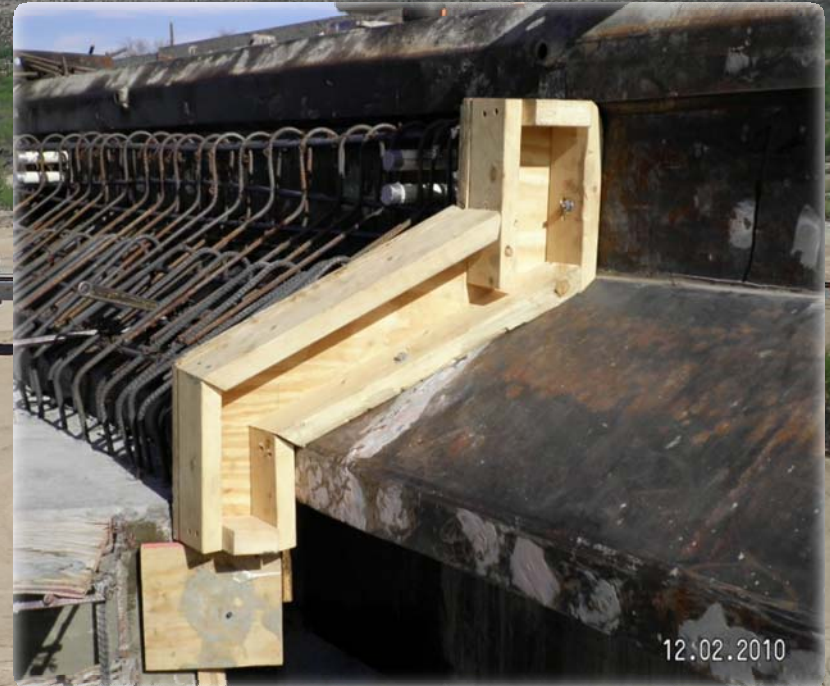
Precast Double-Cell Box Beams

Sloped curbs are cast at the precast plant after the beams are cast

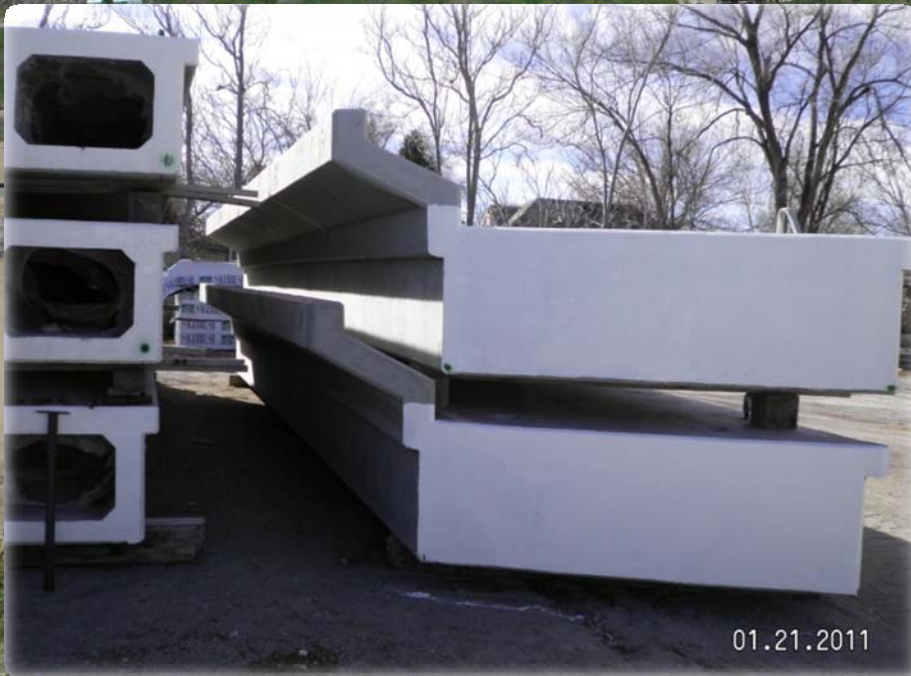
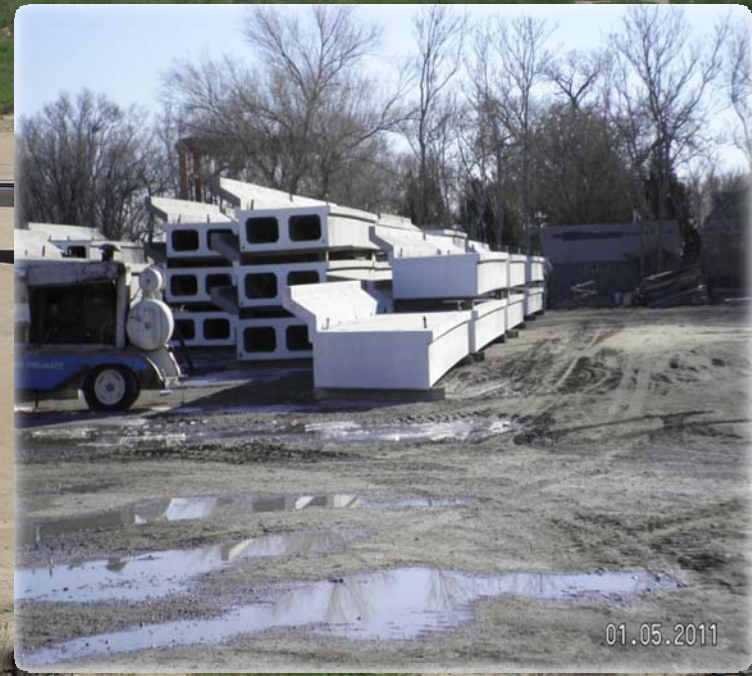
Precast Double-Cell Box Beams

30° skew on ends with solid diaphragms

Standard UPRR box beams without end diaphragms on left of both photos.
Skewed beams on right of both photos
