ARIZONA EASTERN RAILWAY GILSON WASH BRIDGE REPLACEMENT

Western Bridge Engineer's Seminar

- Owner: Arizona Eastern Railway (AZER) (Recently sold to the Genesee & Wyoming Railroad. Formerly owned by Iowa Pacific Holdings, Chicago, Illinois)
- Location: San Carlos Apache Nation, near Globe, AZ
- Contractor: Ames Construction, Inc. (Scottsdale, AZ)
- Original Bridge: 200-foot long steel deck girder bridge
- New Bridge: 288-foot long precast double cell box beam bridge supported on drilled shaft foundations

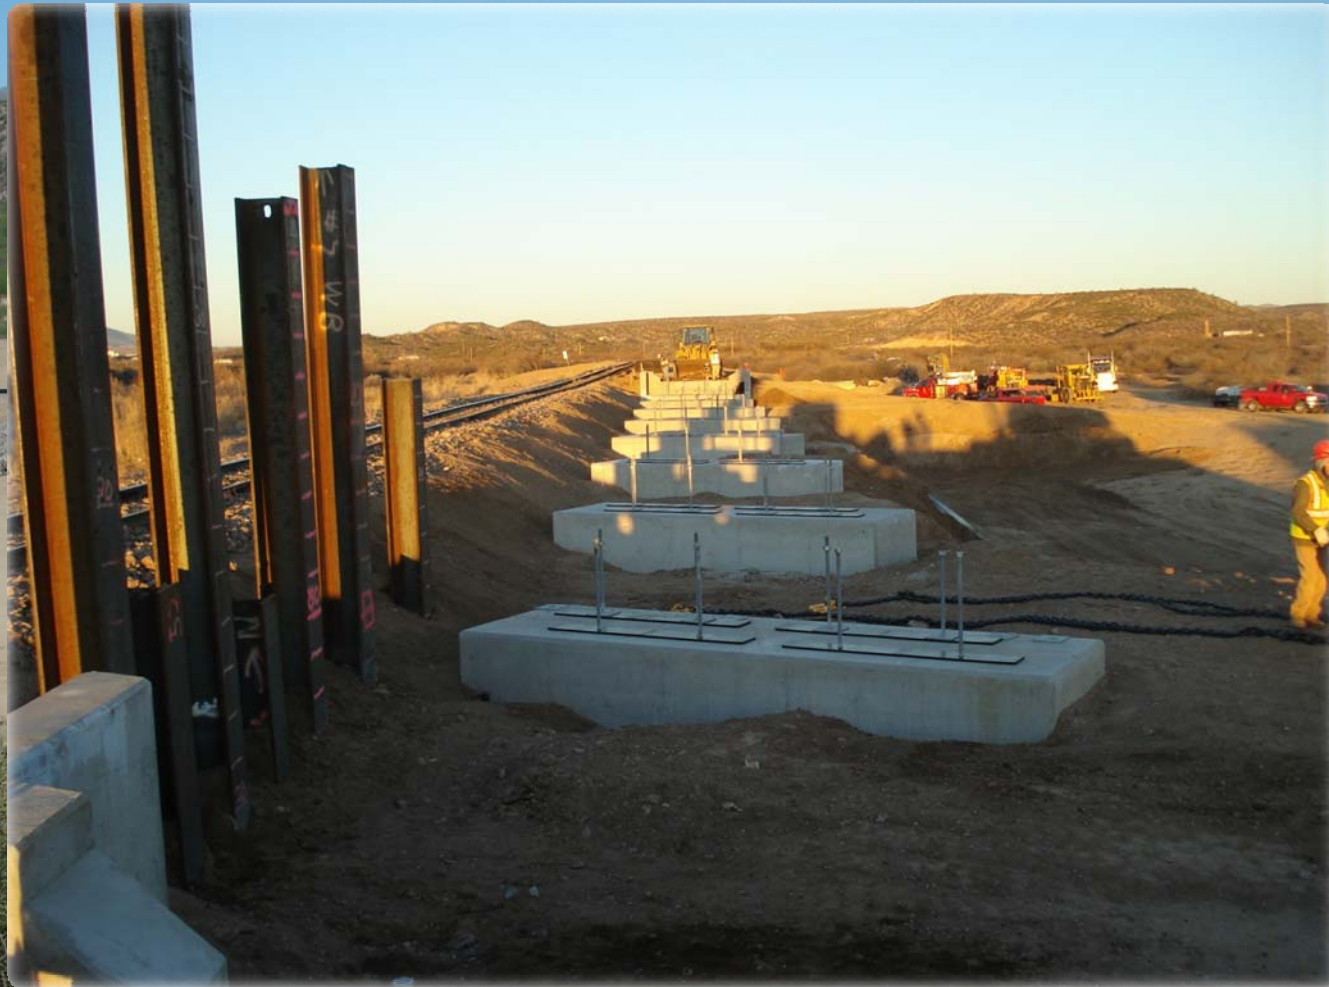
Pier Caps in Place Ready for Box Beams

Bearing pads in place with holes for anchor bolts

The presence of the temporary crossing culvert fill was actually beneficial for this phase

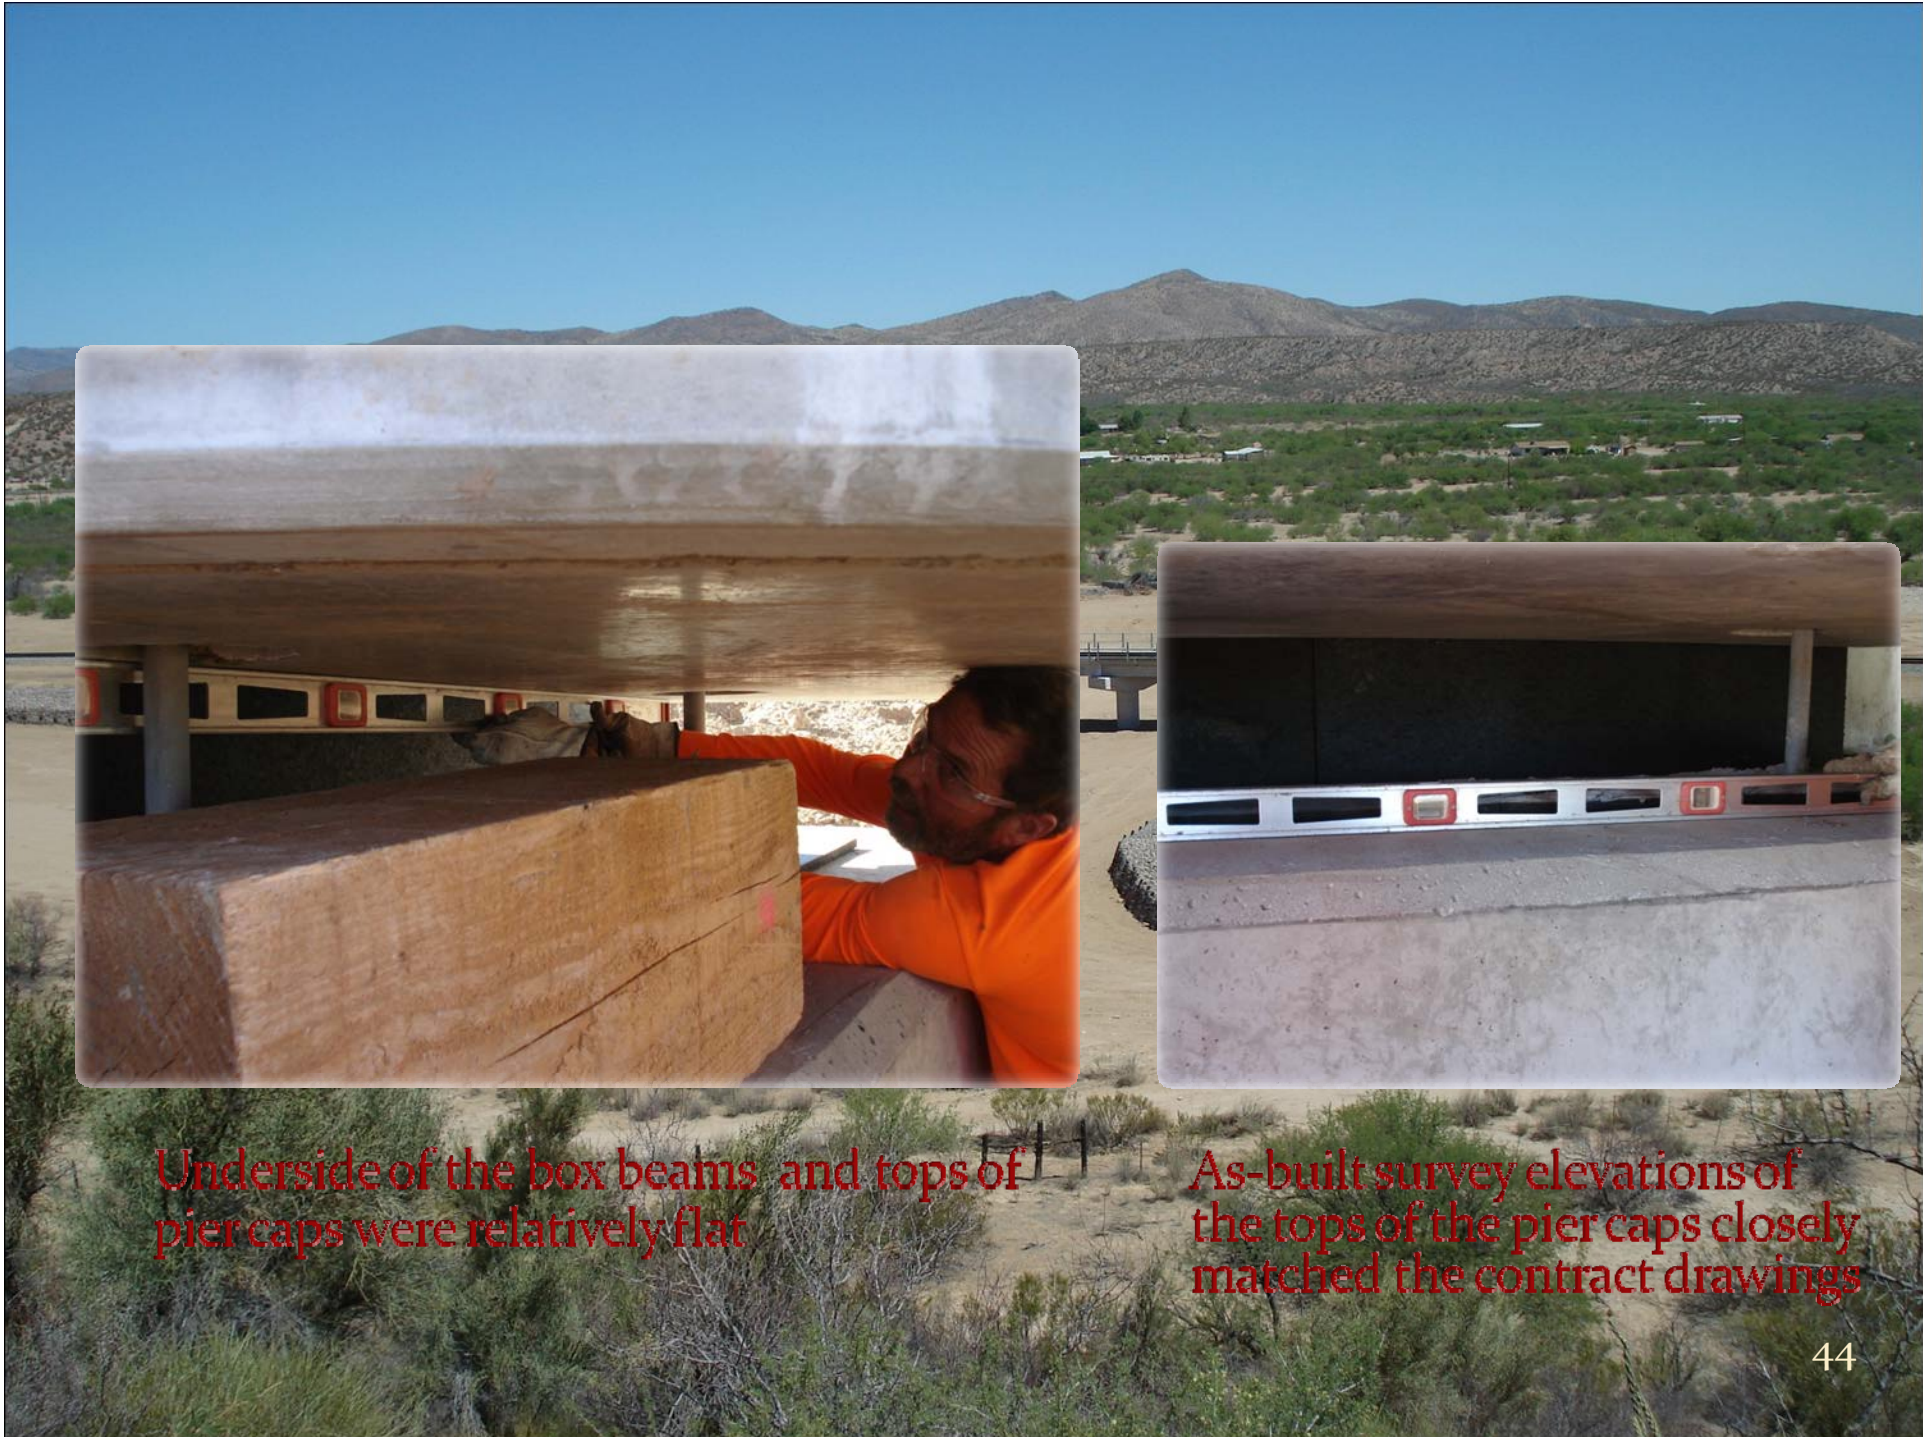
Underside of the box beams and tops of pier caps were relatively flat

As-built survey elevations of the tops of the pier caps closely matched the contract drawings

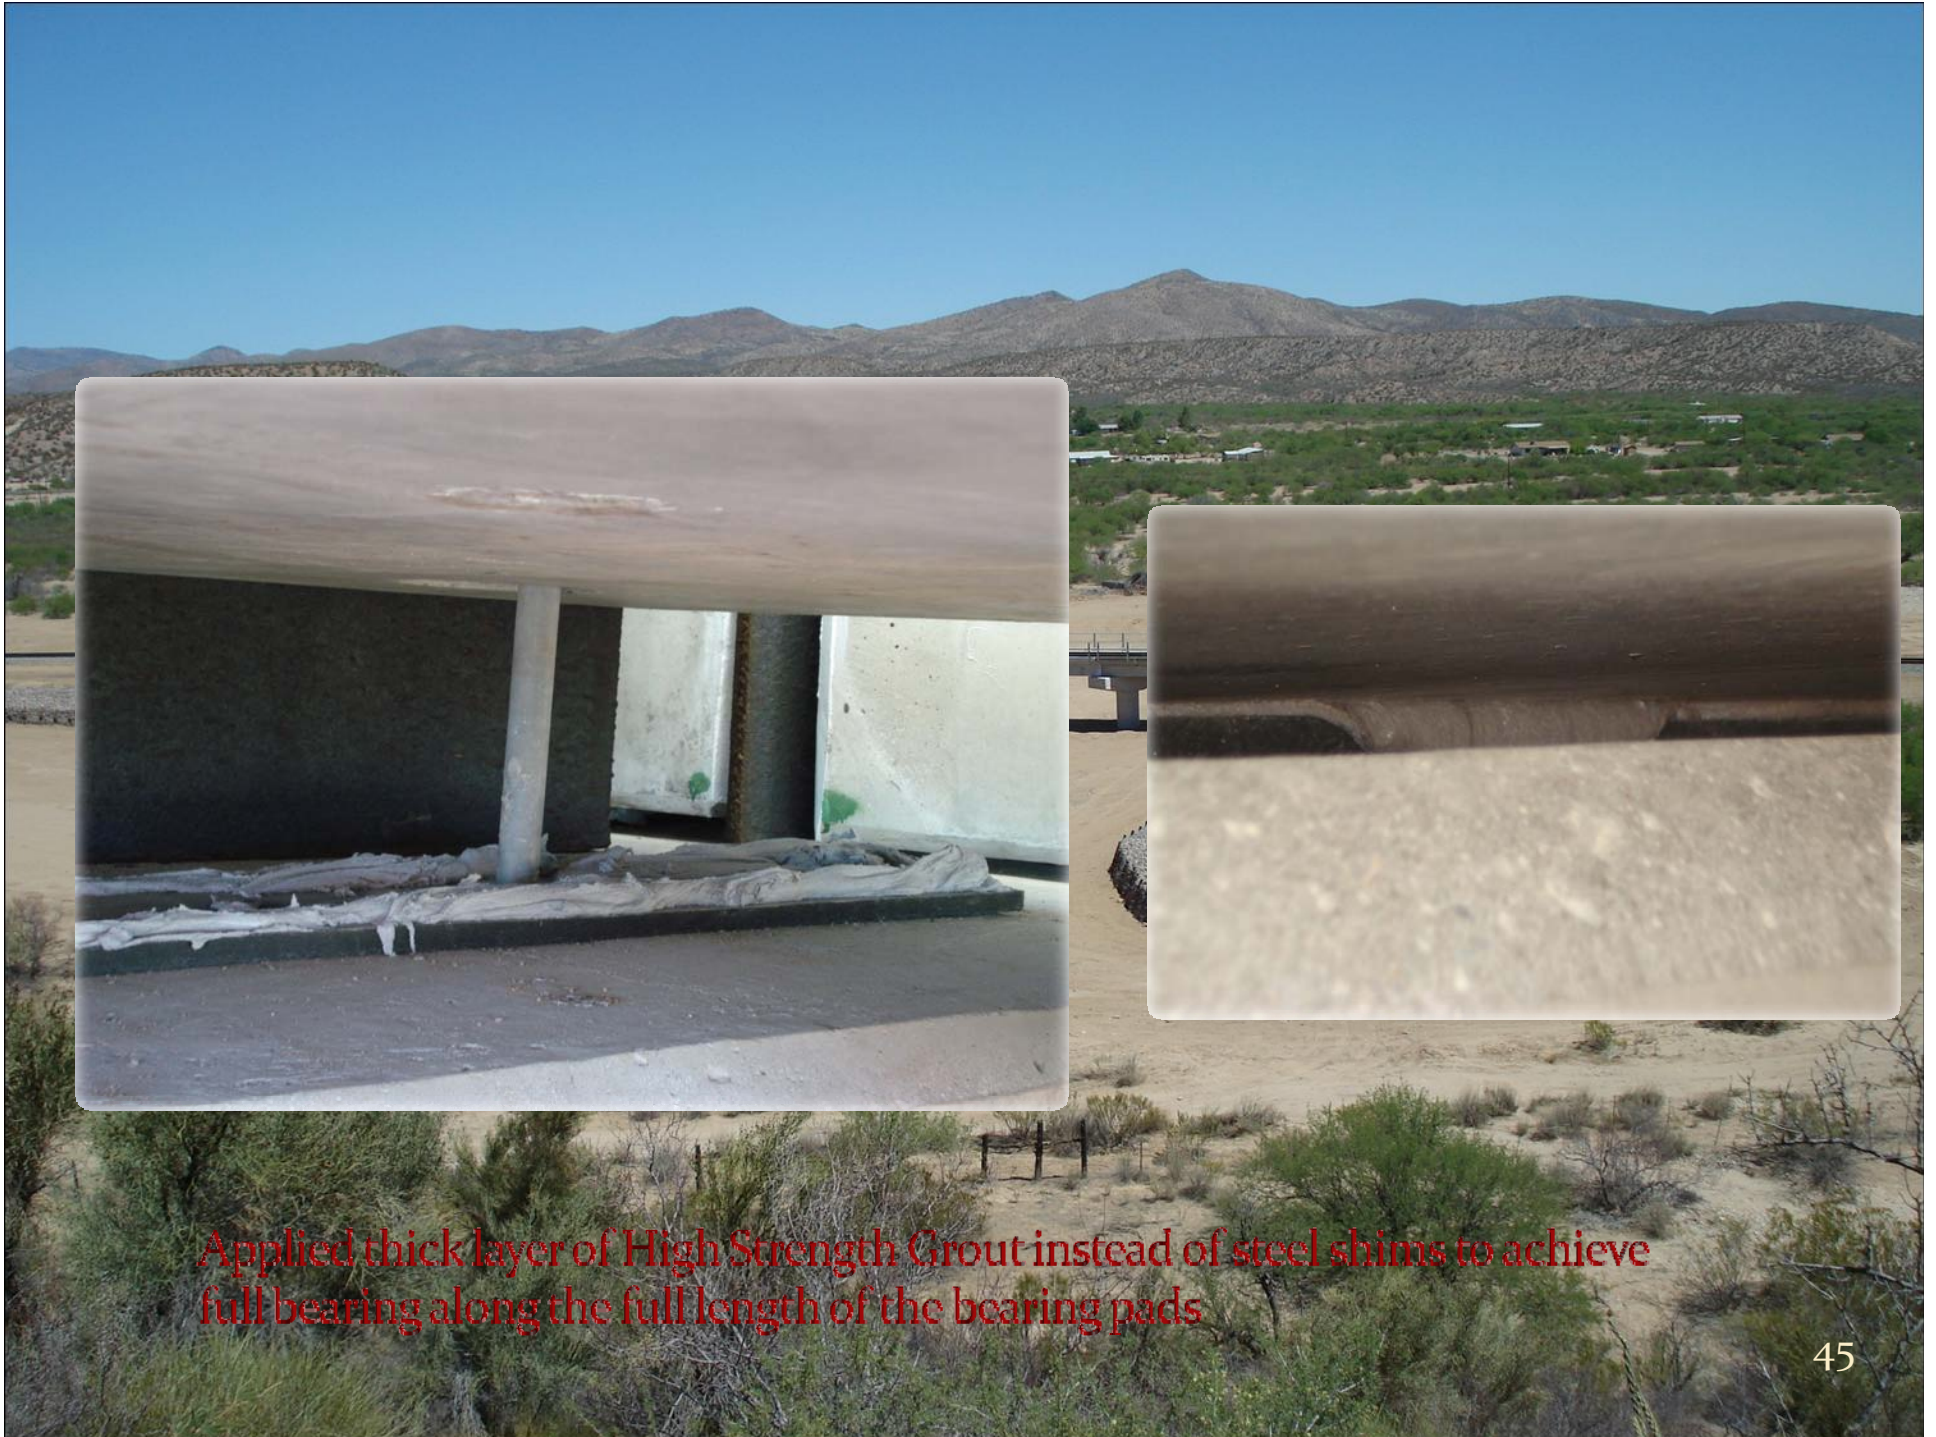
Applied thick layer of High Strength Grout instead of steel shims to achieve full bearing along the full length of the bearing pads

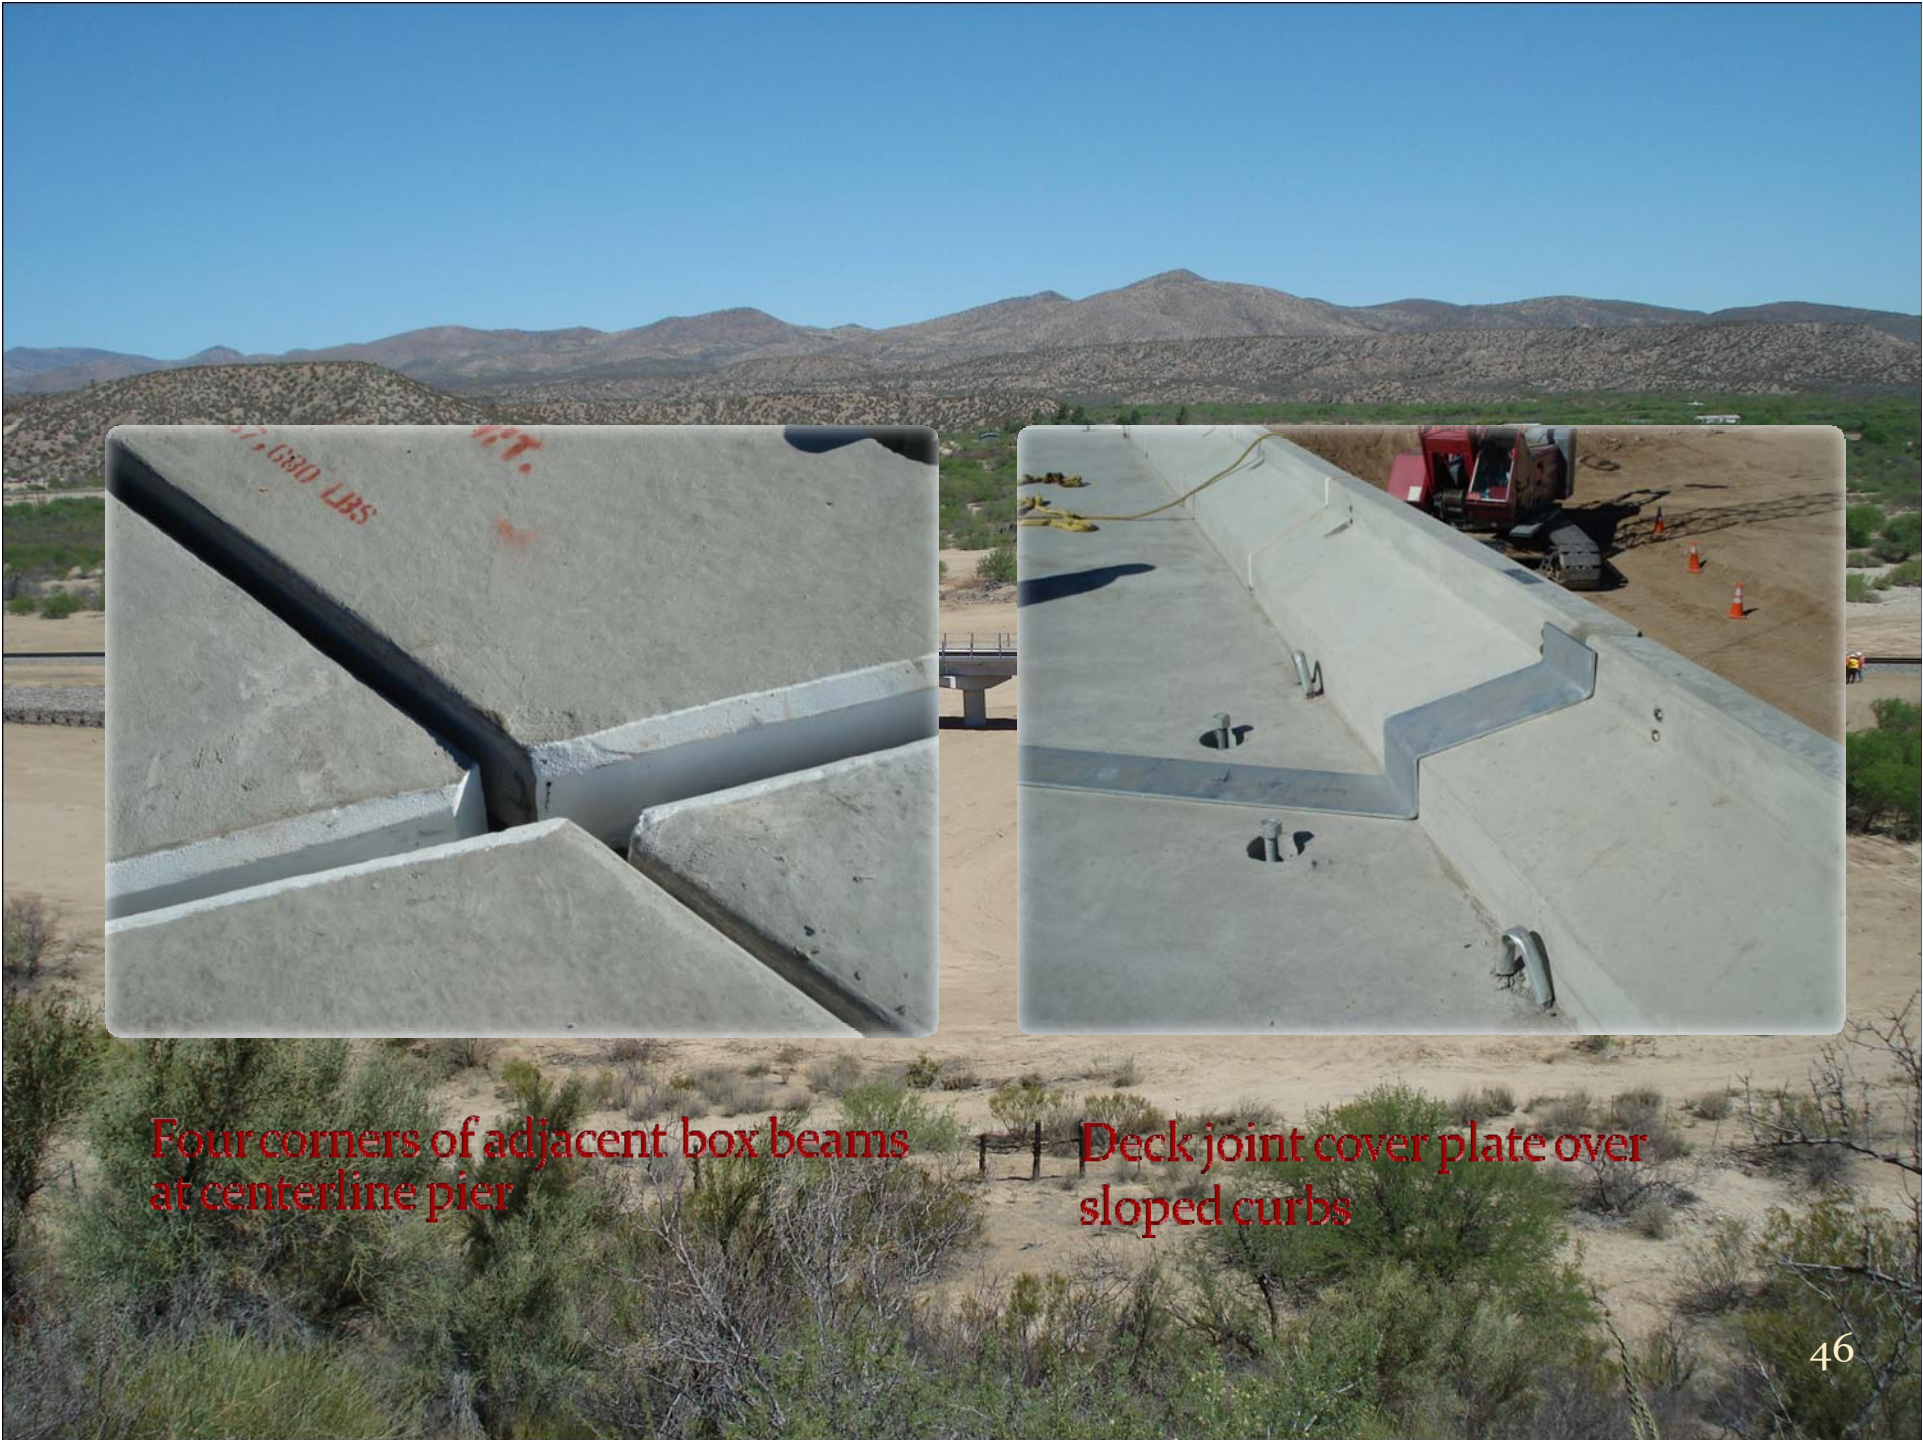
Four corners of adjacent box beams at centerline pier

Deck joint cover plate over sloped curbs

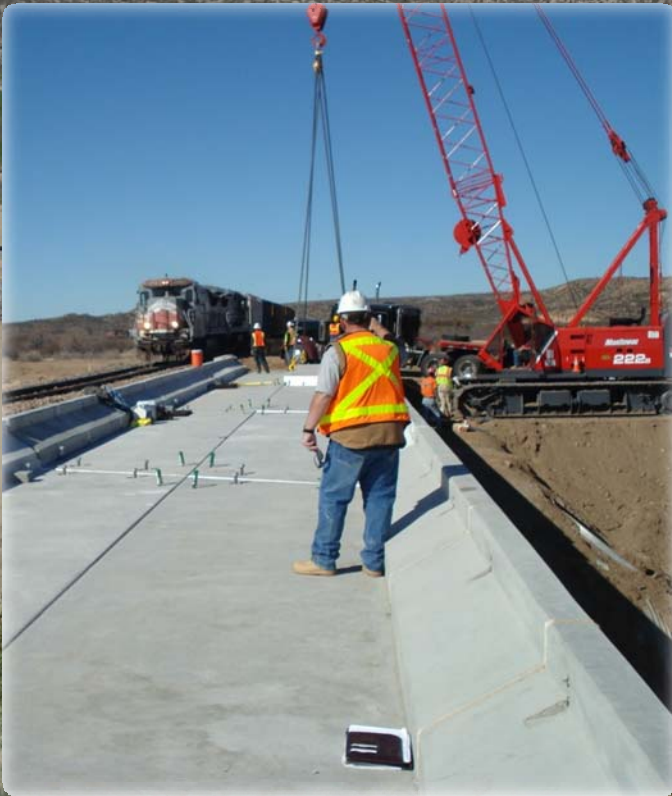
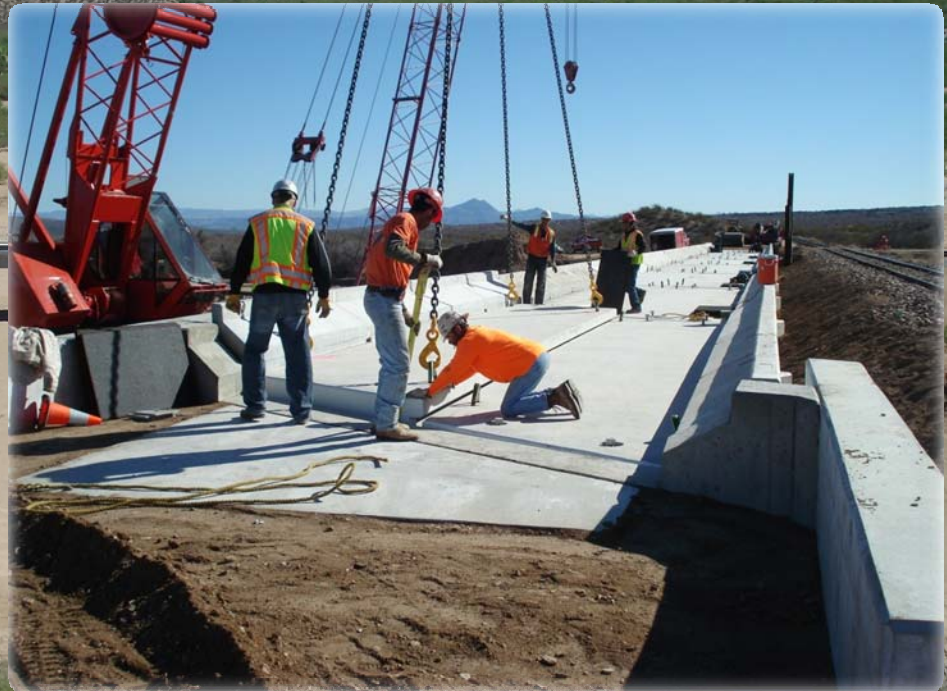
Completion of Box Beam Erection

Once box beams are erected, the bridge is accessible. No deck forming or cast-in-place deck is required

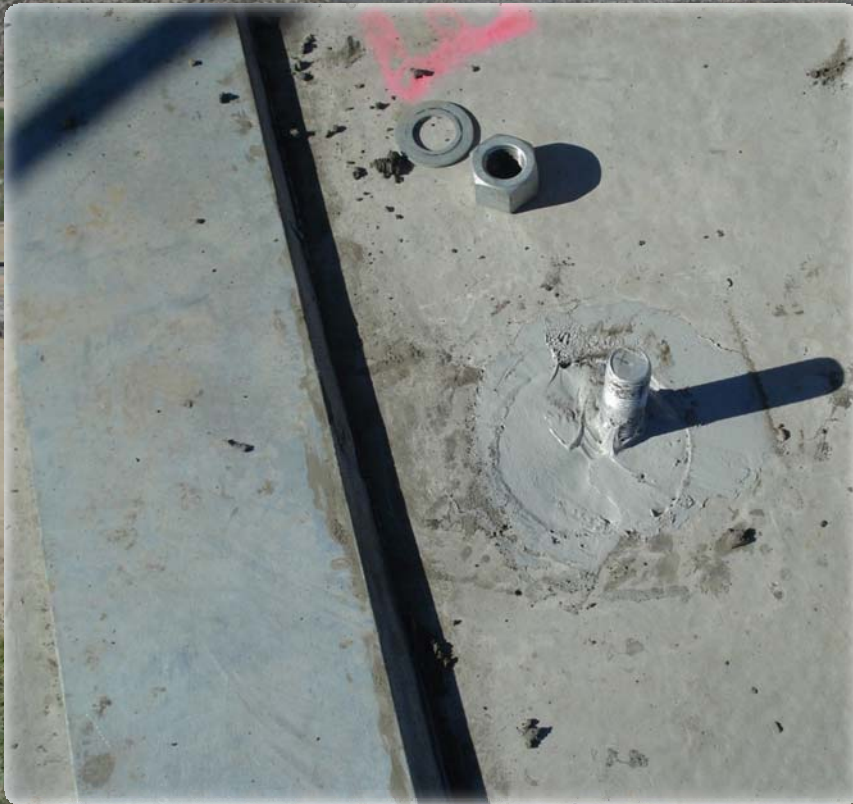
Anchor Bolts at Pinned and Expansion Ends

Expansion connection

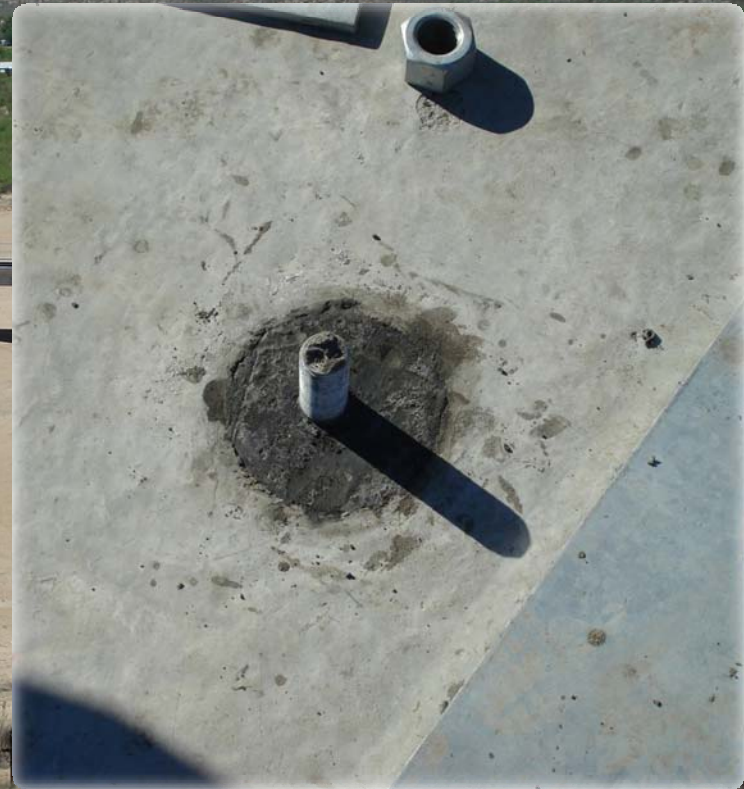
Pinned connection

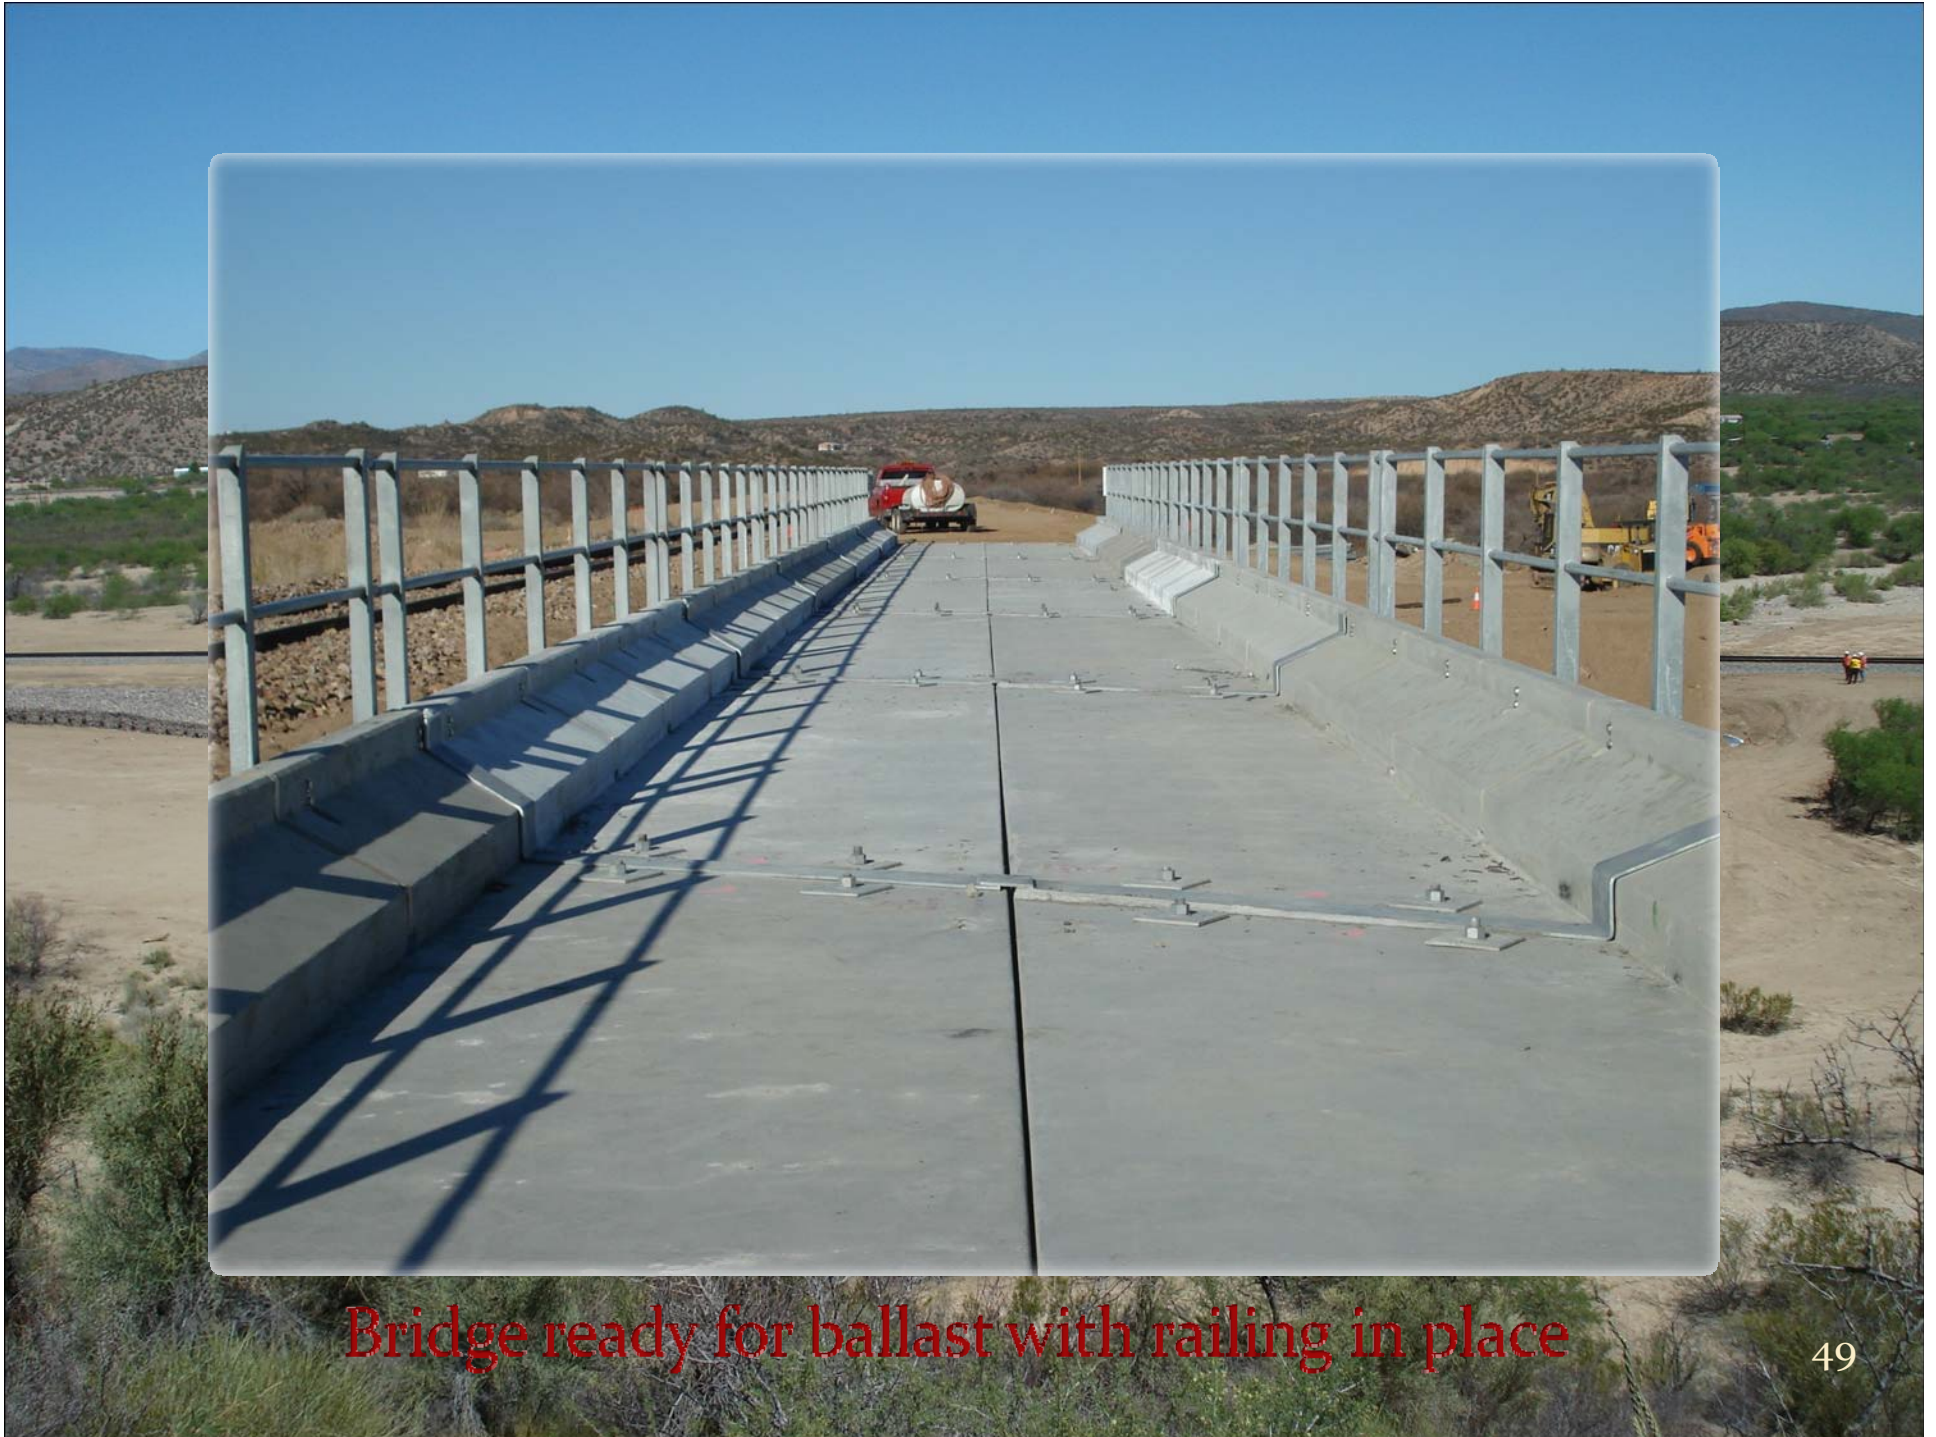
Bridge ready for ballast with railing in place

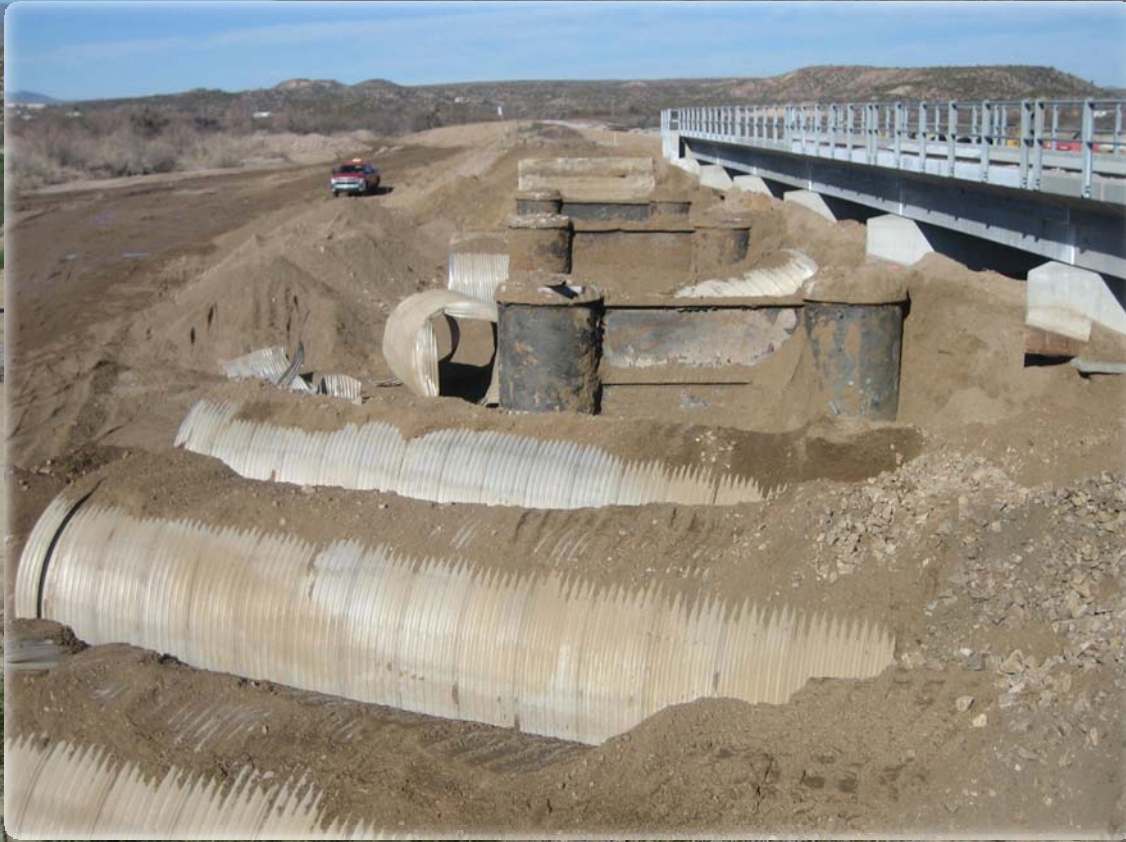
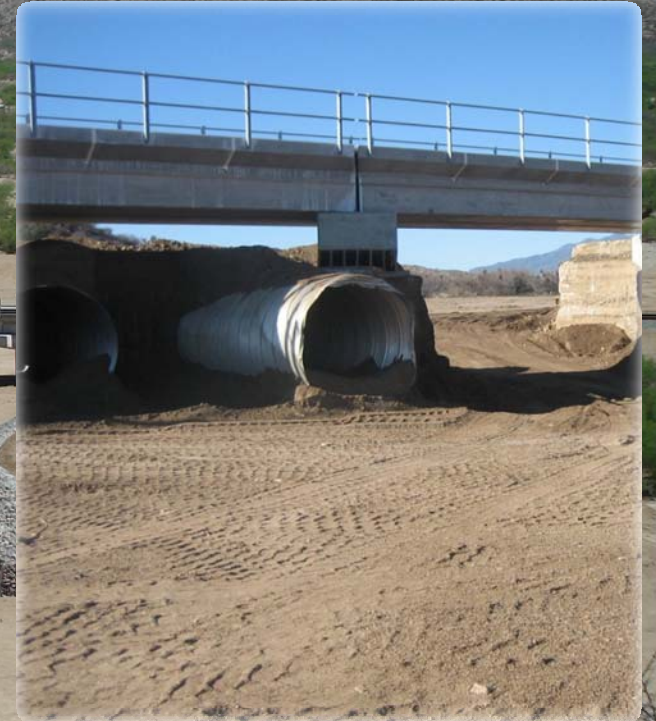
Removal of Temporary Culvert Crossing and Existing Bridge Substructure

Existing foundations & CMP culverts were buried in the fill

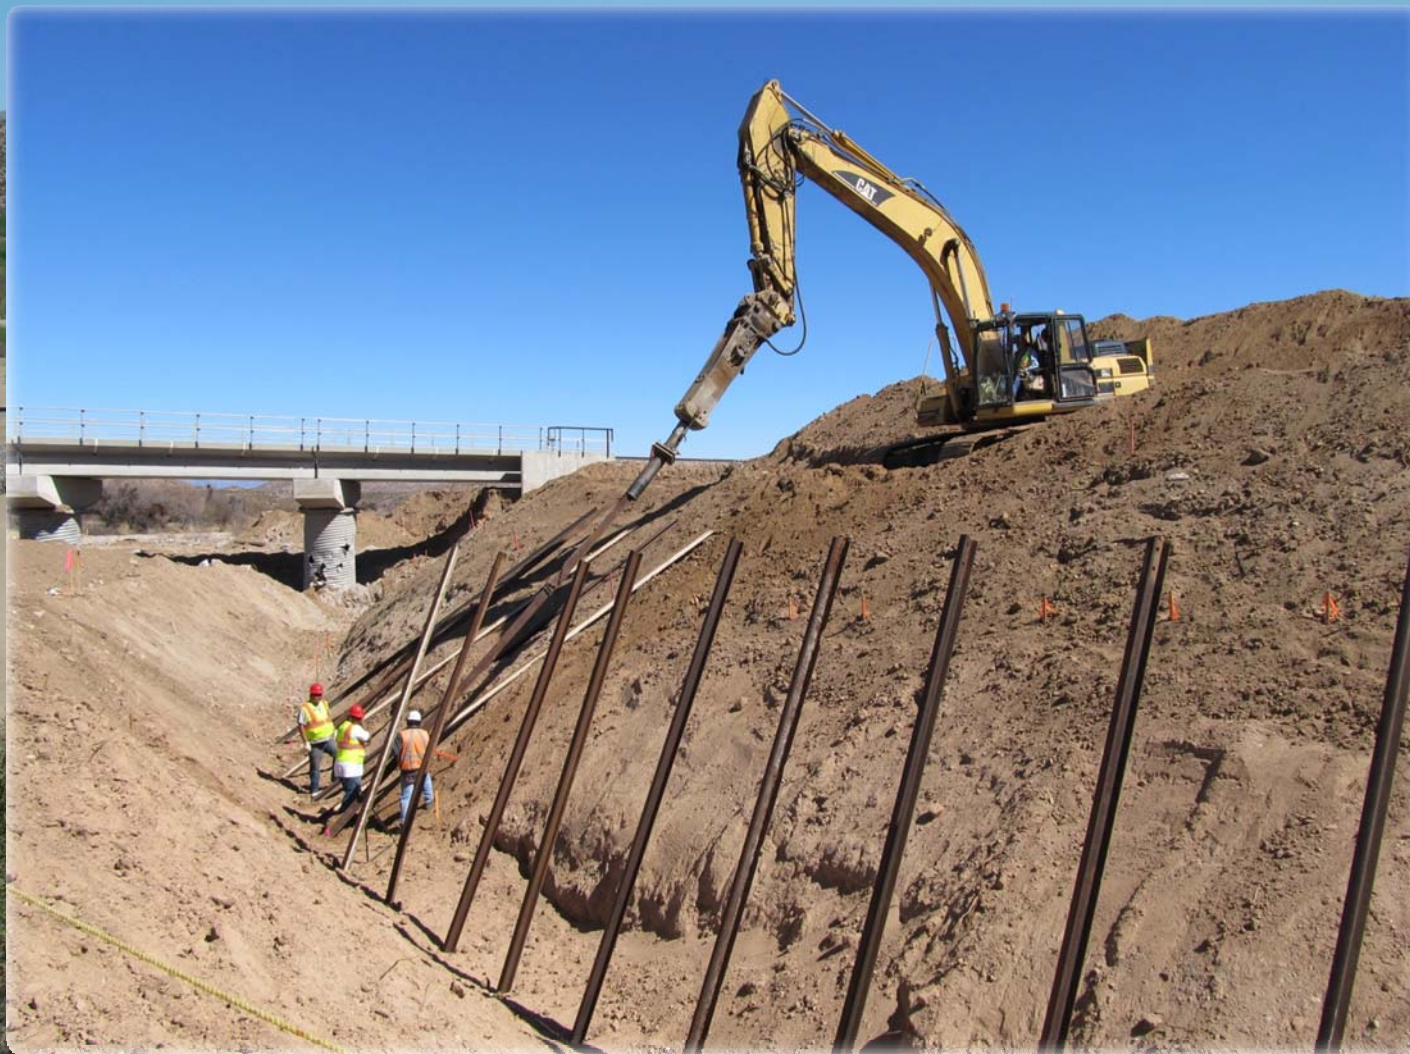
Rail Bank Protection

Installation of long rails on overexcavated slope (1.5H:1V)

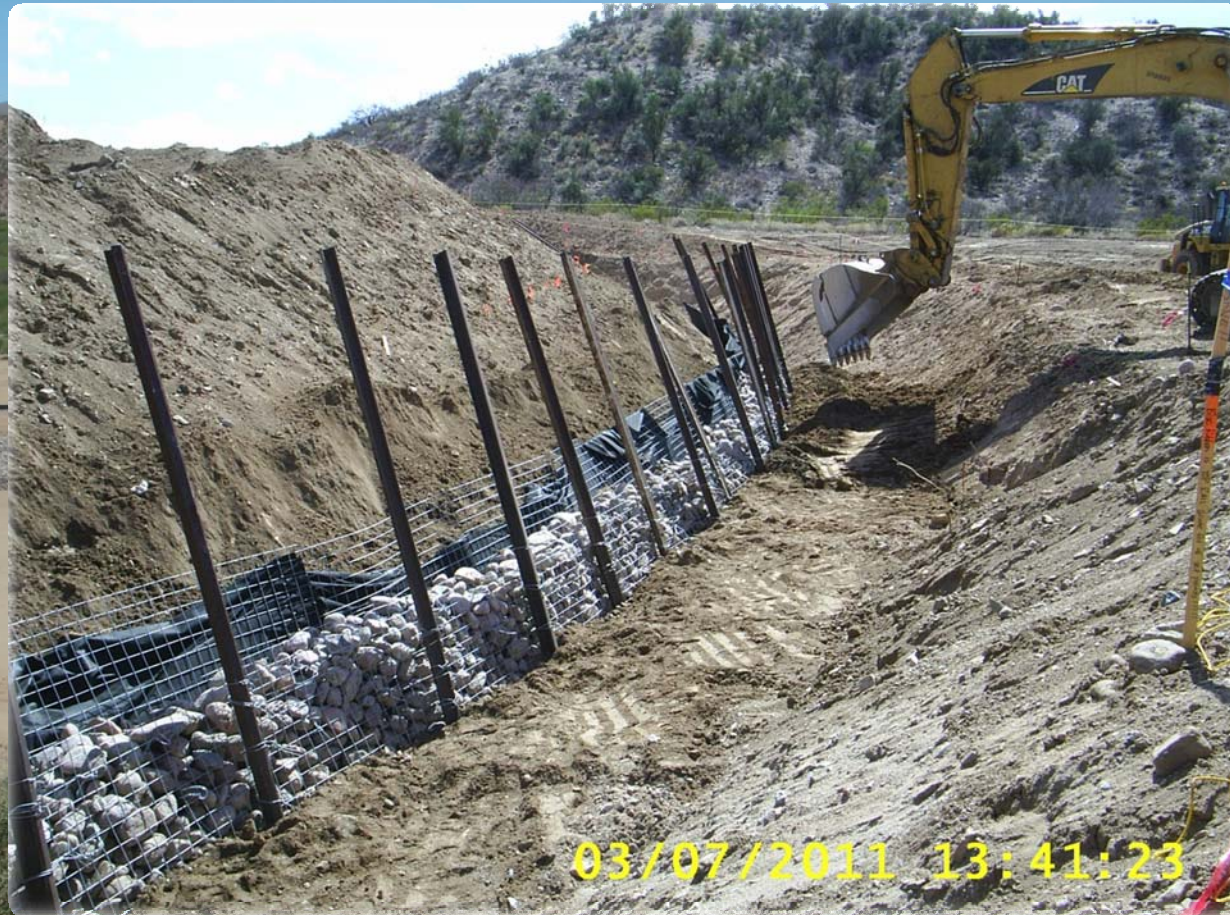
Rail Bank Protection

Backfilling in front of bank protection
(short rails not yet installed)

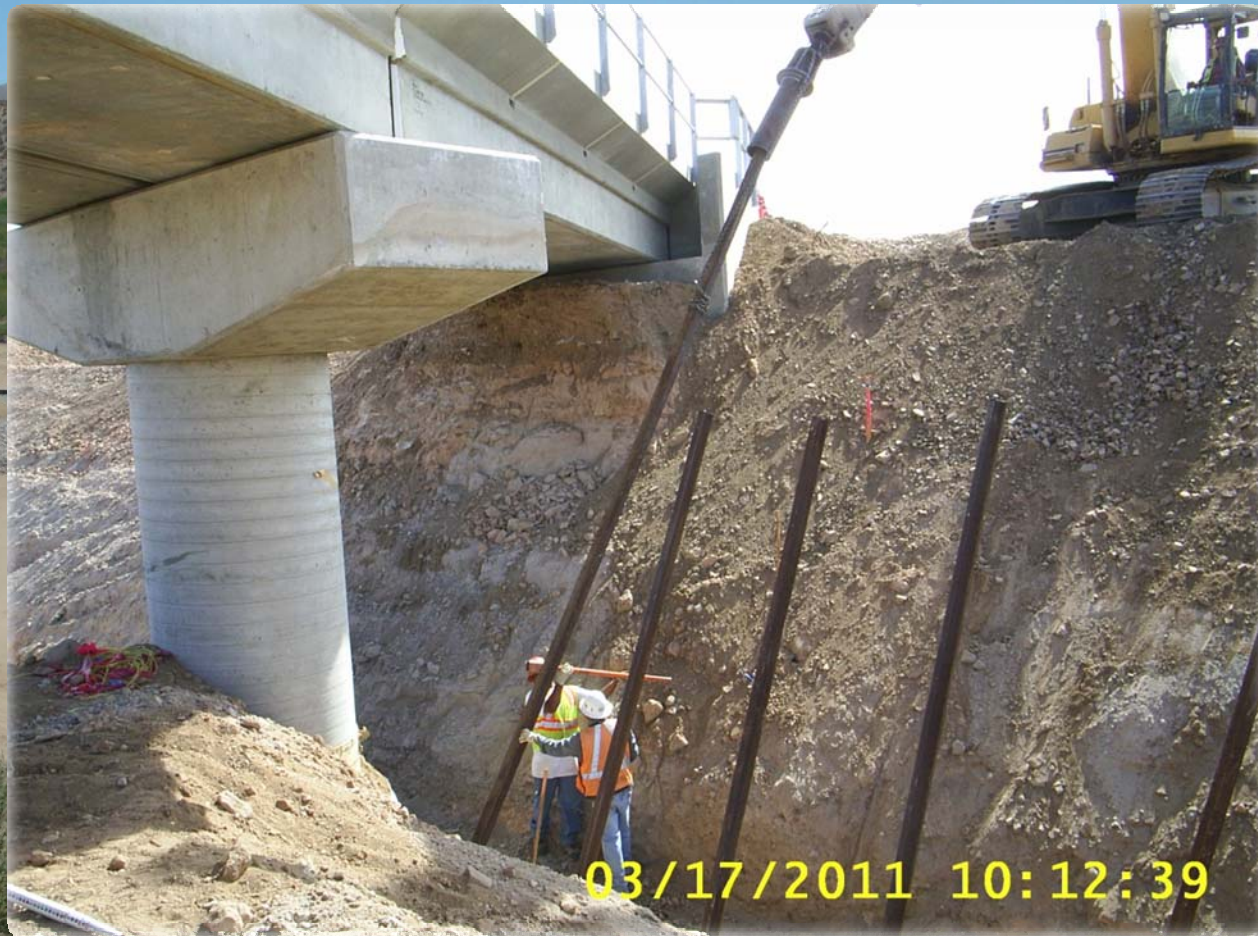
Rail Bank Protection

Installation of long rails near abutments
(as you can see, there were headroom issues)

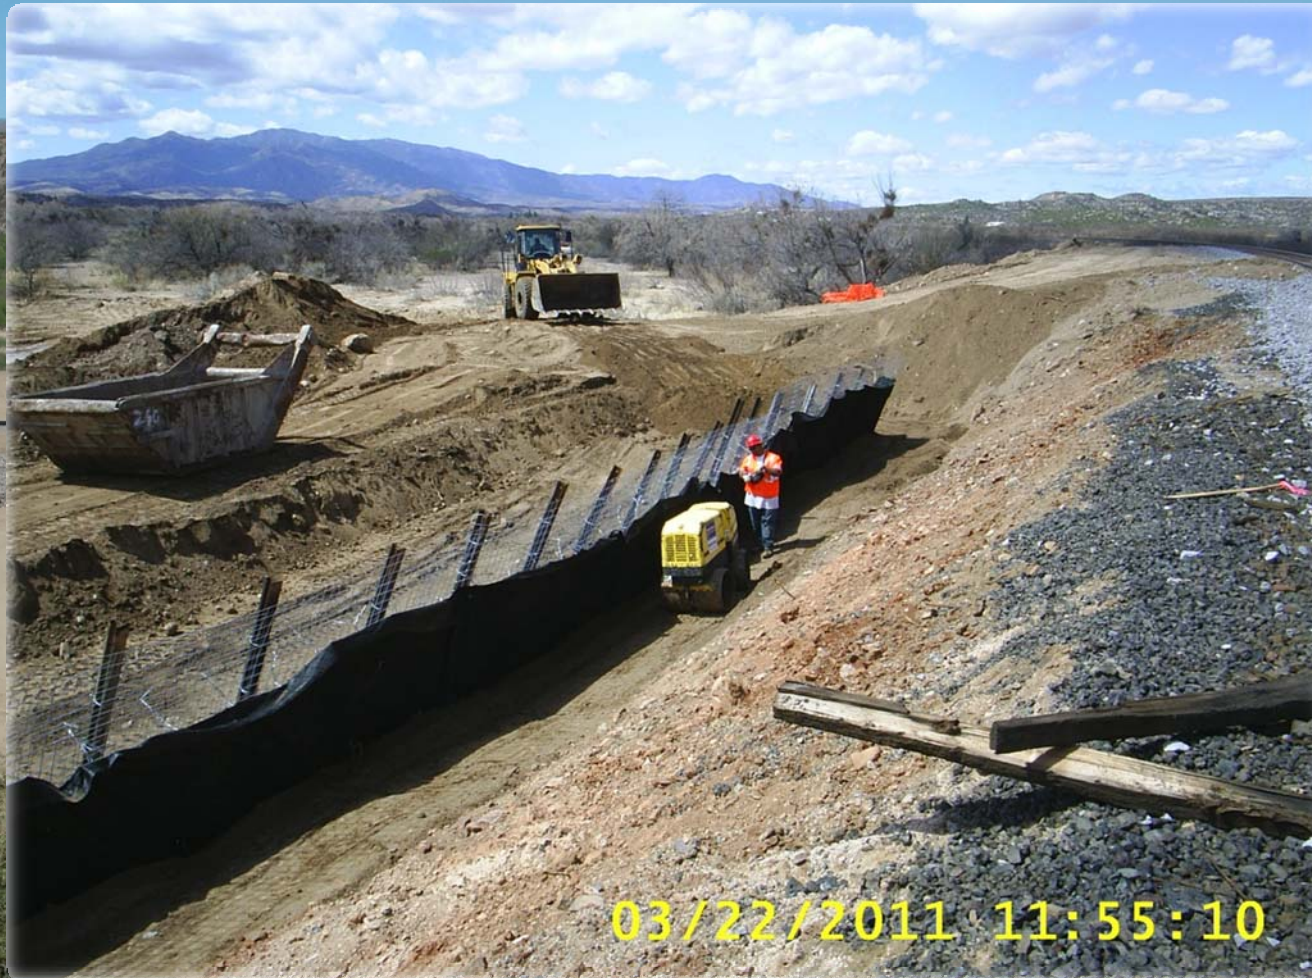
Rail Bank Protection

Backfilling behind bank protection with remote control compactor

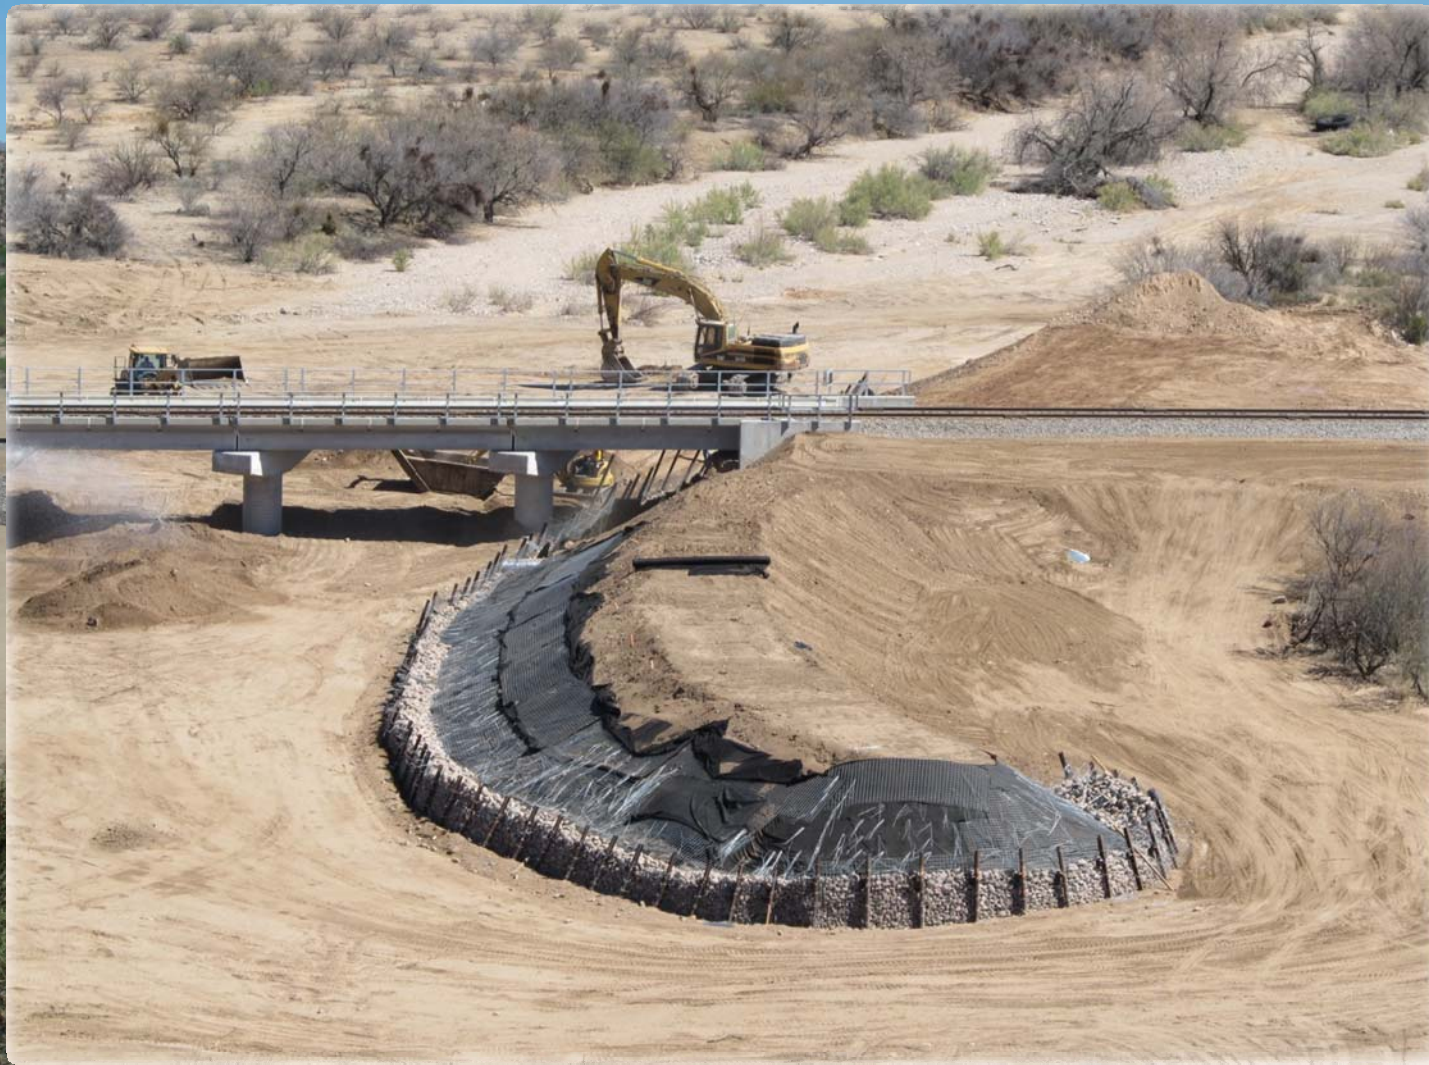
Rail Bank Protection

Bank protection in progress with filter fabric and rock
