ARIZONA EASTERN RAILWAY GILSON WASH BRIDGE REPLACEMENT

Western Bridge Engineer's Seminar

- Owner: Arizona Eastern Railway (AZER) (Recently sold to the Genesee & Wyoming Railroad. Formerly owned by Iowa Pacific Holdings, Chicago, Illinois)
- Location: San Carlos Apache Nation, near Globe, AZ
- Contractor: Ames Construction, Inc. (Scottsdale, AZ)
- Original Bridge: 200-foot long steel deck girder bridge
- New Bridge: 288-foot long precast double cell box beam bridge supported on drilled shaft foundations

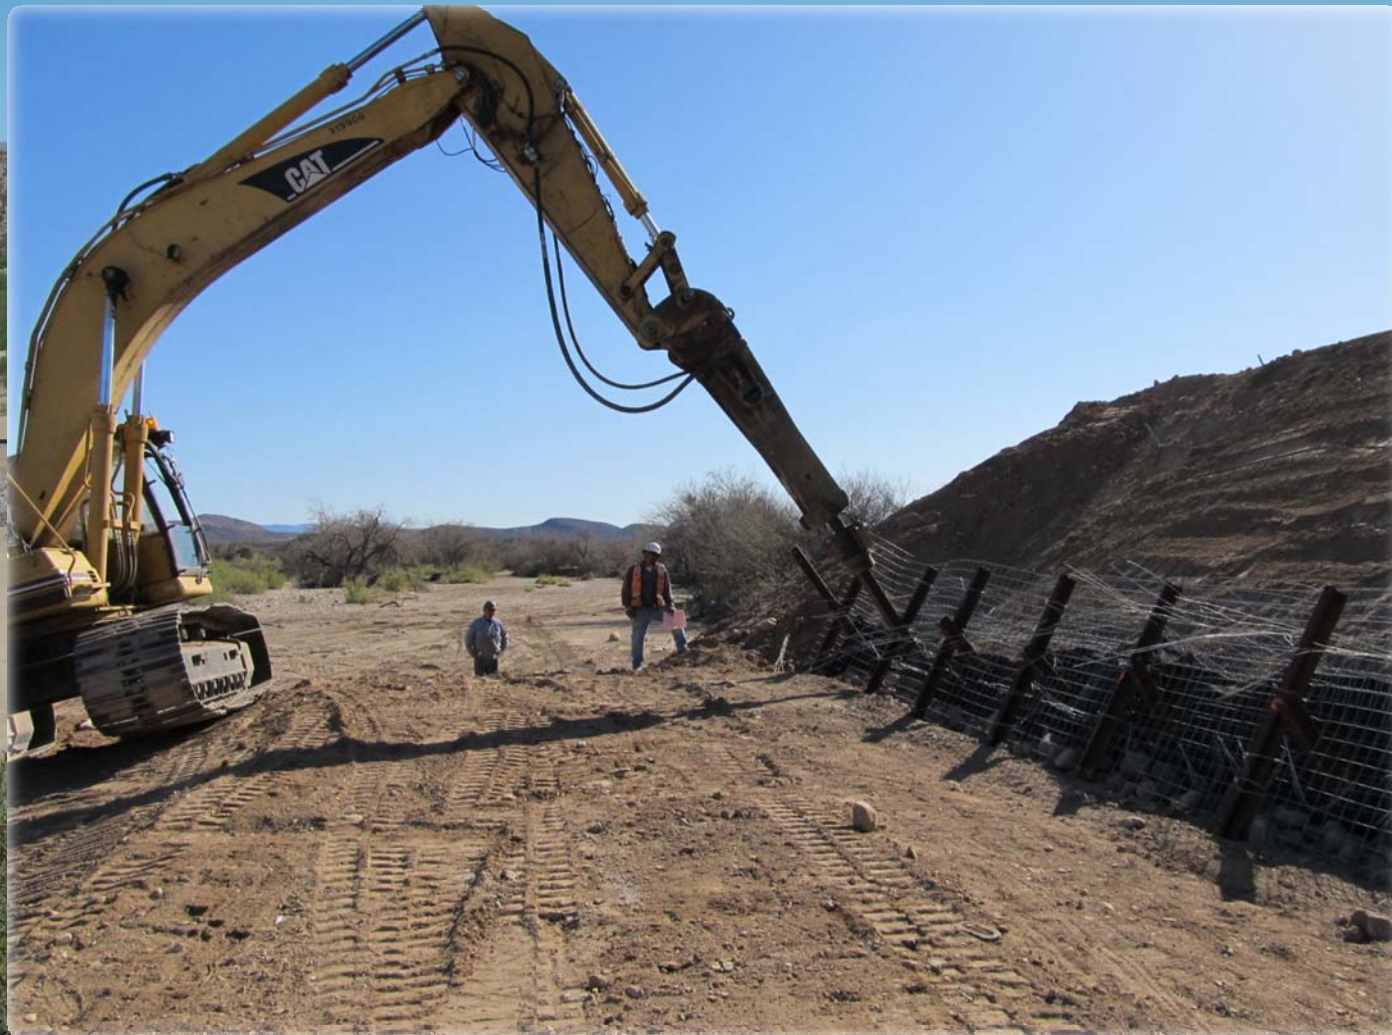
Rail Bank Protection

Installing short rails

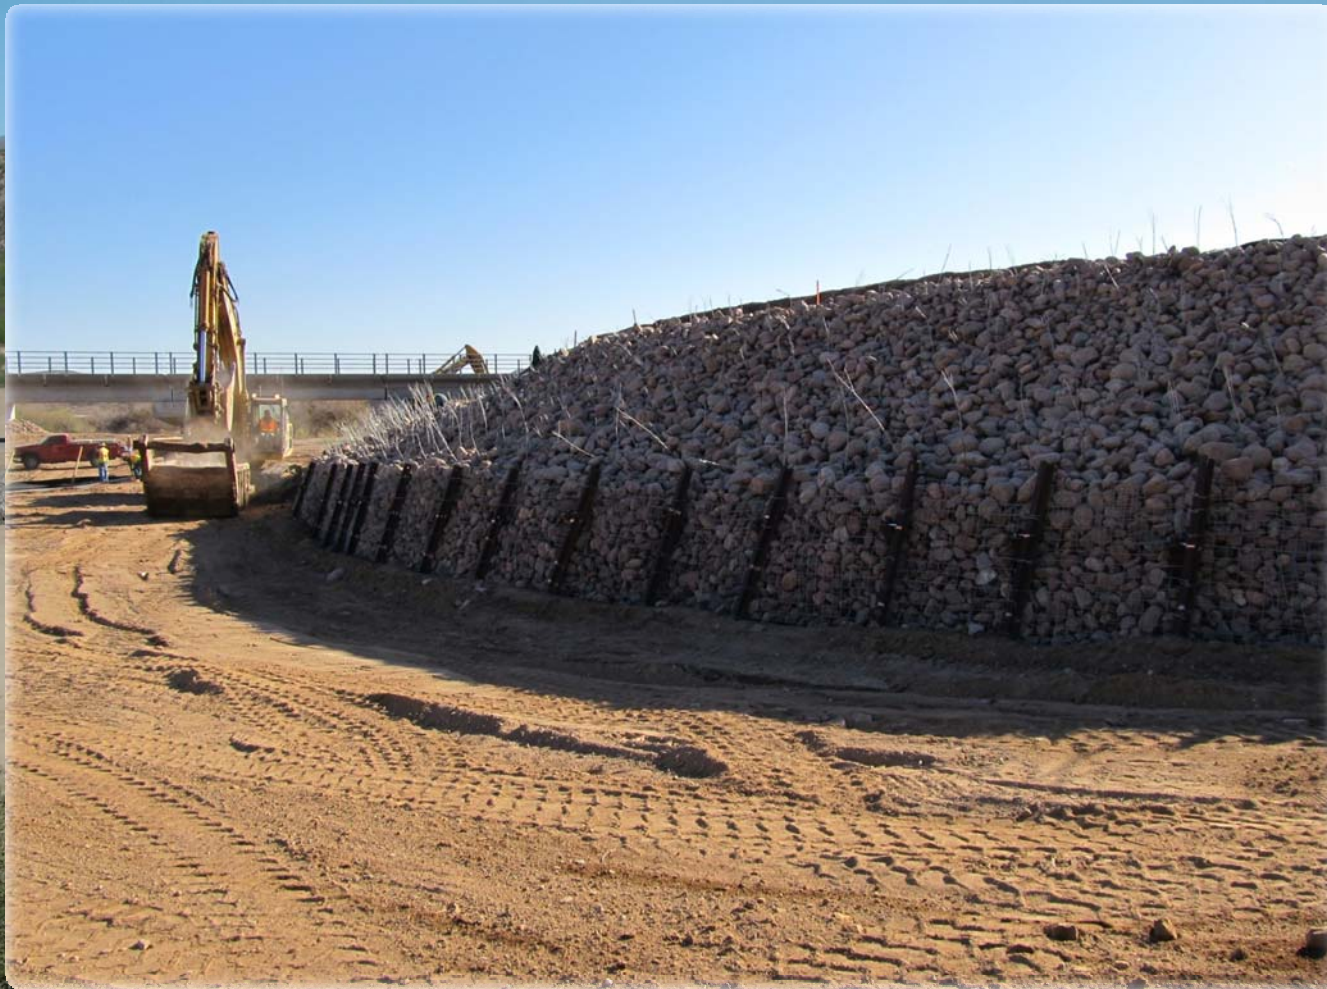
Rail Bank Protection

Placing rock on 1.5H:1V slope
(very time consuming due to flat slope)

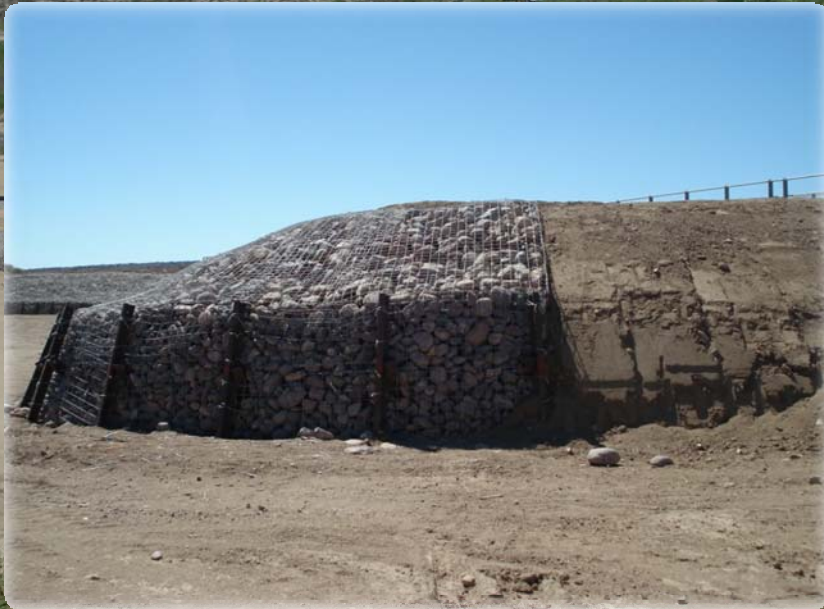
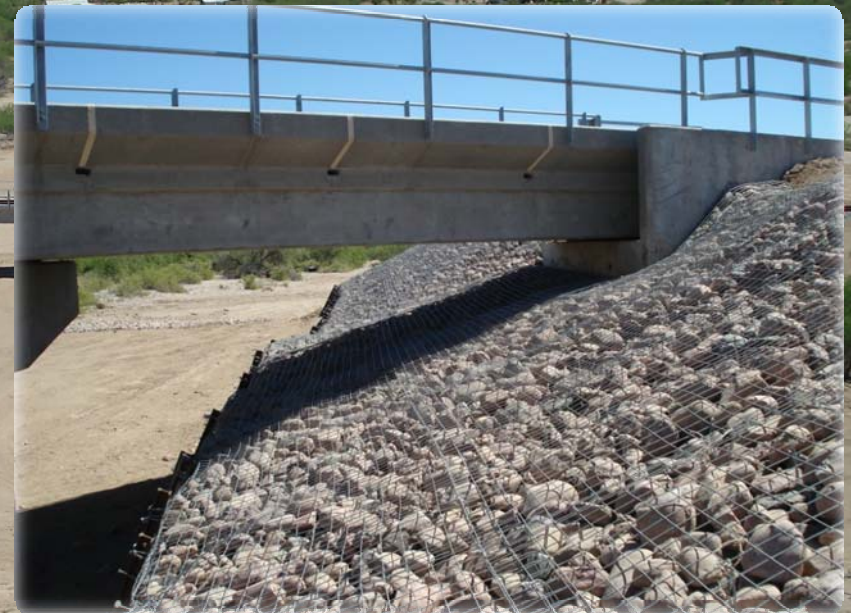
Rail Bank Protection

Completed bank protection

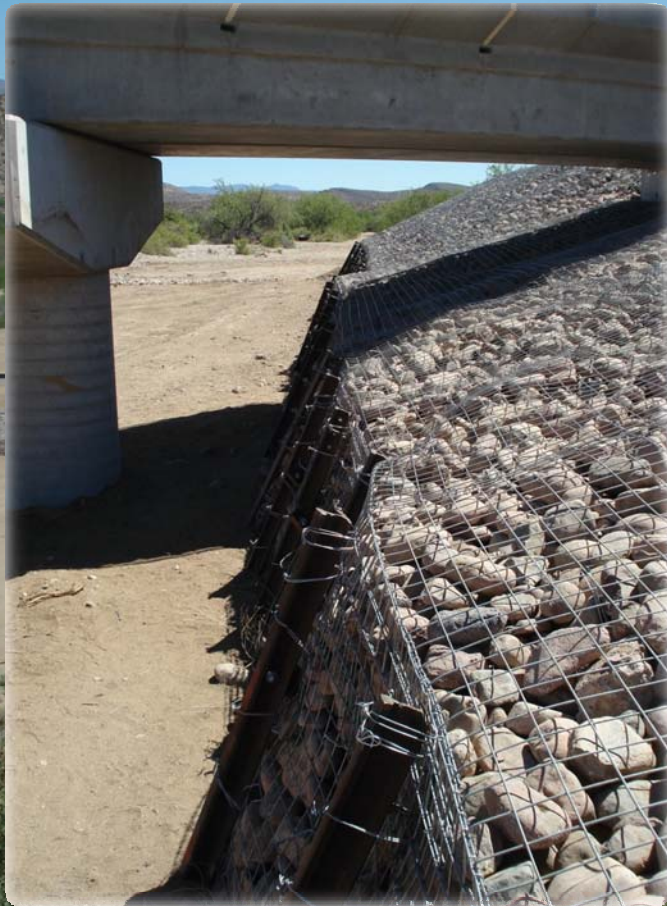
Bank protection at abutments

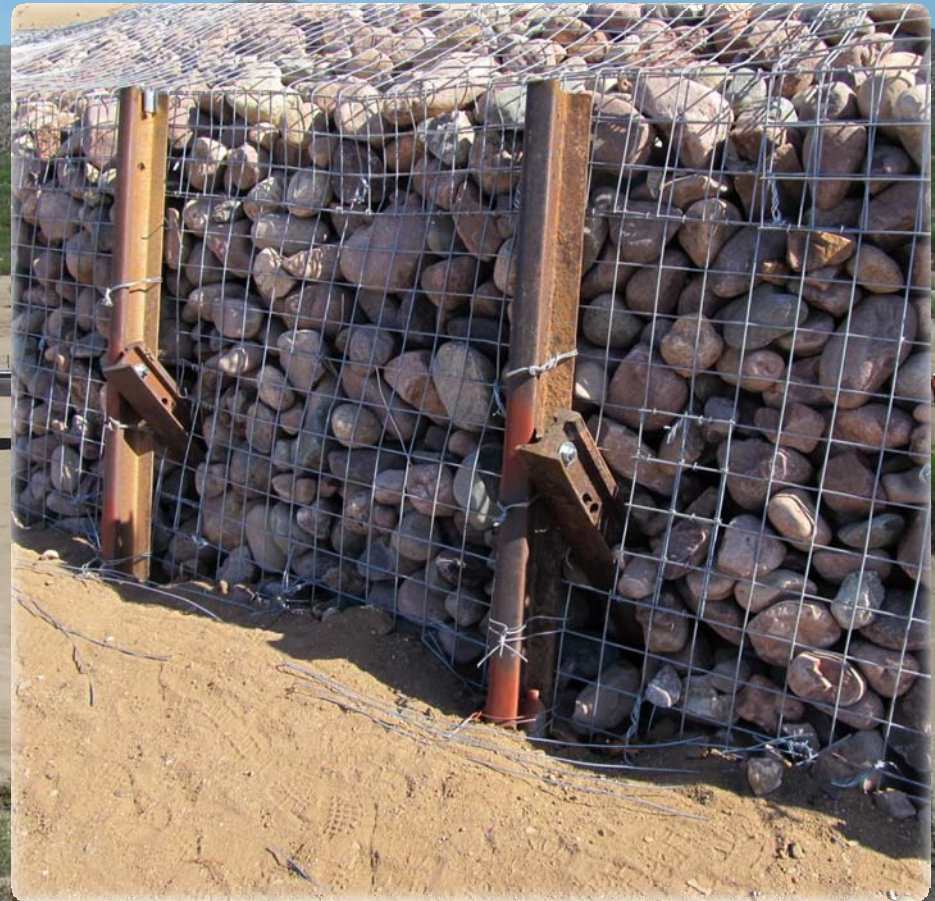
Short rail to long rail connection

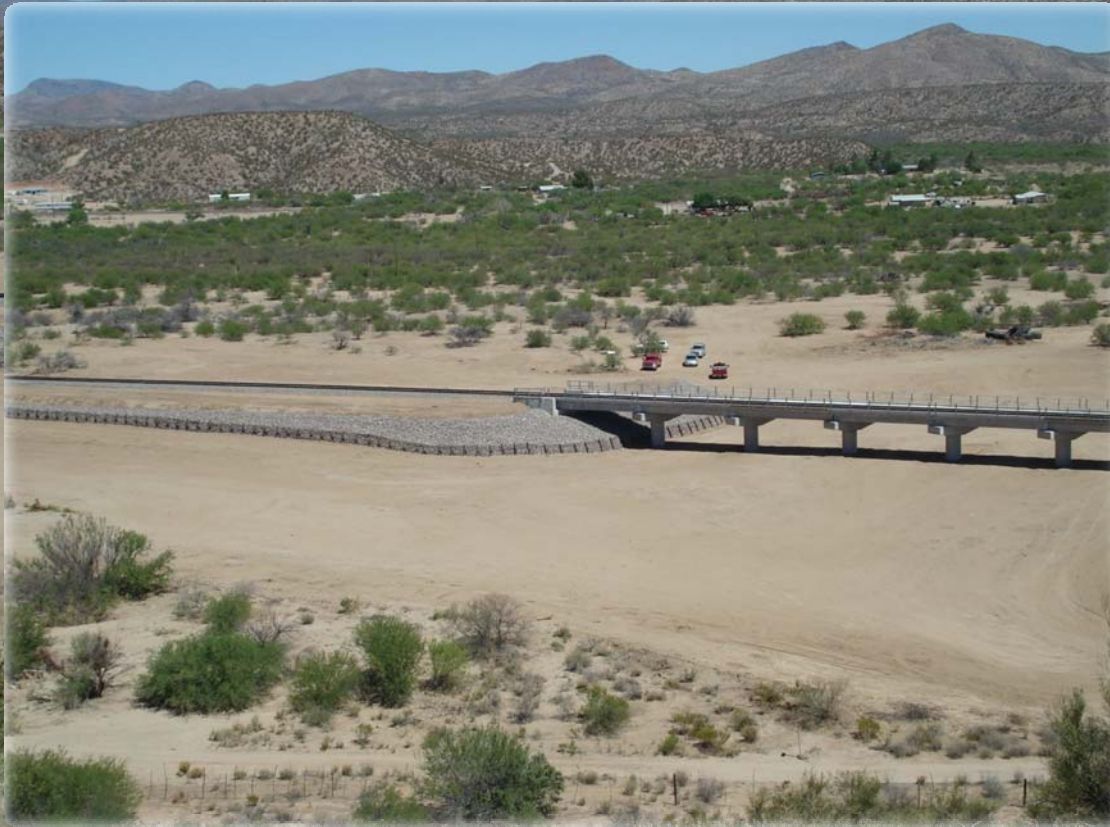
Completed bank protection

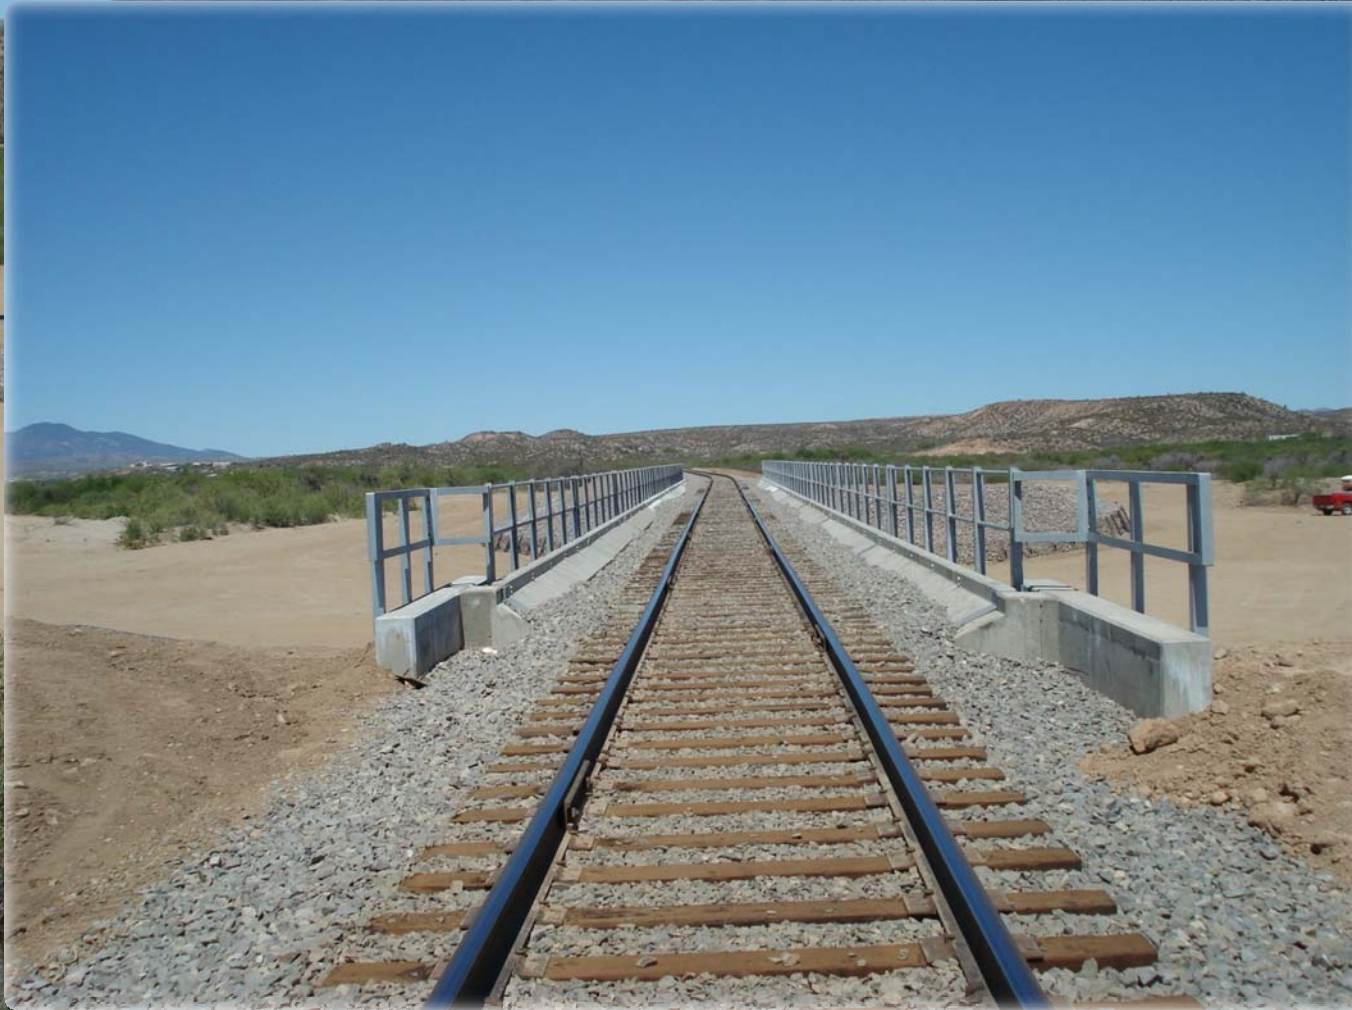
Completed Bridge

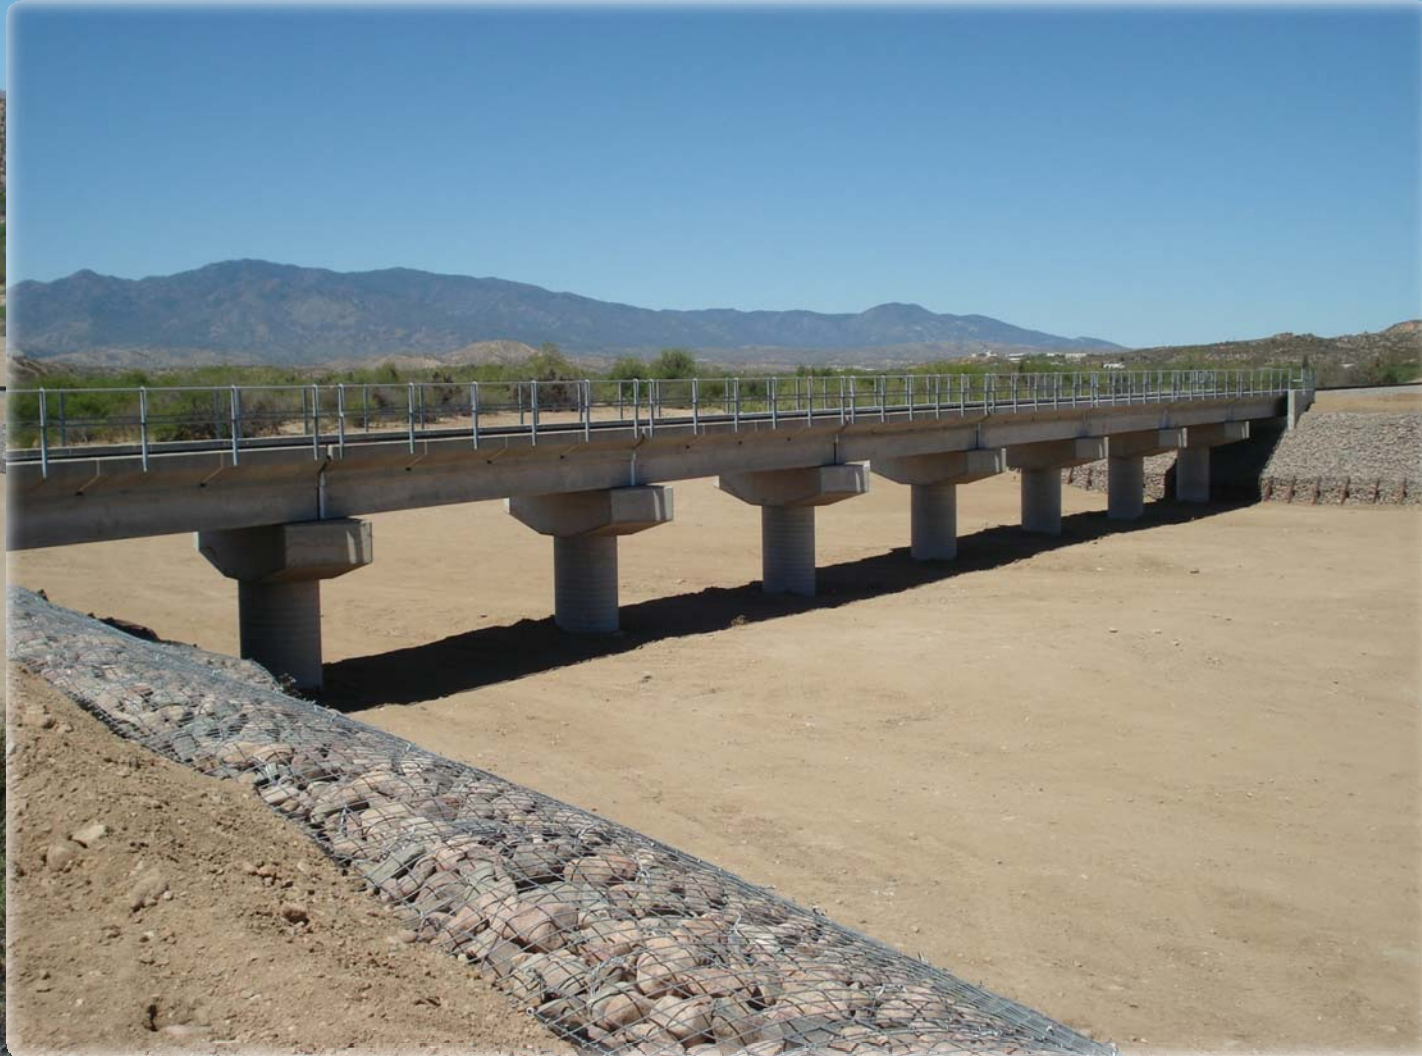
Completed Bridge
