AGENDA

ODOT BRIDGE PRESERVATION THE BEGINNING – ALSEA BAY BRIDGE

ODOT ICCP THE BEGINNING – CAPE CREEK BRIDGE

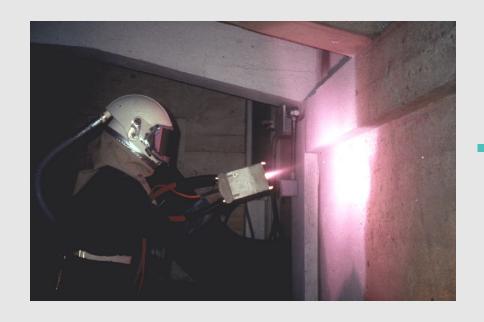
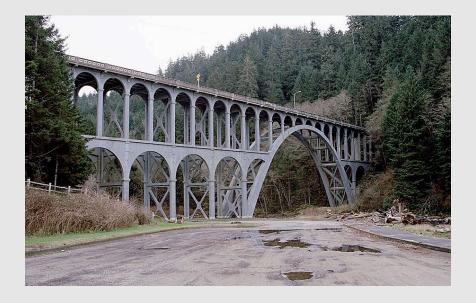
- Arc-sprayed zinc anode technology -Caltrans research
 - Excellent anode properties
 - Gray concrete-like appearance
- Cape Creek Bridge
 - US101 20 miles S of Alsea Bay
 - ICCP in 1991

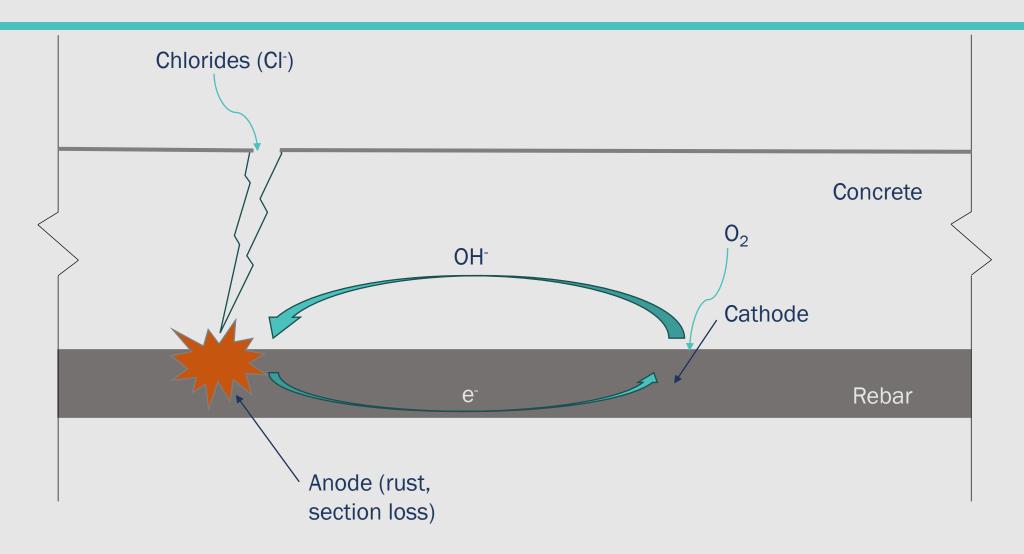
IMPRESSED CURRENT CATHODIC PROTECTION THE BASICS

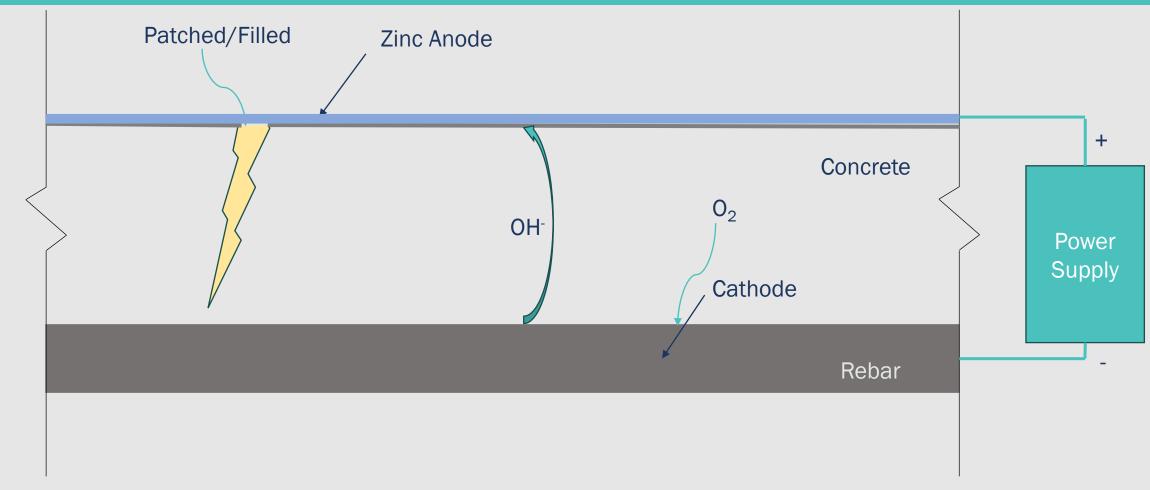
IMPRESSED CURRENT CATHODIC PROTECTION THE BASICS

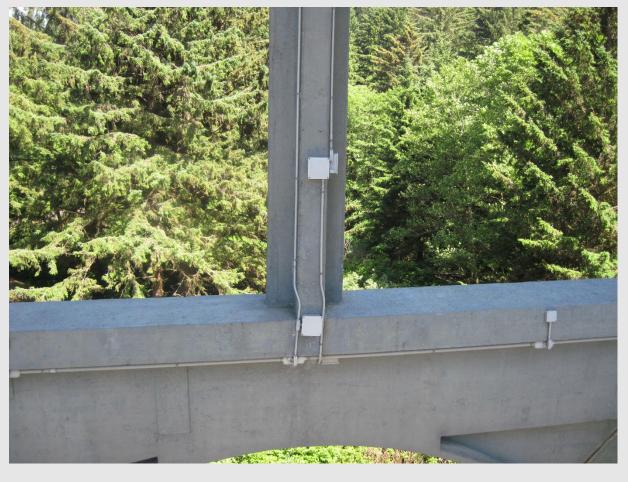
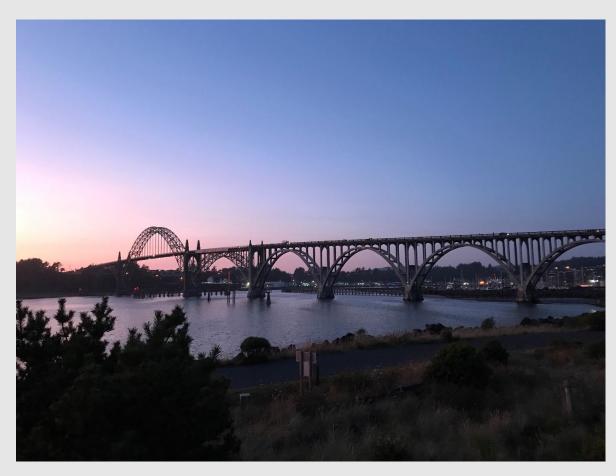
- South Approach
 - ICCP 1994, 2023
 - In 2021 2533 LF of Girder, 55 LF in CS2 (~2%)
- North Approach
 - ICCP 2023
 - In 2021 1269 LF of Girder, 91 LF CS3/4 (~7%), 896 LF in CS2 (~70%)

- South Approach
 - ICCP 1994, 2023
 - In 2021 2533 LF of Girder, 55 LF in CS2 (~2%)
- North Approach
 - ICCP 2023
 - In 2021 1269 LF of Girder, 91 LF CS3/4 (~7%), 896 LF in CS2 $(\sim 70\%)$

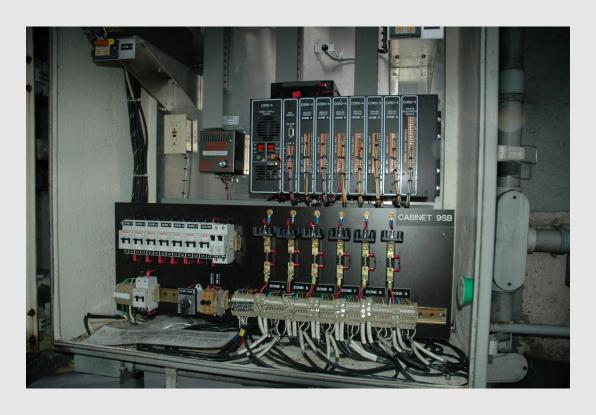
- Yaquina Bay (total)
 - Monthly cost ~\$130
 - Project Cost ~ \$26M
 - ~\$500k in concrete repair
 - \$4M in Zinc Anode
 - \$7.5M in Access and Containment
 - Estimated Replacement
 - ~\$800M-\$1.5B
 - Assume 4 lane signature structure

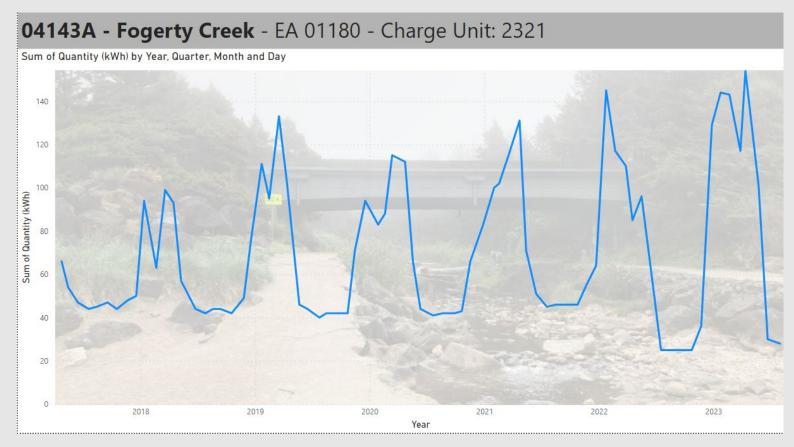
- Fogarty Creek
 (04143A) 2016
 - Monthly cost ~\$30
 - Project Cost ~ \$1.8M
 - ~\$600k in concrete repair
 - \$100k in Access and Containment
 - Estimated
 Replacement \$4M
 - Sensitive Site

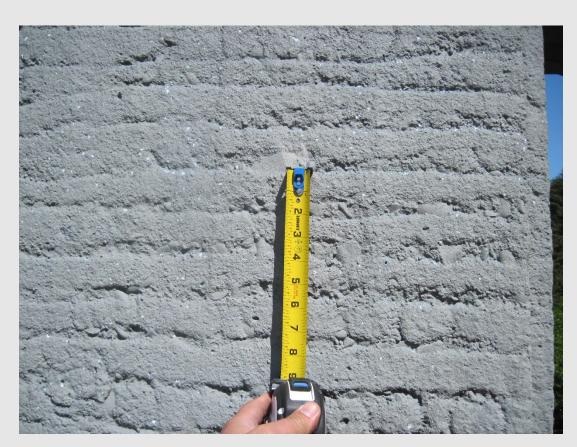
Damage from sand blasting

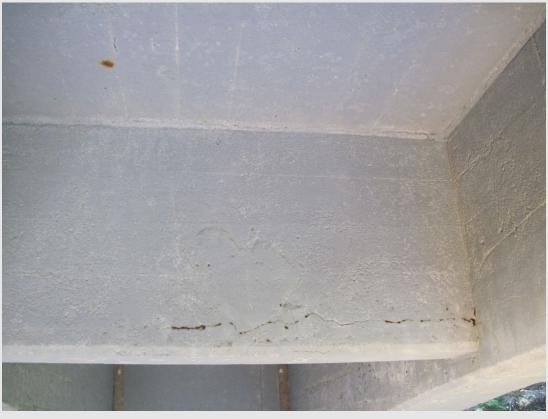
Shallow rebar
