# Asset Preservation: System-Wide and Structure Specific Bridge Asset Management Plans

*Presenters:*  
*Travis Butz, PE*  
*David Van Atta, PE*

# I. B. Perrine Bridge

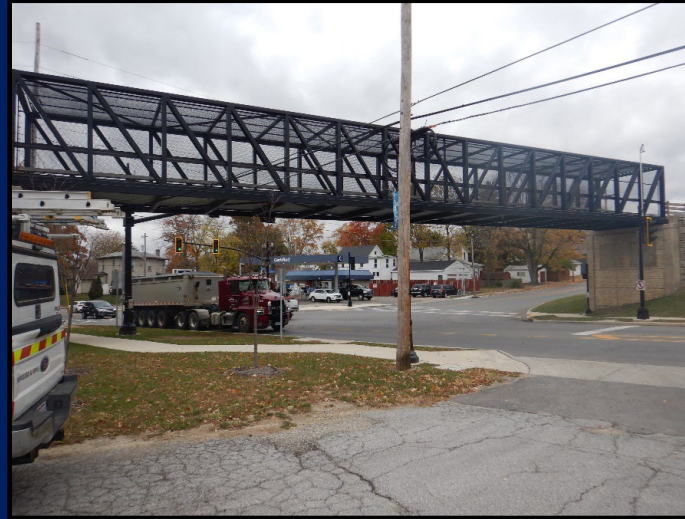
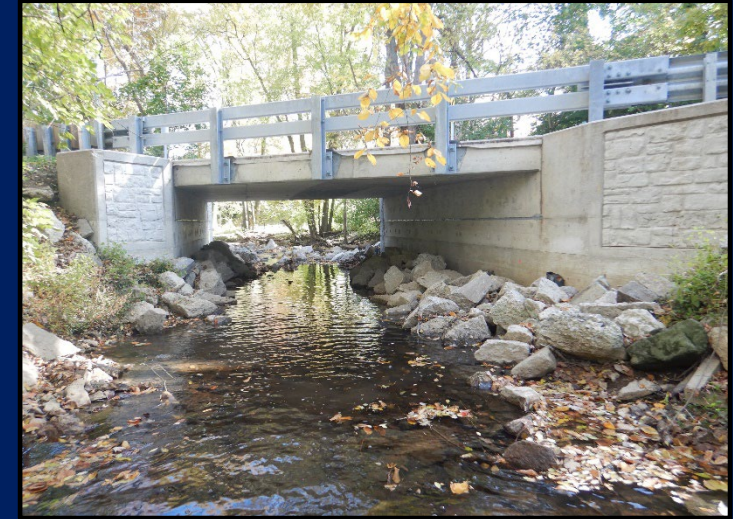
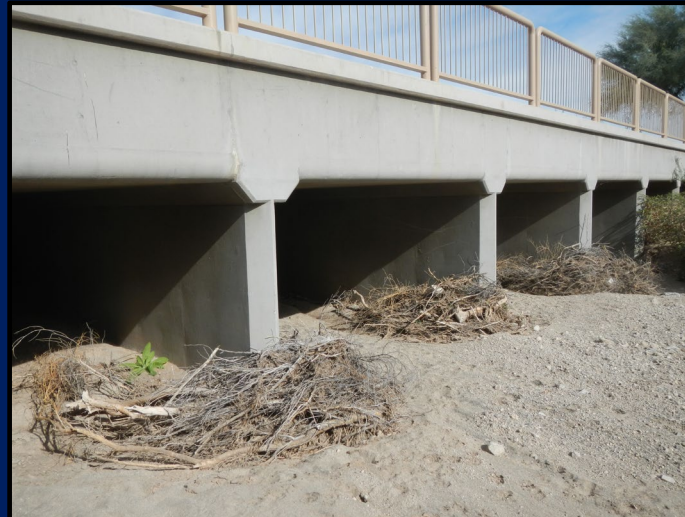
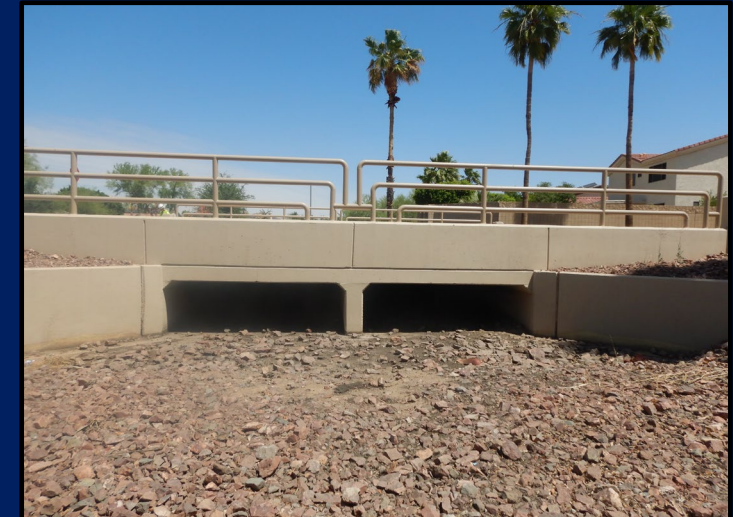
# Phase 2 – Field Review

- 2-person team
- Verify information obtained in data collection phase (condition ratings / repair recommendations)
- Fill gaps in collected data
- Collect repair quantity data to support cost estimating

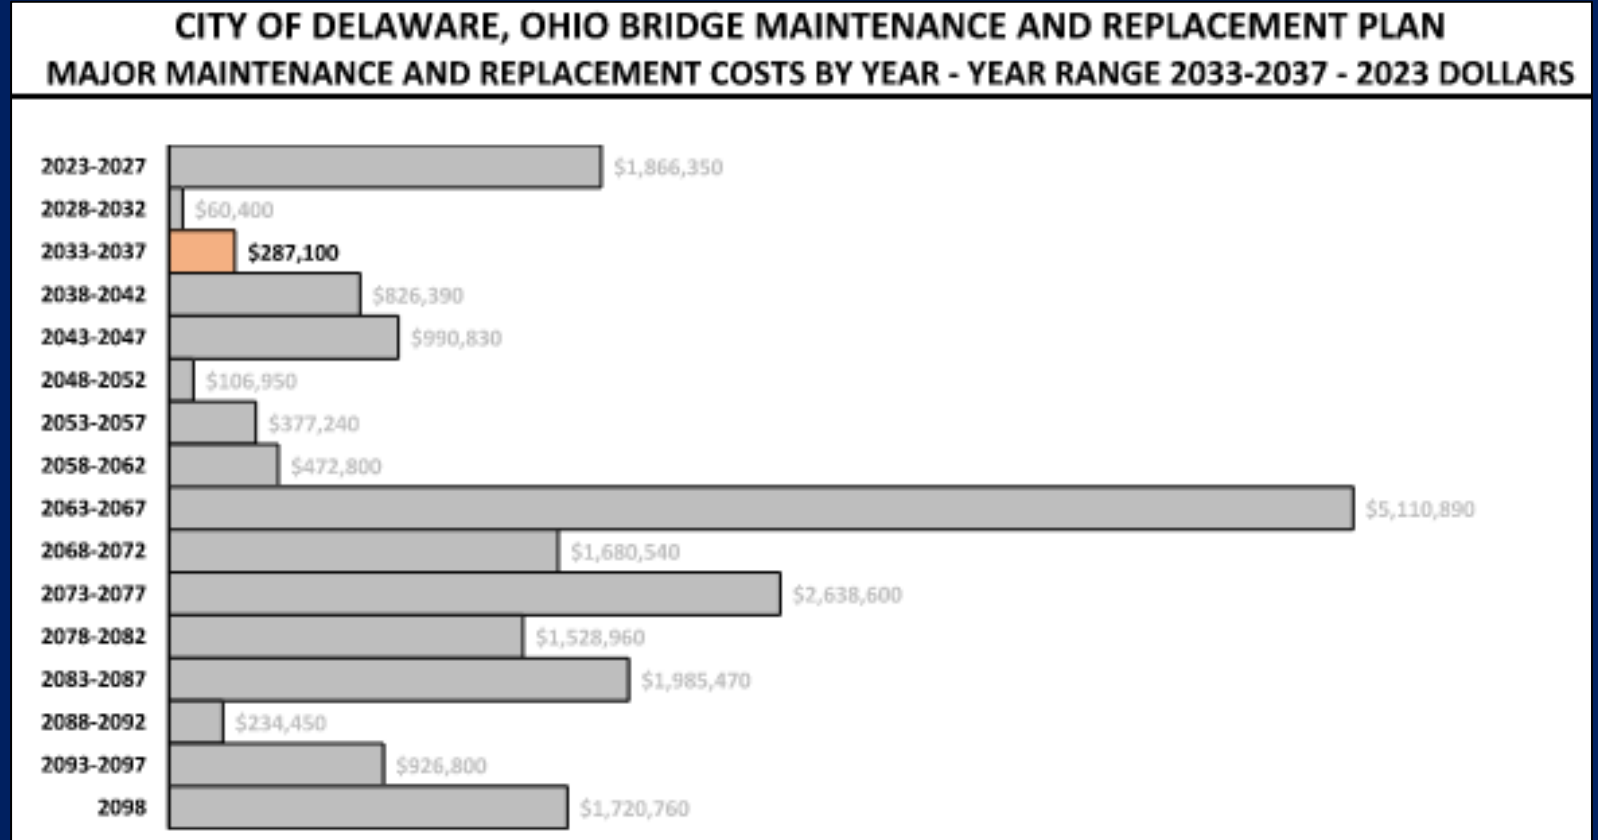
# Phase 4 – Life Cycle Costs

- 75-year projection
- Includes maintenance, rehabilitation, and replacement costs
- Projects anticipated yearly expenditures

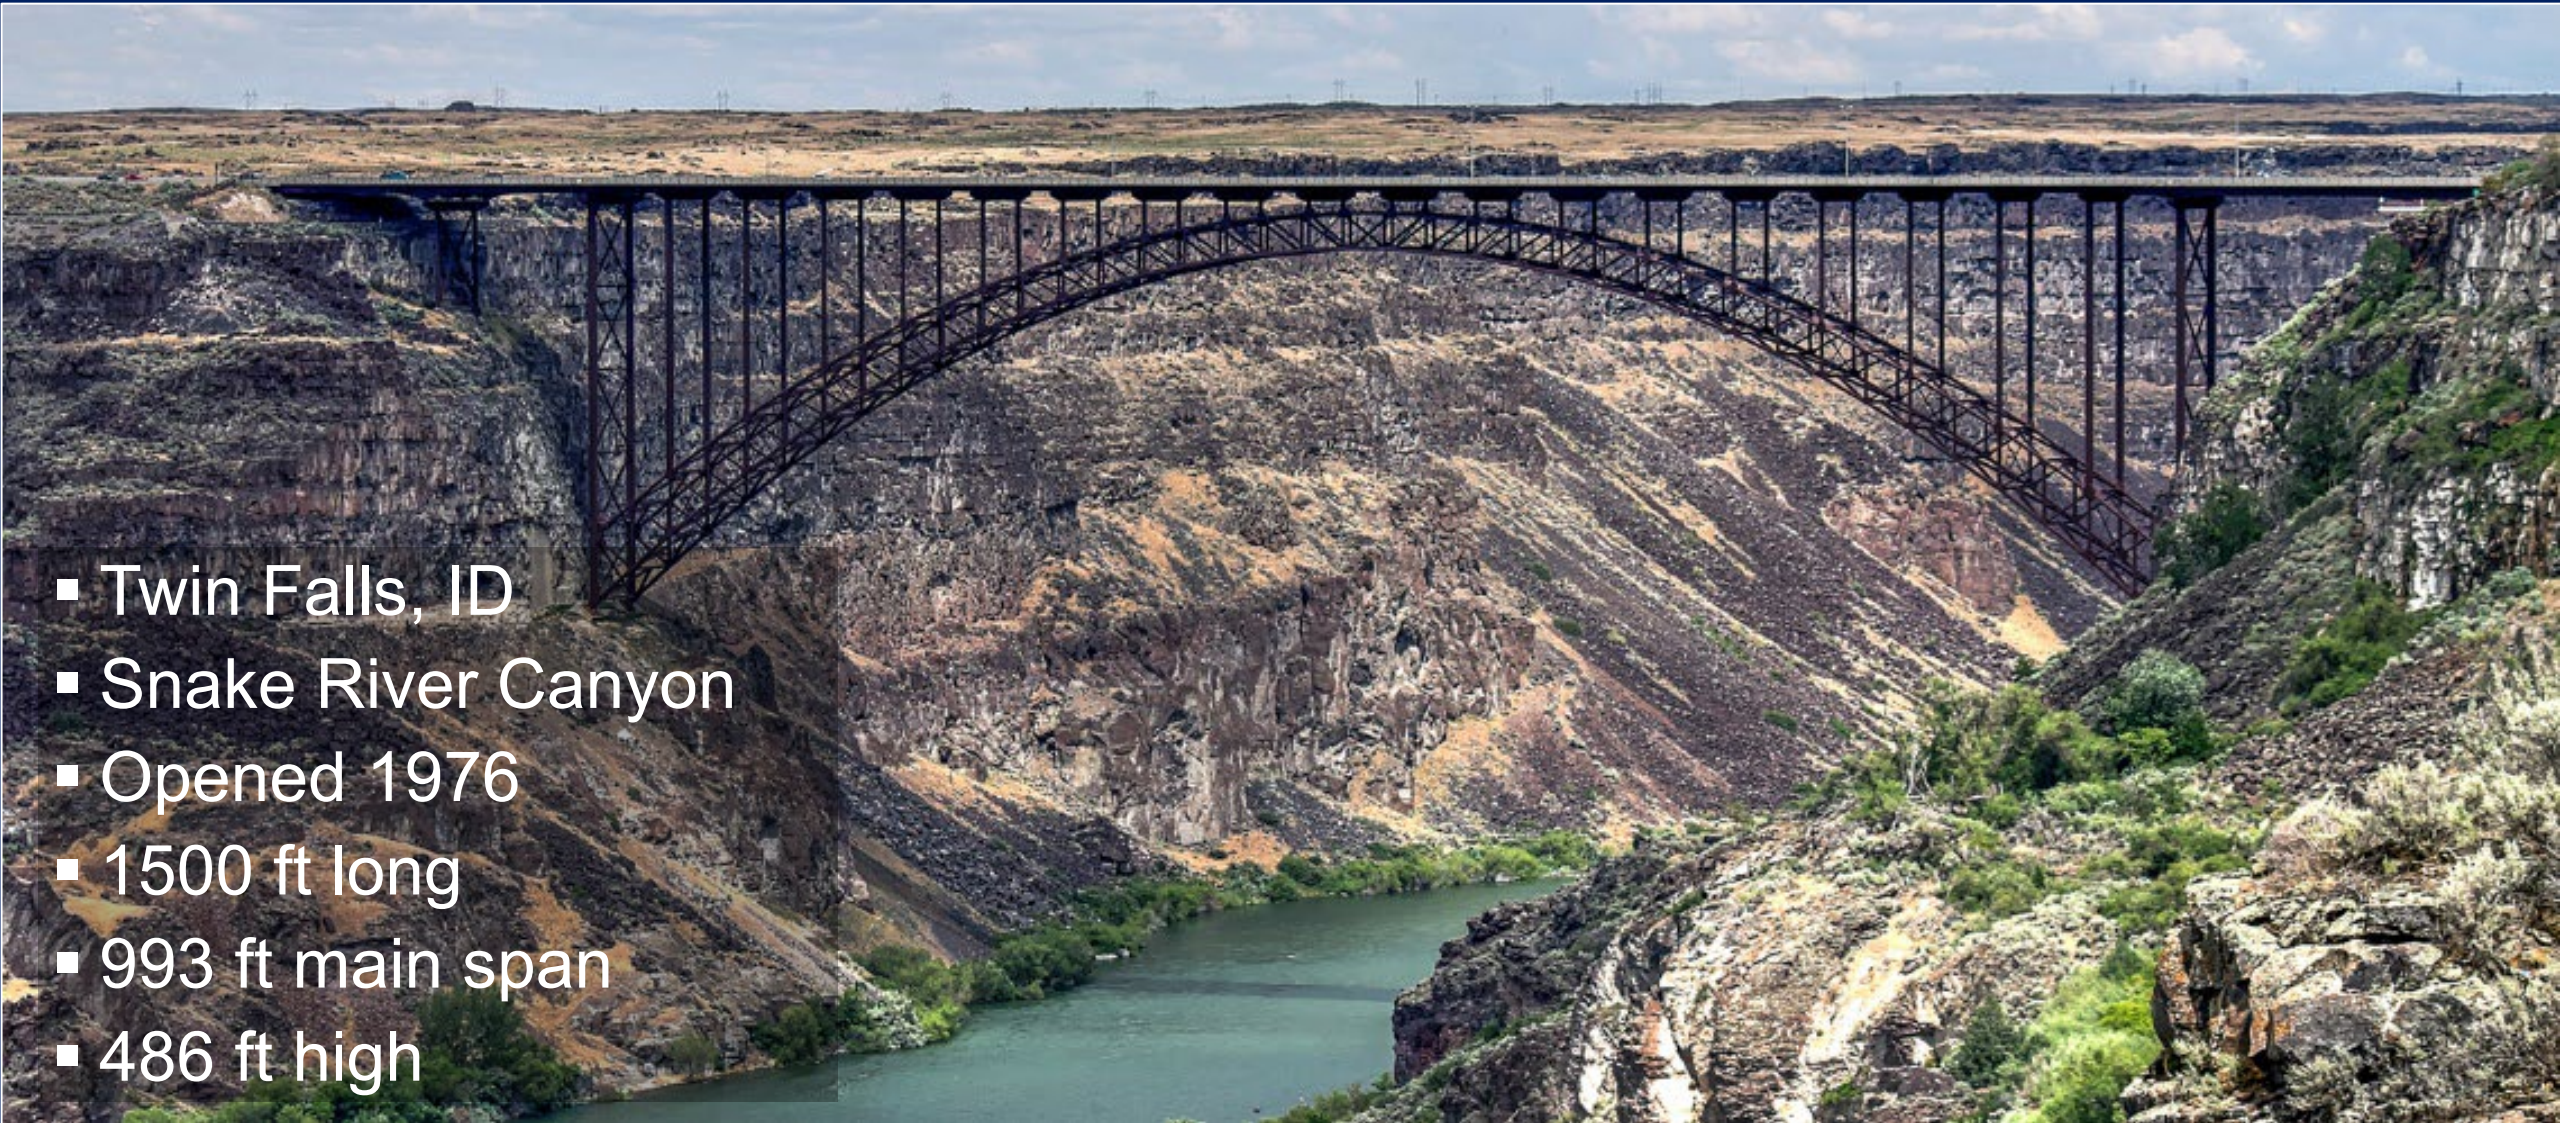
- Twin Falls, ID
- Snake River Canyon
- Opened 1976
- 1500 ft long
- 993 ft main span
- 486 ft high

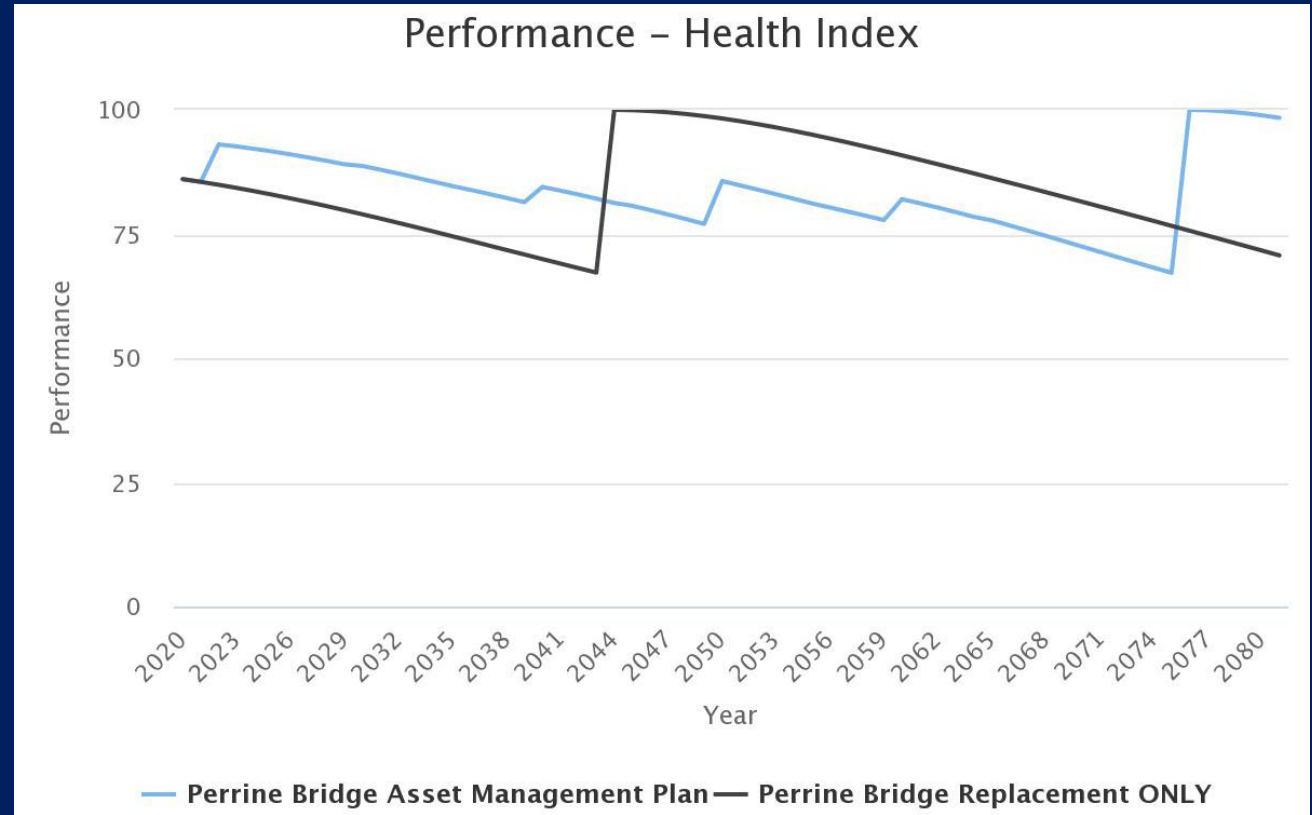
- ITD developed eight individual Bridge Asset Management Plans for high-cost replacement bridges
- AMPs are used to analyze future funding scenarios and tradeoffs to ultimately pay for replacing these structures
- Data from AMP is used to perform life cycle cost analysis in BrM
- BrM accounts for the effect of rehabilitation project on condition of bridge components

Element	Str. Unit	Env.	Quantity	Units	Starting Conditions	Effect
(12) Re Concrete Deck	0	Sev.(4)	117750	sq.ft		
(107) Steel Opn Girder/Beam	0	Low(2)	2014	ft		
(113) Steel Stringer	0	Low(2)	8397	ft

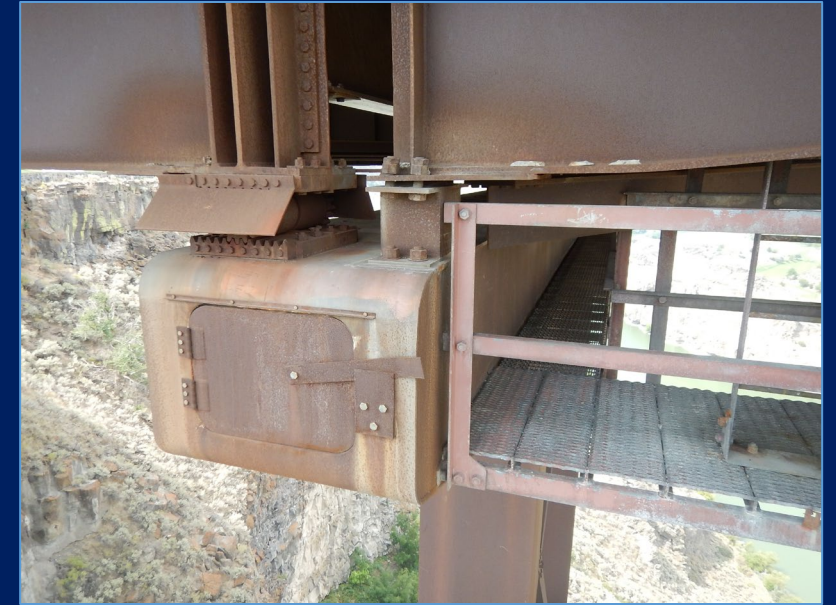
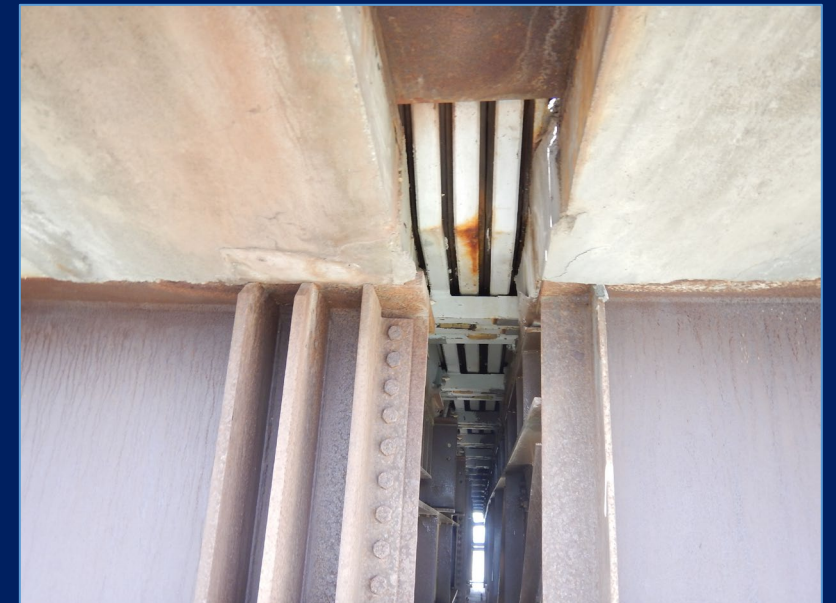
# Bridge Condition Assessment

- Selective visual inspection
- Chloride concentration sampling (deck and abutments)

Location	Depth	Low Contamination	Moderate Contamination	Advanced Contamination	Avg. Concentration (lb/cy)
Deck	1"	88%	13%	0%	0.60
	2.5"	100%	0%	0%	0.14
North Abutment	1"	67%	0%	33%	1.27
	2.5"	67%	33%	0%	0.58
South Abutment	1"	67%	0%	33%	0.93
	2.5"	100%	0%	0%	0.04

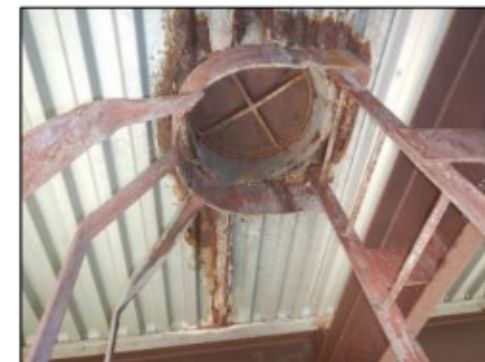
**Corrosion on SIP Forms**

Stay-In-Place Forms: Inspect and monitor the metal stay-in-place forms for corrosion and other signs of leaking. This is indicative of water infiltration through the deck slab and/or access hole penetrations which accelerates deterioration of the deck, forms and superstructure components below.

Deck slab	12	Bi-annual, as part of NBI inspection	From underbridge inspection vehicle	Inspect metal stay-in-place deck forms for corrosion and leaking
General Notes				
Required Additional Repairs

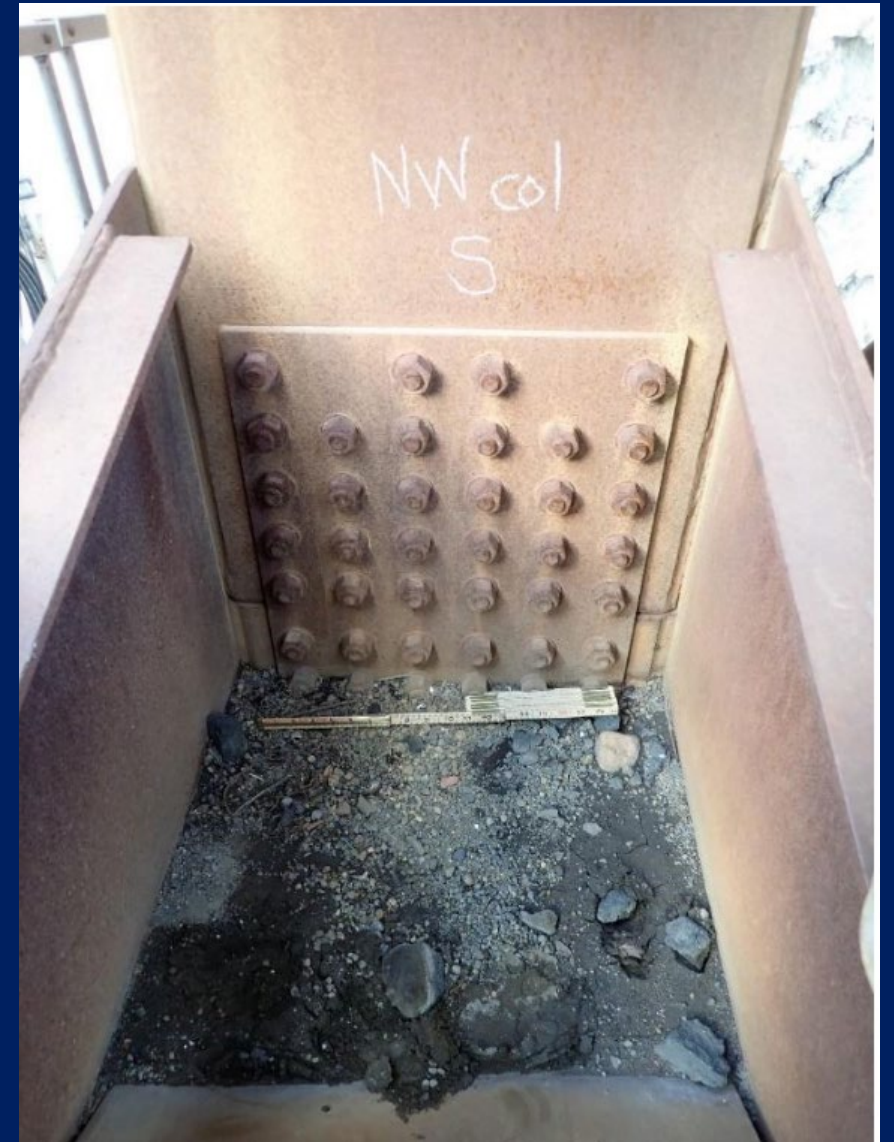
# Repair Project - End Posts

- Repairs to arch end posts
- Painting of corrosion-prone areas
- Inspection access system repairs
- Patching of concrete substructures
- Utility conduit repairs
- Sidewalk joint repairs
- Railing repairs
