Executing a Major Urban Bridge Inspection

A Case Study on the West Marquam and East Fremont Interchanges

Makenzie Ellett, PE – Bridge Engineer & Inspector Matt Harlan, PE – Bridge Inspection & Preservation Group Leader

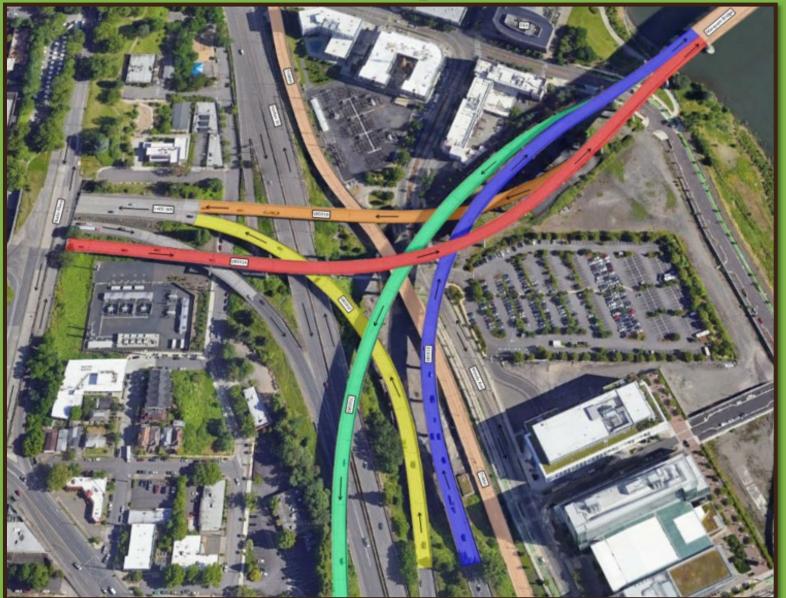
West Marquam Interchange

<u>08591A</u> Length = 1,940ft 17 Spans

<u>08591B</u> Length = 1,610ft 15 Spans

<u>08591C</u> Length = 1,900ft 15 Spans

<u>08591D</u> Length = 1,750ft 15 Spans

<u>08591F</u> Length = 1,140ft 14 Spans

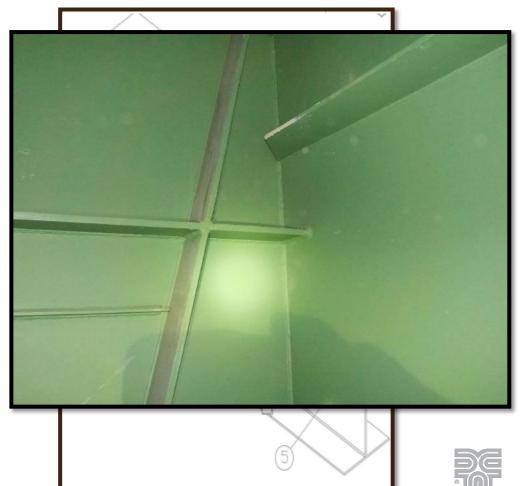
Fatigue Prone

- Poor steel details combined with high number of stress cycles (truck loads)
 - Welded and coped steel members
 - Field welds
 - Intersecting welds
 - Short, welded attachments

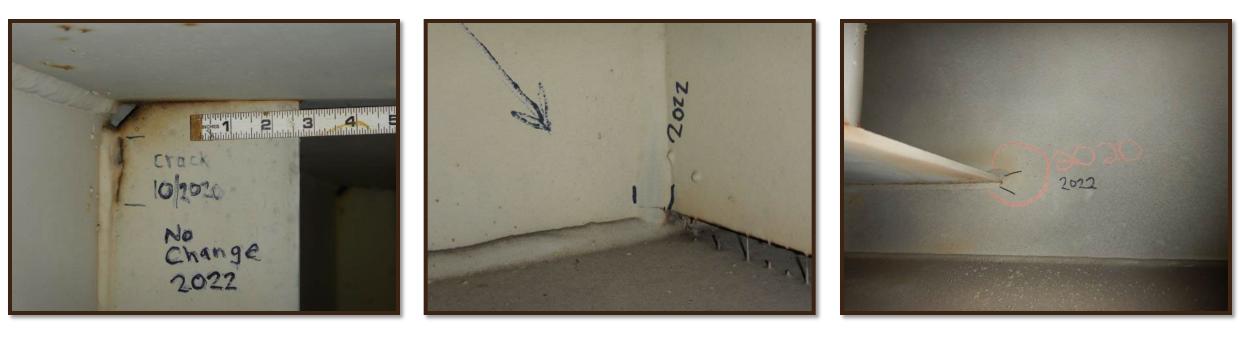
Steel Cracks

Crack in the top of a longitudinal stiffener

Crack in the toe of a longitudinal stiffener

Crack in the toe of cross-bracing

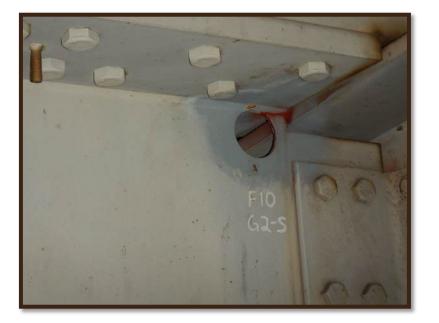
Crack Arrest Hole

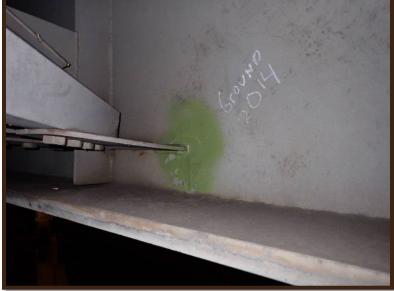
Ground Out Crack

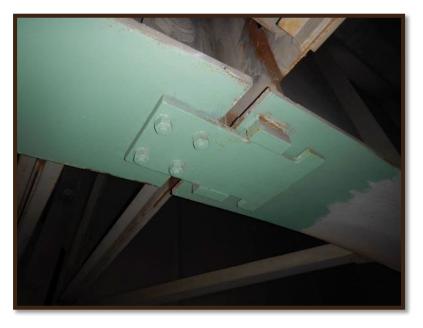
Weld Replaced with Bolts
