Construction of Structural Shoring and Retaining Walls

Jesse L. Beaver Washington State Department of Transportation

US-2 Slide Repair

Sahalee Way

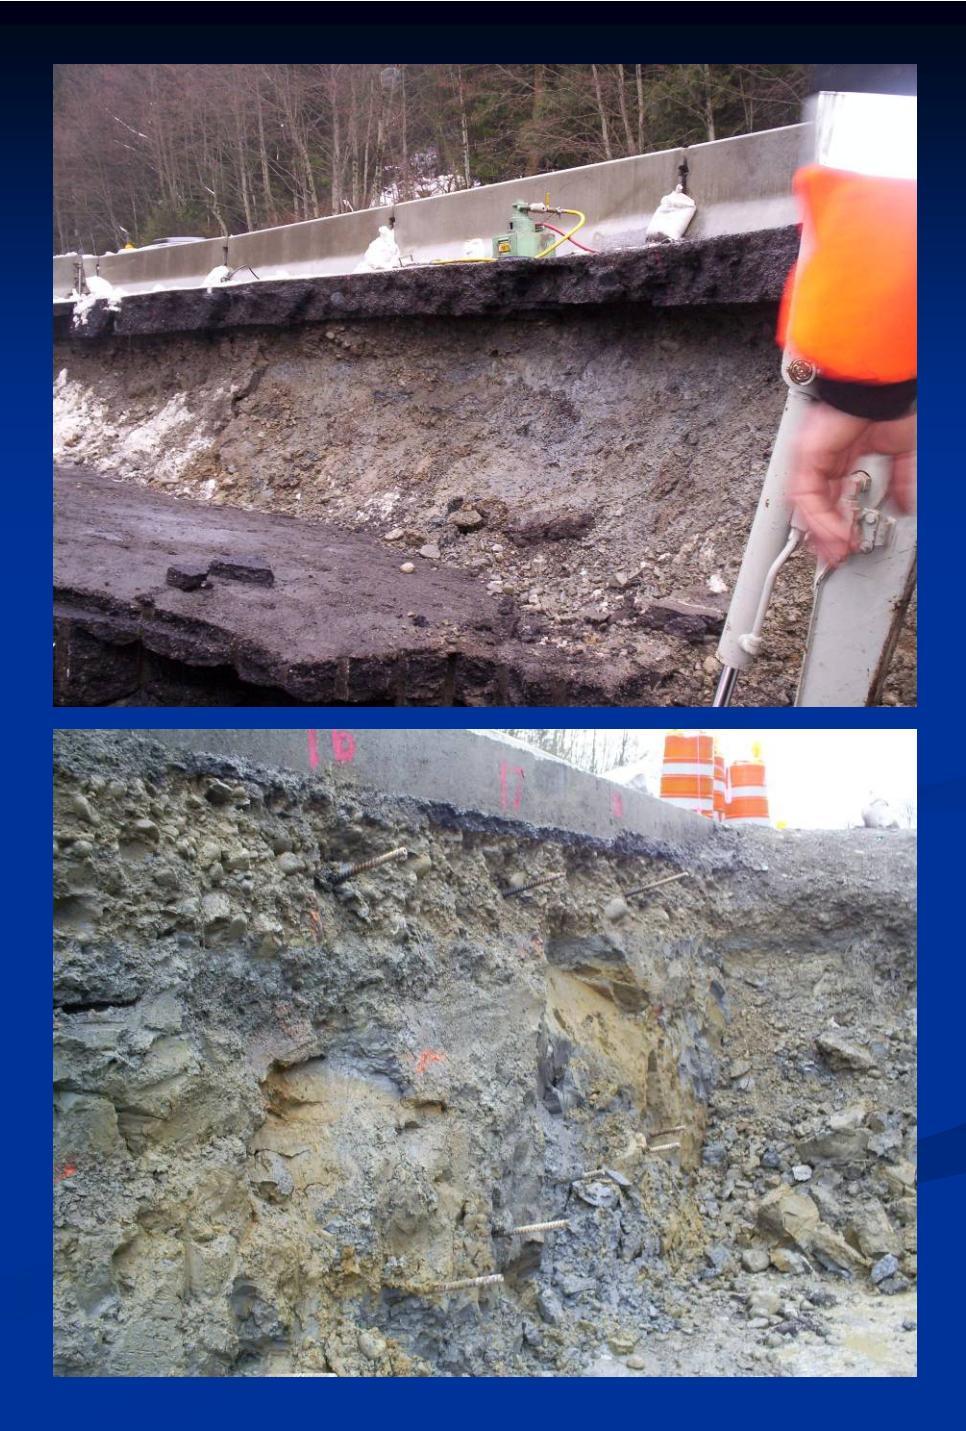
- Bench was adequate for small drill rigs capable of installing hollow-core nails only
- Inadequate roadway width to work from above without closure
- We received waiver of "Buy America" to use hollow-core nails

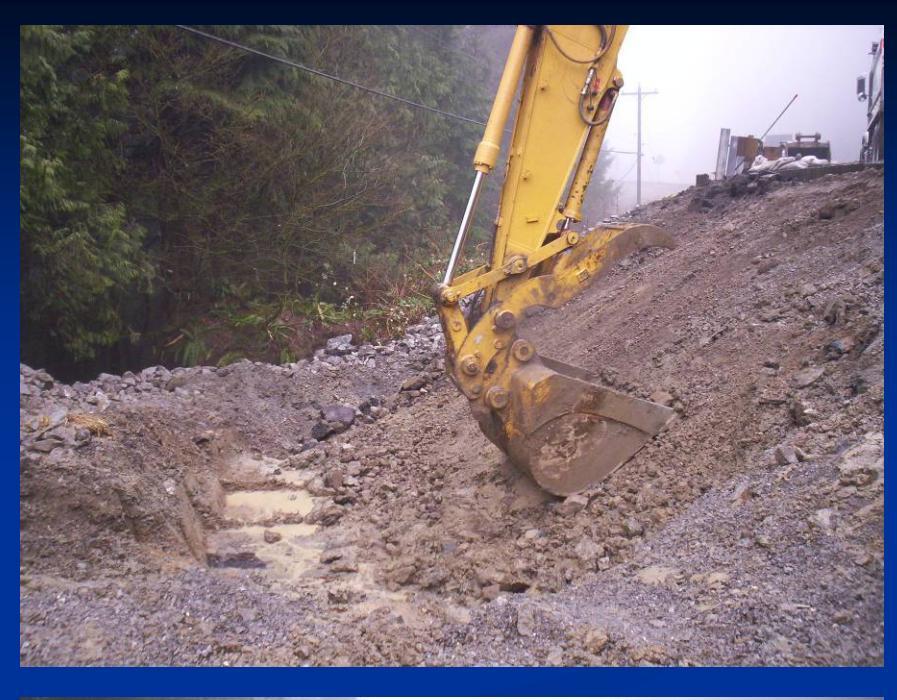
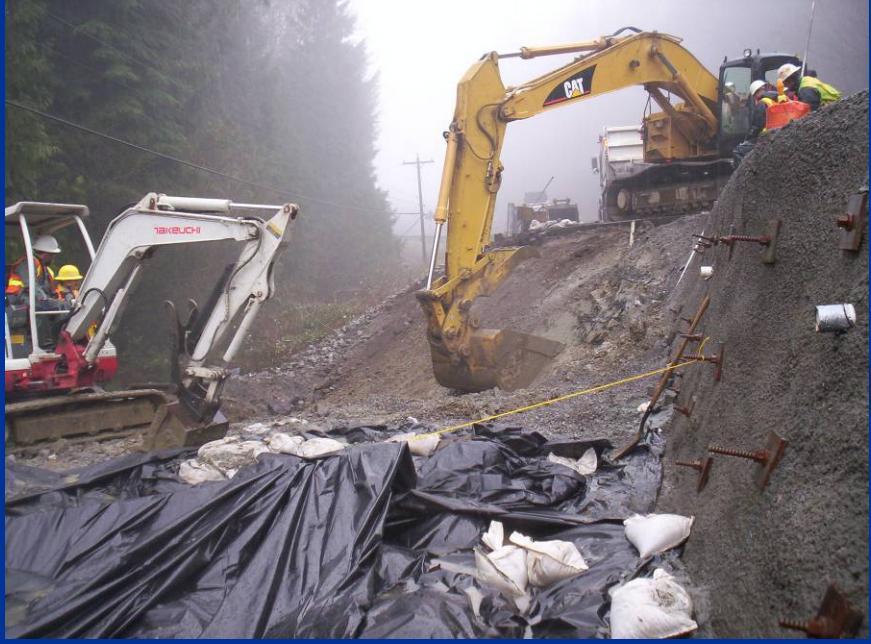
- Soils were clayey sandsCaused by culvert failure
- Nail grout ran
- Competency of some the nails is in question
- Walls designed to be 25ft tall, but only needed 7ft height

- Contract requirements should be confirmed for unusual designs Buy America
- Although an emergency contract, there was adequate time to evaluate the soils for the proposed nails; this repair will require replacement within several years; overdesign allowed us to accept deficient nails
- In the interest of speed, multiple rows of nails were installed without shotcrete facing; this led to instances of face sloughing and no consequent time-saving benefit; it also further jeopardized the roadway
- Standard process for shoring approval would have avoided project delay

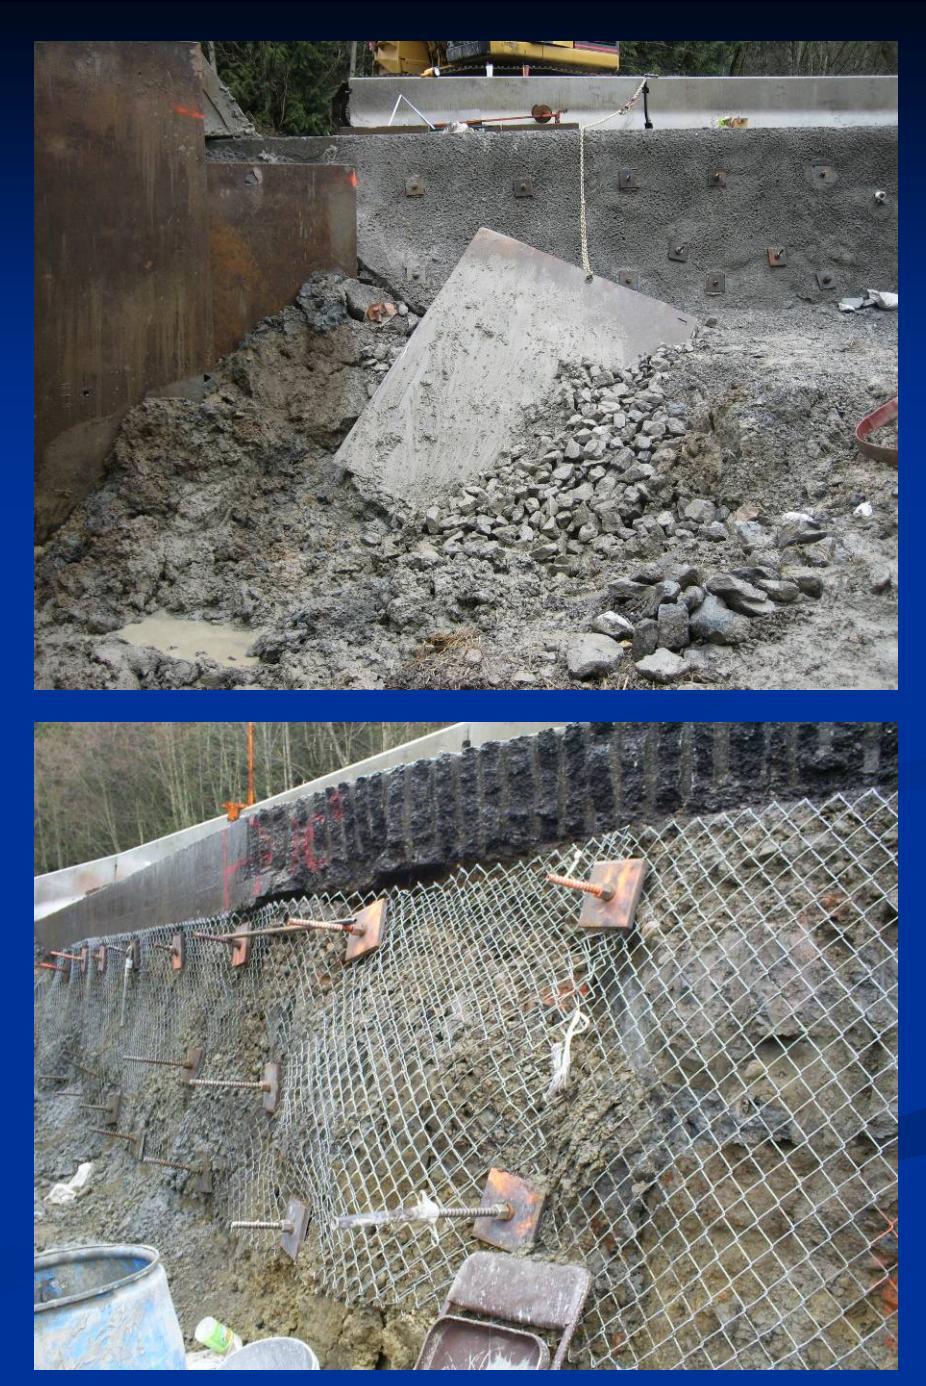
Emergency contract = emergency methods
 Allowed installation of multiple rows of nails before shotcreting face
 Inadequate shoring used to expedite work

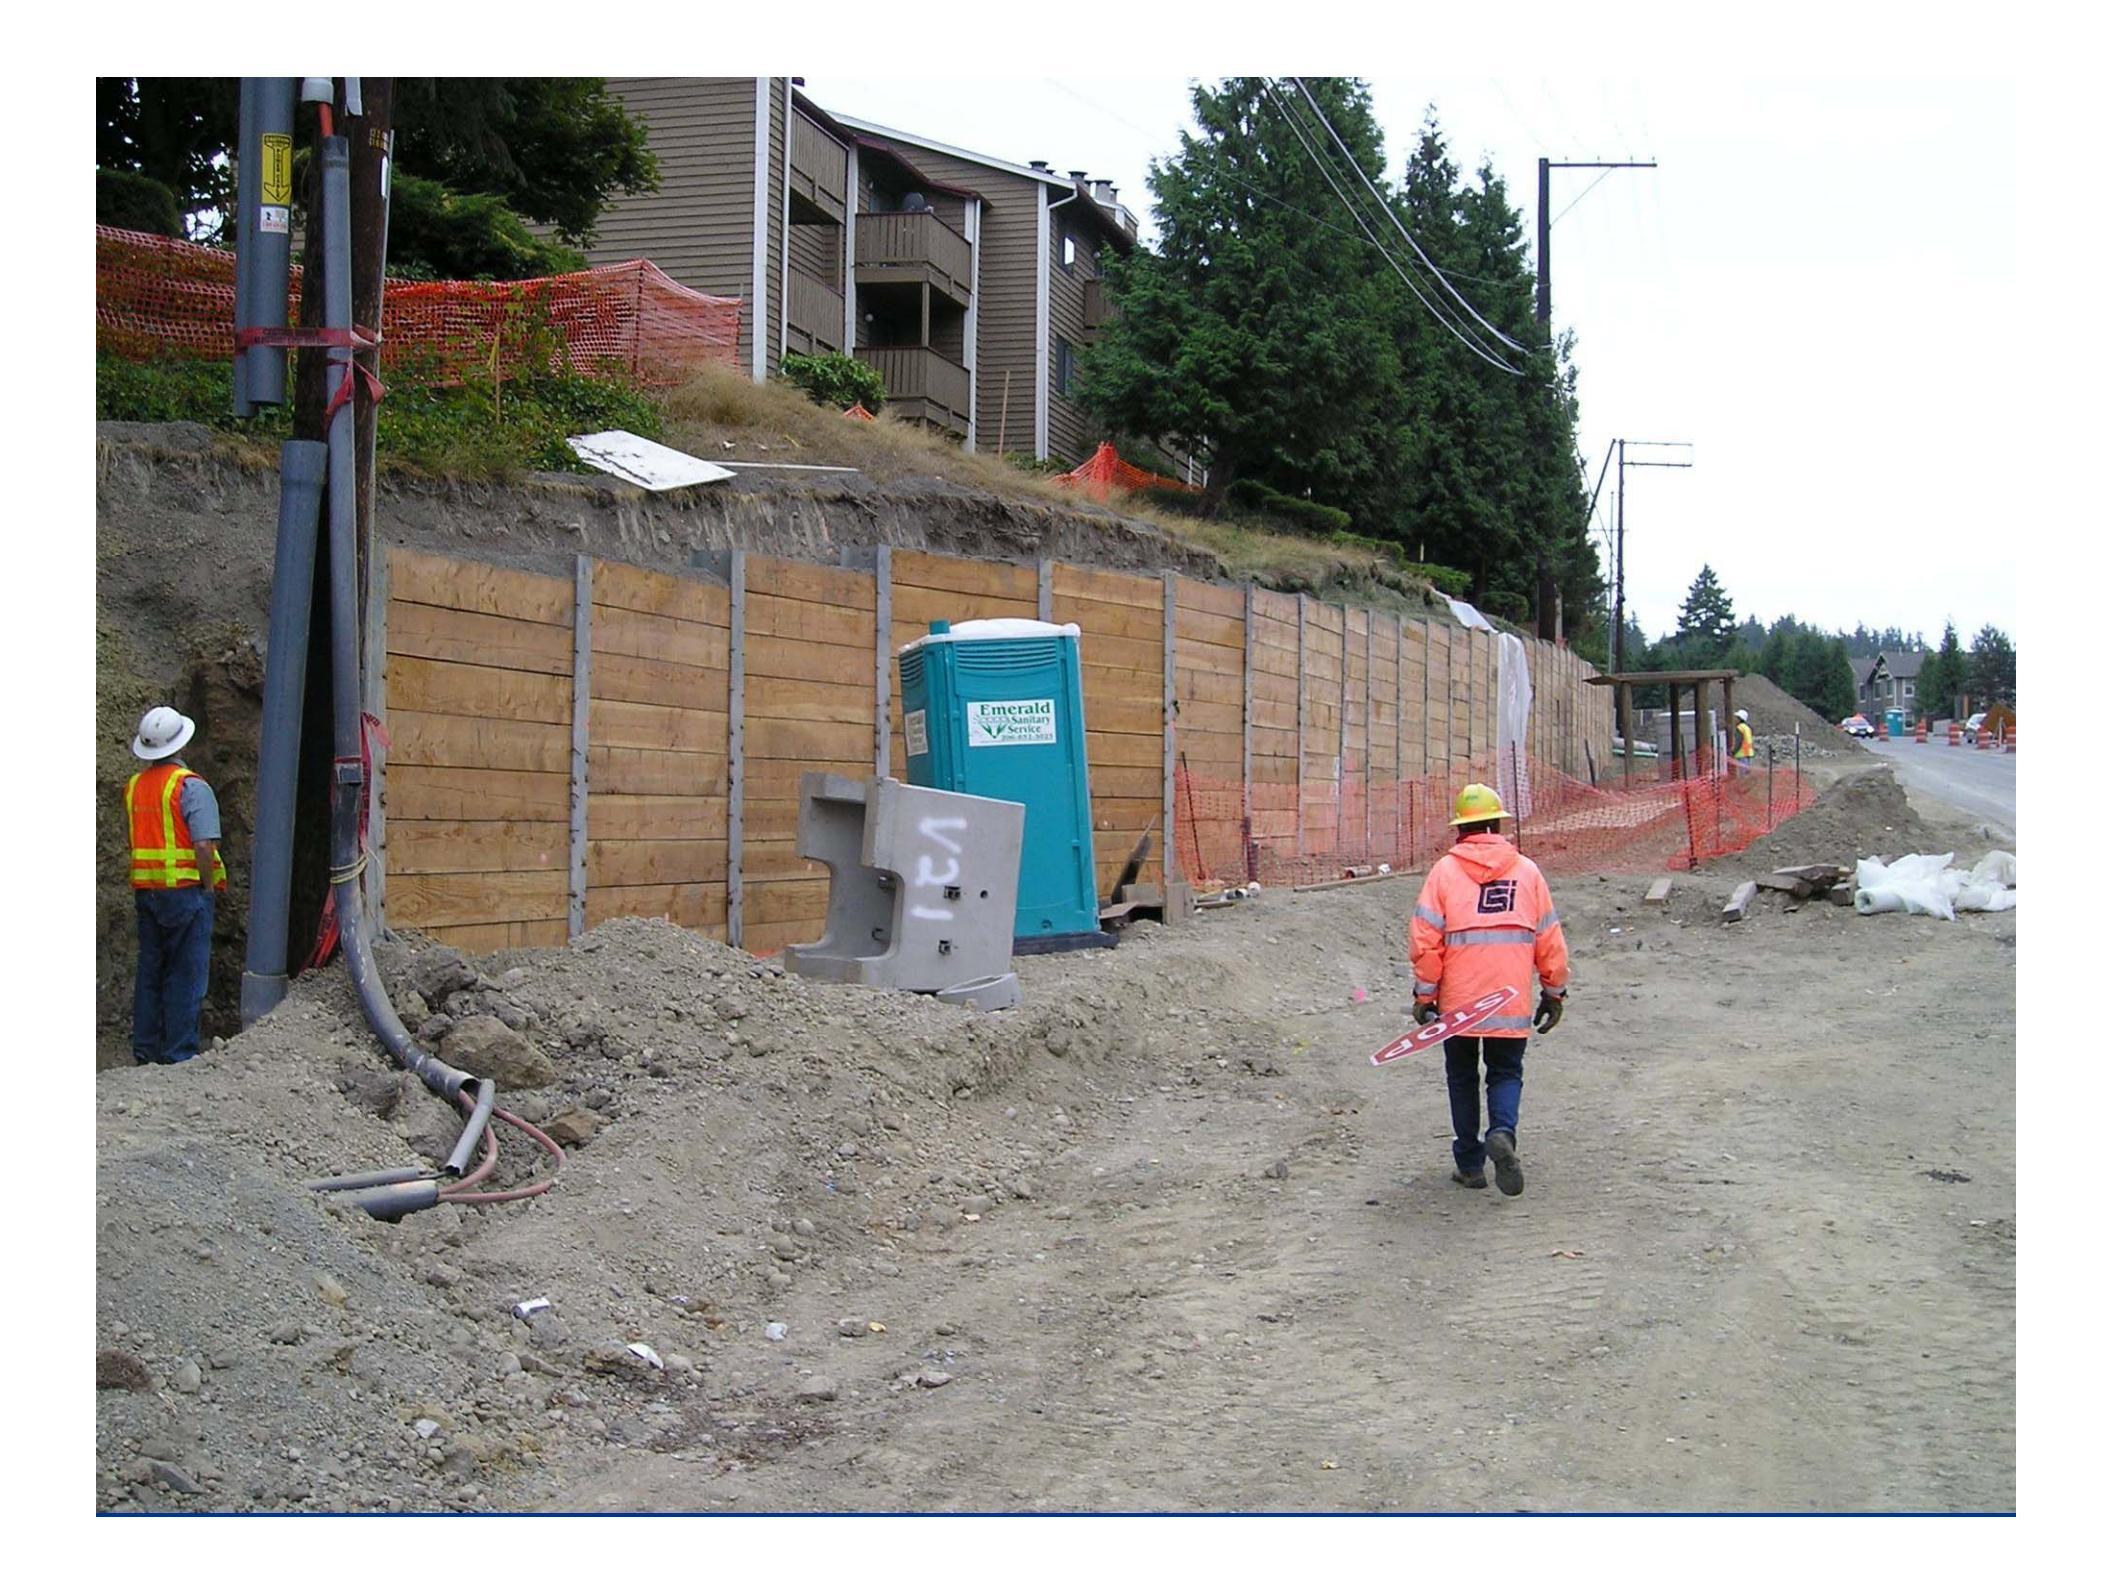
Trenching in front of soldier pile walls for utility installation

Incorrect site survey data

- To prevent undermining of structural walls, require structural designers review final utility plans before contract is advertised
- If site survey data is provided by owner and is extensive part of contract, create checking system; extra surveying is far less expensive than significant construction contract changes & repairs

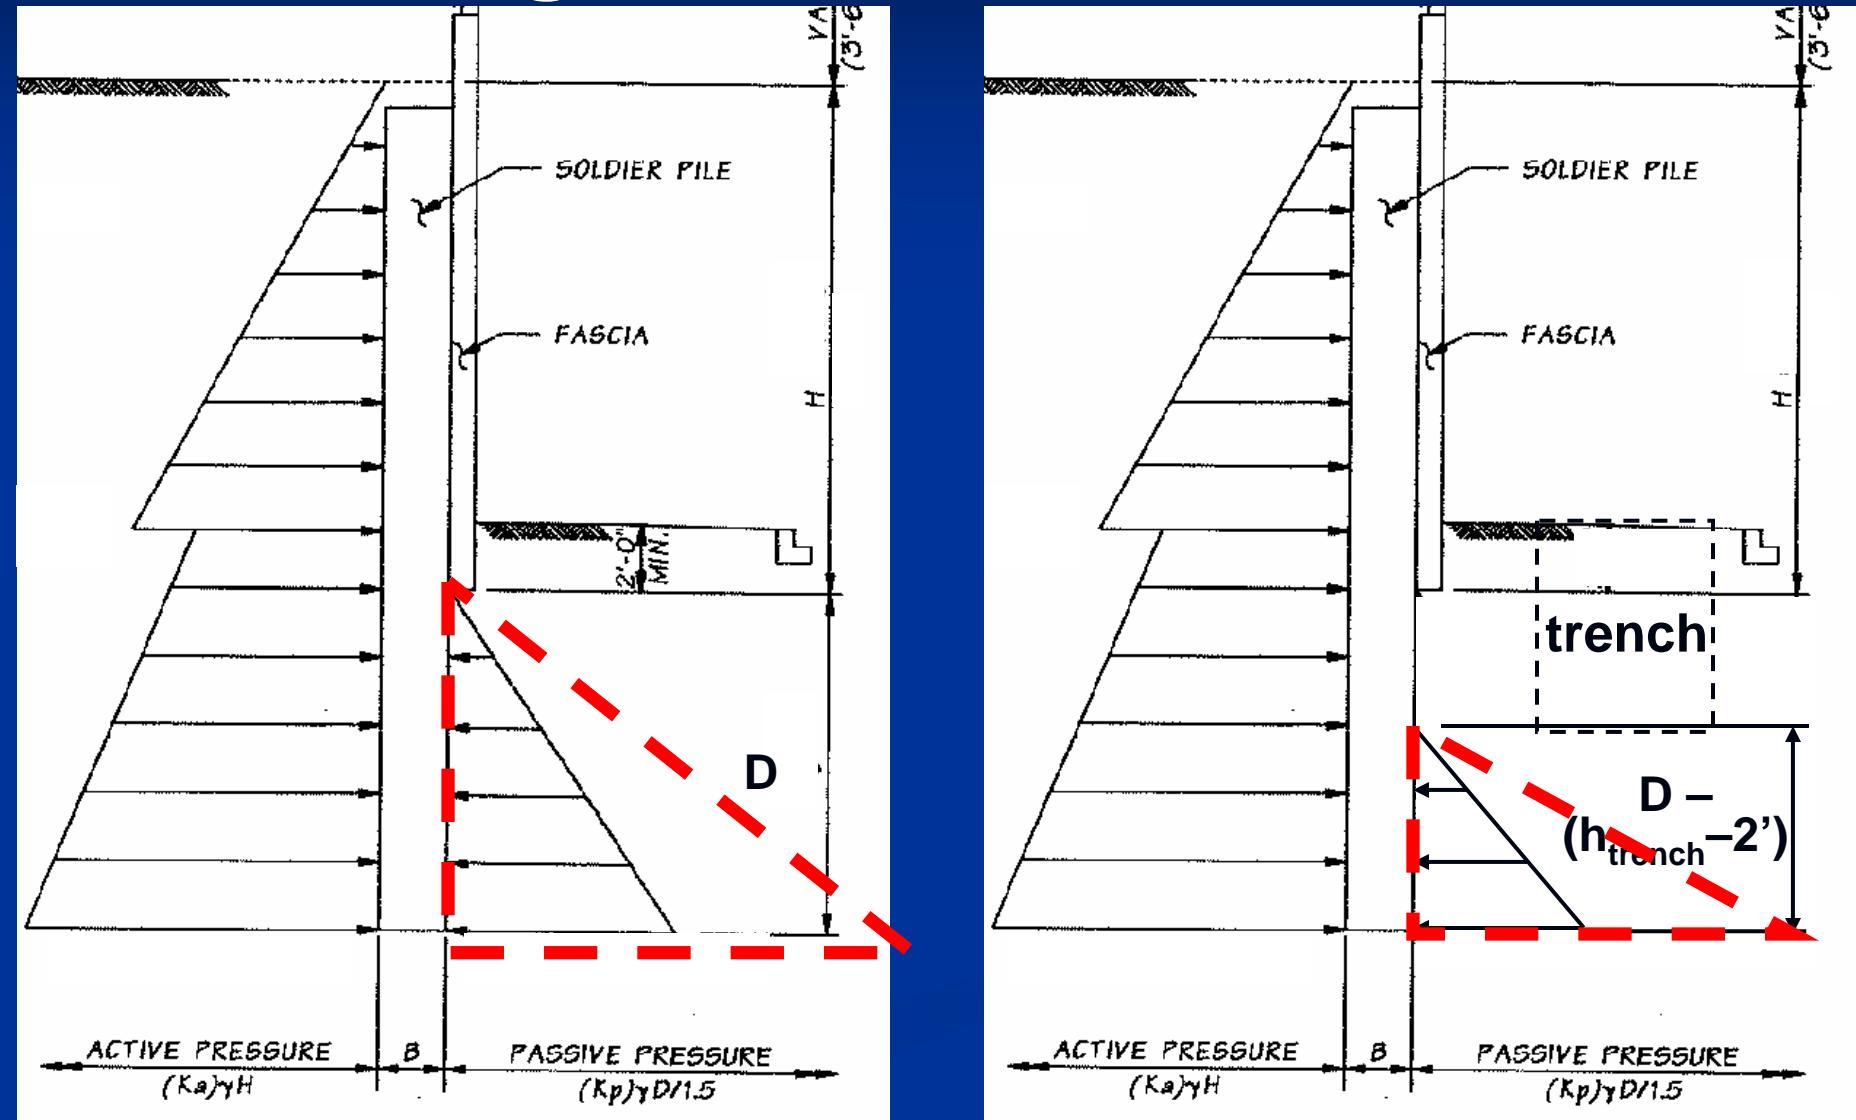
Wall Pressure DiagramAs DesignedAs Constructed

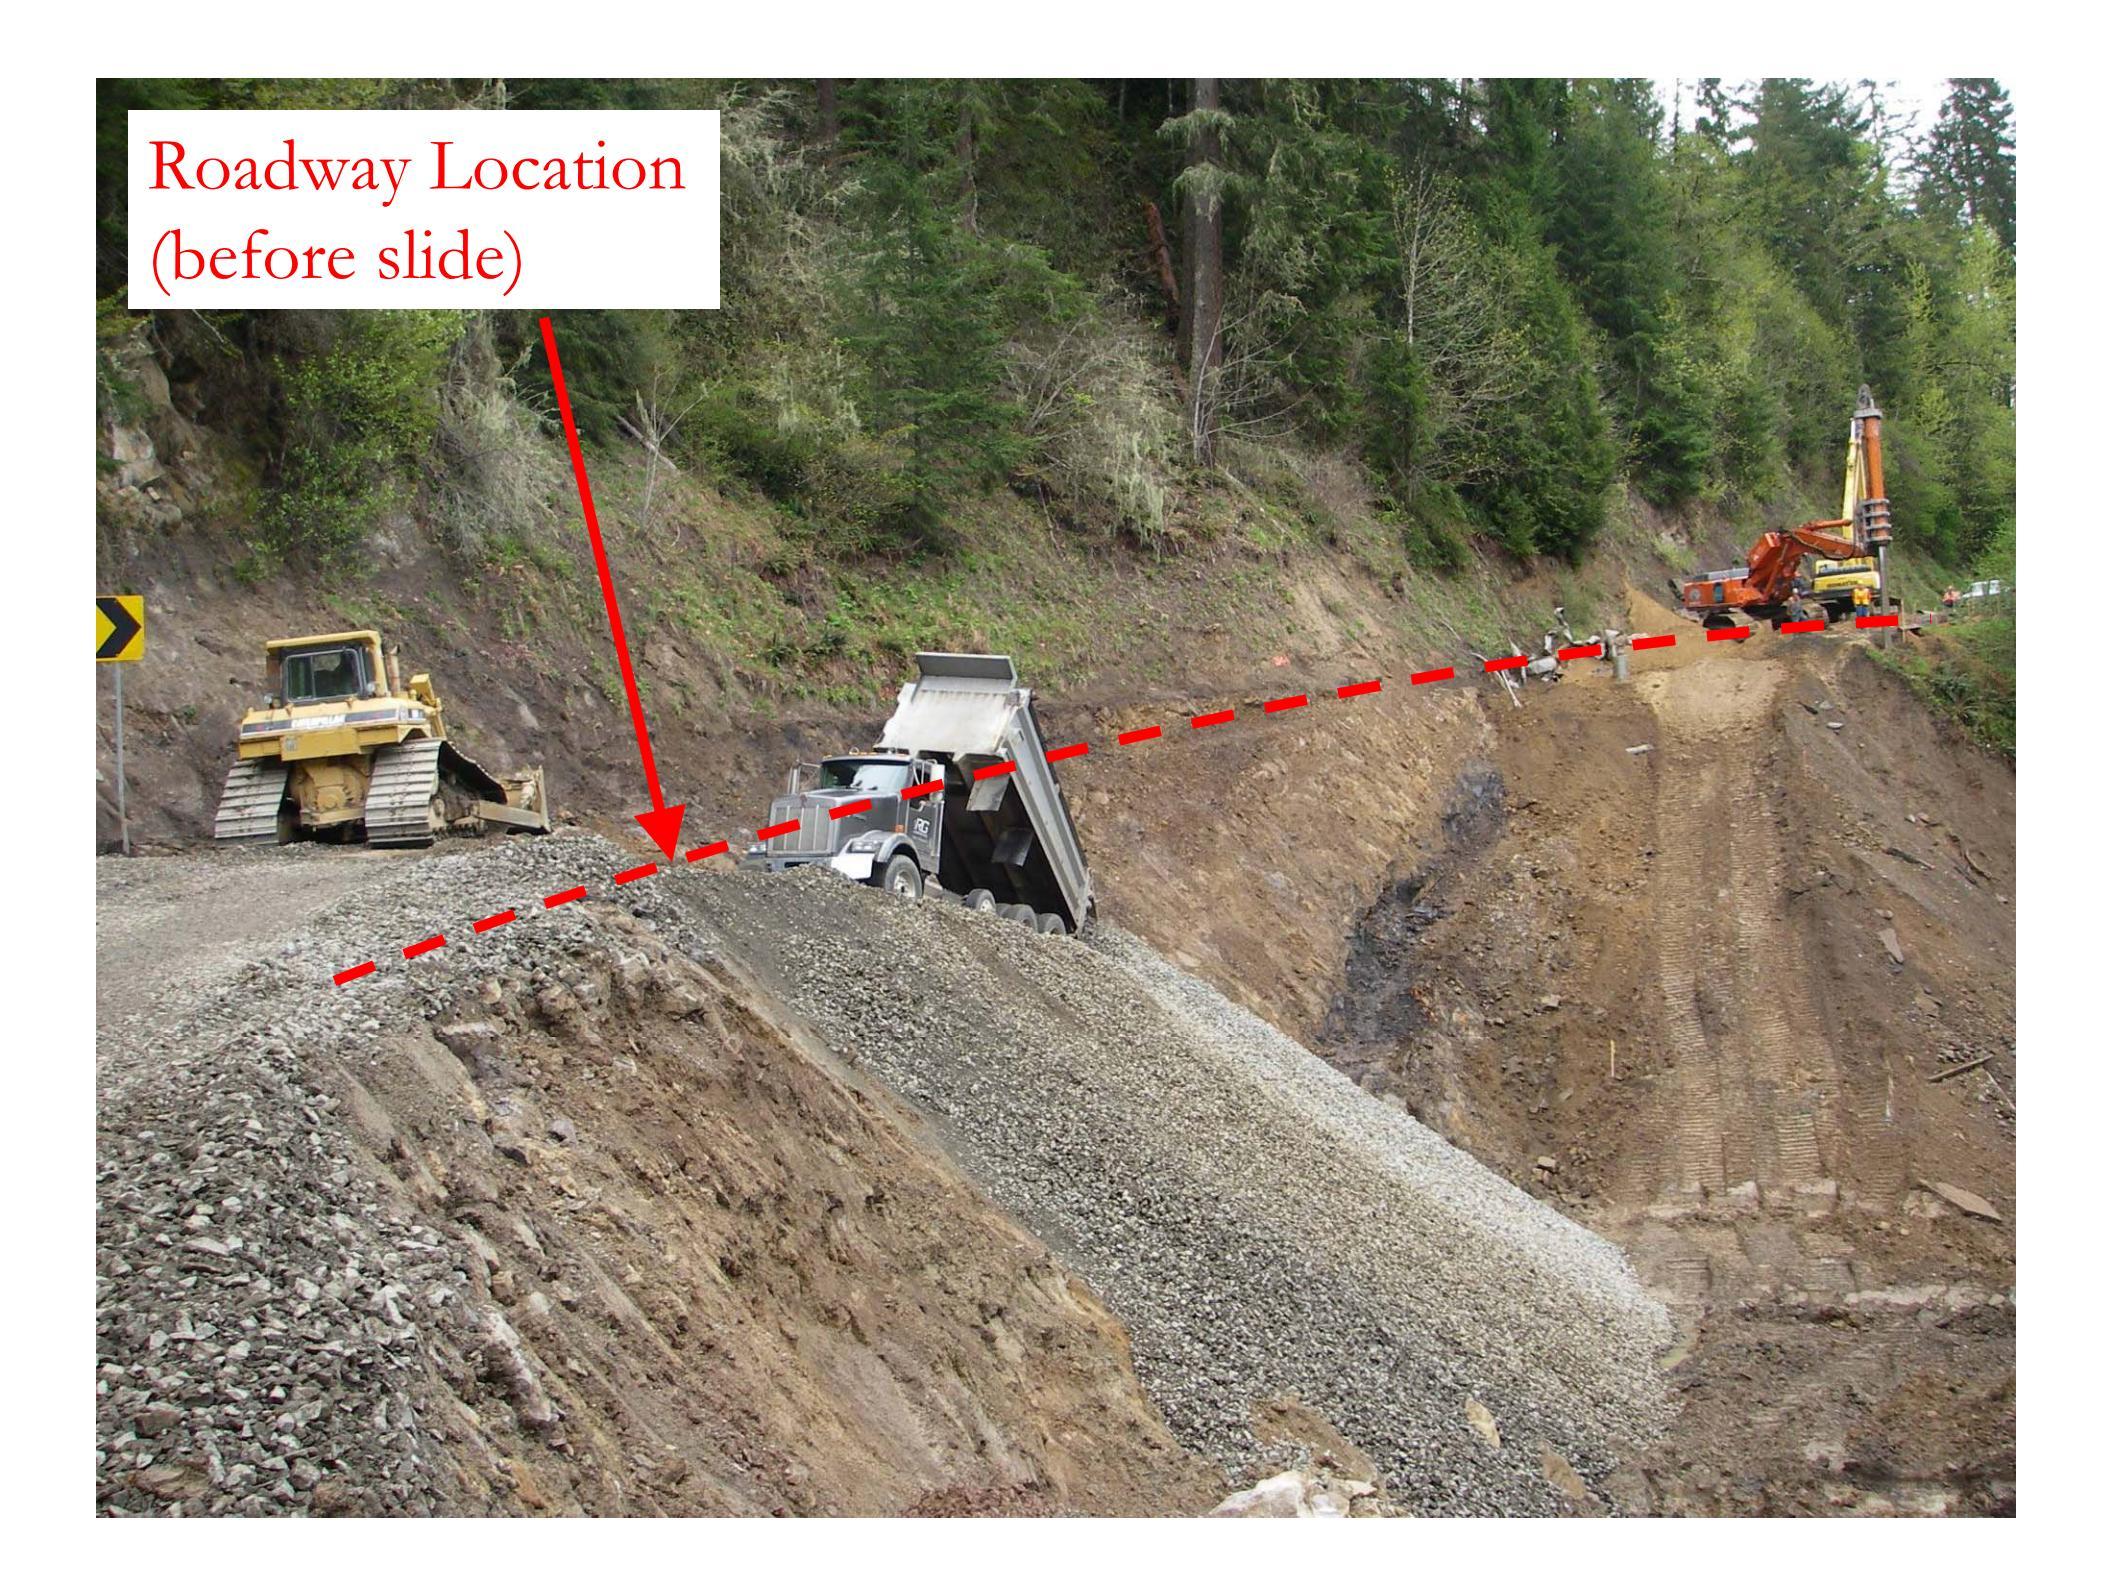
- Slope failure led to loss of lanes on SR-508 near Morton, WA
- Contract design chose soldier pile tieback versus structural earth wall due to extreme slope of slide and proposed installation method
- Construction included stabilization of remaining soils and re-build of lost slope and roadway
