Construction of Structural Shoring and Retaining Walls

Jesse L. Beaver Washington State Department of Transportation

US-2 Slide Repair

Sahalee Way

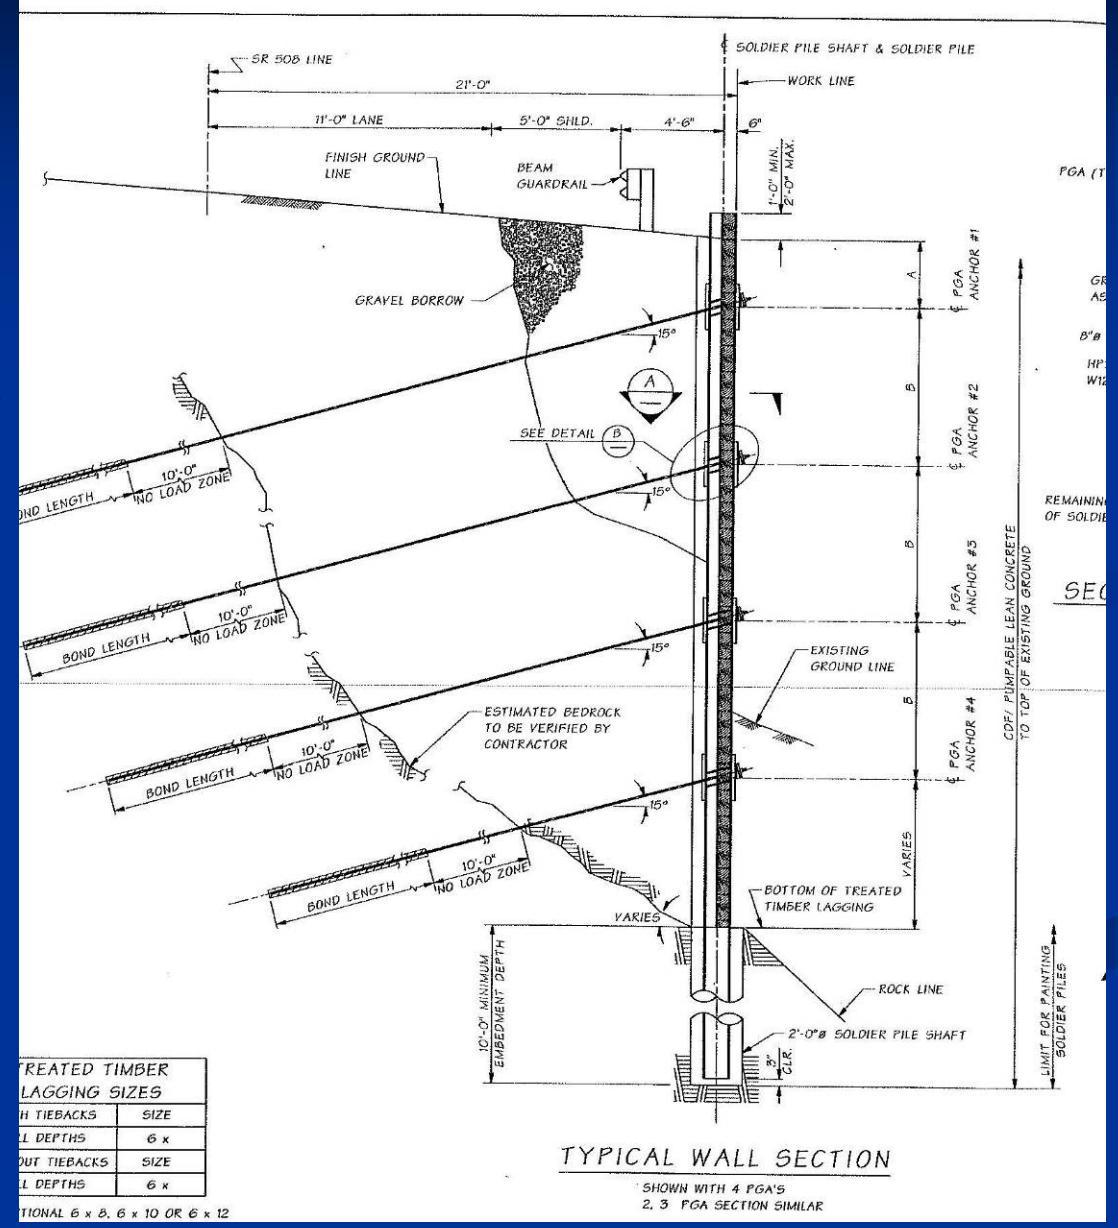
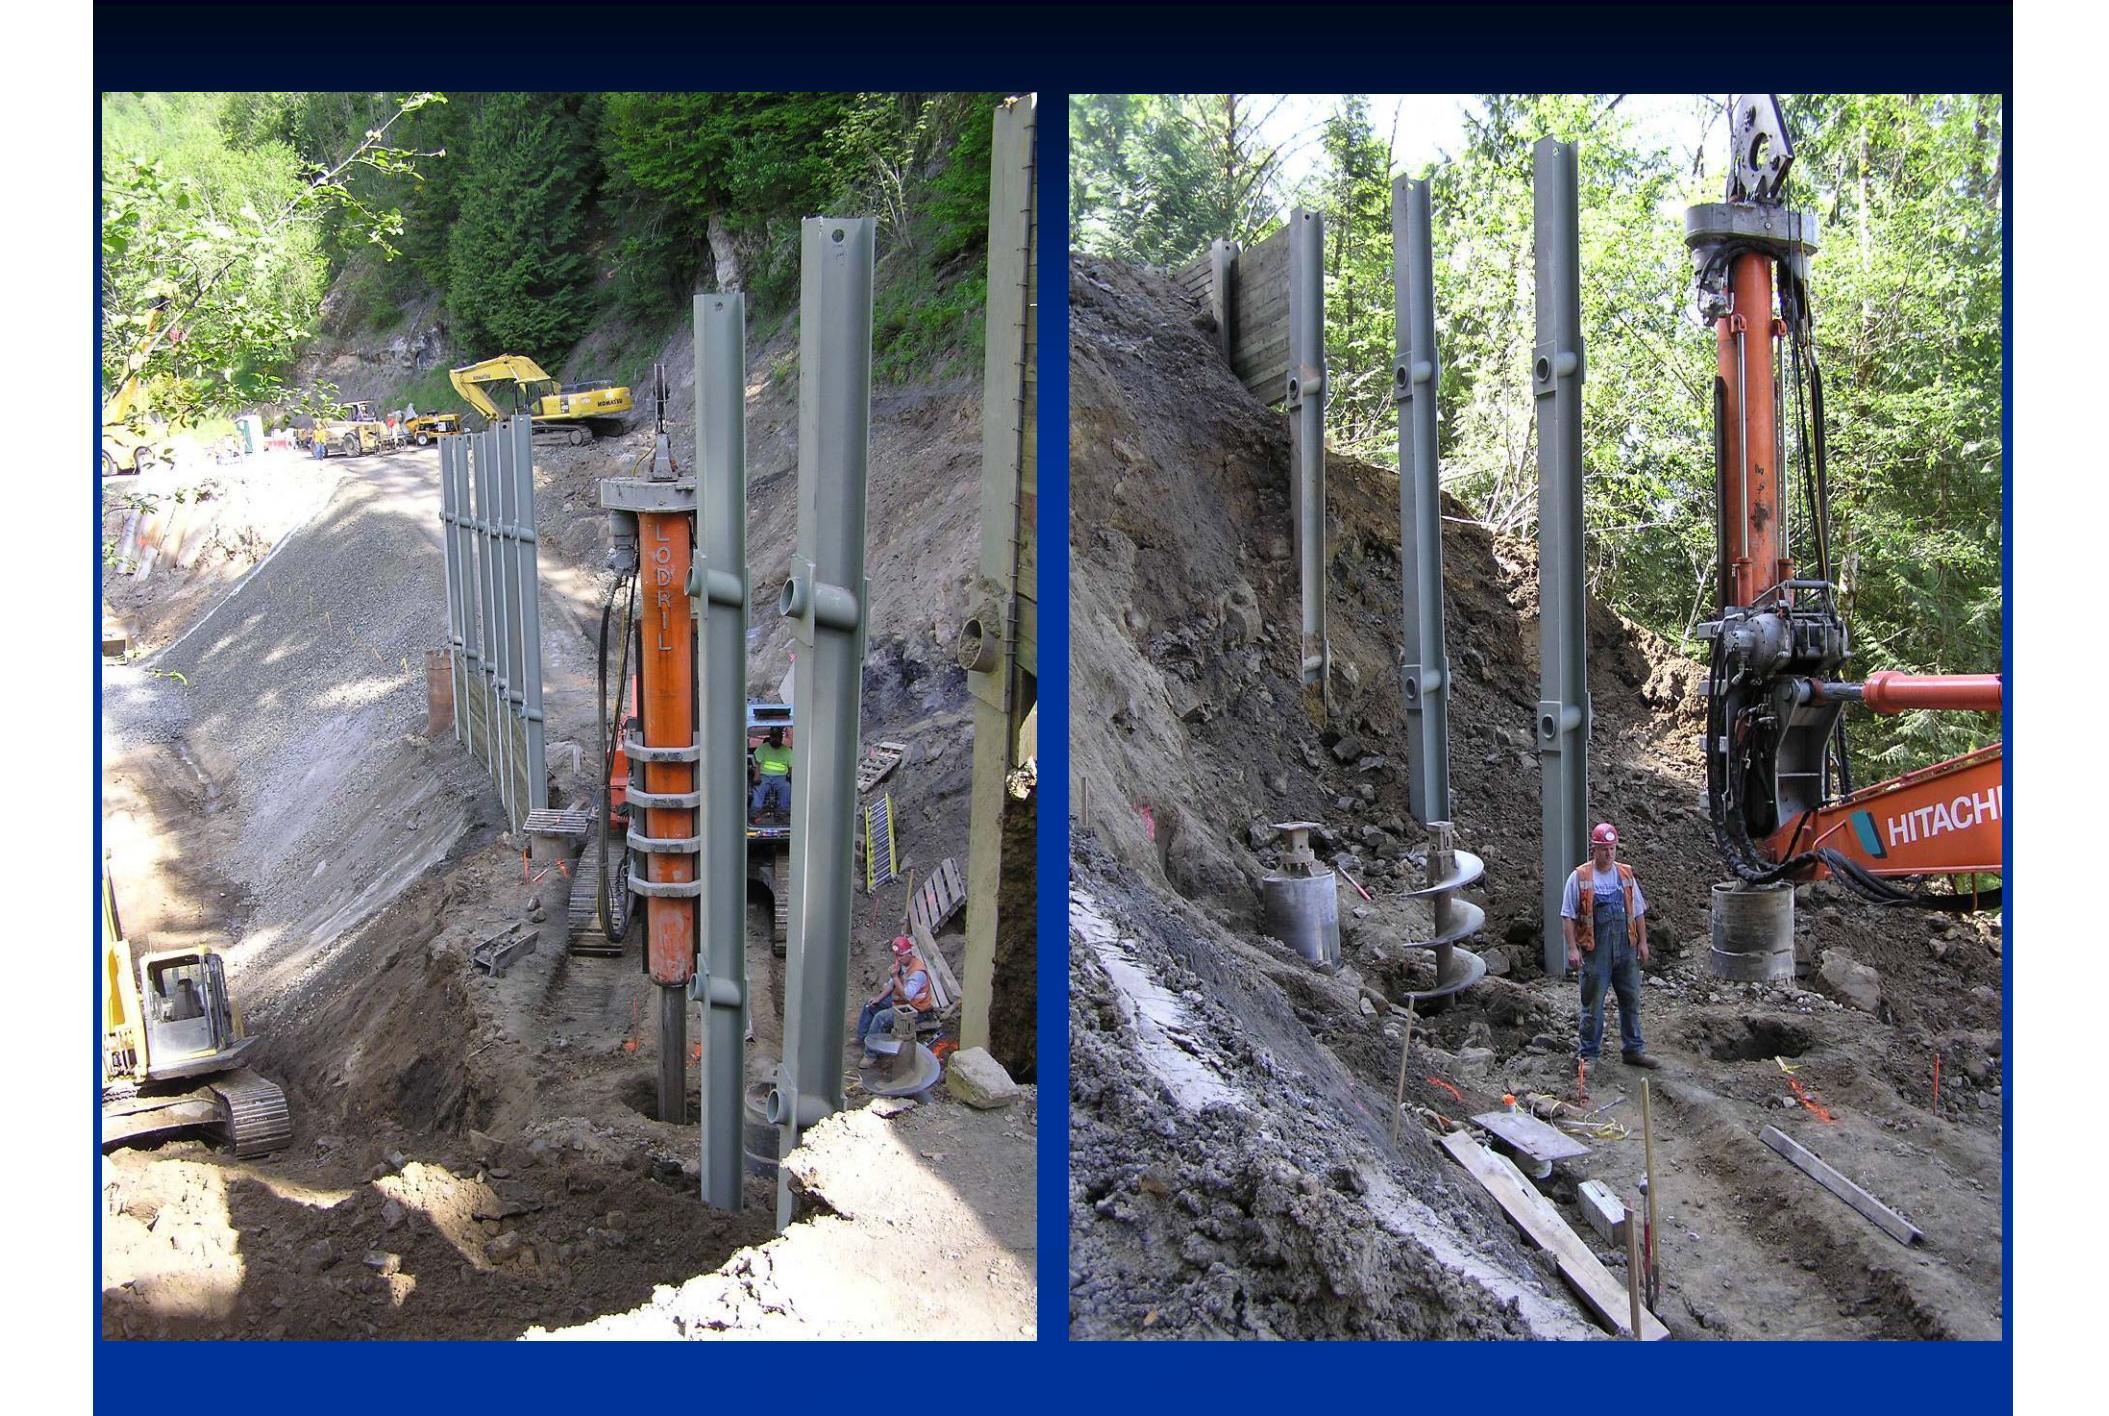
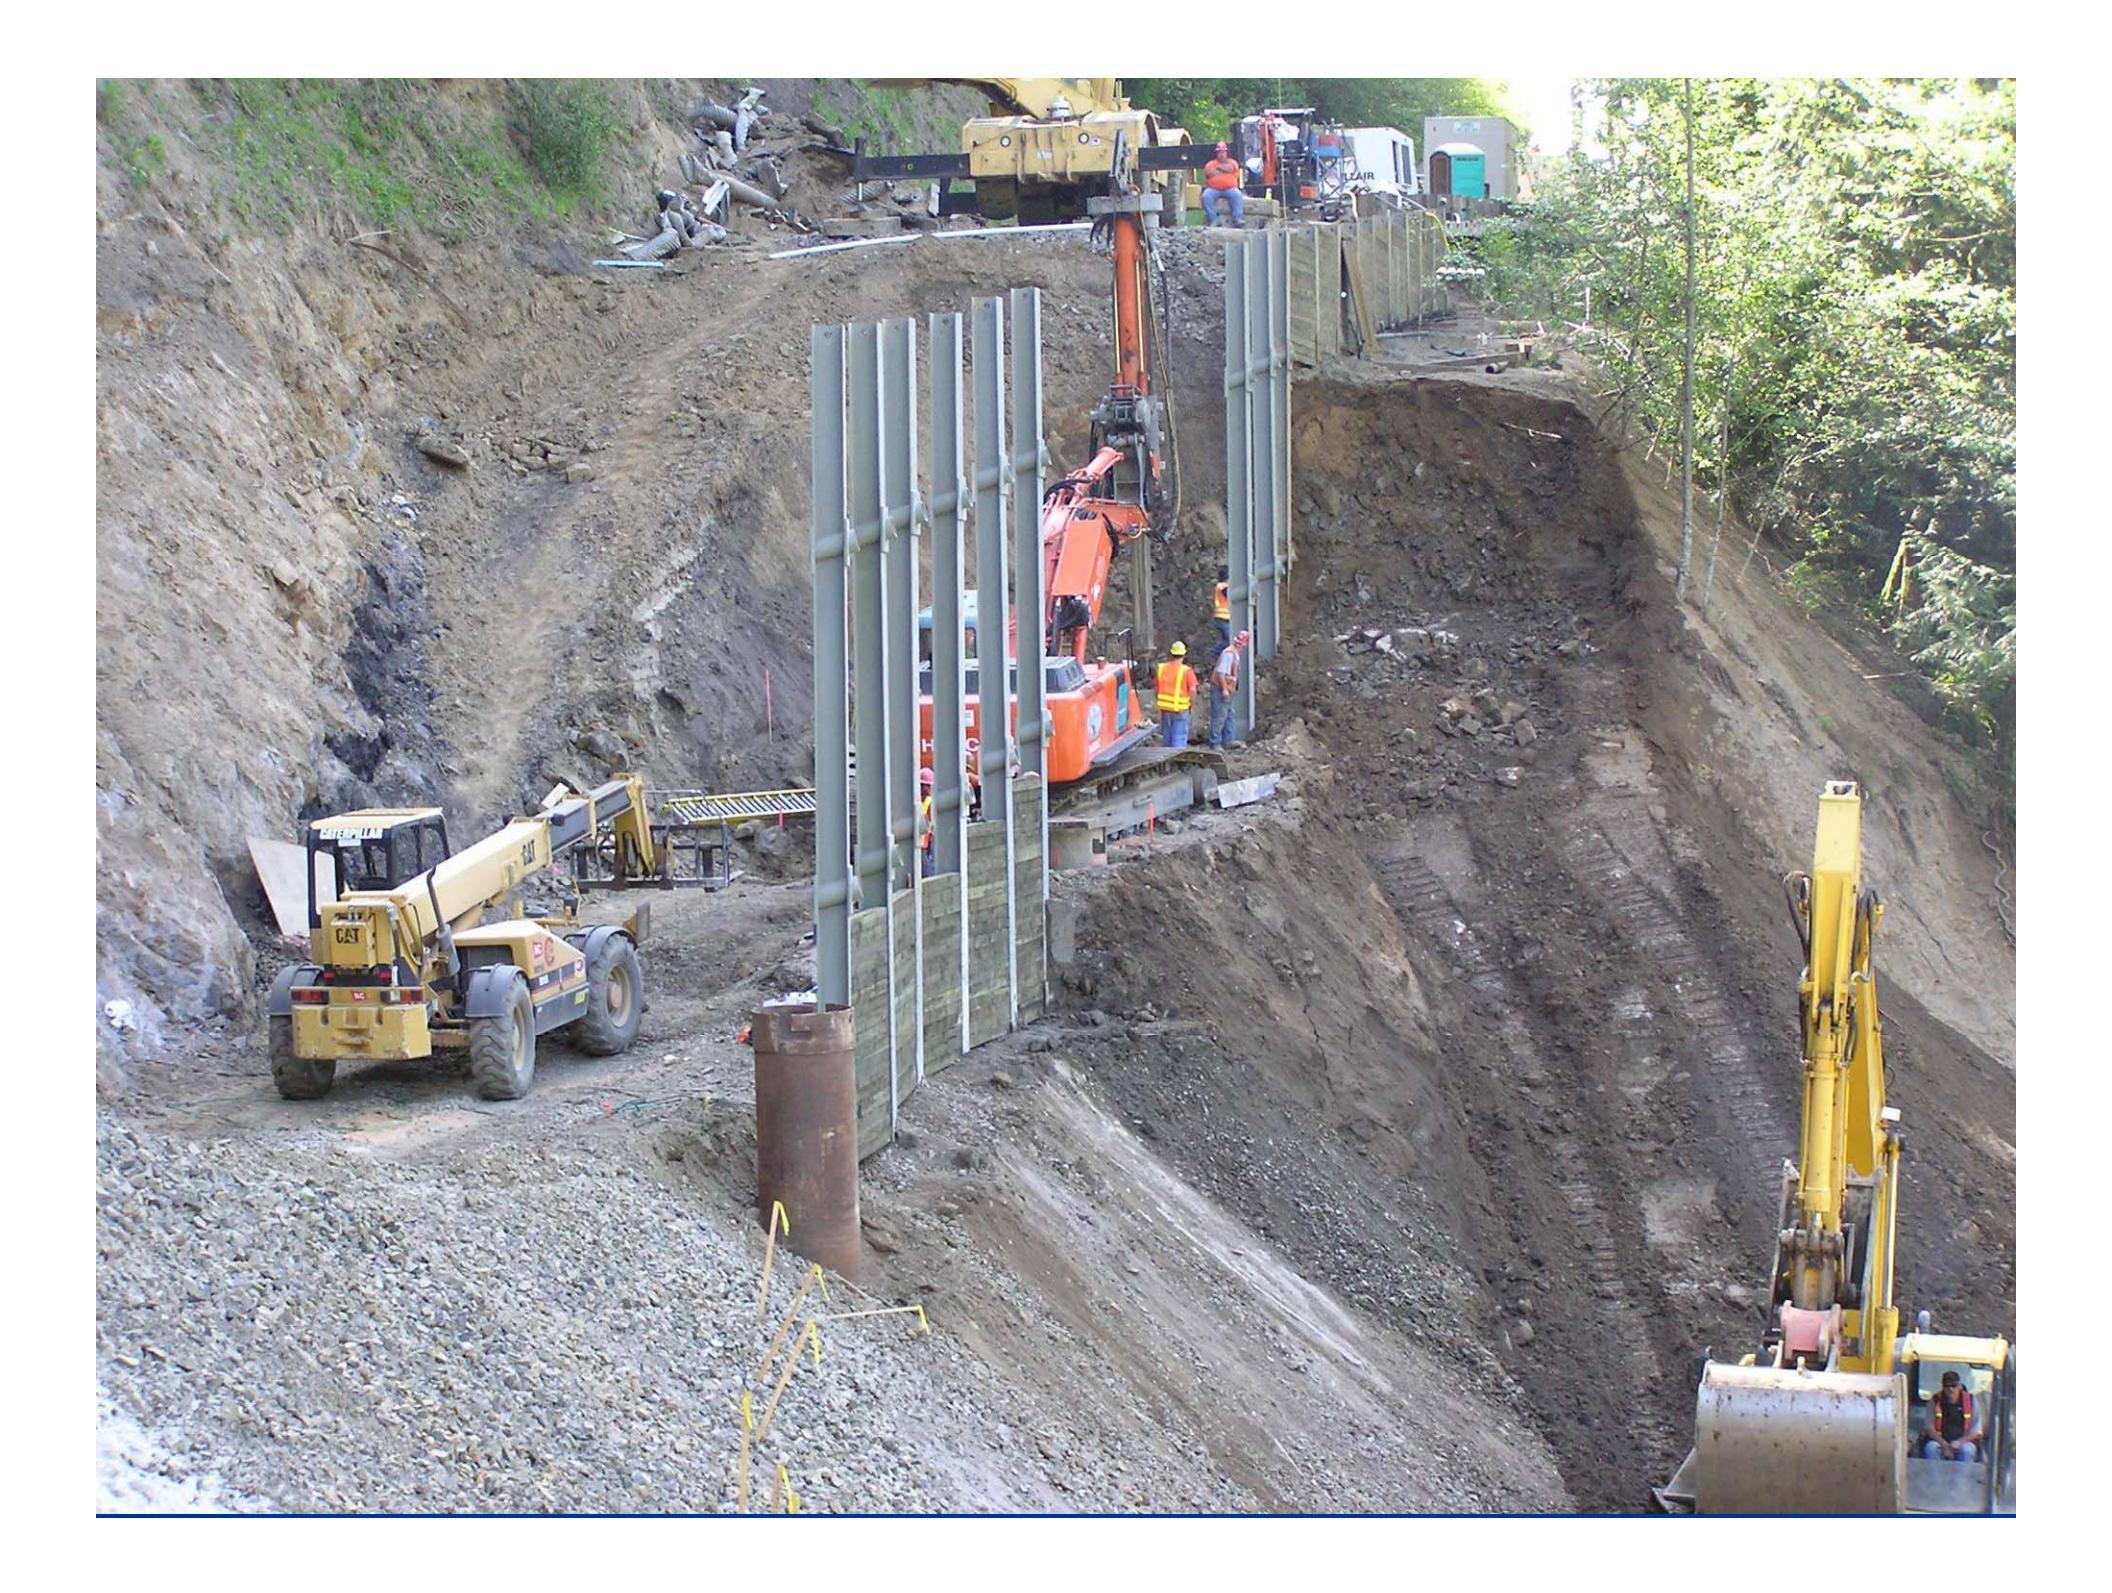
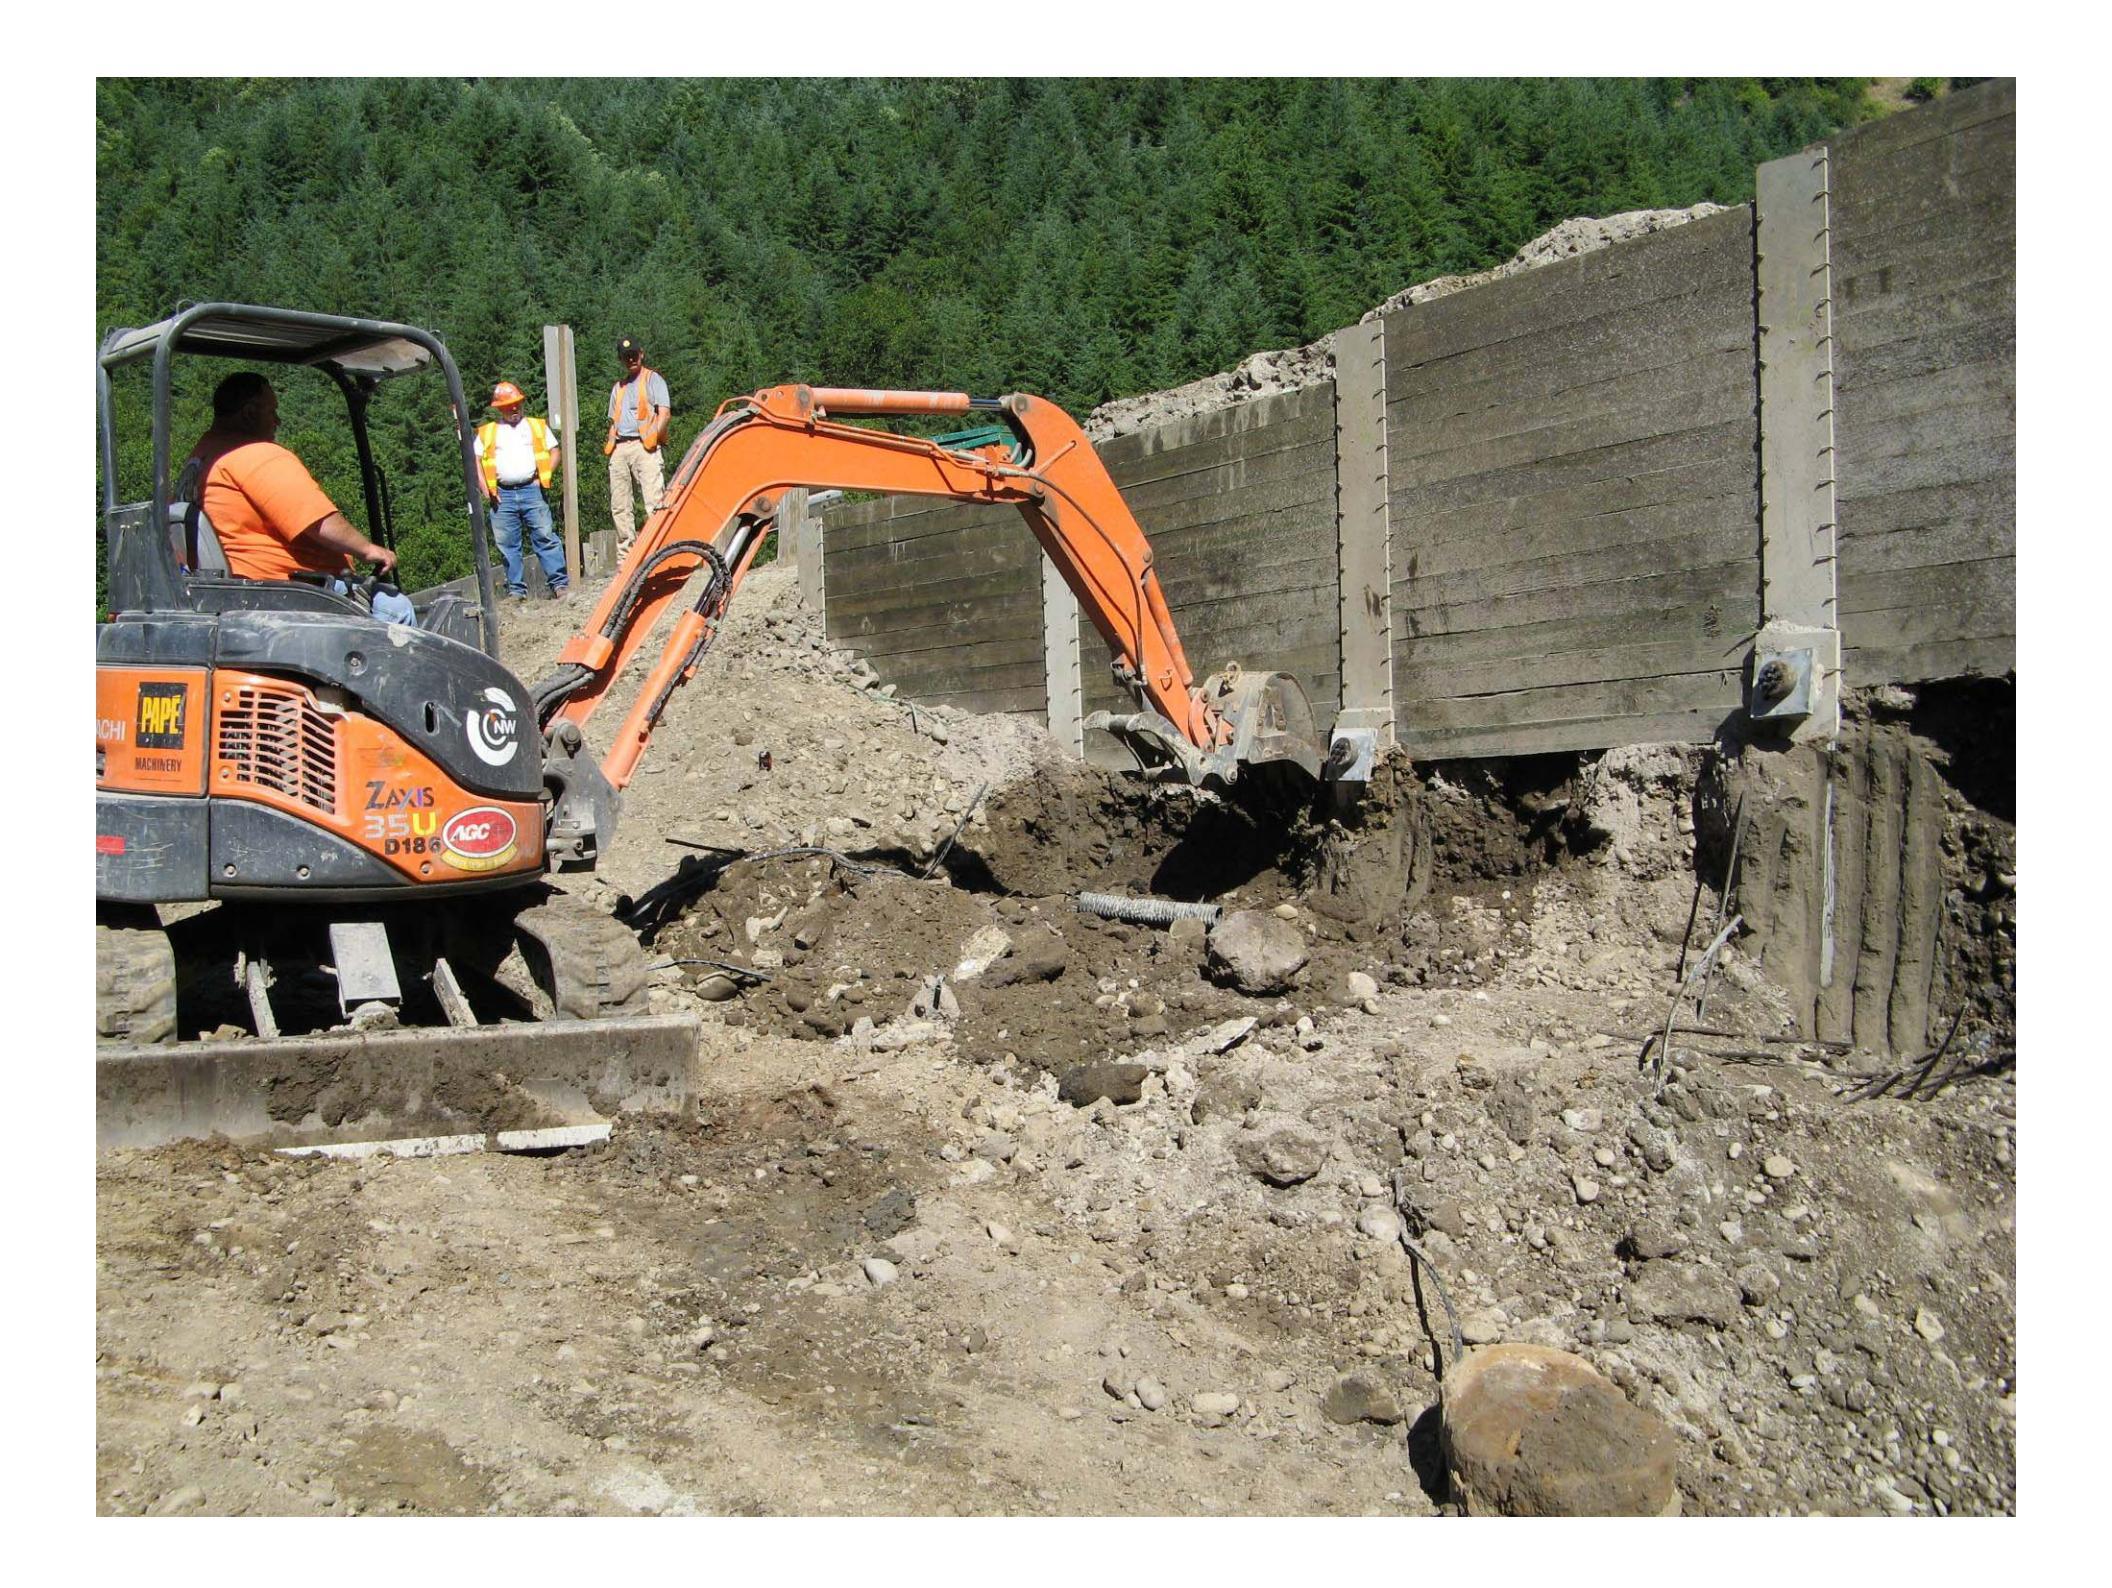
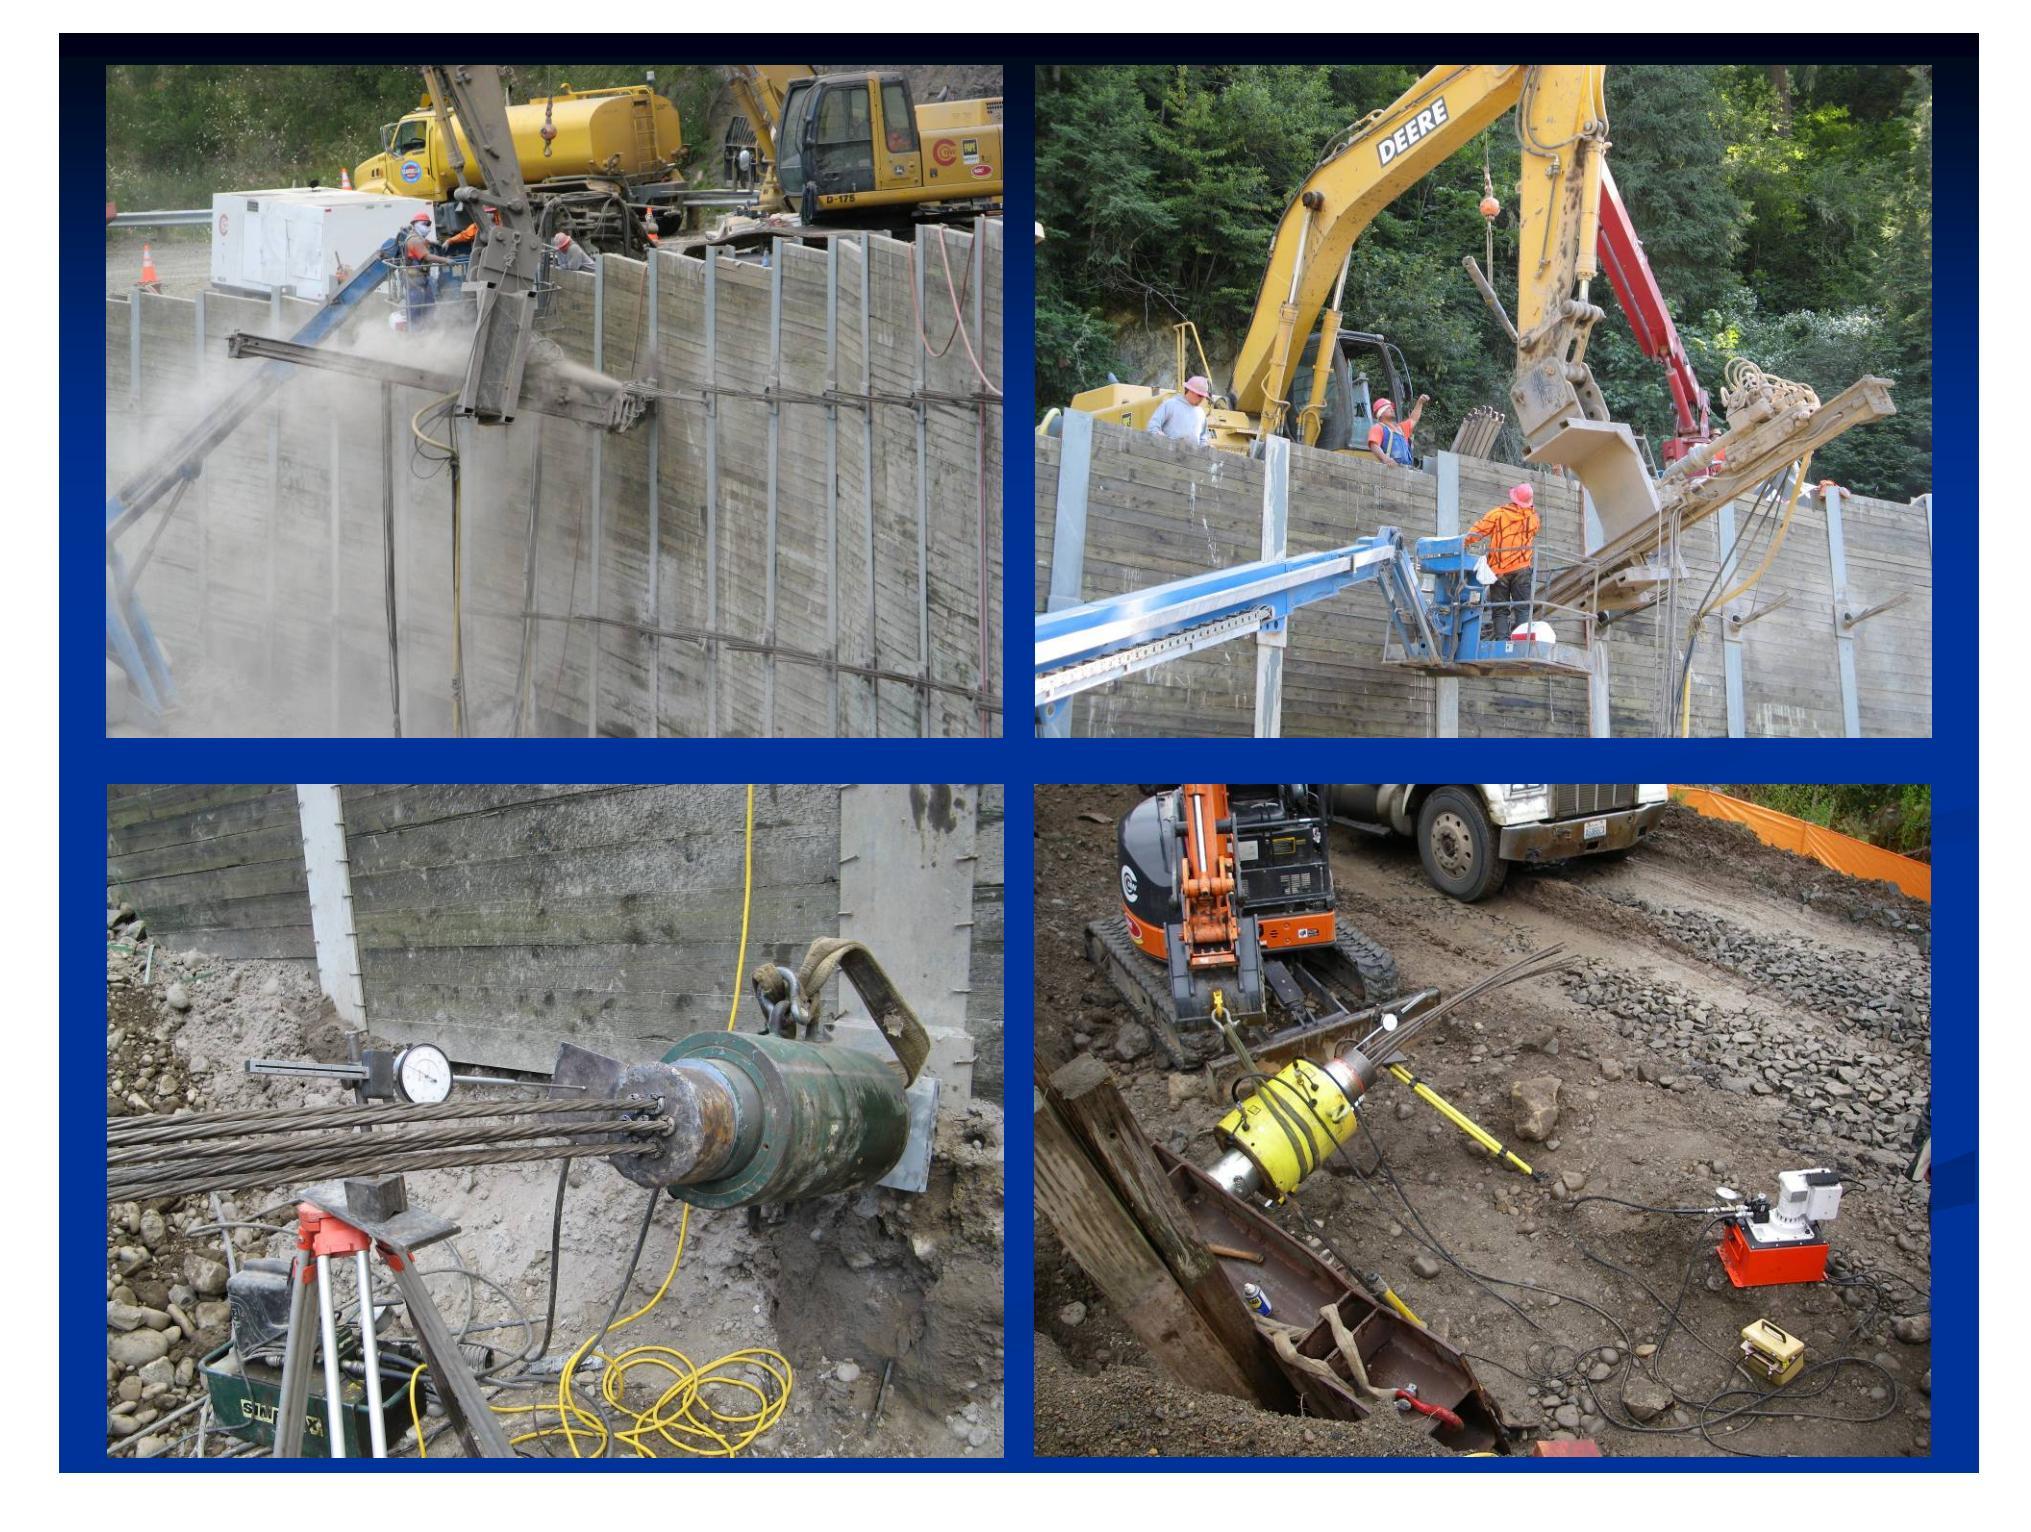
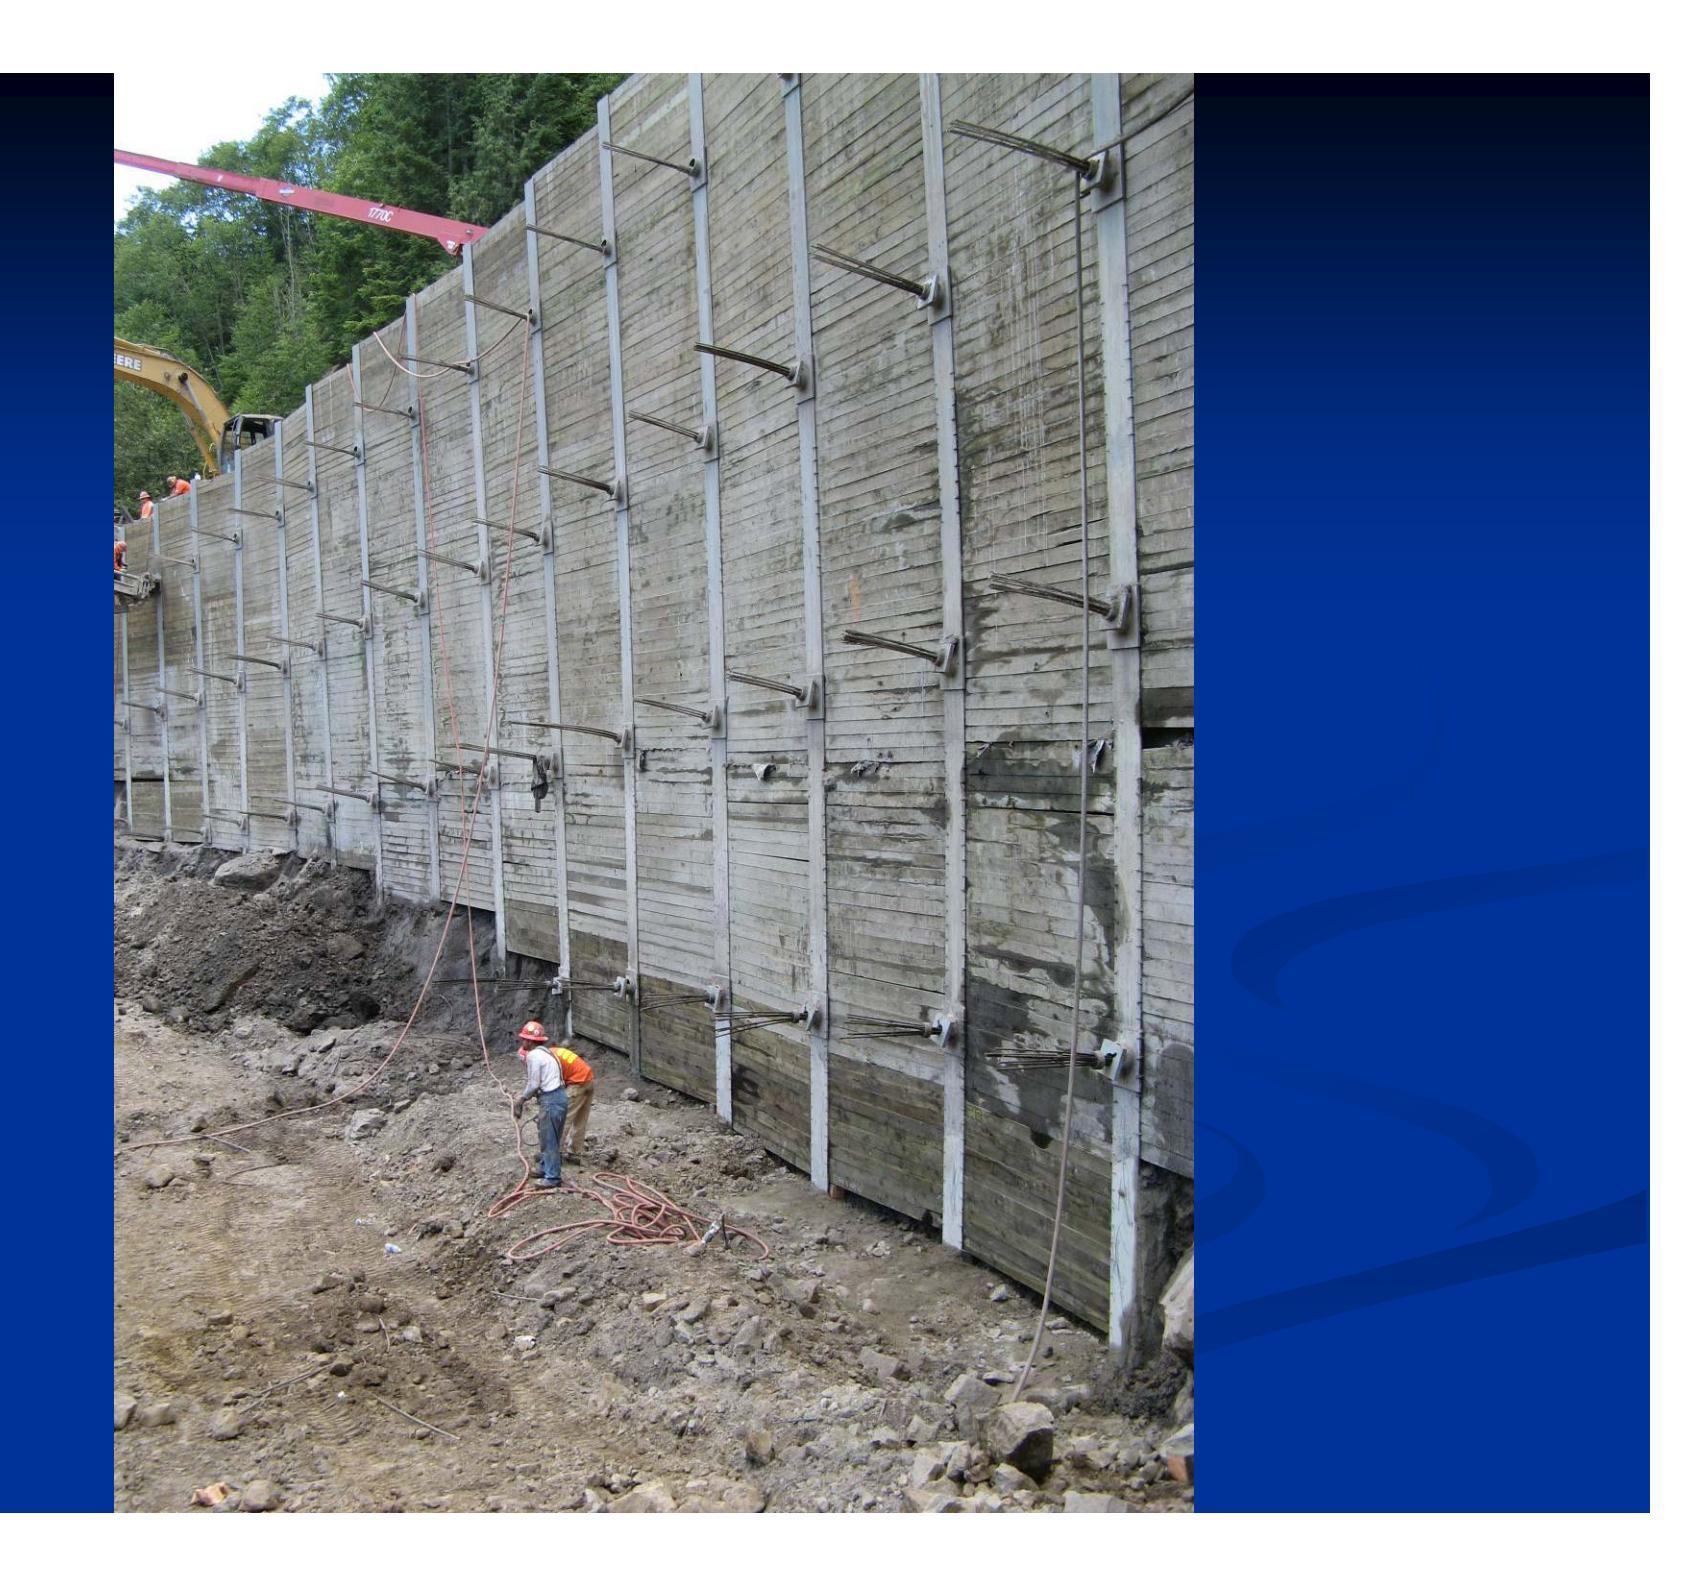
- Stabilize slope be removing sliding material and creating road access
- Install pile 10ft embed in rock, typ 15-20ft in ground
- Pile lengths 50-60ft
- Excavate slope at wall toe and lag down to rock
- Backfill to original road and lag up
- Install PGAs whenever soldier pile supports
 ~>11ft fill; partial tention

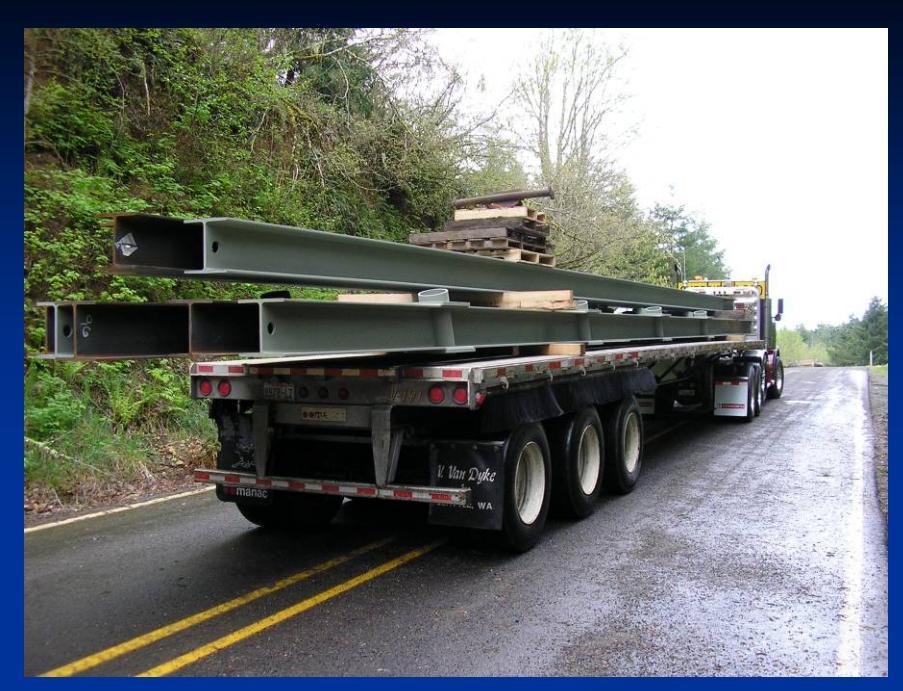
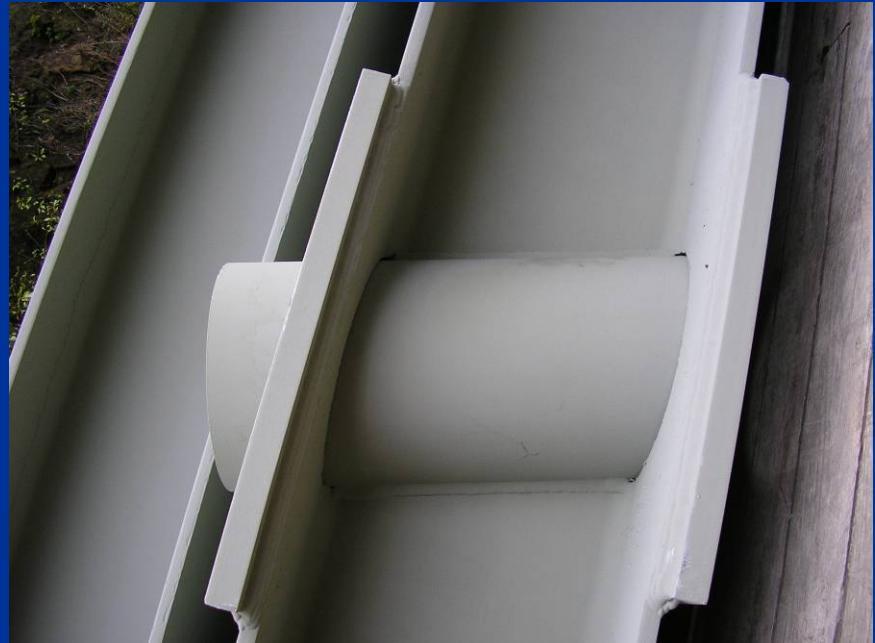
- Fabrication process is on critical path – highly undesirable
- We had to accept deviations from standard fabrication quality to maintain contract timeline

- Avoid owner procurement of materials
- Revise tolerances and construction method for bottom-up soldier pile tieback walls
- Estimate outward deflection from fill compaction in bottom-up construction
 Prohibit overexcavation during lagging installation

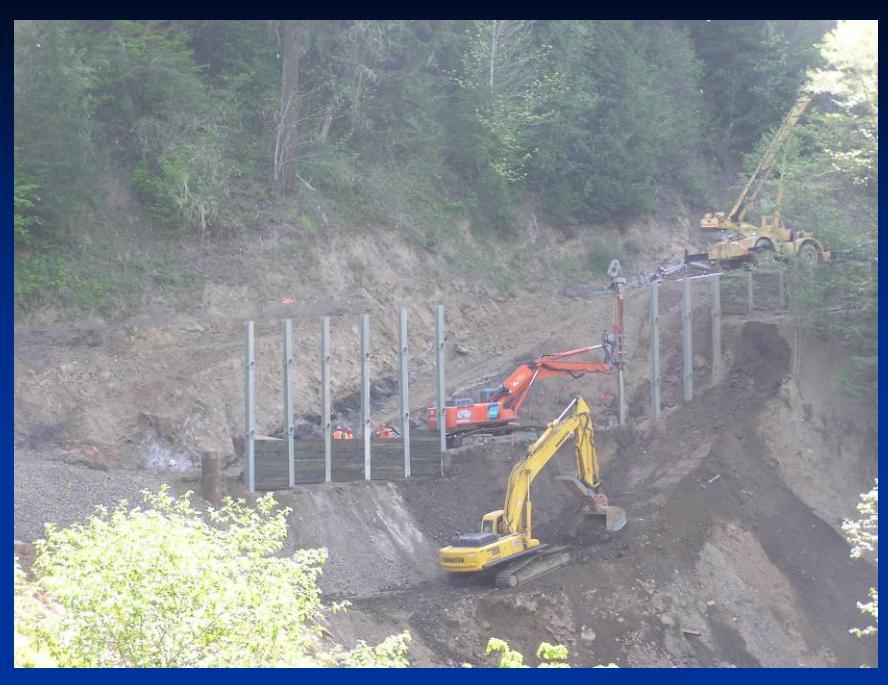
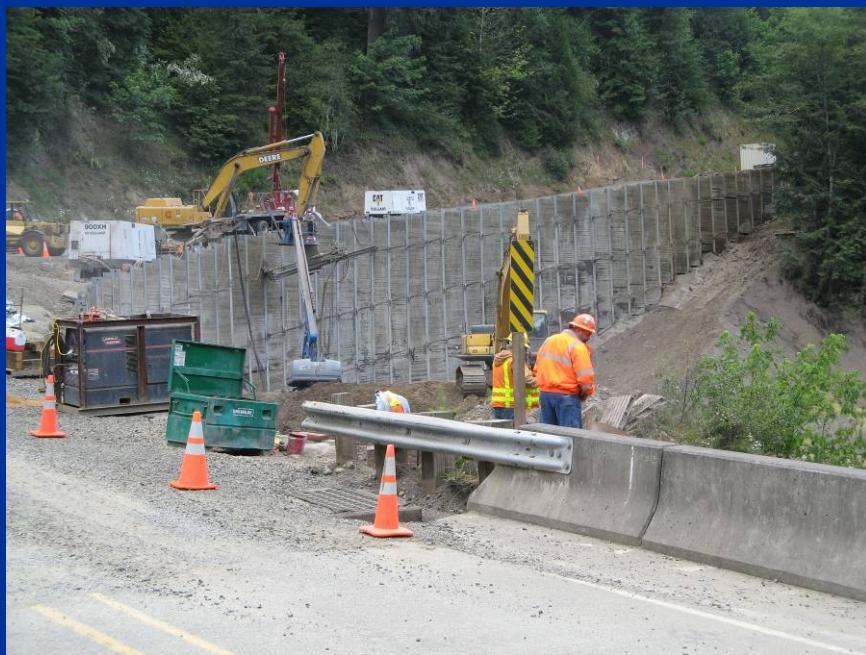
- Pile top location tolerance changed to 6"
- Goal construct backfill per plan and maintain wall alignment with expanded tolerance
 - PGA tensioned to less than design
 - PGAs tensioned 2+ times
 - Eliminate performance testing which unloads PGAs

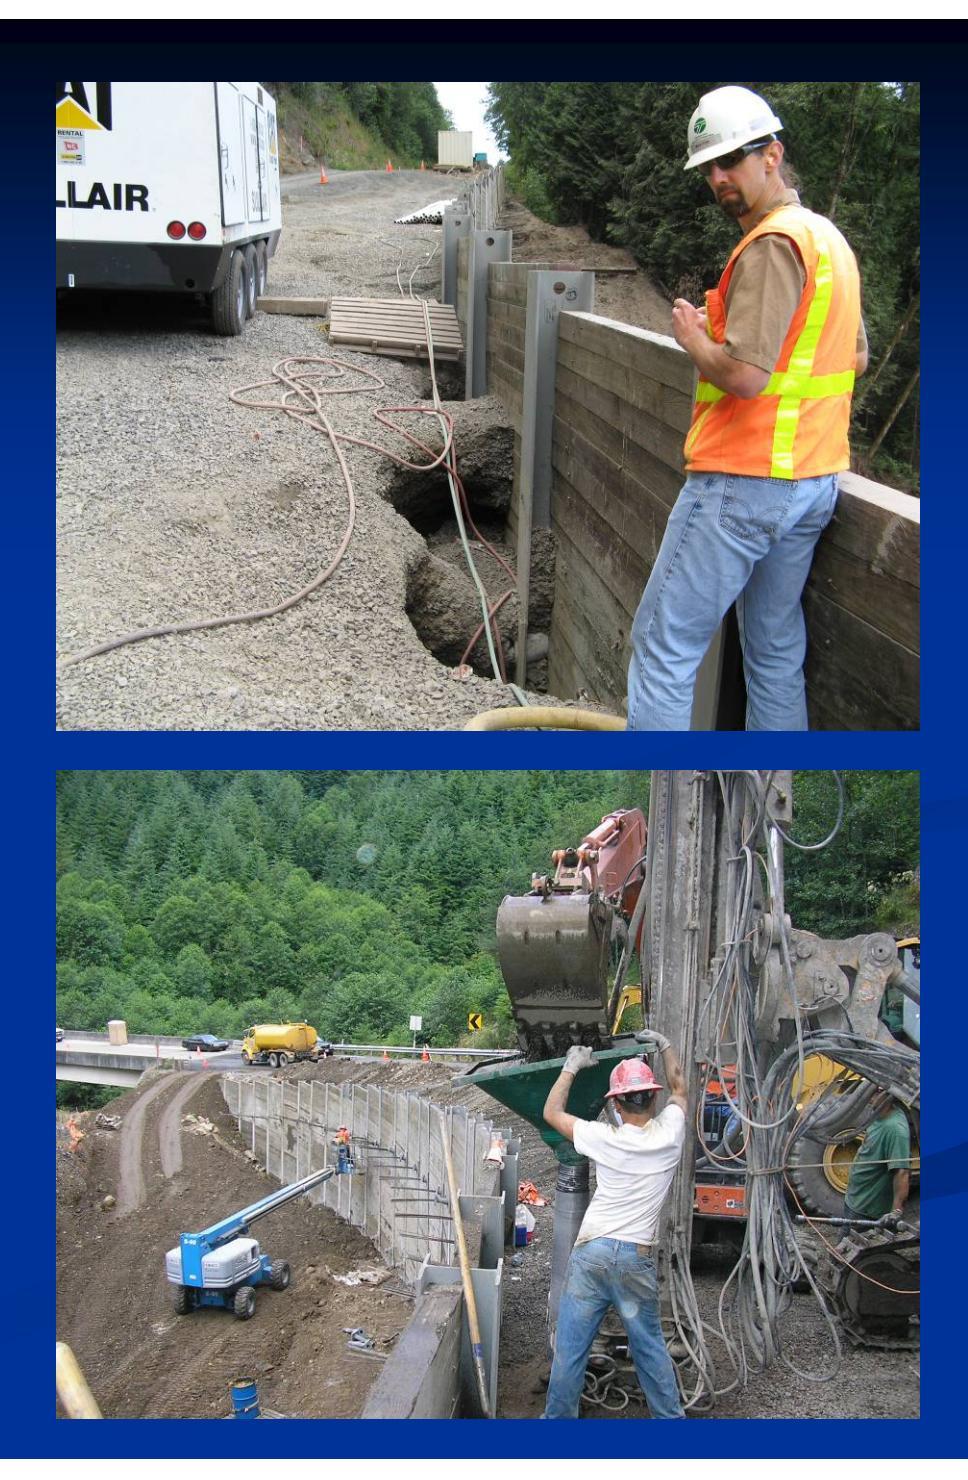
- Overexcavation during removal of lean concrete around piles to install lagging
- Softer materials such as CDF, lean concrete reduces the removal effort and voids
- Tremie placed gravel at base of voids that chimneyed to surface

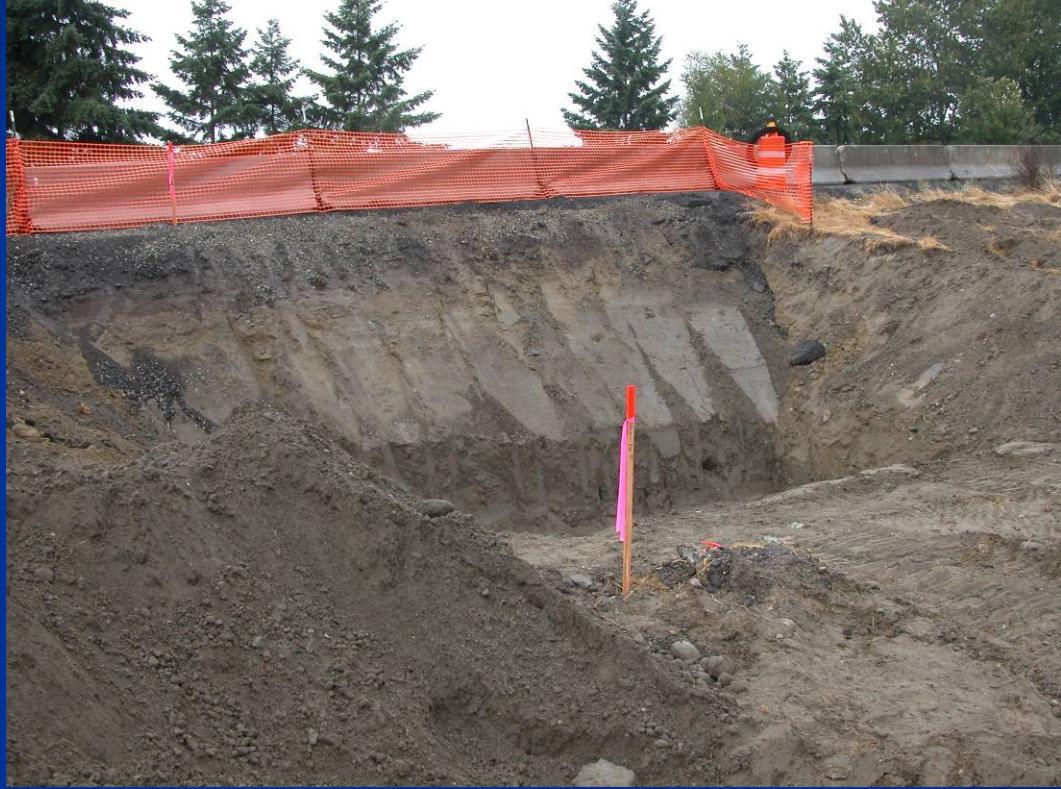
Require Geotechnical Engineer design for shoring – Geologist is not acceptable Design is critical case for temporary installations that may change – heavy rains...

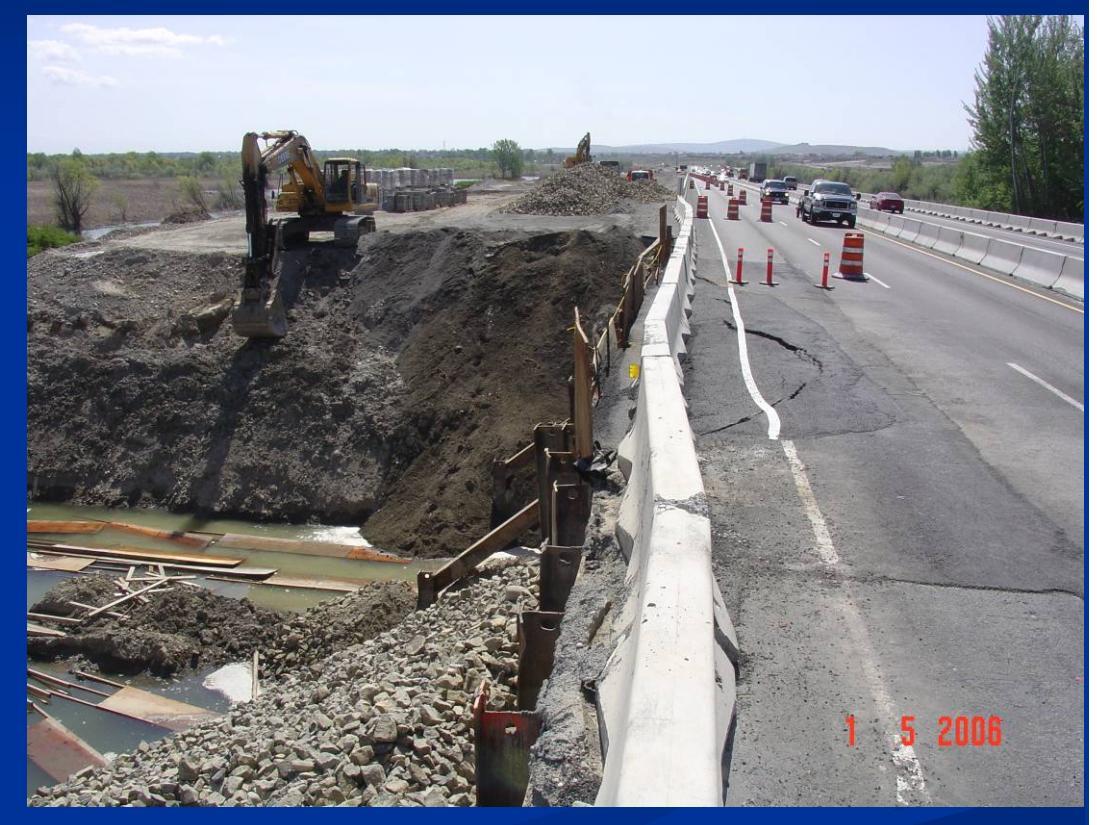
- Allow Contractor selection of lagging
 Steel plates may be preferable where sloughing materials are present
- Recommend research to design alternate laging materials
