CHAPTER TWO

INVENTORY OF EXISTING CONDITIONS AND FORECASTS OF AVIATION ACTIVITY

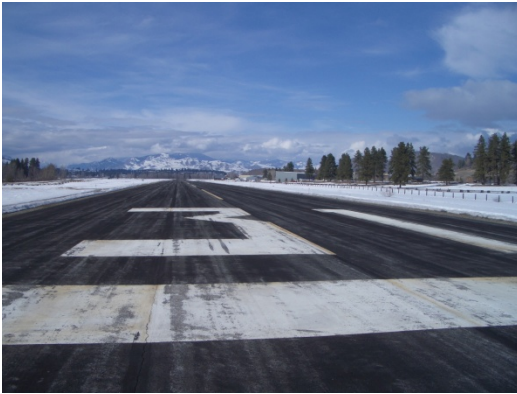
Runway 13/31 has basic (visual) markings (runway numbers and centerline stripe). Threshold bars (10 feet wide) are located at each runway end, corresponding with the displaced thresholds. The displaced threshold markings at both ends of the runway include a centerline arrow and three arrow heads leading to the threshold bar. The markings are generally in fair condition, although some markings were in poor condition (worn paint). All runway markings are painted in white.

Moderate transverse and block cracking was observed on the runway during a recent site visit. Some cracks are approximately 3/4-inch to 1 1/2-inch wide, although most are less than 3/4-inch wide. Some prior crackfilling is evident, although most cracks have re-opened. Isolated areas of cracking were observed (early 2008 site visit) that were wide enough to reveal the aggregate course under the asphalt. The surface is moderately weathered and some wear from snowplows (tire chains) was

observed. The runway condition was rated “very good” in the most recent (2005) comprehensive pavement evaluation. It appears that crackfilling/repair, sealcoating and repainting markings will be required in the near future.

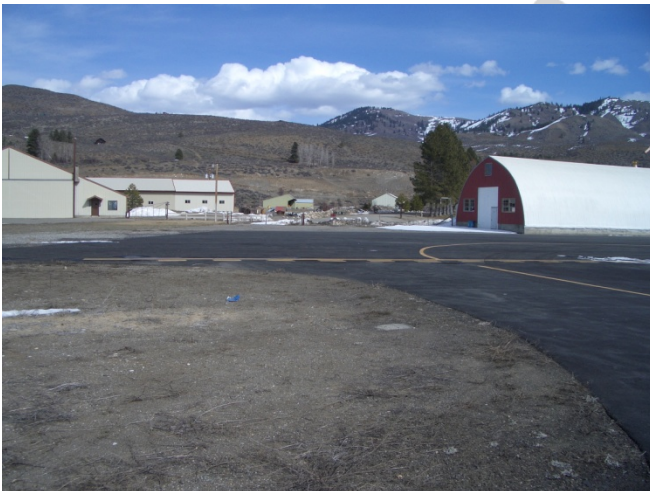
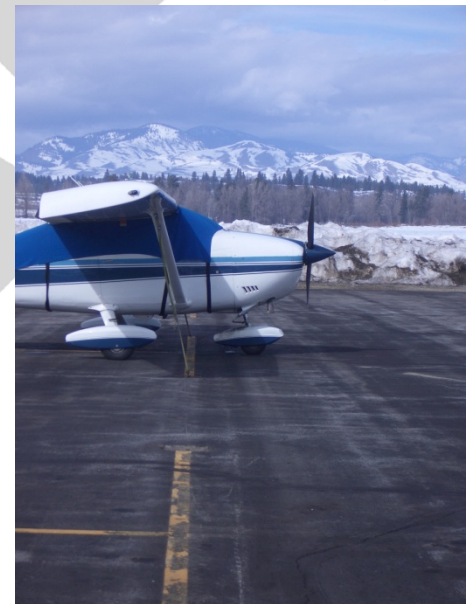
A small apron is located in front of the newer 3-unit hangar located near the southeast corner of the airport. The apron is located at the end of the taxiway that extends from the runway to the hangar. The apron condition was rated "very good" in the 2005 pavement inspection.

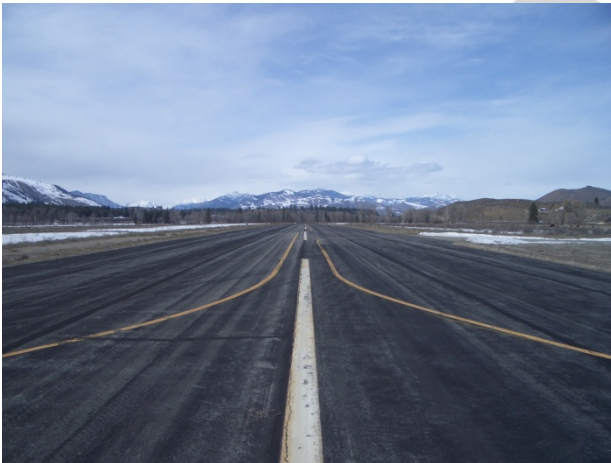
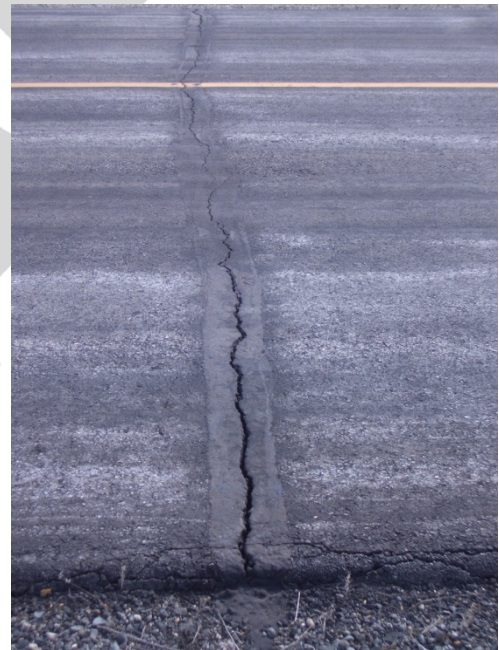
In the 2005 inspection, the runway and most taxiways and aprons were rated “very good” or better. Two small sections of apron were rated “good” and “fair.” The circular taxiway located adjacent to the fueling area was rated “very poor.”

The condition of the airfield pavements observed during recent site visits conducted for this project were generally consistent with the 2005 pavement evaluations. The runway and taxiway pavement surfaces are in generally good condition, with moderate transverse and longitudinal cracking, some weathering (oxidation) and surface wear observed. Although the older cracks (1/2-inch to 1-1/2 inch) have been previously filled, many have reopened and newer cracks have appeared. In some isolated areas of the runway, the crushed aggregate base beneath the 3-inch asphalt surface course was visible through open cracks. It appears that the pavement surfaces will require maintenance (crack filling, repair and sealcoats) in the near term.

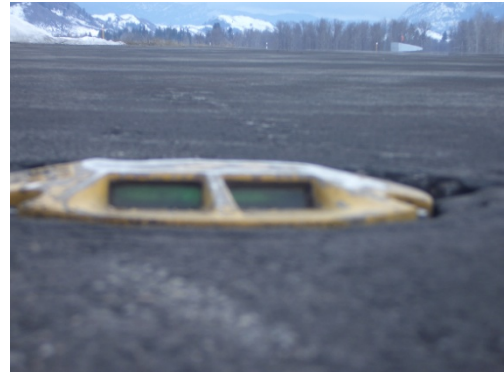
- Runway 13 has flushed-mounted threshold lights. The lights located left (east) of runway centerline are imbedded in the asphalt surfaced aircraft turnaround. The lights appear to function properly, although minor damage (scraped and worn surface) was observed from snow plowing operations. The flush mounted threshold lights located right of centerline (west side) are installed directly into the ground surface. These lights appear to operate normally and are in good condition.
