**WSDOT NPDES Municipal Stormwater Permit
Highway Monitoring Status Report
Water Year 2023**

October 2024

Stormwater Monitoring and Research Program
Environmental Services Office
Washington State Department of Transportation

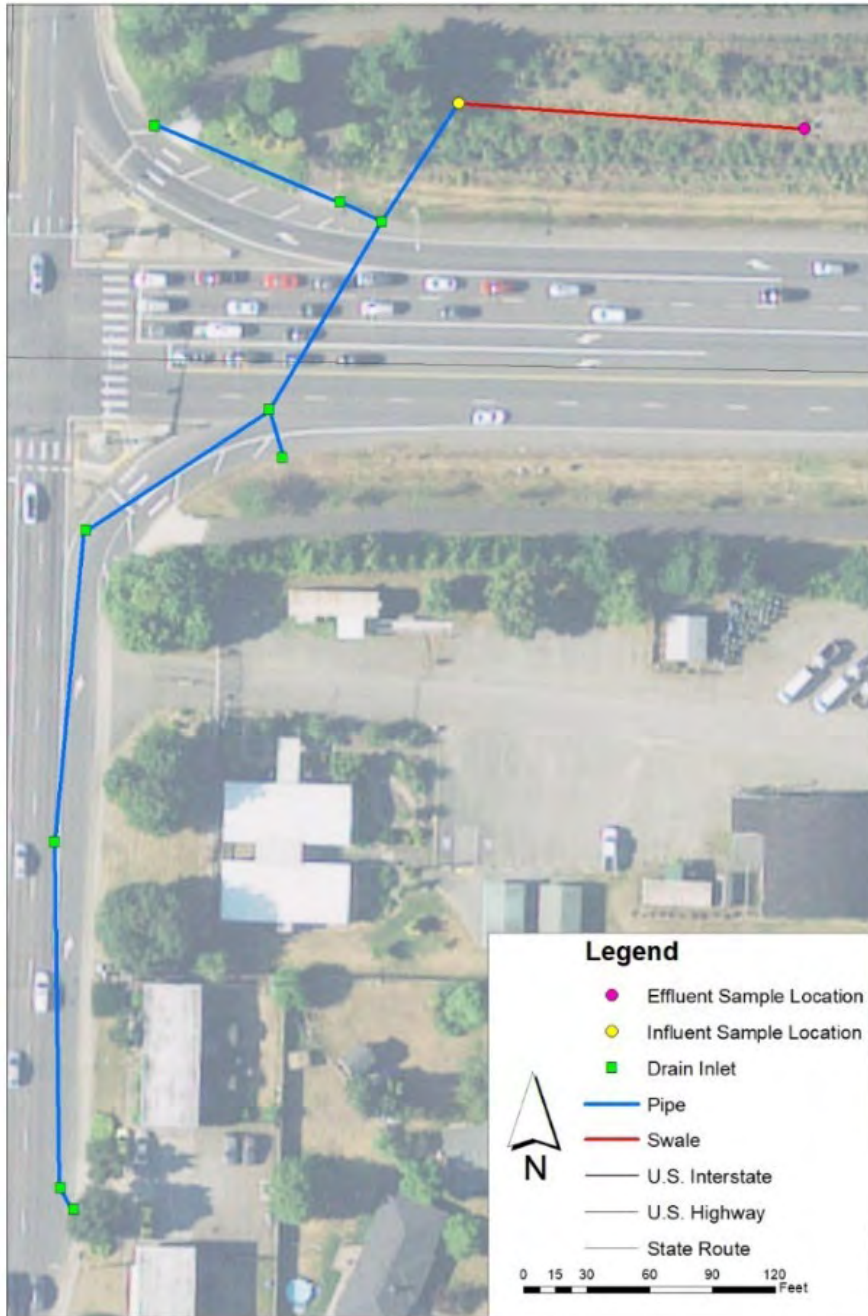
Figure 2. Vancouver biofiltration swale monitoring site and associated drainage features

The biofiltration swale is located northeast of the intersection and receives runoff from a 1-acre drainage area. The stormwater conveyance system is highlighted in Figure 2. The drainage area was ground-checked through multiple site observations during storm events, including heavy rain events. The biofiltration swale does not receive water from local roads or any non-WSDOT property.

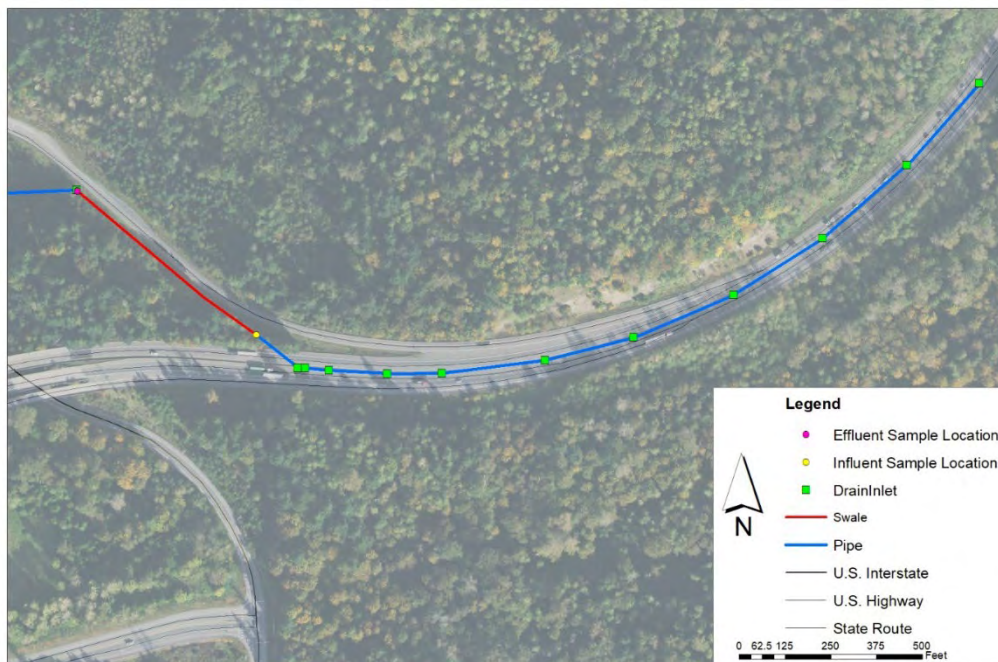
Figure 4. Mirrormont biofiltration swale monitoring site and associated drainage features

The biofiltration swale is located on an offramp north of mainline SR 18 and receives runoff from a 3.5-acre impervious drainage area. The stormwater conveyance system is highlighted in Figure 4. The drainage area was ground-checked through multiple site observations during storm events, including heavy rain events. The biofiltration swale does not receive water from local roads or any non-WSDOT property.

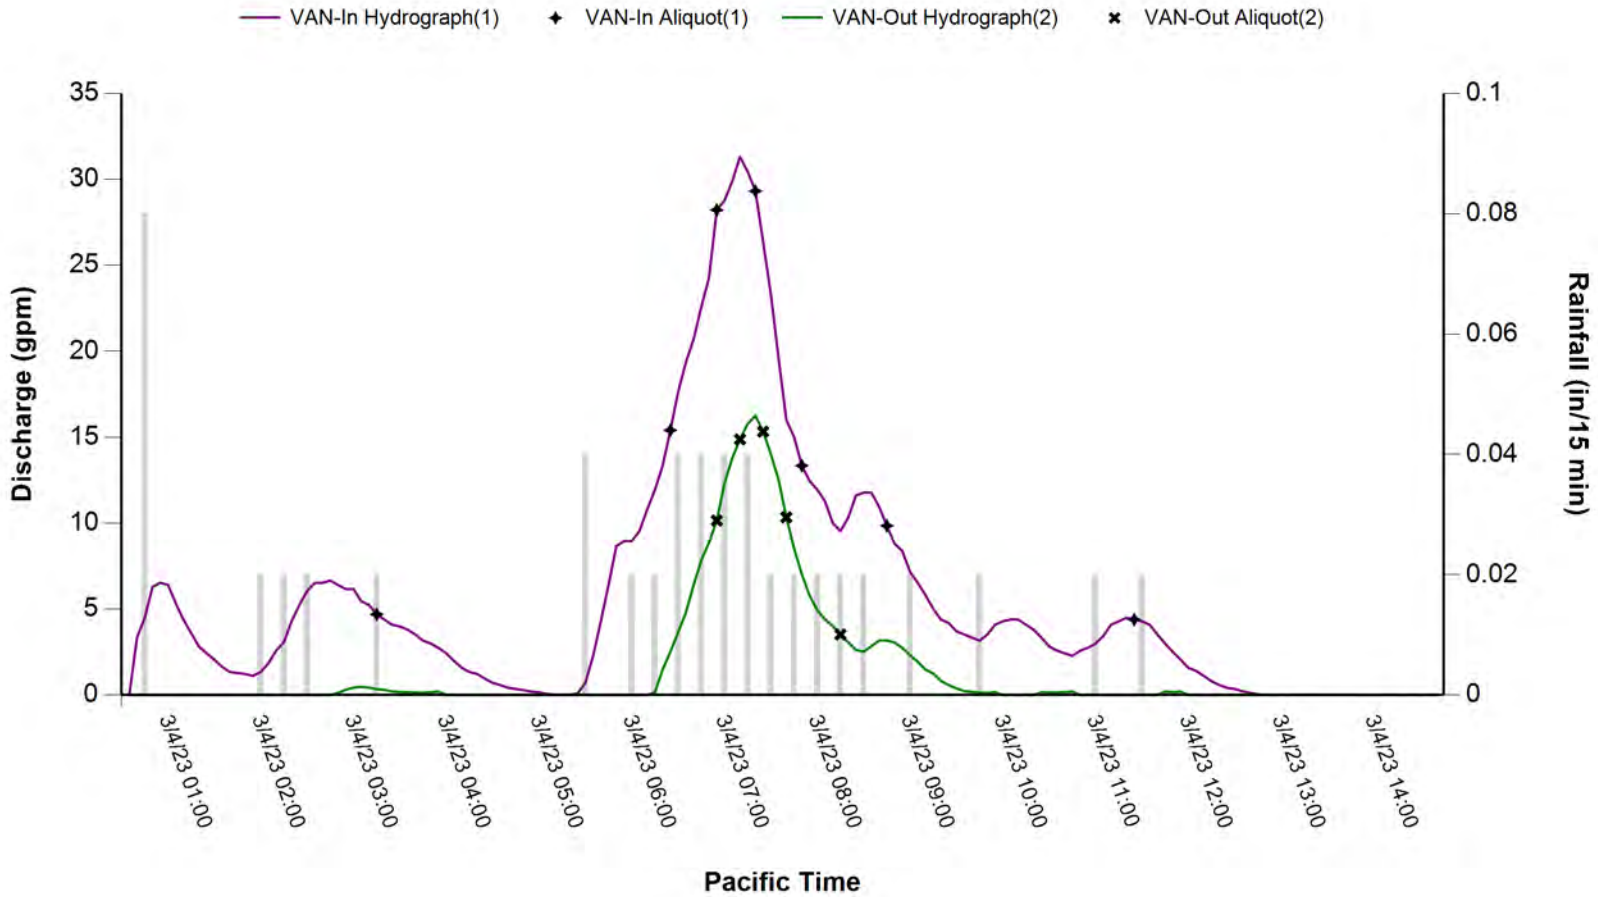
22 Vancouver 3/4/2023 Storm Event

Precipitation				
Total (in)	Start Time (Pacific)	End Time (Pacific)	Duration (hrs)	Antecedent Dry (hrs)
0.29	03/04/2023 00:35	03/04/2023 11:30	10.92	32.83

Aliquots								Water Temp	
Sample Point (m)	Sample Point Name	Aliquots Collected	First Aliquot Time (Pacific)	Last Aliquot Time (Pacific)	Sampling Duration (hrs)	Volume (mL)	Total Sample Volume (mL)	Min (°C)	Max (°C)
1	VAN-In	7	03/04/2023 03:15	03/04/2023 11:25	8.17	250	1,750	4.00	5.10
2	VAN-Out	5	03/04/2023 06:55	03/04/2023 08:15	1.33	250	1,250	4.00	4.40

Runoff / Discharge														
		Runoff Time			Volume			Sampled		Flow			Stage	
Sample Point (m)	Sample Point Name	Start Time (Pacific)	End Time (Pacific)	Duration (hrs)	Total (gal)	Intensity (gal/hr)	First 24Hrs (gal)	Discharge Total Volume Sampled (gal)	% Hydrograph Sampled	Peak (gpm)	Min (gpm)	Mean (gpm)	Max (ft)	Hydrology Validation Code
1	VAN-In	03/04/2023 00:40	03/04/2023 14:50	14.17	4,770.2	336.6	4,770.2	4,639.0	97.20	31.30	0.01	5.89	0.221	
2	VAN-Out	03/04/2023 02:50	03/04/2023 11:55	9.08	1,235.8	136.1	1,235.8	1,064.6	86.10	16.25	0.13	3.69	0.124

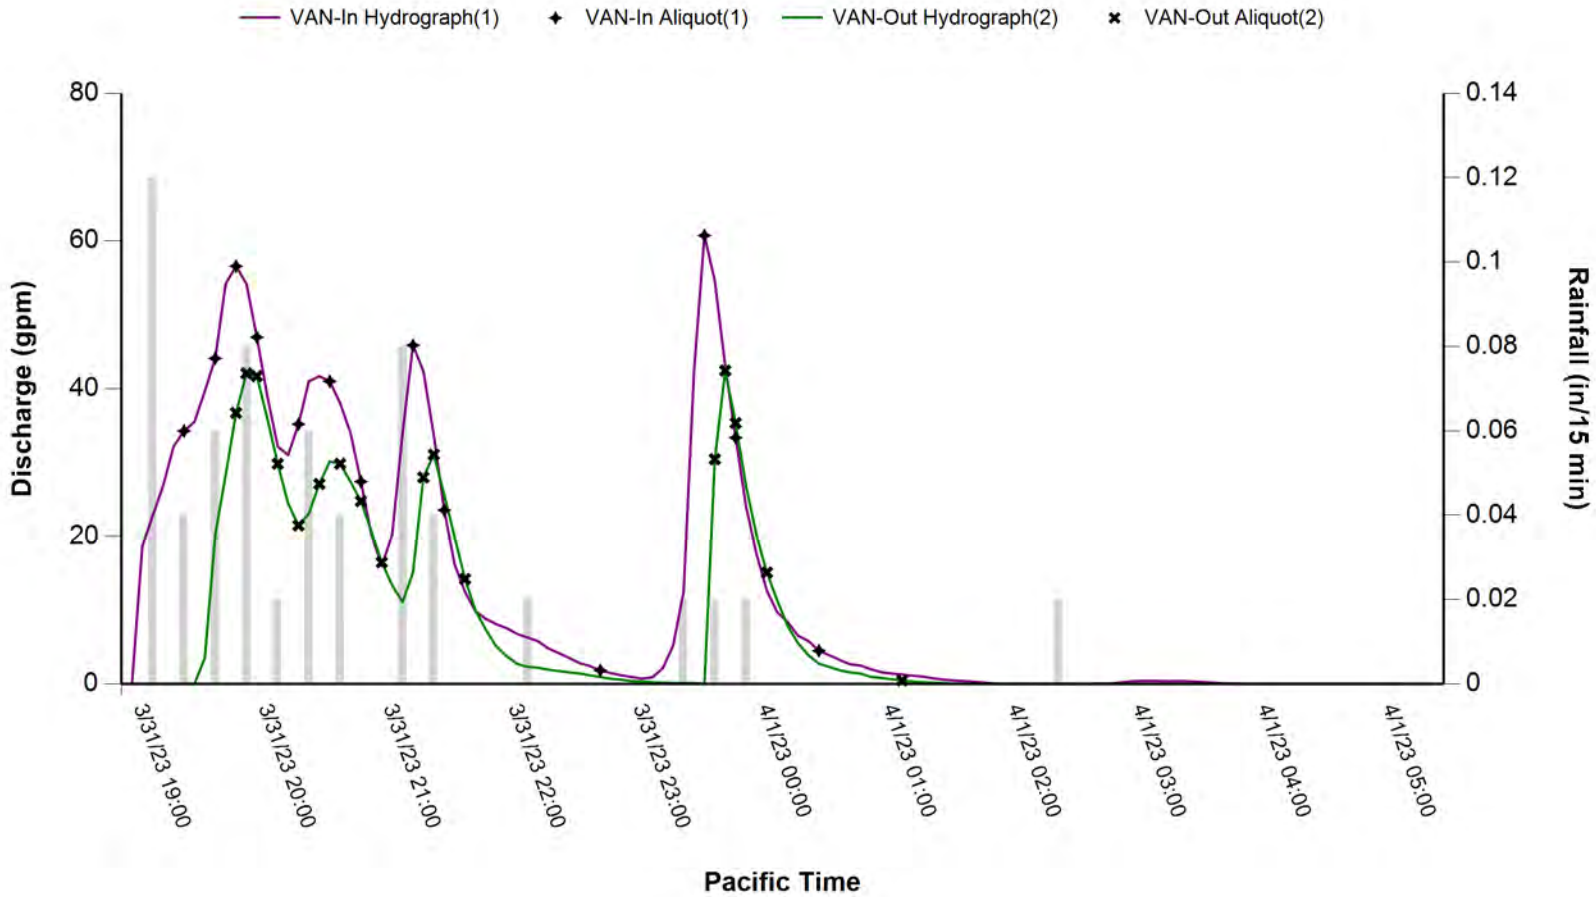
22 Vancouver 4/1/2023 Storm Event

Precipitation				
Total (in)	Start Time (Pacific)	End Time (Pacific)	Duration (hrs)	Antecedent Dry (hrs)
0.32	03/31/2023 18:55	04/01/2023 02:15	7.33	81.08

Aliquots								Water Temp	
Sample Point (m)	Sample Point Name	Aliquots Collected	First Aliquot Time (Pacific)	Last Aliquot Time (Pacific)	Sampling Duration (hrs)	Volume (mL)	Total Sample Volume (mL)	Min (°C)	Max (°C)
1	VAN-In	13	03/31/2023 19:20	04/01/2023 00:25	5.08	250	3,250	7.70	9.00
2	VAN-Out	17	03/31/2023 19:45	04/01/2023 01:05	5.33	250	4,250	7.60	8.70

Runoff / Discharge														
		Runoff Time			Volume			Sampled		Flow			Stage	
Sample Point (m)	Sample Point Name	Start Time (Pacific)	End Time (Pacific)	Duration (hrs)	Total (gal)	Intensity (gal/hr)	First 24Hrs (gal)	Discharge Total Volume Sampled (gal)	% Hydrograph Sampled	Peak (gpm)	Min (gpm)	Mean (gpm)	Max (ft)	Hydrology Validation Code
1	VAN-In	03/31/2023 19:00	04/01/2023 05:15	10.25	7,697.2	750.9	7,697.2	7,560.8	98.20	60.74	0.01	12.94	0.304	
2	VAN-Out	03/31/2023 19:30	04/01/2023 01:25	5.92	4,497.7	759.7	4,497.7	4,493.3	99.90	42.45	0.13	12.67	0.211
