**Landmark Preservation Board Report  
on Designation: L'Amourita Apartment  
Building**

# L'Amourita Apartment Building

### Landmark Nomination Report

December 2004

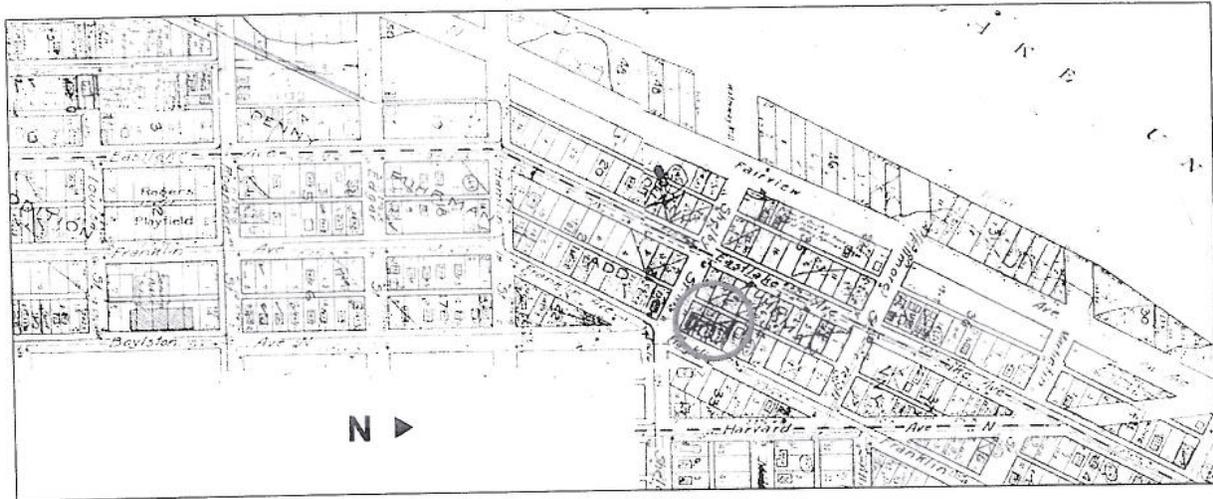
1912 - 1920 Kroll Map

Below, two figure-ground maps of a portion of the Eastlake neighborhood dating from 1912 - 1920 and 1940 - 1960, which show its gradual development and the impact of the construction of Interstate 5. (The Kroll Map Company.)

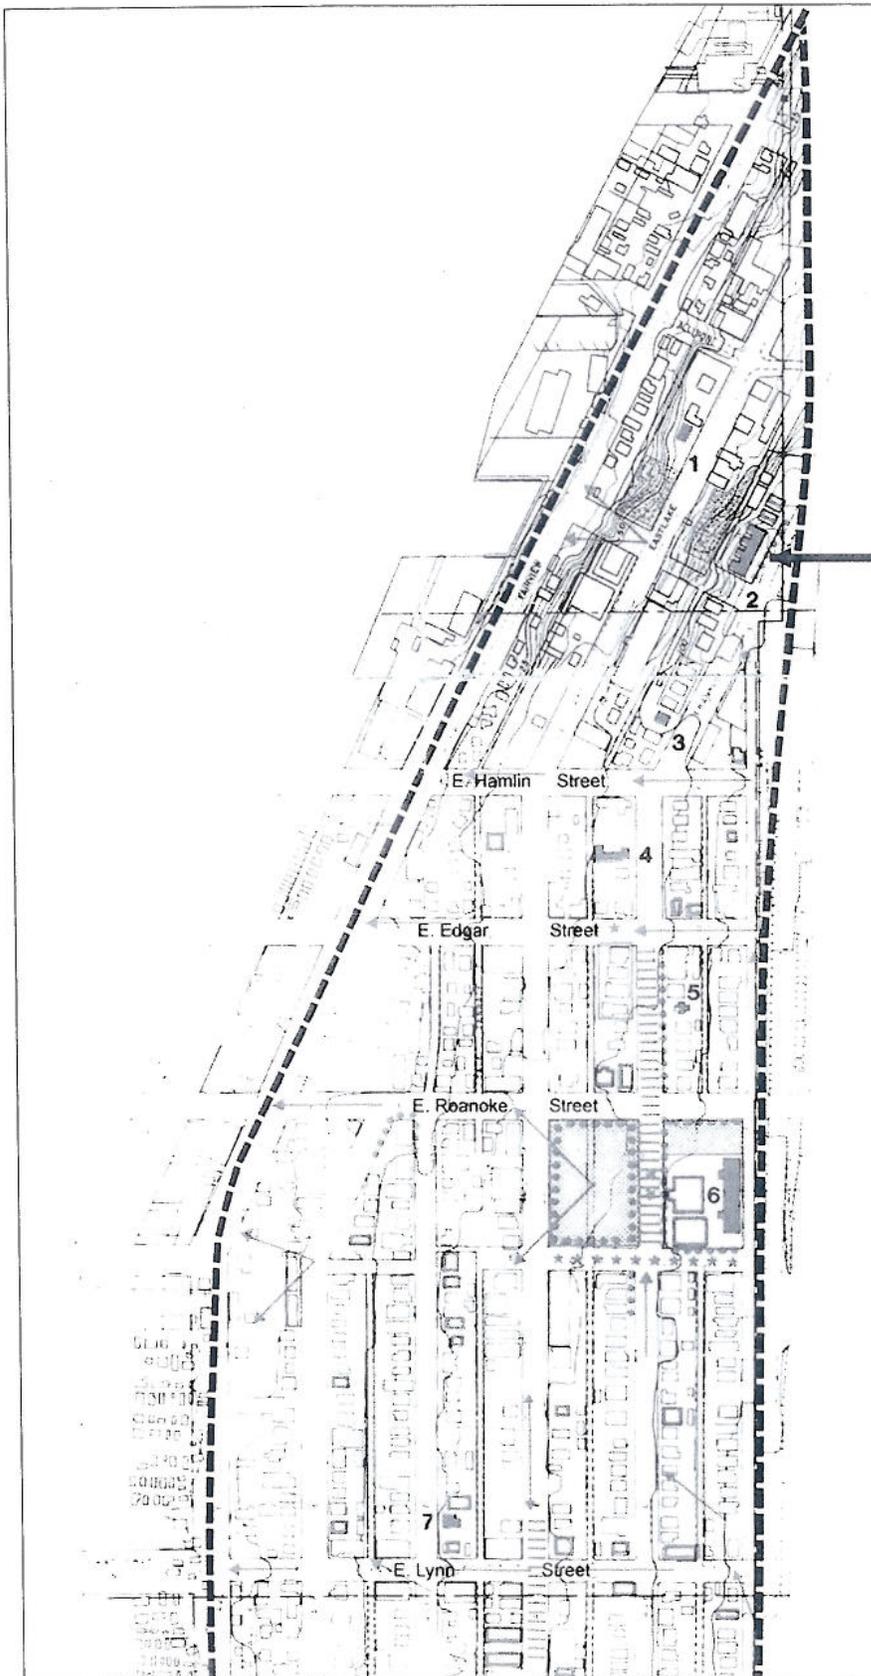
In 1975, Historic Seattle surveyed urban and historic features in the Eastlake/Cascade neighborhoods in an effort led by architects Victor Steinbrueck and Folke Nyberg. A portion of the inventory map is copied, left. The footprint of the L'Amourita Apartment Building is shown in orange. Buildings that were cited as being "significant to the city" were shown in a solid orange color on the map, while those that were "significant to the community" were outlined in orange. Other historic buildings with city significance, which are in the four blocks south of the L'Amourita, include No. 3, the ca. 1895 Fisher-Howell House; No. 4, the 1929 Art Deco Castlewood Apartment Building; No. 5, the 1891 - 1893 Steinbrueck Residence; and No. 6, the 1895 - 1917 Seward School. This portion of the map shows the narrow north end of Eastlake, a sliver of land isolated from nearby North Capitol Hill by Interstate 5. (Steinbrueck and Nyberg, 1975, n.p.)
