## SR 520 pontoon repairs in a coffer cell on Lake Washington

November 2013

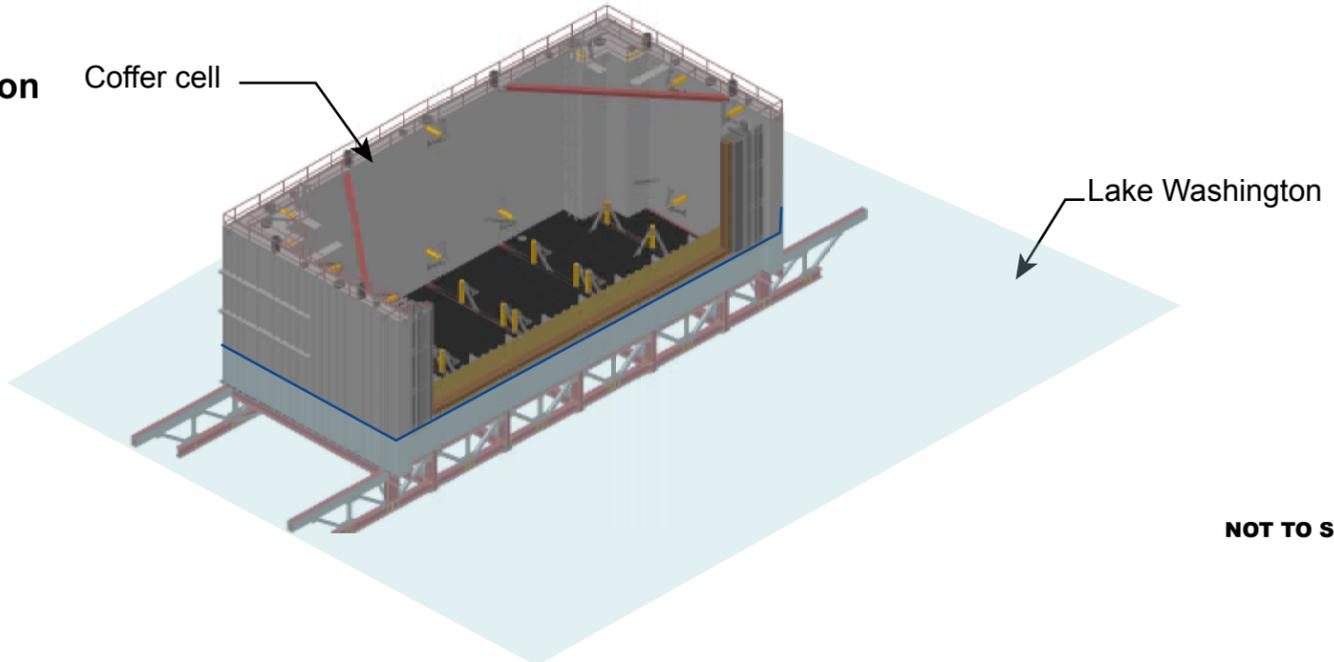
### STEP 1

- Launch coffer cell into Lake Washington

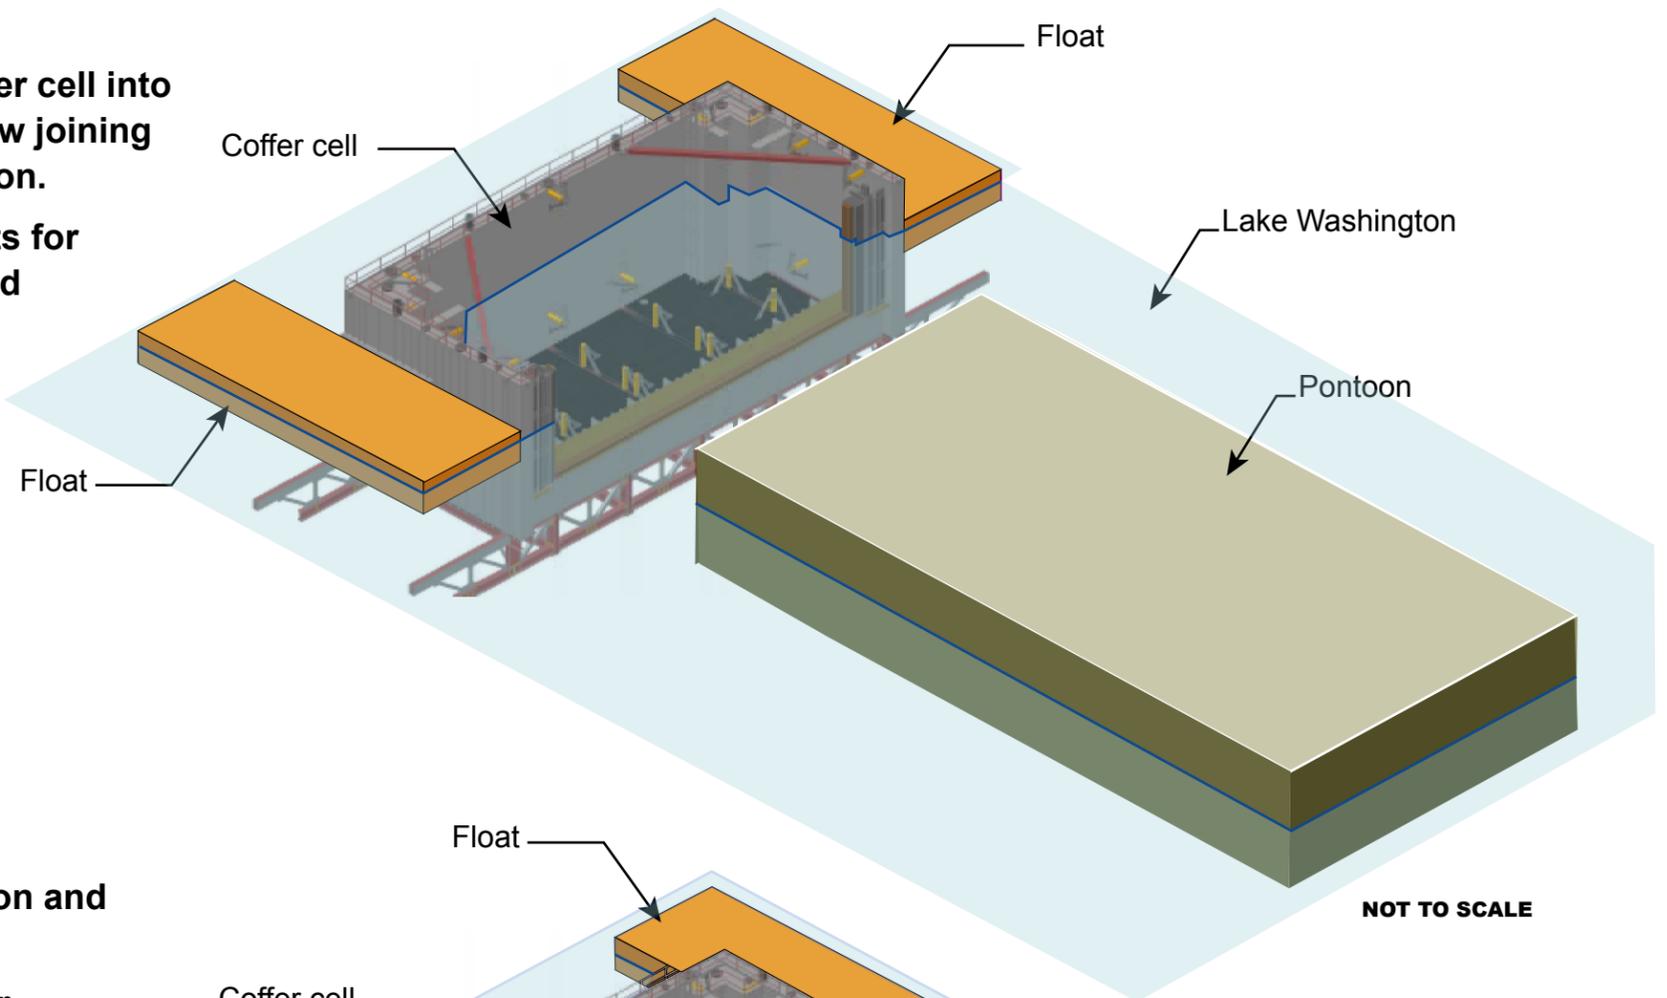
### STEP 2

- Lower coffer cell into lake to allow joining with pontoon.
- Install floats for stability and buoyancy.

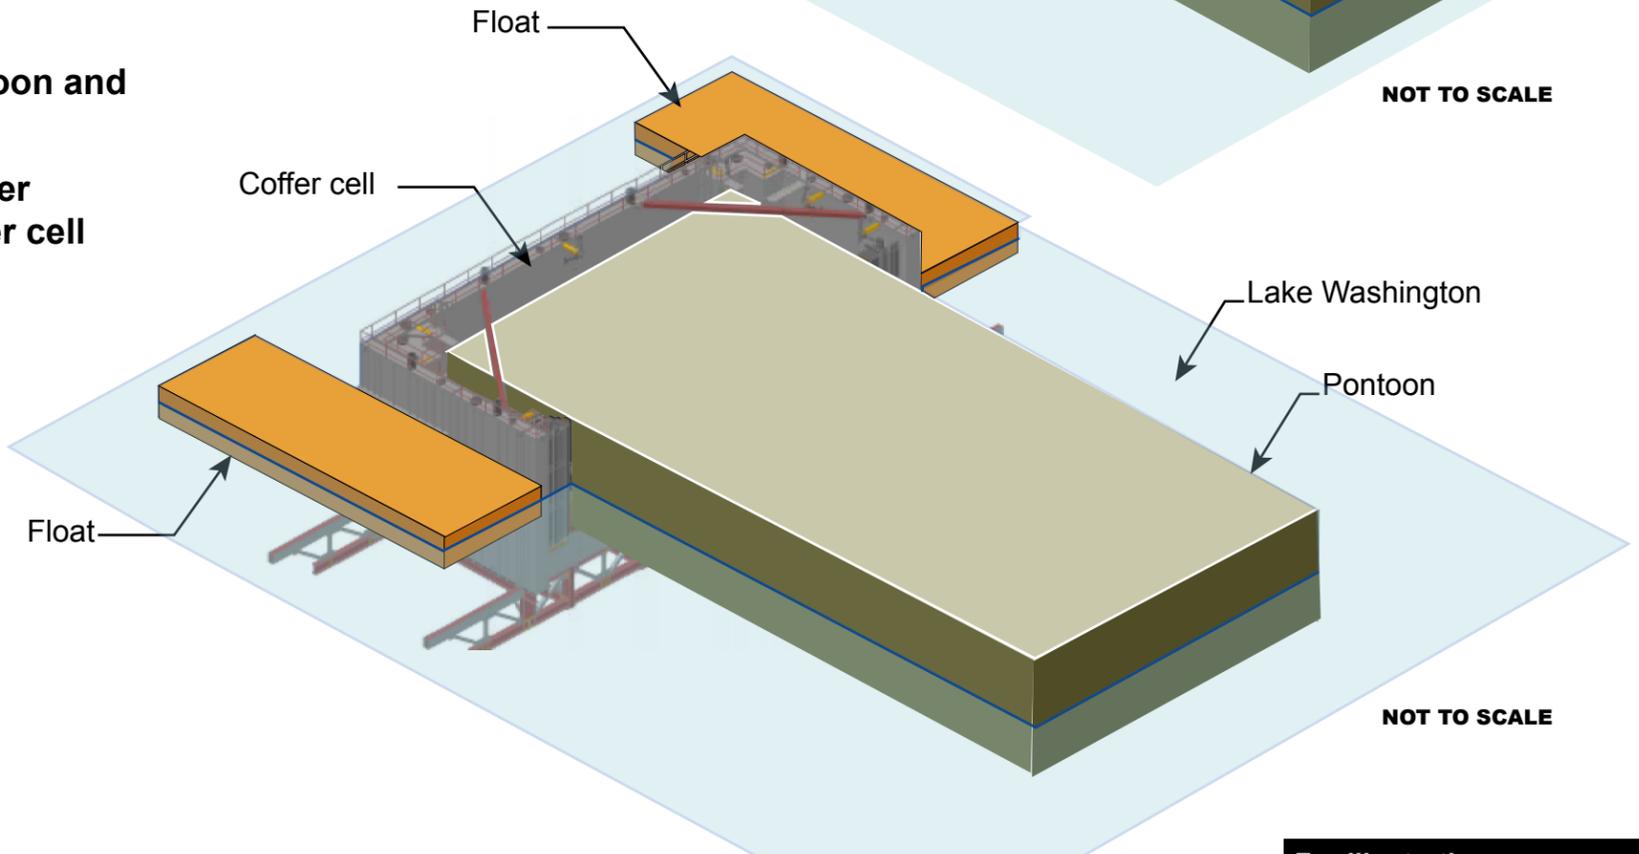
### STEP 3

- Join pontoon and coffer cell
- Pump water from coffer cell
