CHAPTER TWO

INVENTORY OF EXISTING CONDITIONS AND FORECASTS OF AVIATION ACTIVITY

Methow Valley State Airport is owned and operated by the Washington Department of Transportation (WSDOT) Aviation Division. The airport is also home to the U.S. Forest Service (USFS) North Cascades Smoke Jumper Base, which is located on USFS-owned property immediately adjacent to the east side of the runway.

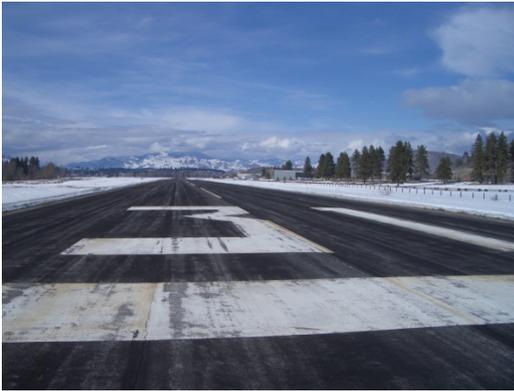
Runway 13/31 has basic (visual) markings (runway numbers and centerline stripe). Threshold bars (10 feet wide) are located at each runway end, corresponding with the displaced thresholds. The displaced threshold markings at both ends of the runway include a centerline arrow and three arrow heads leading to the threshold bar. The markings are generally in fair condition, although some markings were in poor condition (worn paint). All runway markings are painted in white.

Moderate transverse and block cracking was observed on the runway during a recent site visit. Some cracks are approximately 3/4-inch to 1 1/2-inch wide, although most are less than 3/4-inch wide. Some prior crackfilling is evident, although most cracks have re-opened. Isolated areas of cracking were observed (early 2008 site visit) that were wide enough to reveal the aggregate course under the asphalt. The surface is moderately weathered and some wear from snowplows (tire chains) was

observed. The runway condition was rated “very good” in the most recent (2005) comprehensive pavement evaluation. It appears that crackfilling/repair, sealcoating and repainting markings will be required in the near future.

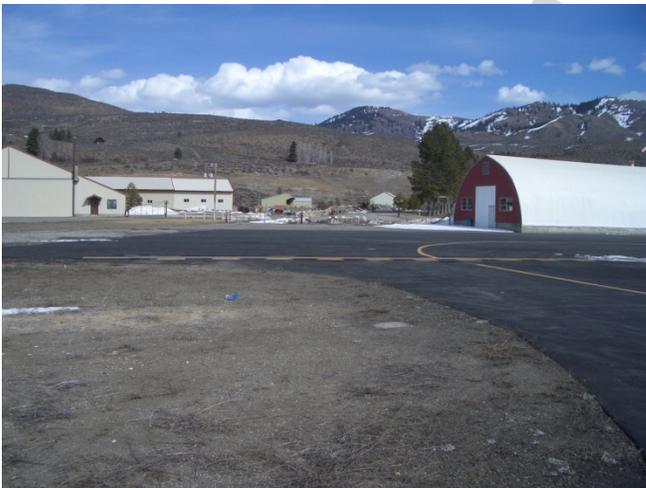
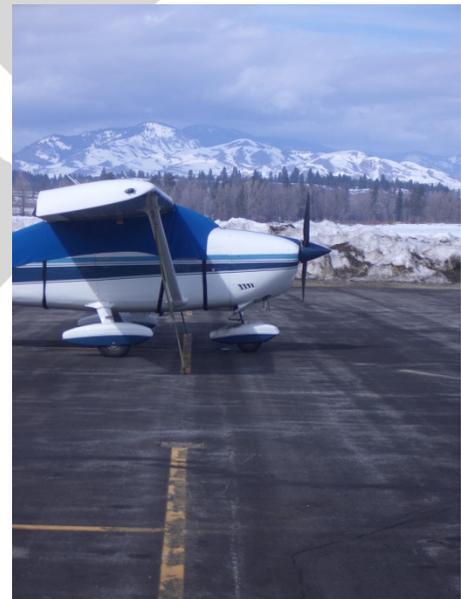
The main aircraft tiedown apron is located near the middle of Runway 13/31, with a single taxiway connection to the runway. The airport name “Methow Valley” is painted on the main apron (20 foot tall white letters). The paved apron is approximately 450 feet by 189 feet and has eleven (11) small aircraft tiedowns and two (2) large aircraft tiedowns in two single rows. The large tiedowns are 48 feet wide and 41 feet deep (anchor spacing in the “T”); the smaller tiedowns are standard size for small aircraft. The tiedowns are configured with the parking positions facing inward toward a taxilane that runs the length of the apron (parallel to the runway). The tops of the painted tiedowns are located 41 feet from the taxilane centerline.

The apron appears to be in similar condition as the runway, with surface weathering and light-to-moderate cracking ($\frac{1}{2}$ to $\frac{3}{4}$ -inch). The apron condition was rated “very good” in the 2005 pavement inspection. The apron markings (taxilane centerline stripe and aircraft tiedowns) appear to be in good or fair condition.

The apron includes a rectangular section (approximately 600 feet long and 100 feet wide) located immediately adjacent to the runway; a rear section of apron is connected to the southern portion of the rectangular apron. The rectangular apron section has a single taxilane (parallel to the runway) with four short taxiway connections to the runway. According to the airport's pavement maintenance plan, most sections of the USFS apron were constructed or resurfaced between 1996 and 2003. The pavement and markings appear to be in very good condition.

A small apron is located in front of the newer 3-unit hangar located near the southeast corner of the airport. The apron is located at the end of the taxiway that extends from the runway to the hangar. The apron condition was rated "very good" in the 2005 pavement inspection.

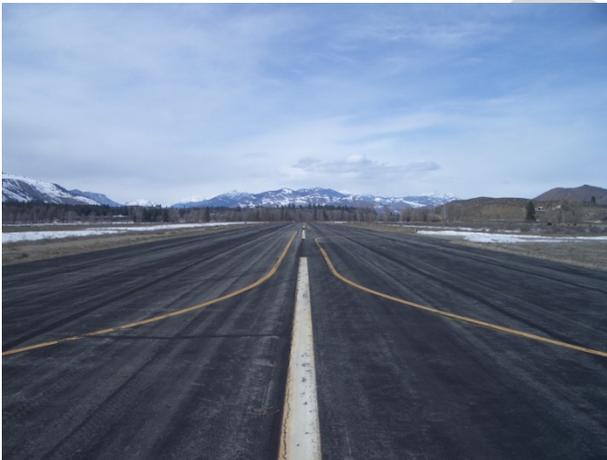
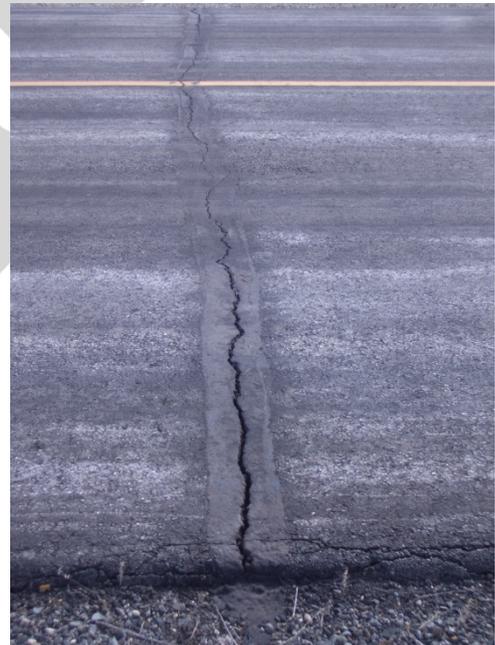
In the 2005 inspection, the runway and most taxiways and aprons were rated “very good” or better. Two small sections of apron were rated “good” and “fair.” The circular taxiway located adjacent to the fueling area was rated “very poor.”

The condition of the airfield pavements observed during recent site visits conducted for this project were generally consistent with the 2005 pavement evaluations. The runway and taxiway pavement surfaces are in generally good condition, with moderate transverse and longitudinal cracking, some weathering (oxidation) and surface wear observed. Although the older cracks (1/2-inch to 1-1/2 inch) have been previously filled, many have reopened and newer cracks have appeared. In some isolated areas of the runway, the crushed aggregate base beneath the 3-inch asphalt surface course was visible through open cracks. It appears that the pavement surfaces will require maintenance (crack filling, repair and sealcoats) in the near term.

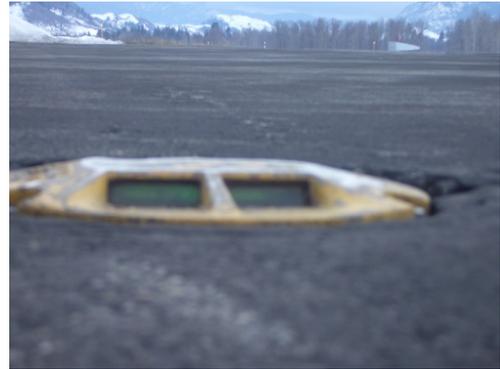
Threshold lights are located adjacent to both displaced thresholds; no lights are located at either end of the runway pavement. Since displaced thresholds are part of the useable runway, threshold lights should be located both at the end of the runway and at the landing threshold. The recommended lens colors for threshold lights depend on the runway configuration and whether standard runway safety areas are provided beyond the runway ends. The threshold lights for both displaced thresholds consist of 3 units per side with split red/green lenses.

- Runway 13 has flushed-mounted threshold lights. The lights located left (east) of runway centerline are imbedded in the asphalt surfaced aircraft turnaround. The lights appear to function properly, although minor damage (scraped and worn surface) was observed from snow plowing operations. The flush mounted threshold lights located right of centerline (west side) are installed directly into the ground surface. These lights appear to operate normally and are in good condition.
