**WSDOT NPDES Municipal Stormwater Permit  
Highway Monitoring Status Report  
Water Year 2023**

October 2024

Stormwater Monitoring and Research Program  
Environmental Services Office  
Washington State Department of Transportation

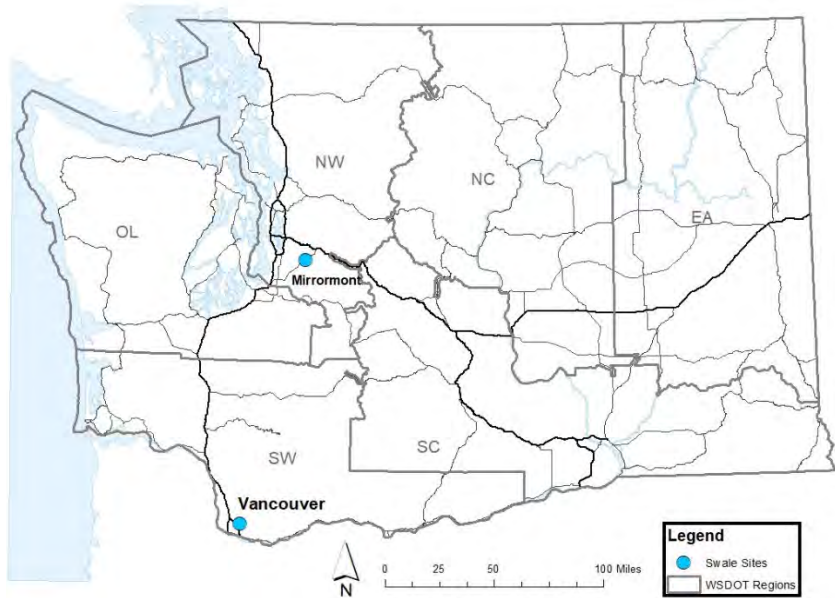
**Figure 1. Highway Study Site Locations**

WSDOT selected two biofiltration swale study sites (Figure 1) based on the design guidelines listed below. An overview of the sites selected is given in Table 1. Additional site selection criteria for this study, accounting for characteristics of both monitoring locations, are:

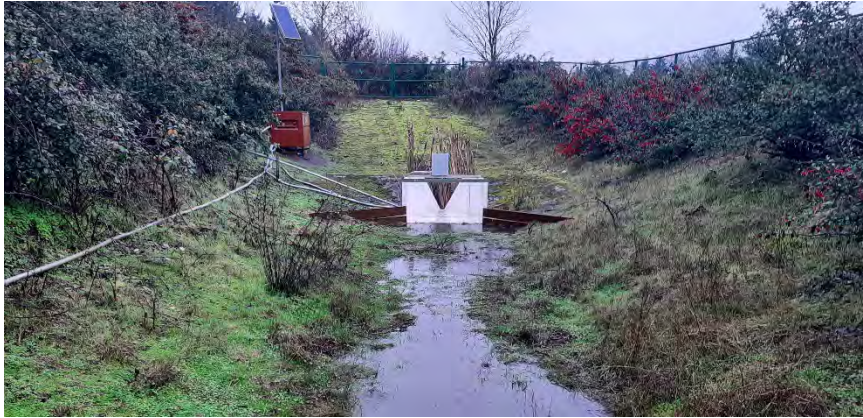
**Figure 3. Vancouver bioswale effluent**

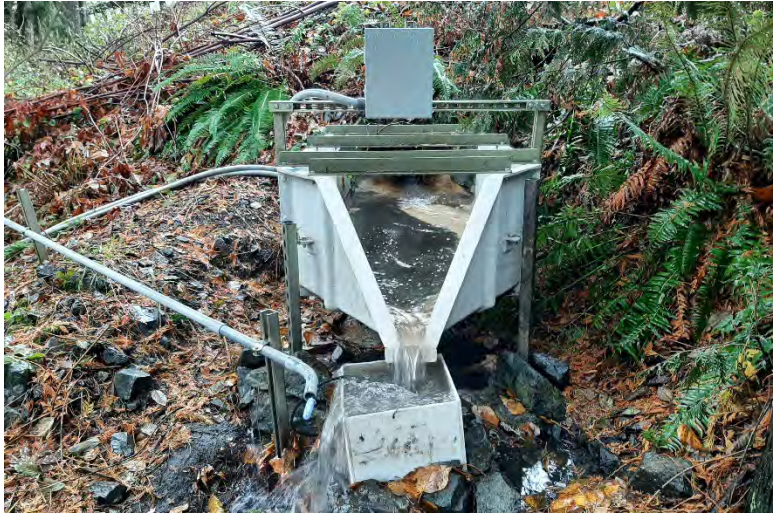
**Figure 5. Mirrormont influent monitoring equipment**

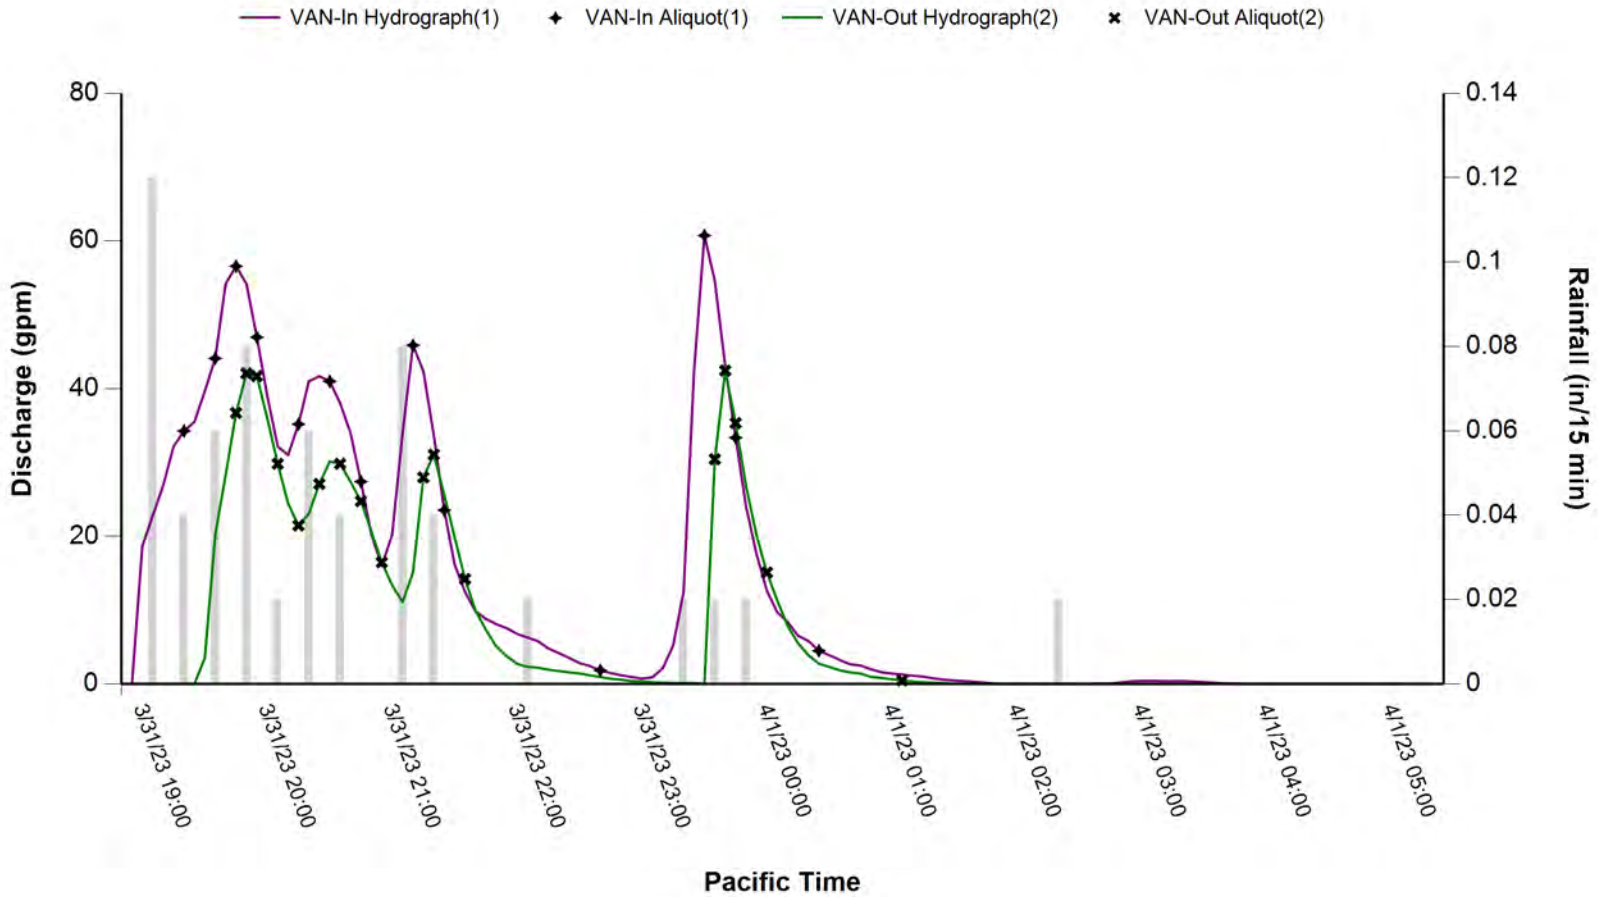
### 22 Vancouver 4/1/2023 Storm Event

Precipitation				
Total (in)	Start Time (Pacific)	End Time (Pacific)	Duration (hrs)	Antecedent Dry (hrs)
0.32	03/31/2023 18:55	04/01/2023 02:15	7.33	81.08

Aliquots								Water Temp	
Sample Point (m)	Sample Point Name	Aliquots Collected	First Aliquot Time (Pacific)	Last Aliquot Time (Pacific)	Sampling Duration (hrs)	Volume (mL)	Total Sample Volume (mL)	Min (°C)	Max (°C)
1	VAN-In	13	03/31/2023 19:20	04/01/2023 00:25	5.08	250	3,250	7.70	9.00
2	VAN-Out	17	03/31/2023 19:45	04/01/2023 01:05	5.33	250	4,250	7.60	8.70

Runoff / Discharge														
		Runoff Time			Volume			Sampled		Flow			Stage	
Sample Point (m)	Sample Point Name	Start Time (Pacific)	End Time (Pacific)	Duration (hrs)	Total (gal)	Intensity (gal/hr)	First 24Hrs (gal)	Discharge Total Volume Sampled (gal)	% Hydrograph Sampled	Peak (gpm)	Min (gpm)	Mean (gpm)	Max (ft)	Hydrology Validation Code
1	VAN-In	03/31/2023 19:00	04/01/2023 05:15	10.25	7,697.2	750.9	7,697.2	7,560.8	98.20	60.74	0.01	12.94	0.304	
2	VAN-Out	03/31/2023 19:30	04/01/2023 01:25	5.92	4,497.7	759.7	4,497.7	4,493.3	99.90	42.45	0.13	12.67	0.211
