2007 Western Bridge Engineers' Seminar

Fracture Critical and Fatigue Prone Inspection of the West Fremont Bridge Approach Structures

Portland, Oregon

Mark Libby, PE – HDR Engineering, Inc.

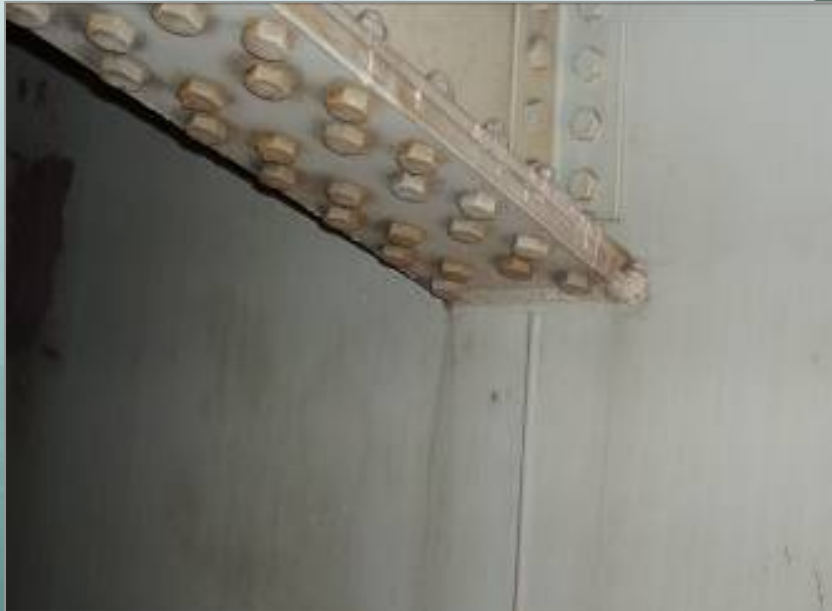
- Web splice at floorbeam connection

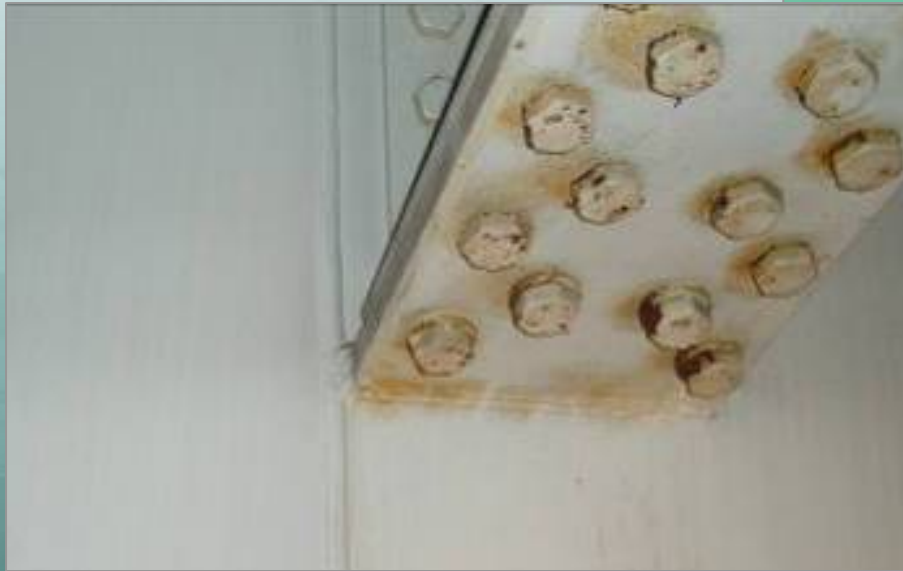
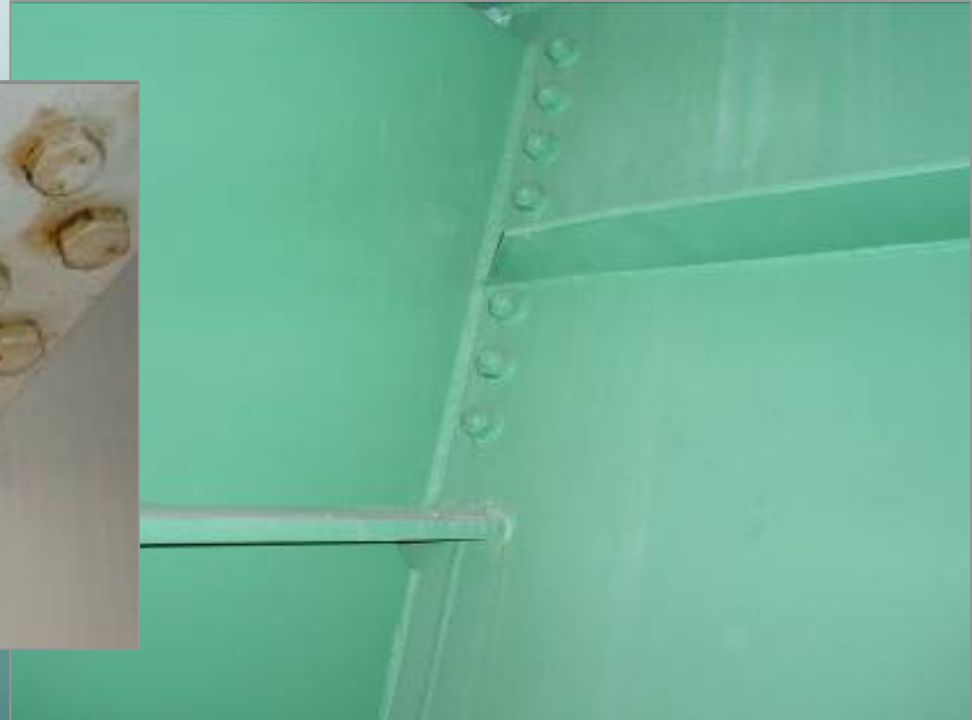
- Web splice at floorbeam connection

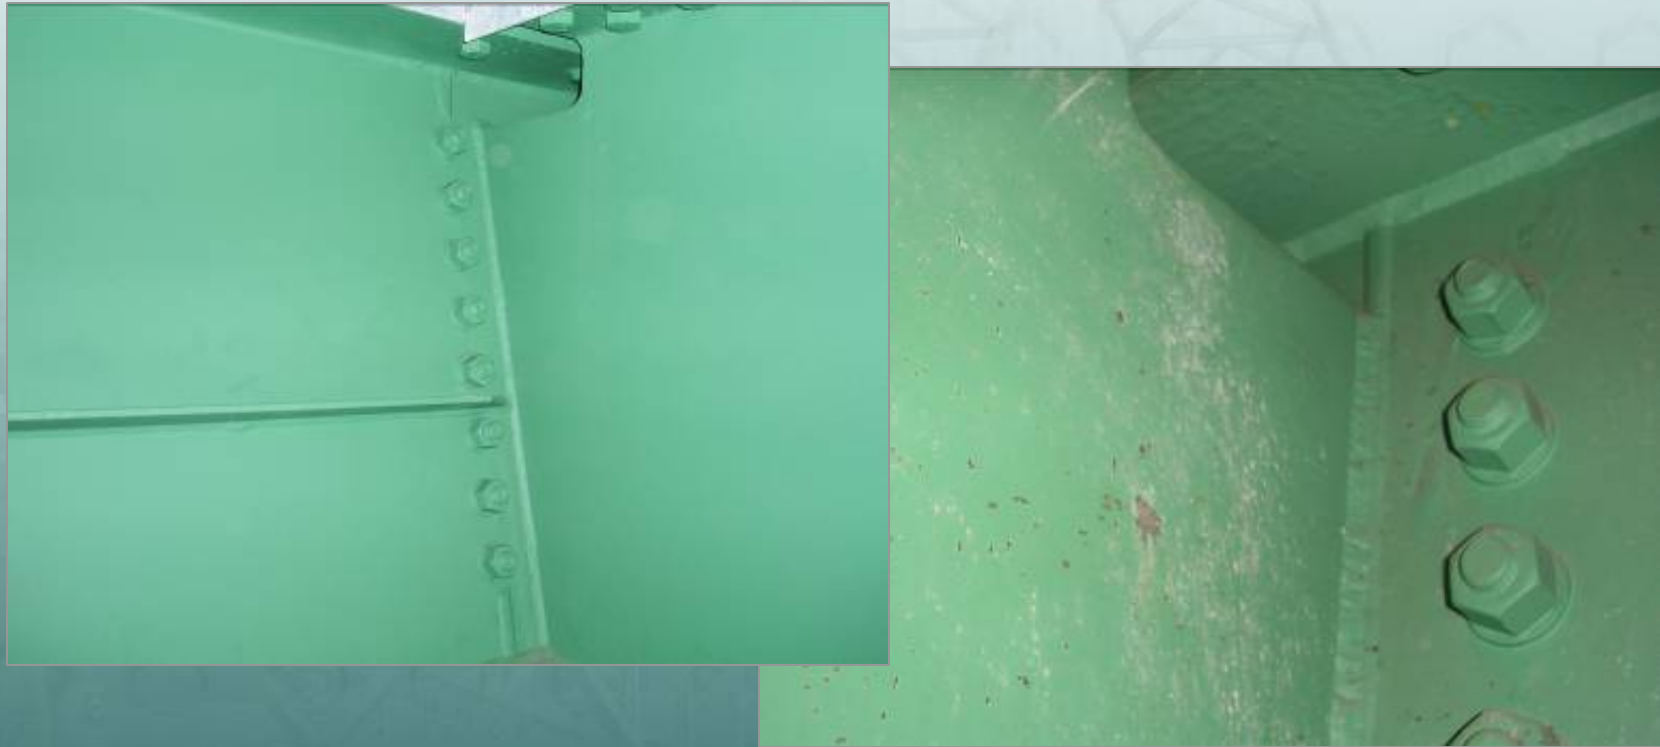
- Web splice at internal diaphragm

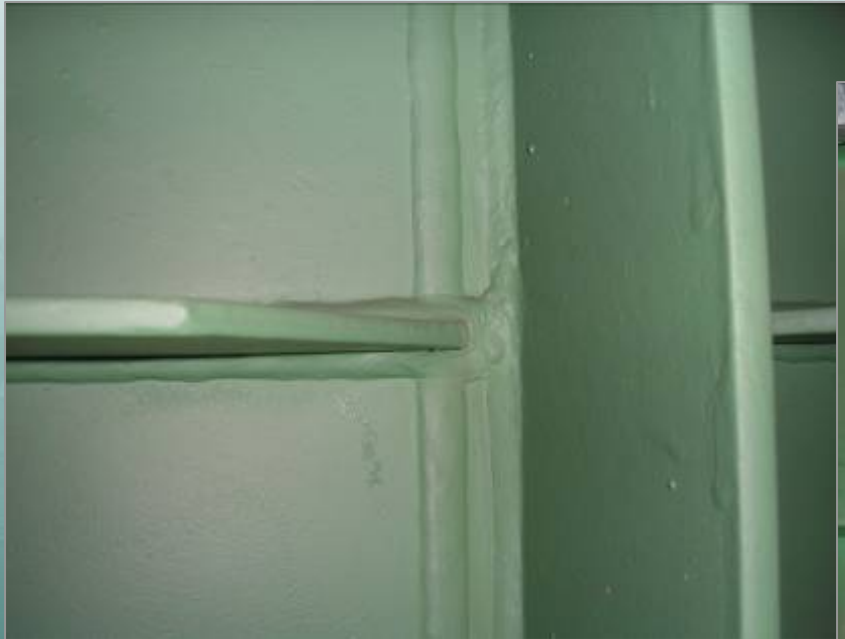
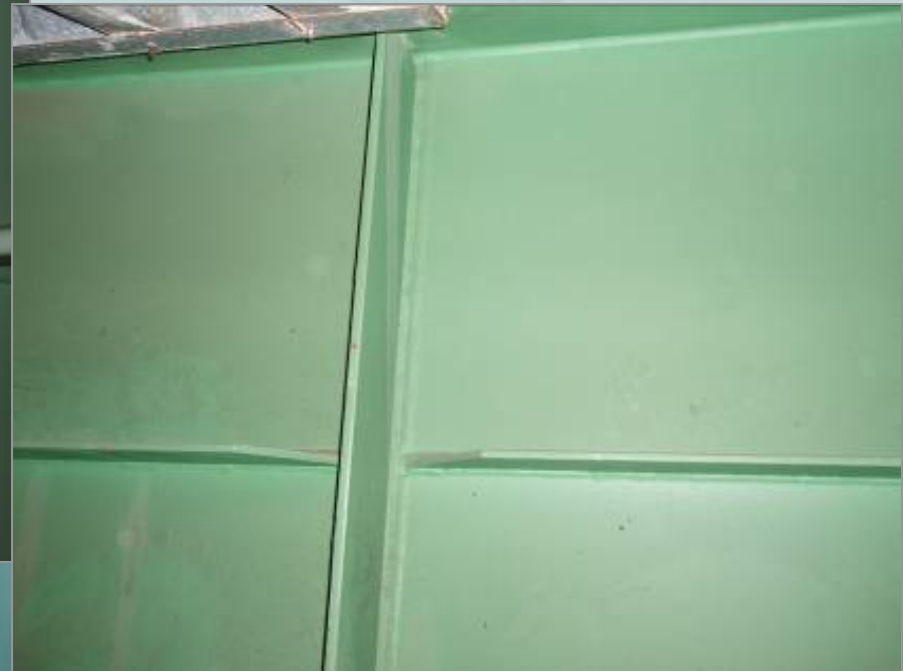
- Web splice, transverse stiffener, longitudinal stiffener

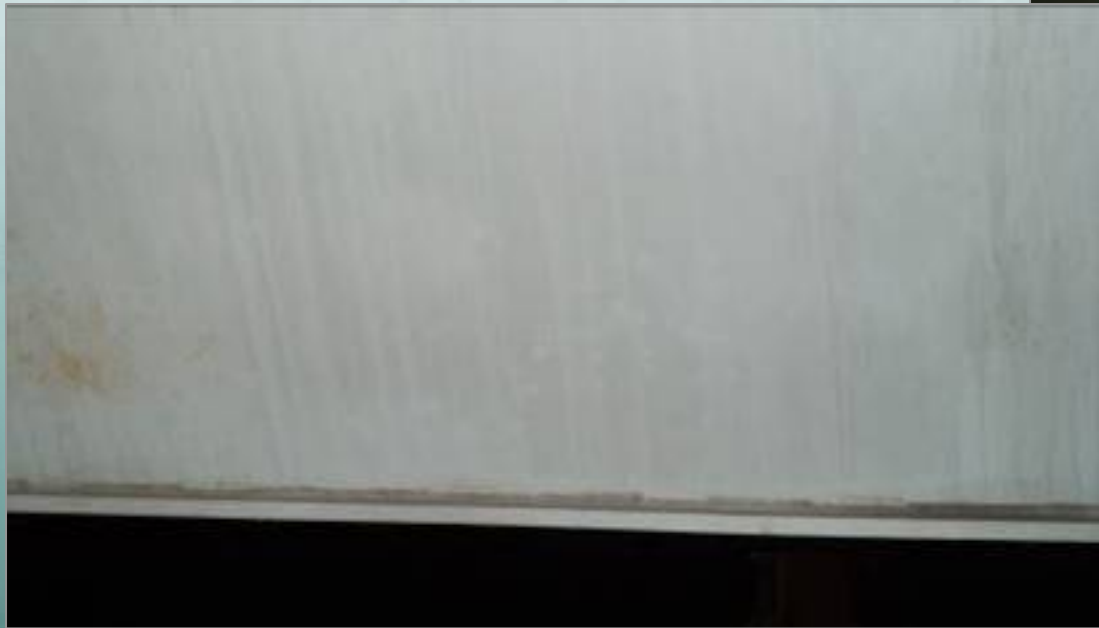
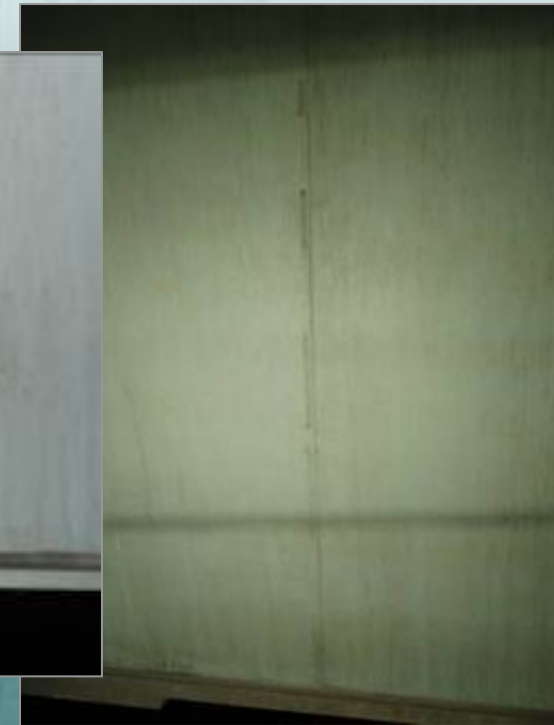
- Intermittent piggy-back welds

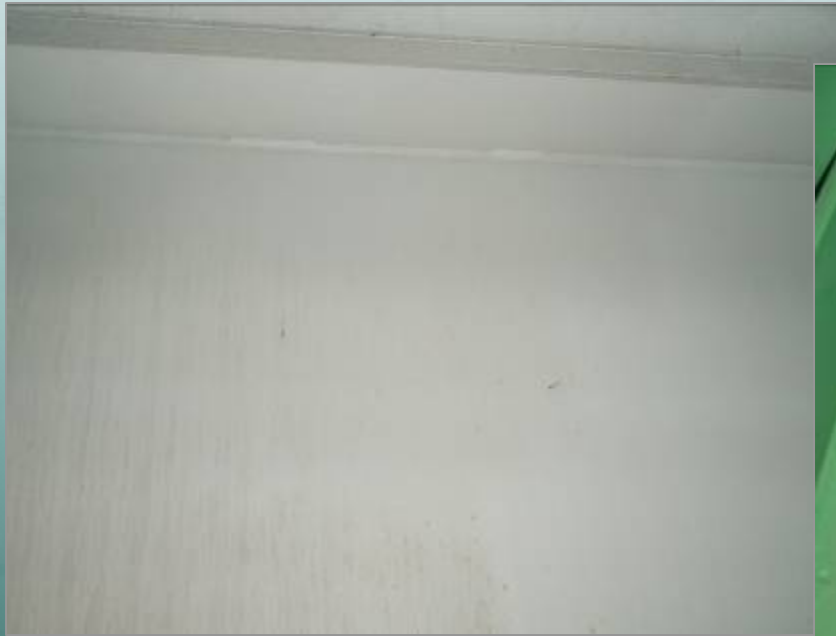
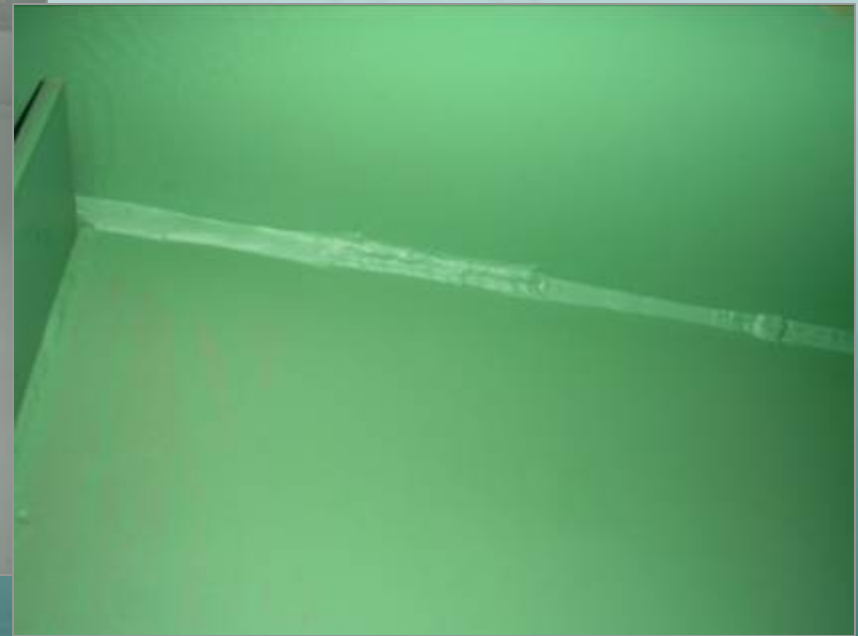
- Intermittent piggy-back welds
